WATERSHED MANAGEMENT PLAN FOR BETHLEHEM ST. CROIX, USVI

JUNE 2022

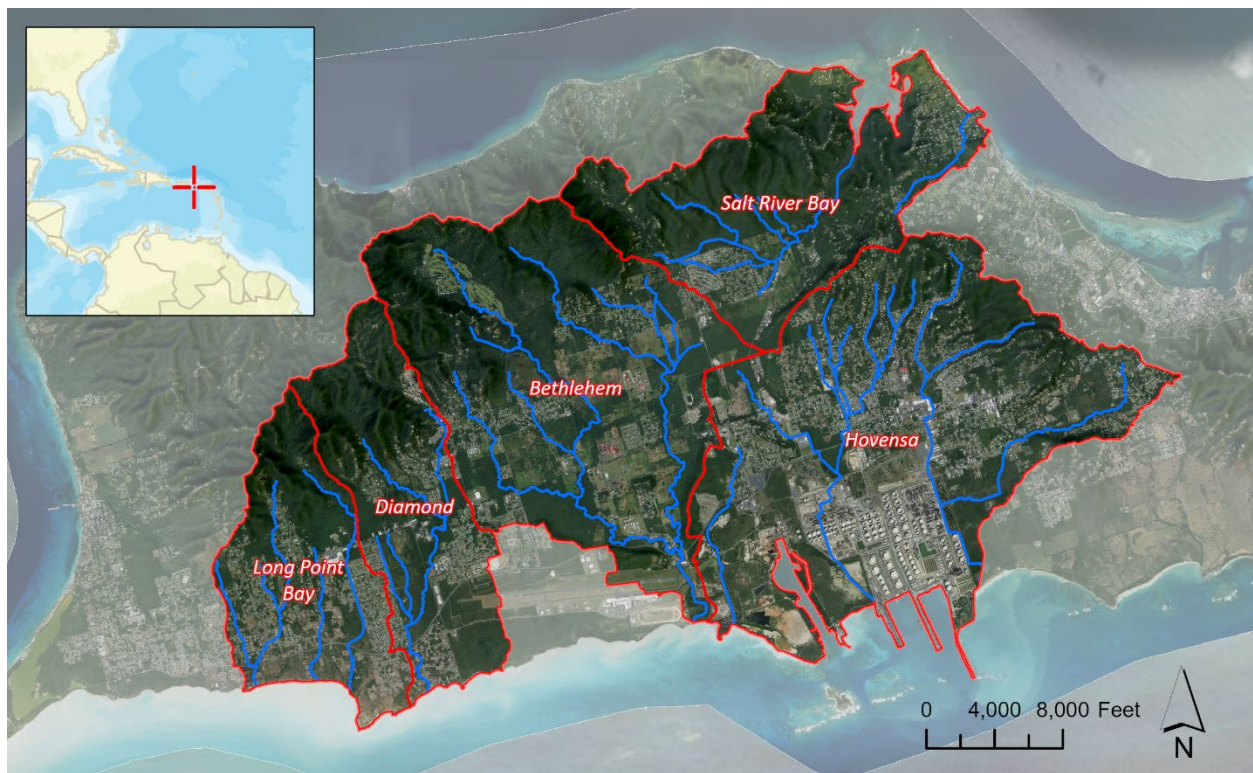
Figure 1. The five study watersheds on St. Croix are outlined in red.

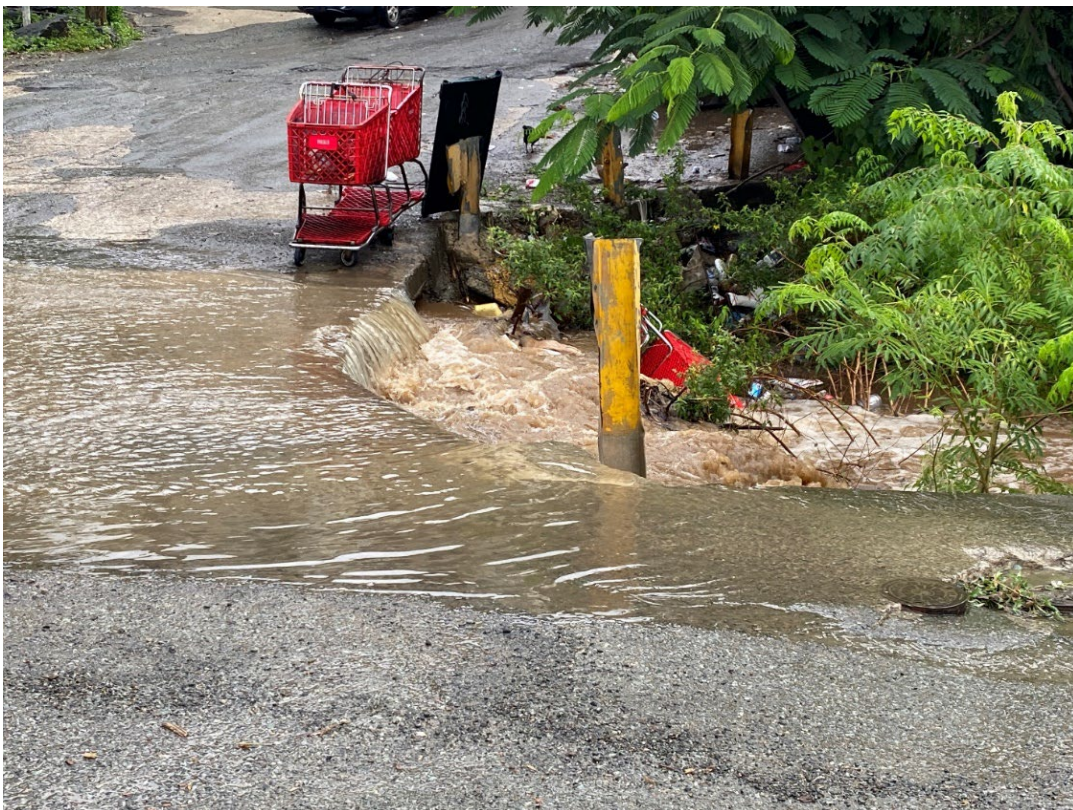
Figure 5. Runoff from impervious surfaces such as a road contributes to flooding and water quality problems.

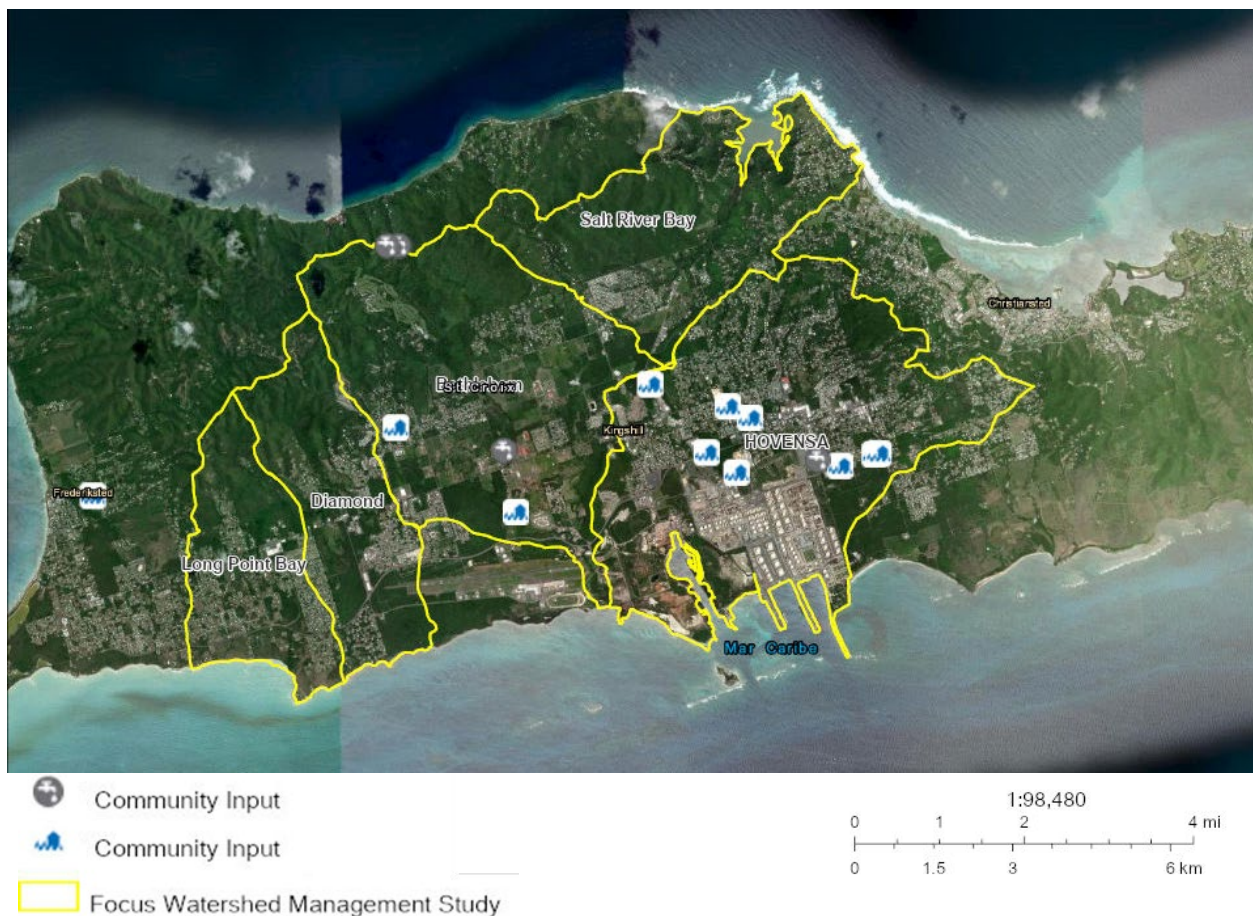
Figure 12. Flooding and water quality problem areas identified by community members.

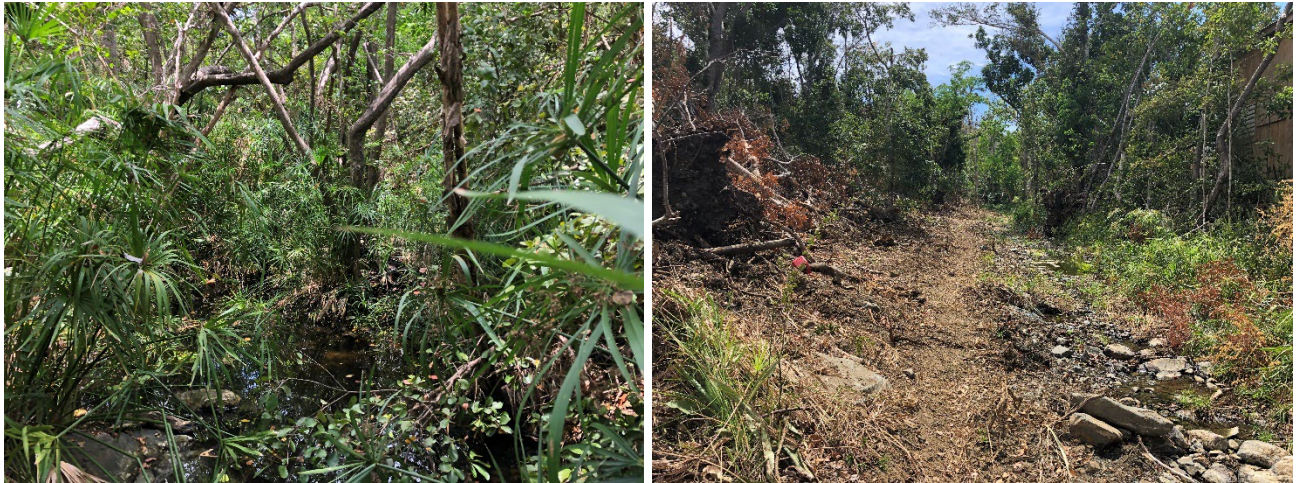
Figure 13. Photos of a gut taken by a resident before (left) and after (right) excavation.

In one specific incident, a community member detailed the excavation of old growth trees within an existing gut and along its banks (Figure 13). The community member noted how the trees used to provide shade and shelter to many species of mammals, birds, and reptiles. The area was once a place he would take his family to recreate. He stated that the excavation of the gut and its riparian buffer destroyed this ecosystem, and there has been no follow up to amend the environmental consequences of the destruction.

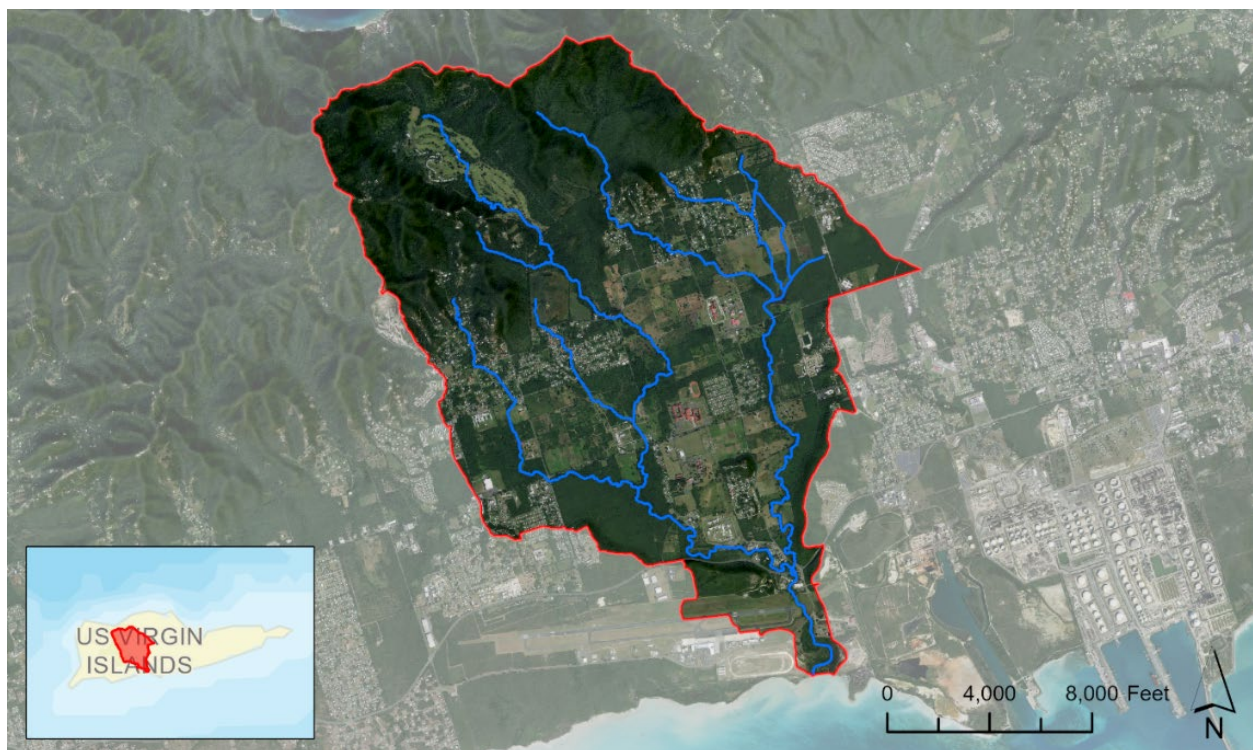
Figure 16. Overview map of the Bethlehem watershed.

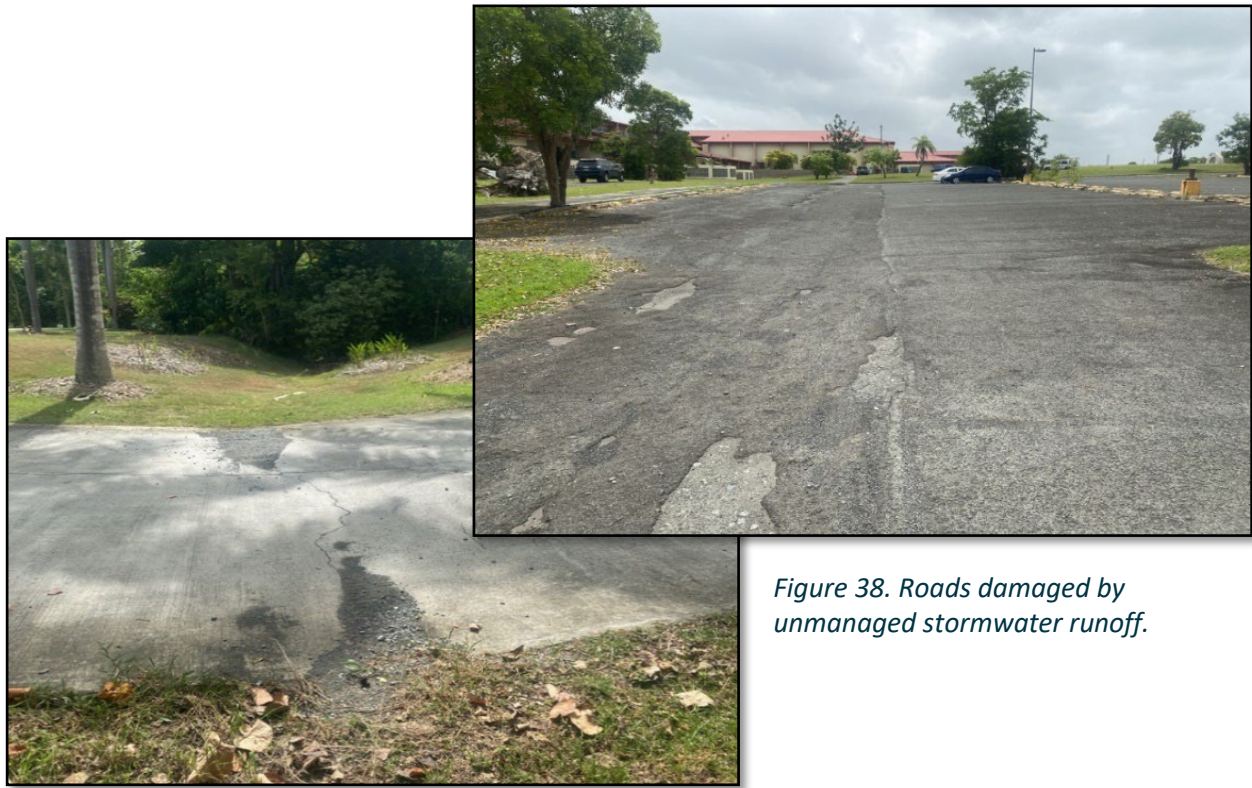
Figure 38. Roads damaged by unmanaged stormwater runoff.

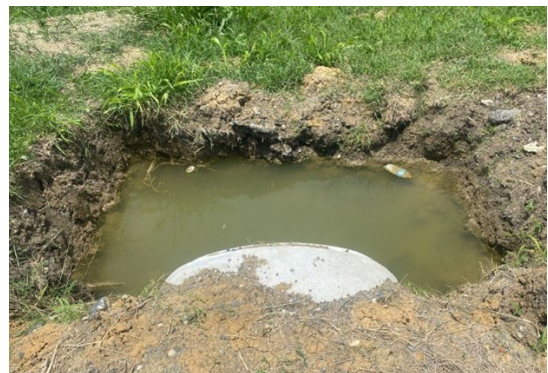
Figure 40. Illicit discharge coming from outfall on St. Croix.

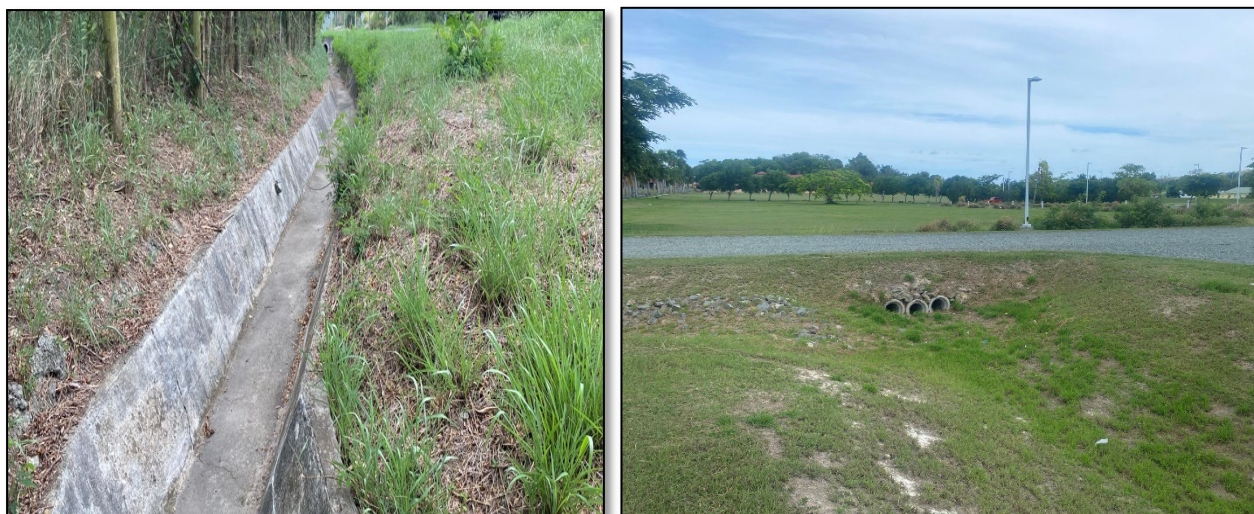
Figure 48. Examples of stormwater infrastructure: a swale (left) and culverts (right).

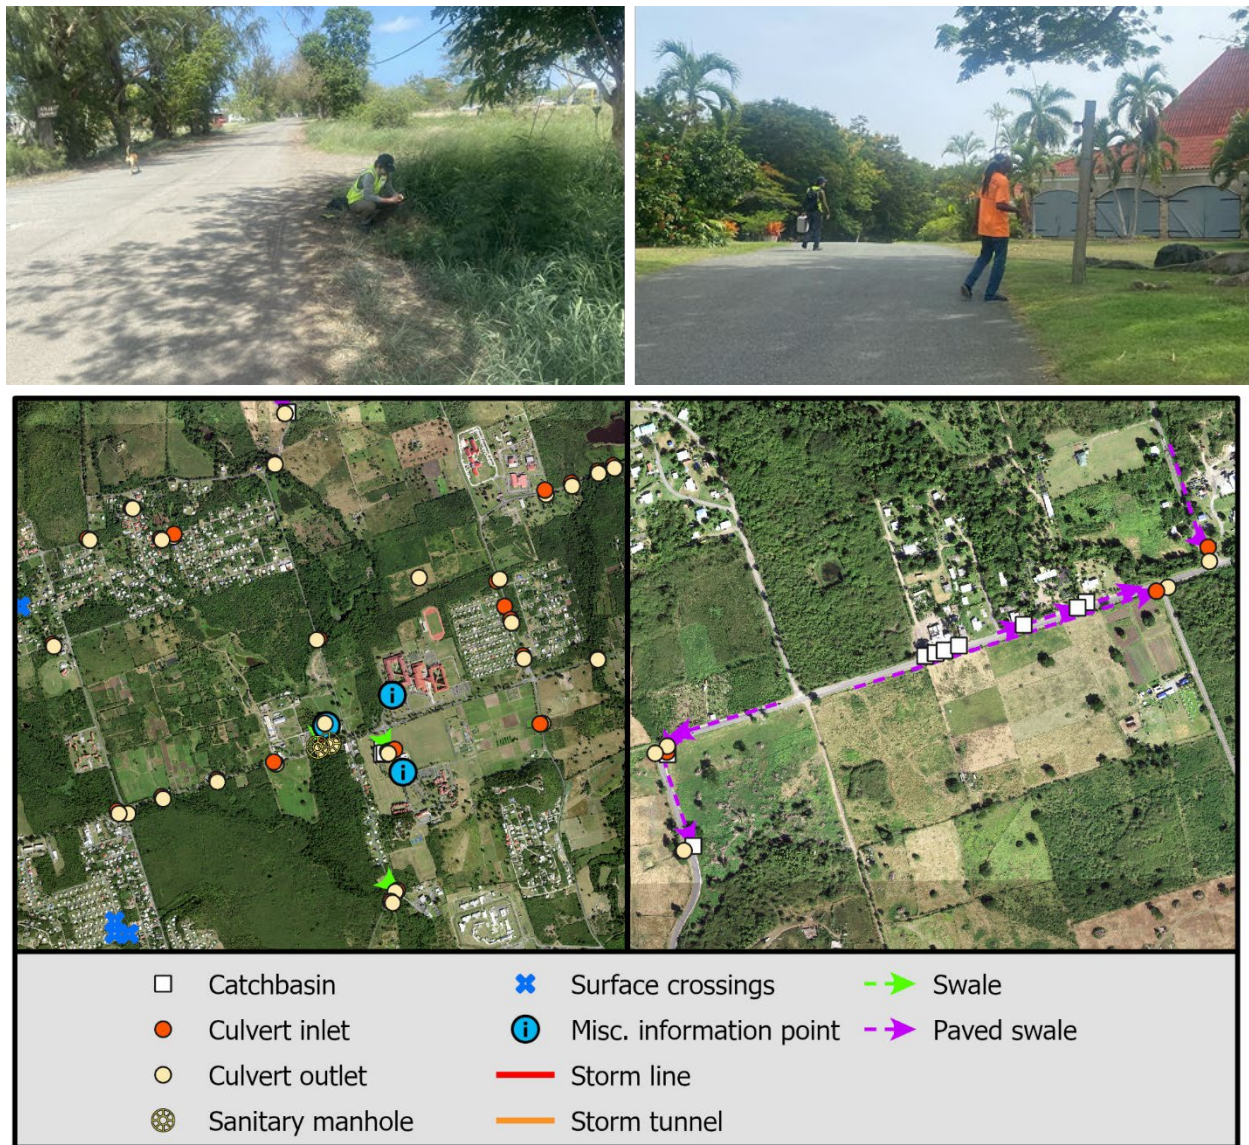
Figure 49. Inspection of existing stormwater infrastructure during field assessments (above) and an example of the maps produced (below).

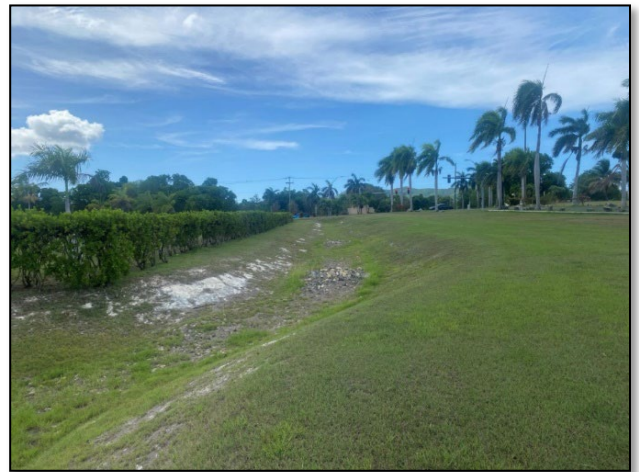
Figure 50. Existing infiltration basin.

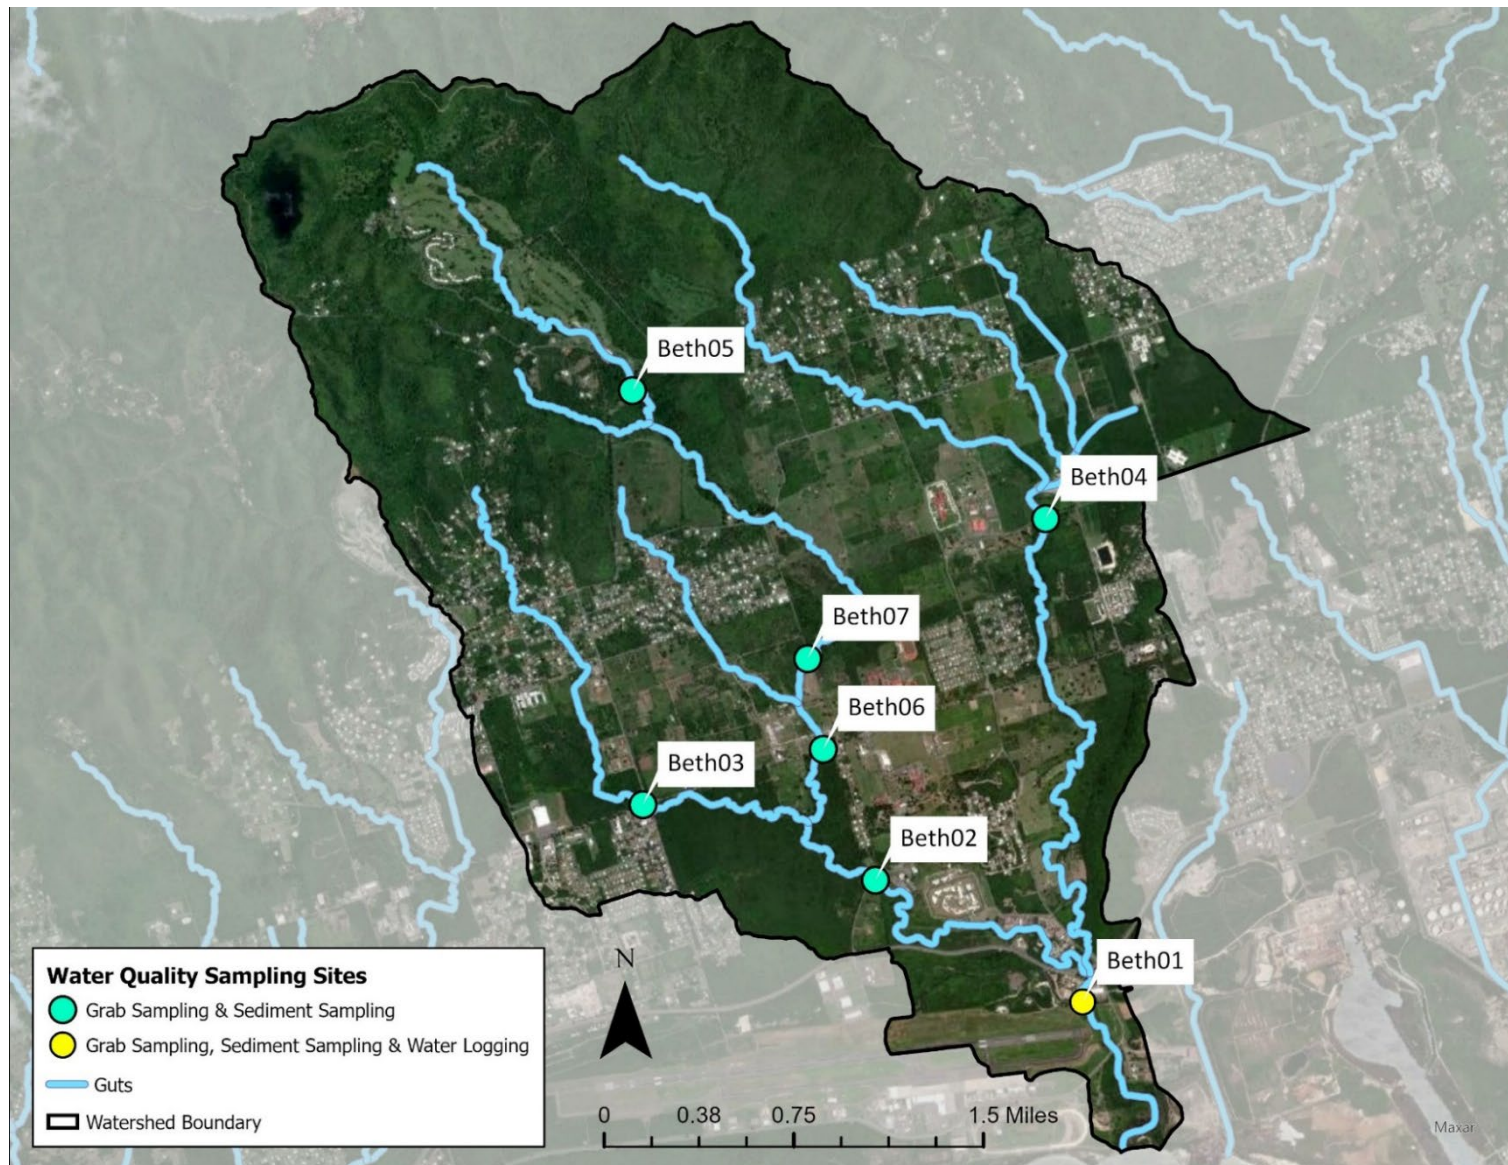
Figure 53. Grab sampling, sediment sampling, and water logging locations.

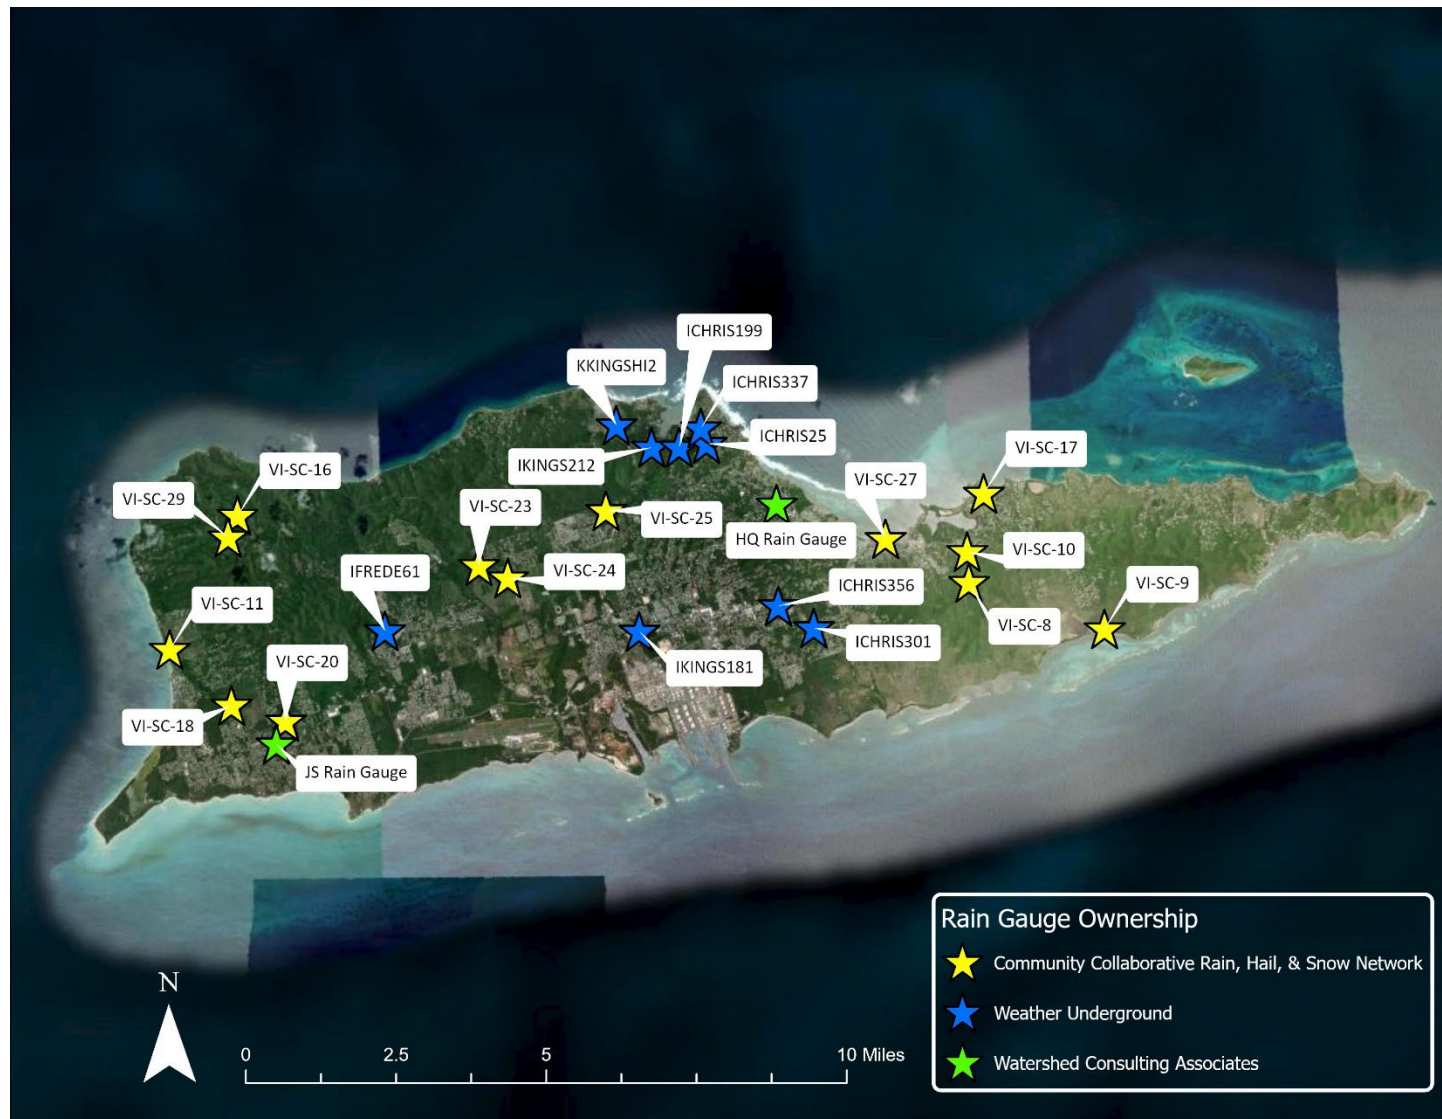
Figure 55. Rain gauge locations on St. Croix

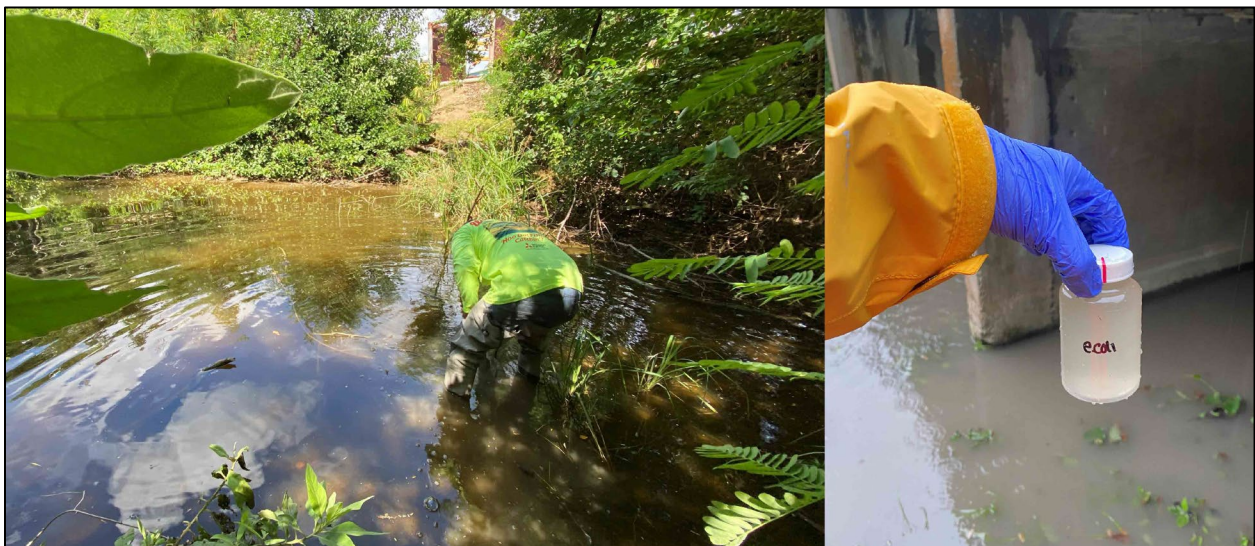
Figure 56. Grab sample collection from sampling sites Beth01 (left) & Beth03 (right).

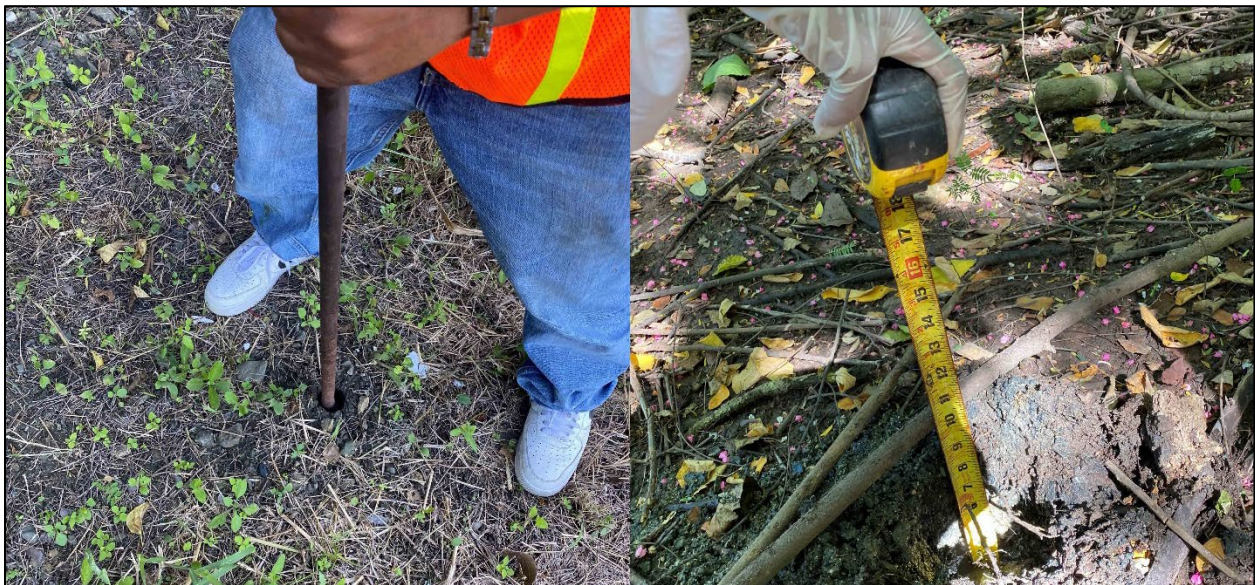
Figure 58. A sediment core being collected from the Beth06 gut channel (left). The depth of the extracted sediment core verified with a tape measure at Beth01 (right).

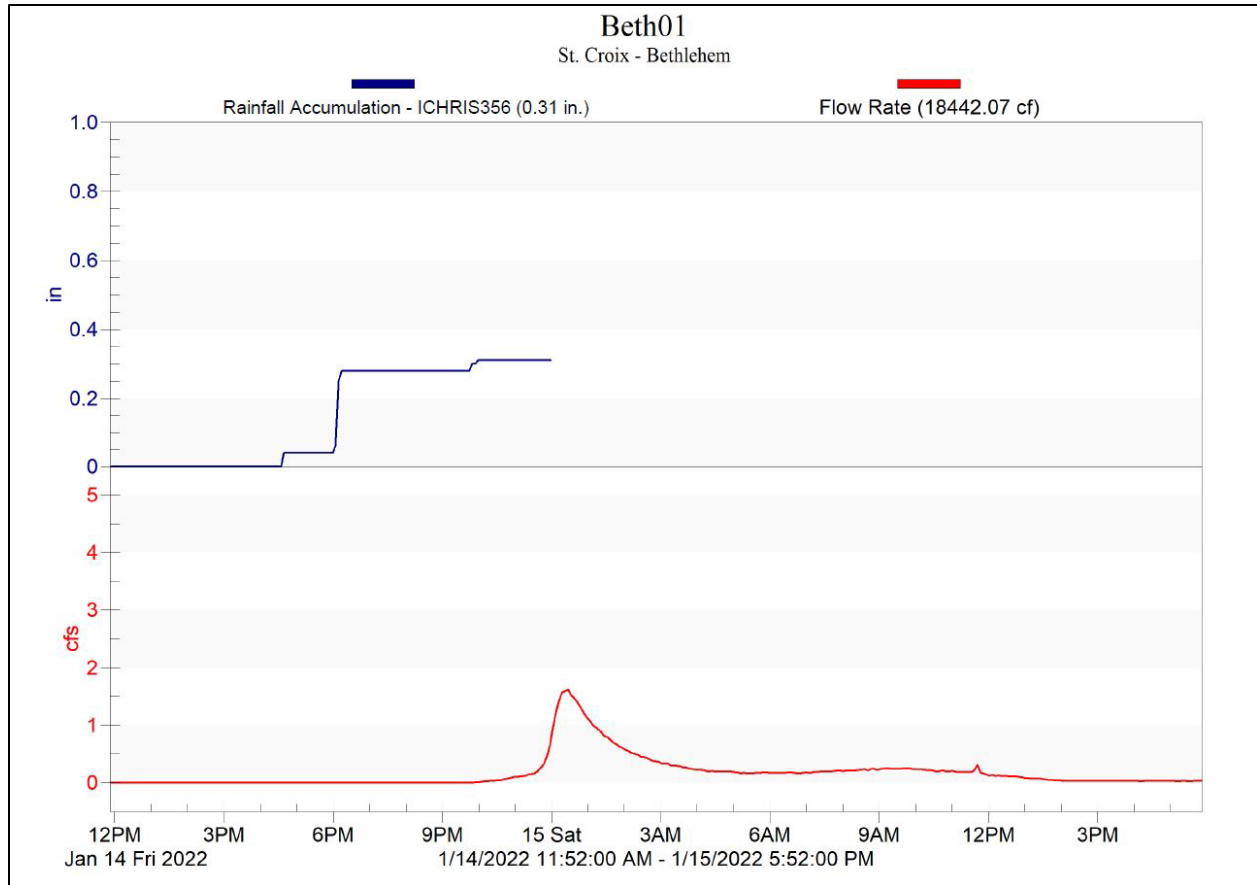
Figure 59. A hydrograph displaying flow at the Beth01 gut monitoring site (1.61 cfs) in red and the corresponding rainfall accumulation for the storm event (0.31 in.) in blue that occurred on January 14th, 2022.

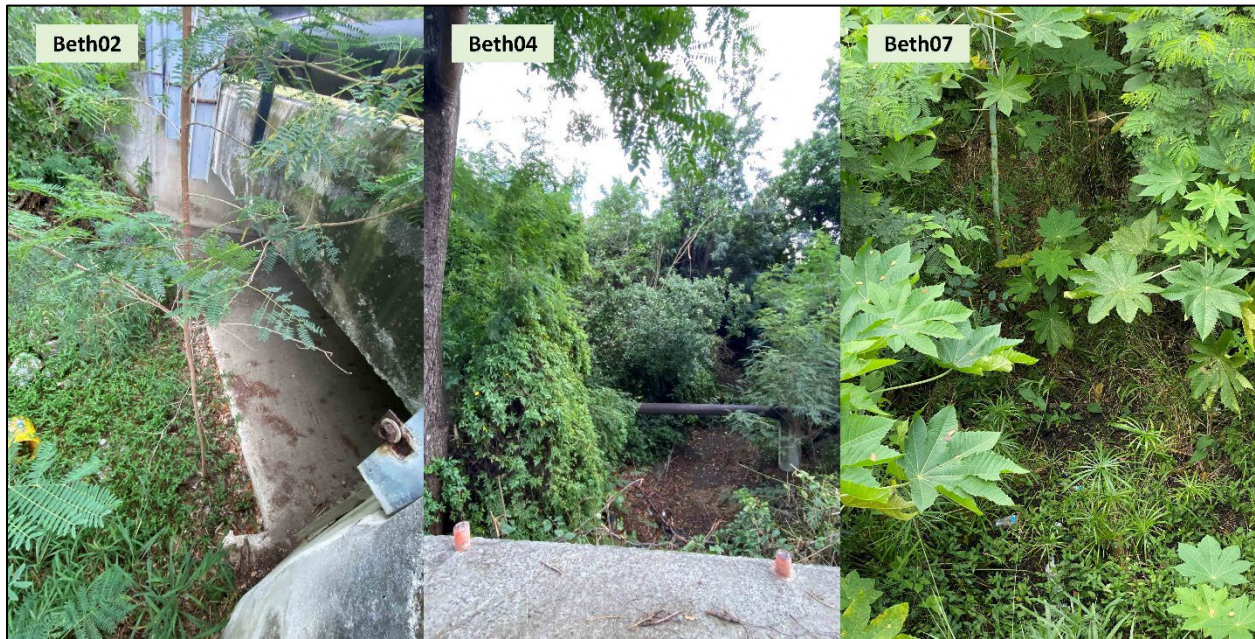
Figure 61. No storm flow was observed at Beth02, Beth04, and Beth07 monitoring locations during a qualifying storm event.

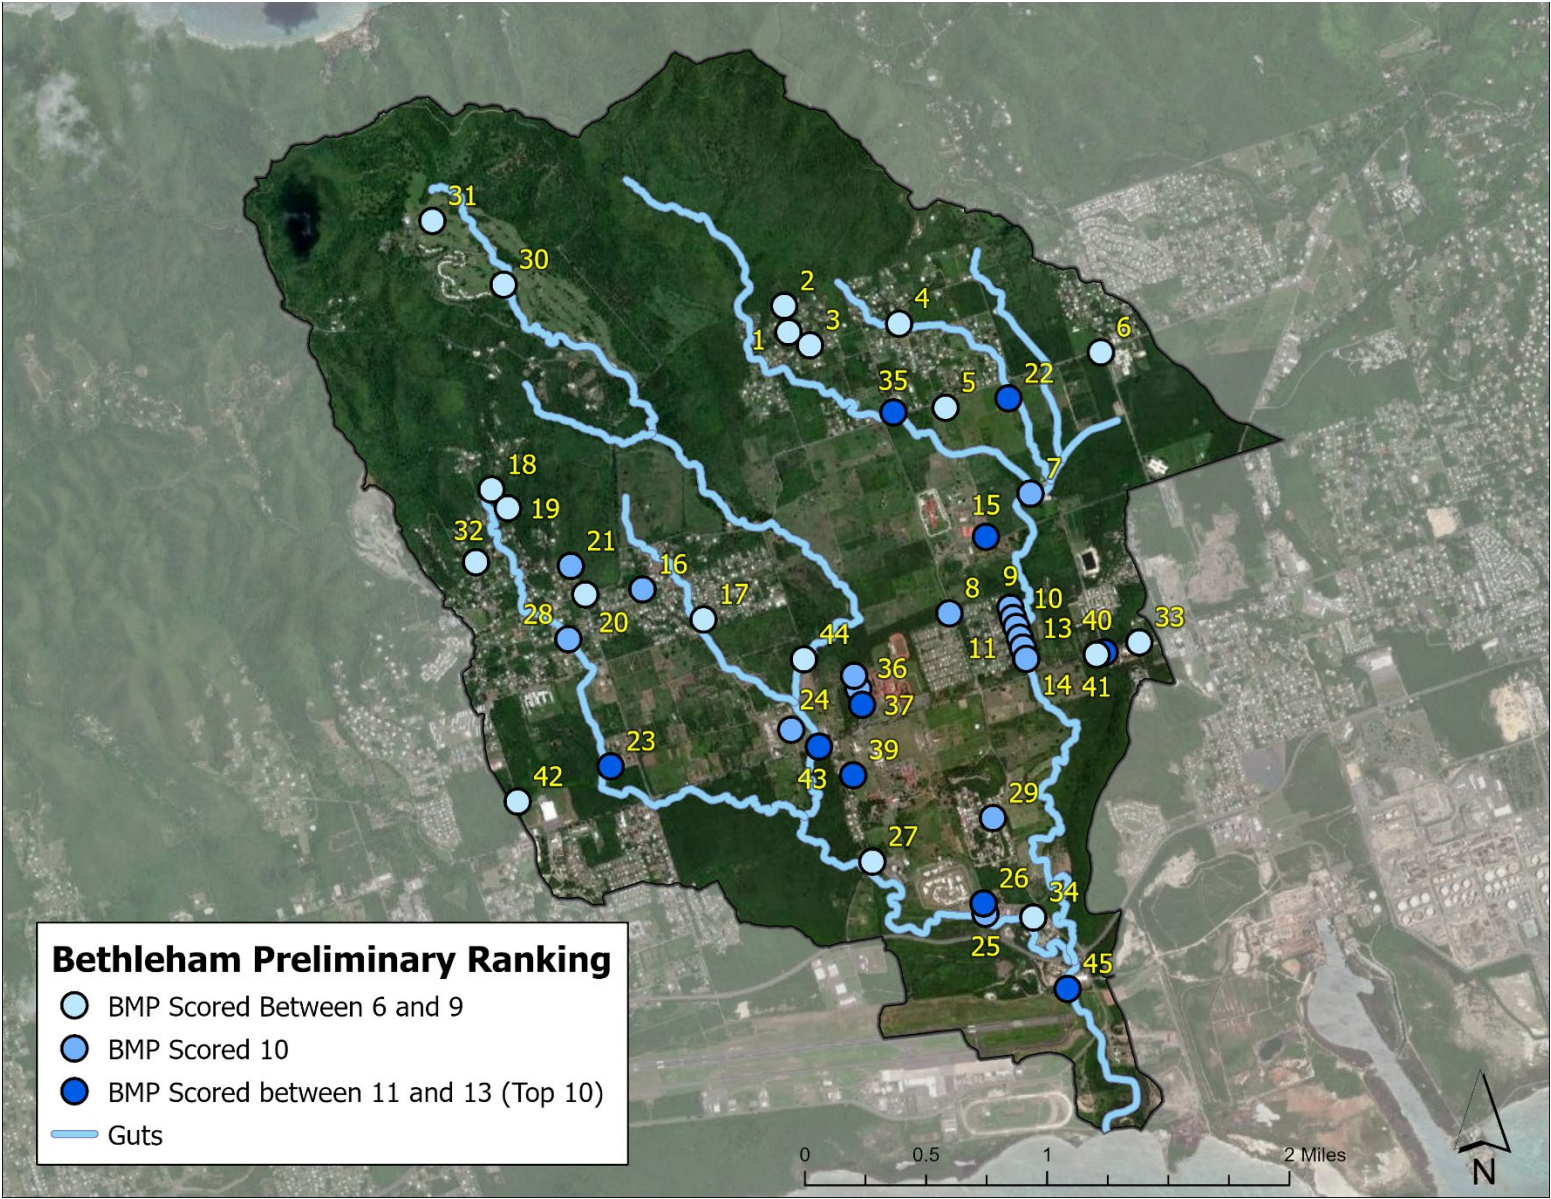
Figure 77. Map of proposed BMP points and preliminary ranking results for the Bethlehem watershed.

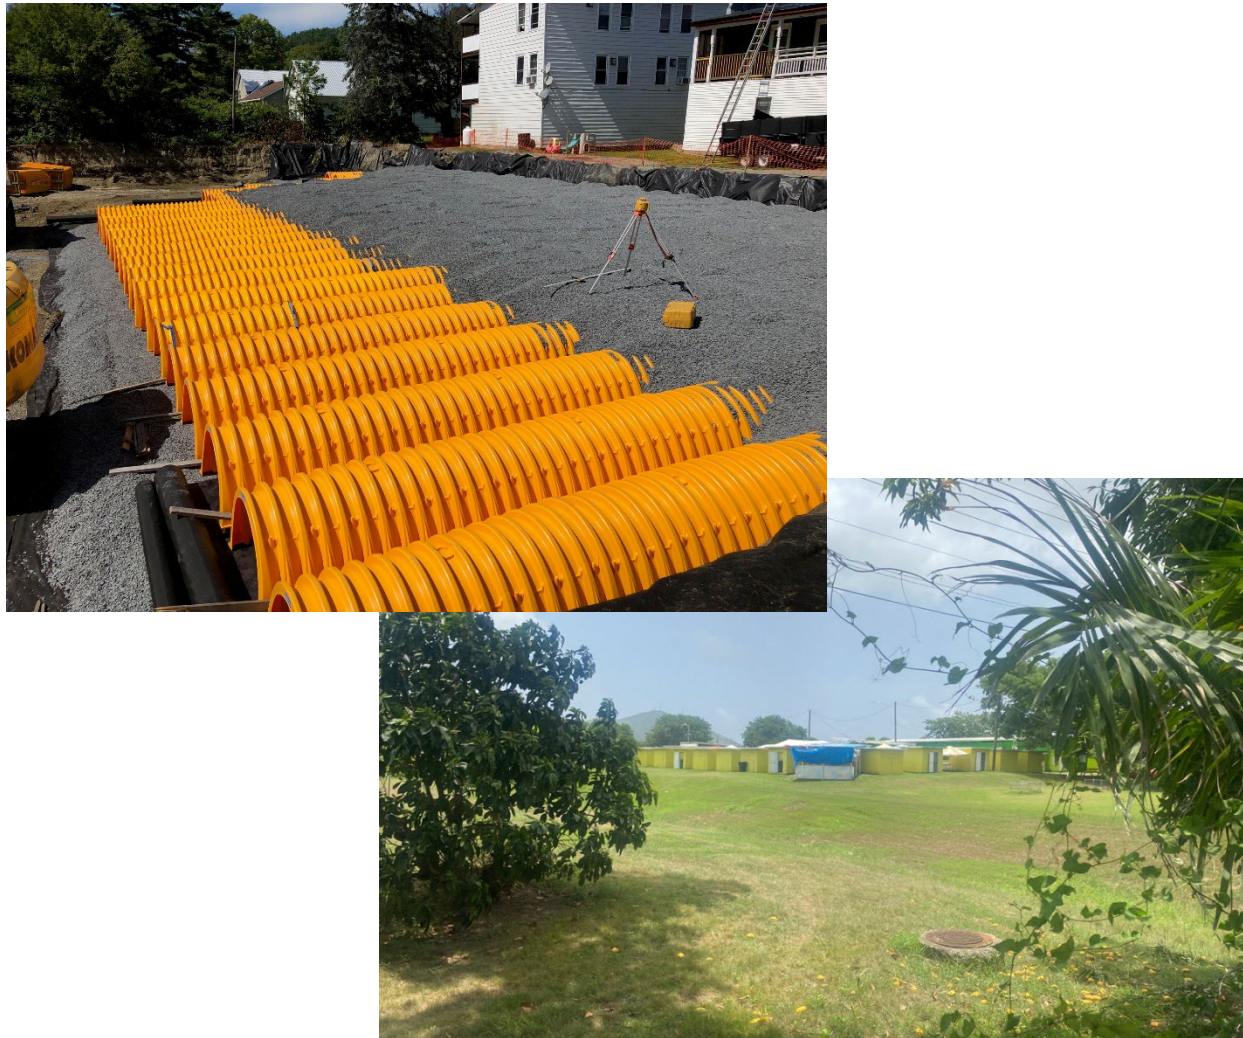
Figure 79. Example photo of subsurface infiltration chambers (above) and USVI Department of Agriculture fairgrounds (below).

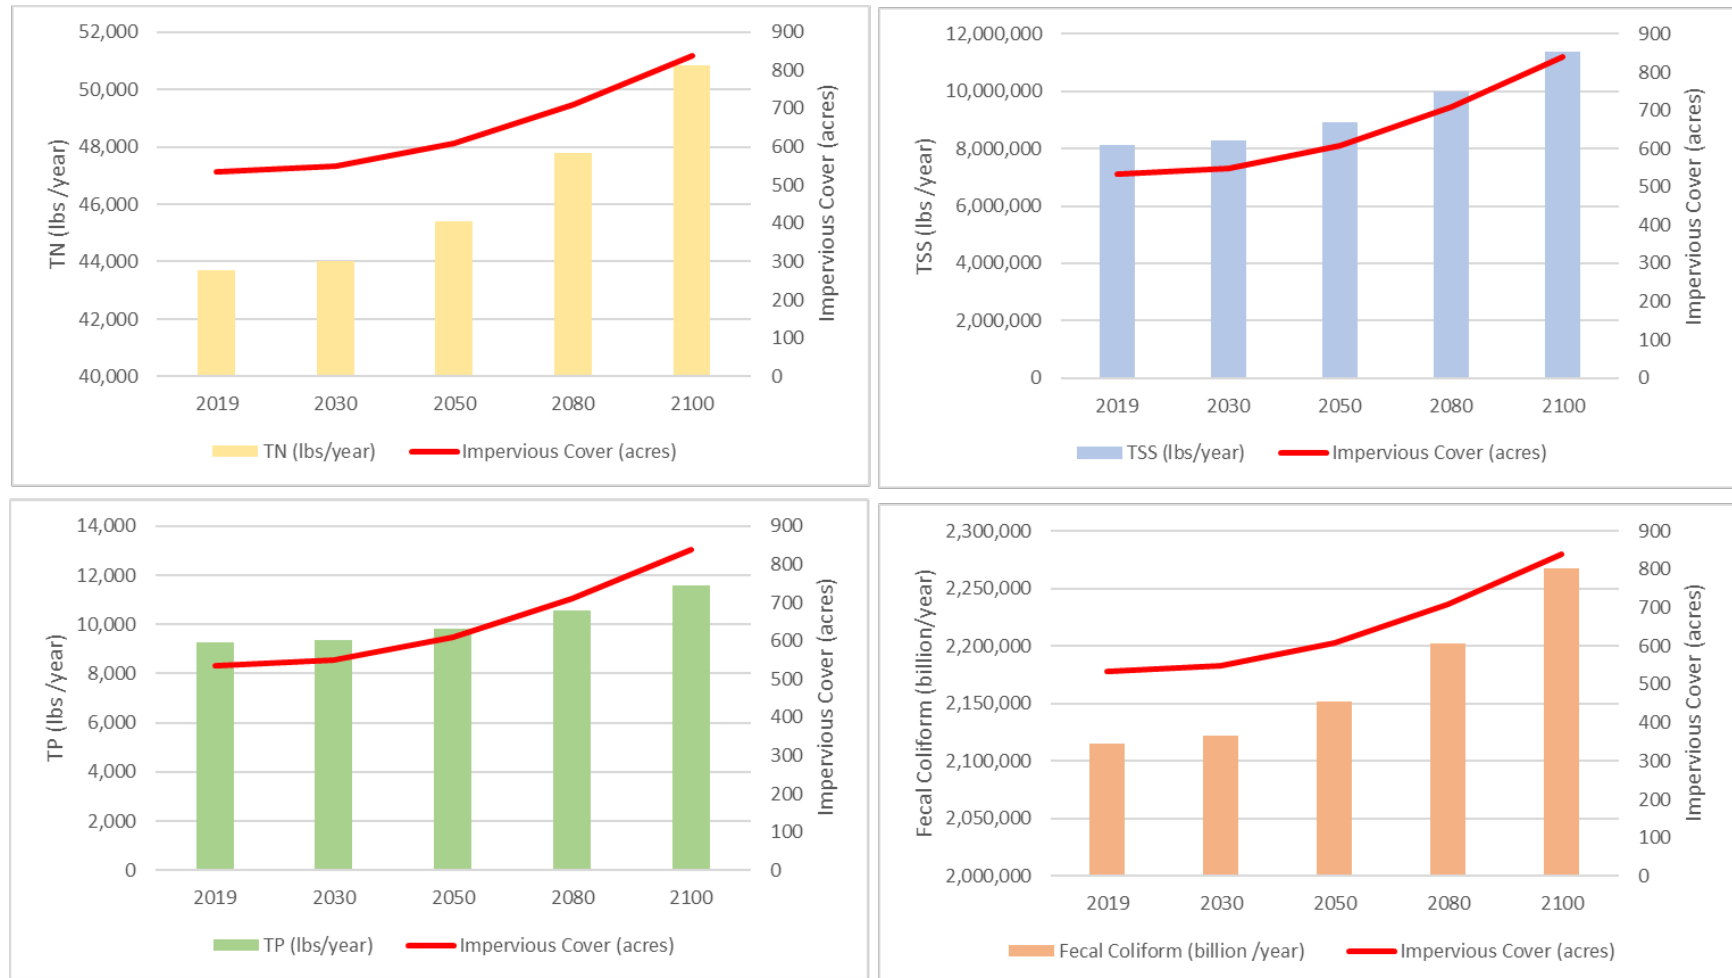
Figure 85. Relationship between watershed-scale pollutant loading for TN (yellow), TSS (blue), TP (green), and Fecal Coliform (orange) and the predicted impervious cover increase (red) over time.

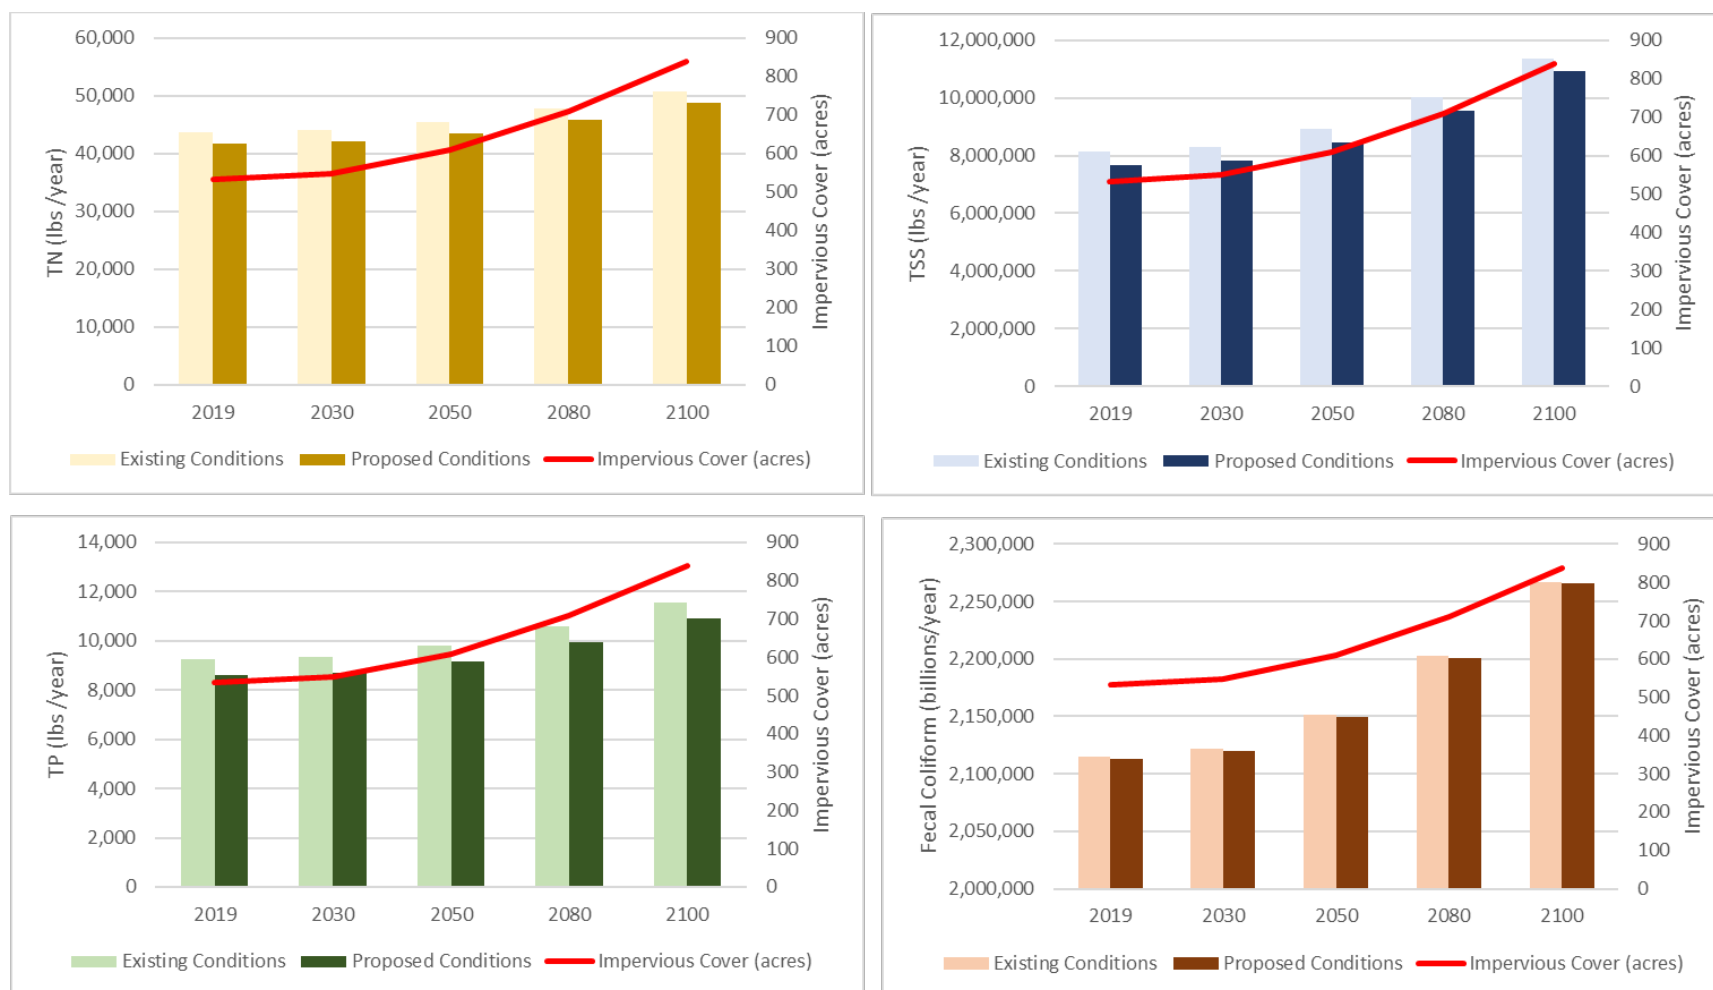
Figure 90. Relationship over time between watershed scale pollutant loading for the existing conditions (lighter colors) and proposed conditions (darker colors), which includes the implementation of the Top 10 BMPs. Loading is shown for TN (yellow), TSS (blue), TP (green), and Fecal Coliform (orange). The predicted impervious cover increase (red line) over time is also shown.
