# WATERSHED MANAGEMENT PLAN FOR THE DIAMOND WATERSHED ST. CROIX, USVI

JUNE 2022

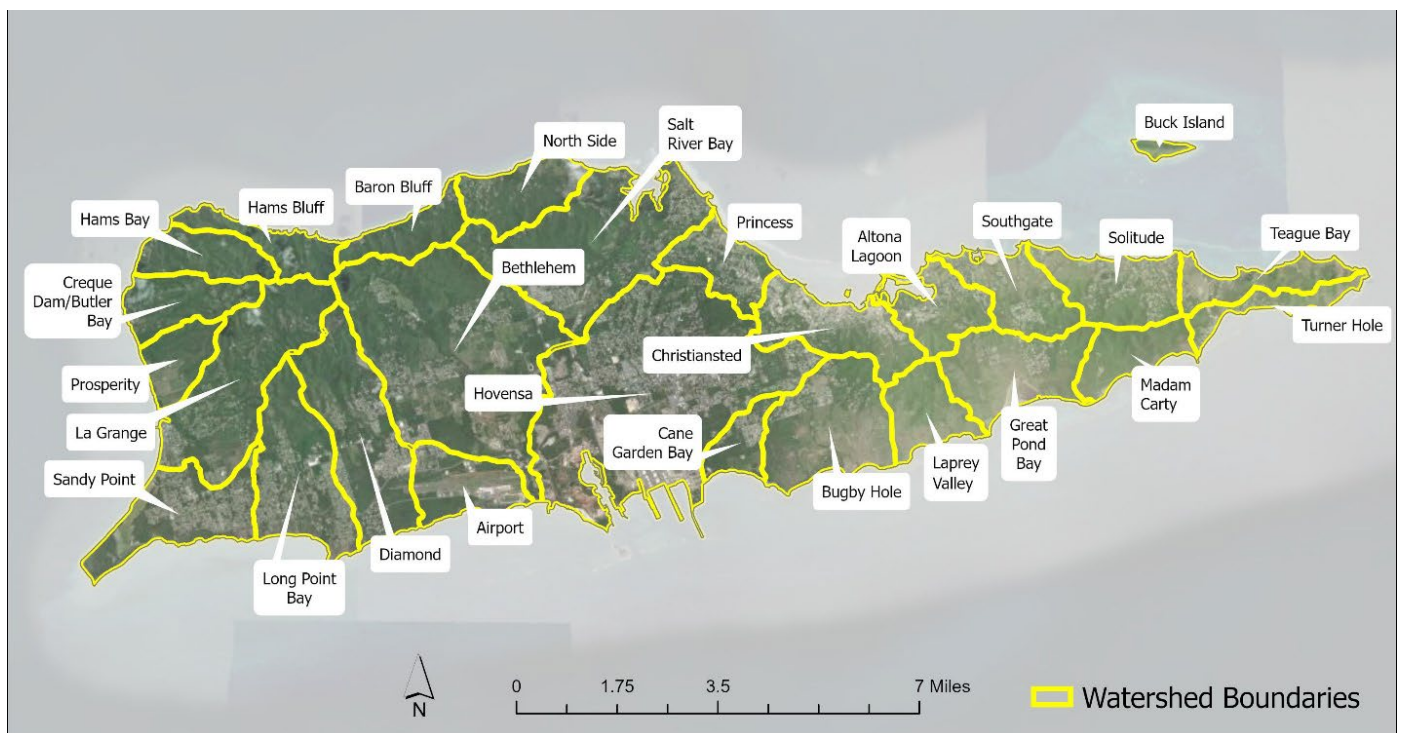
Figure 4. The 27 primary watersheds of St. Croix.

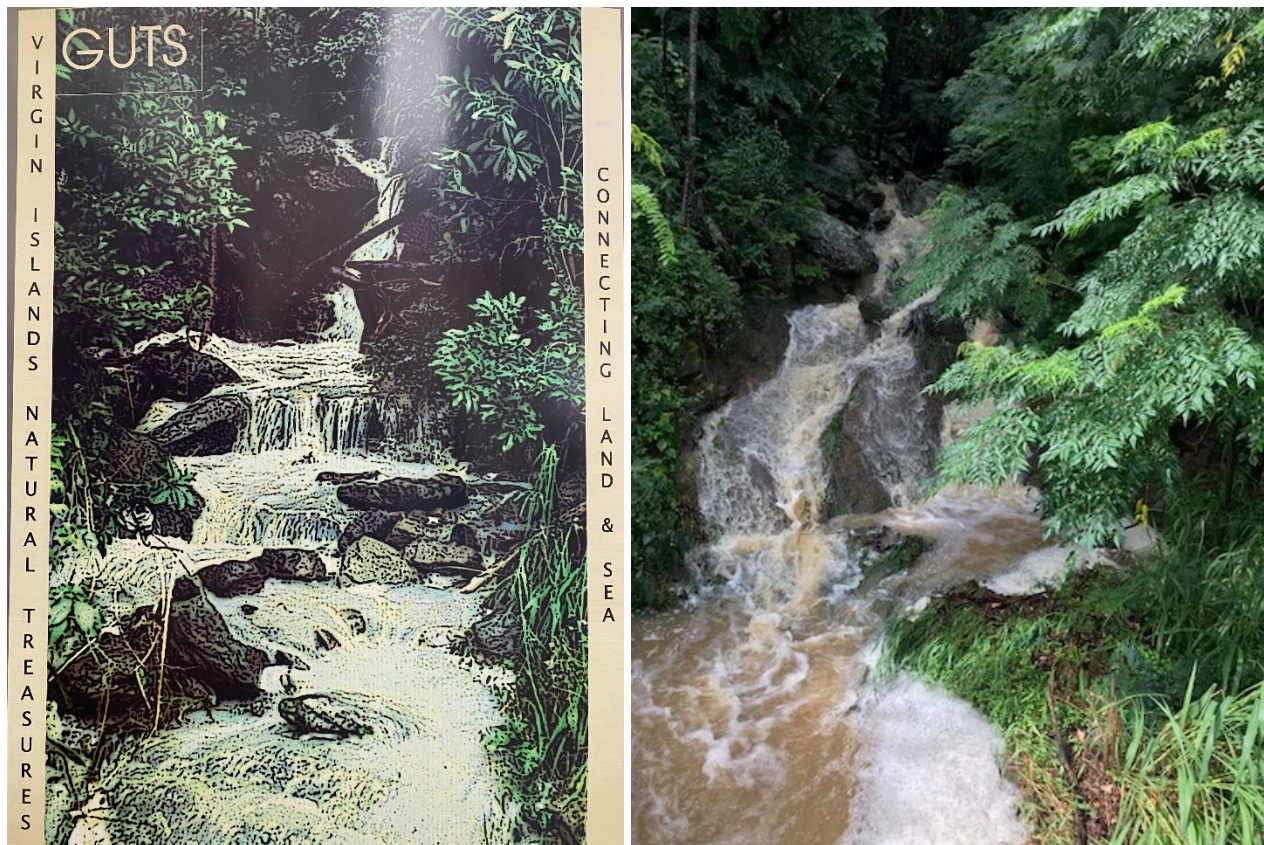
*Figure 6. Illustration of a gut (University of the Virgin Islands, Cooperative Extension Service (left)) and a picture of gut (right).*

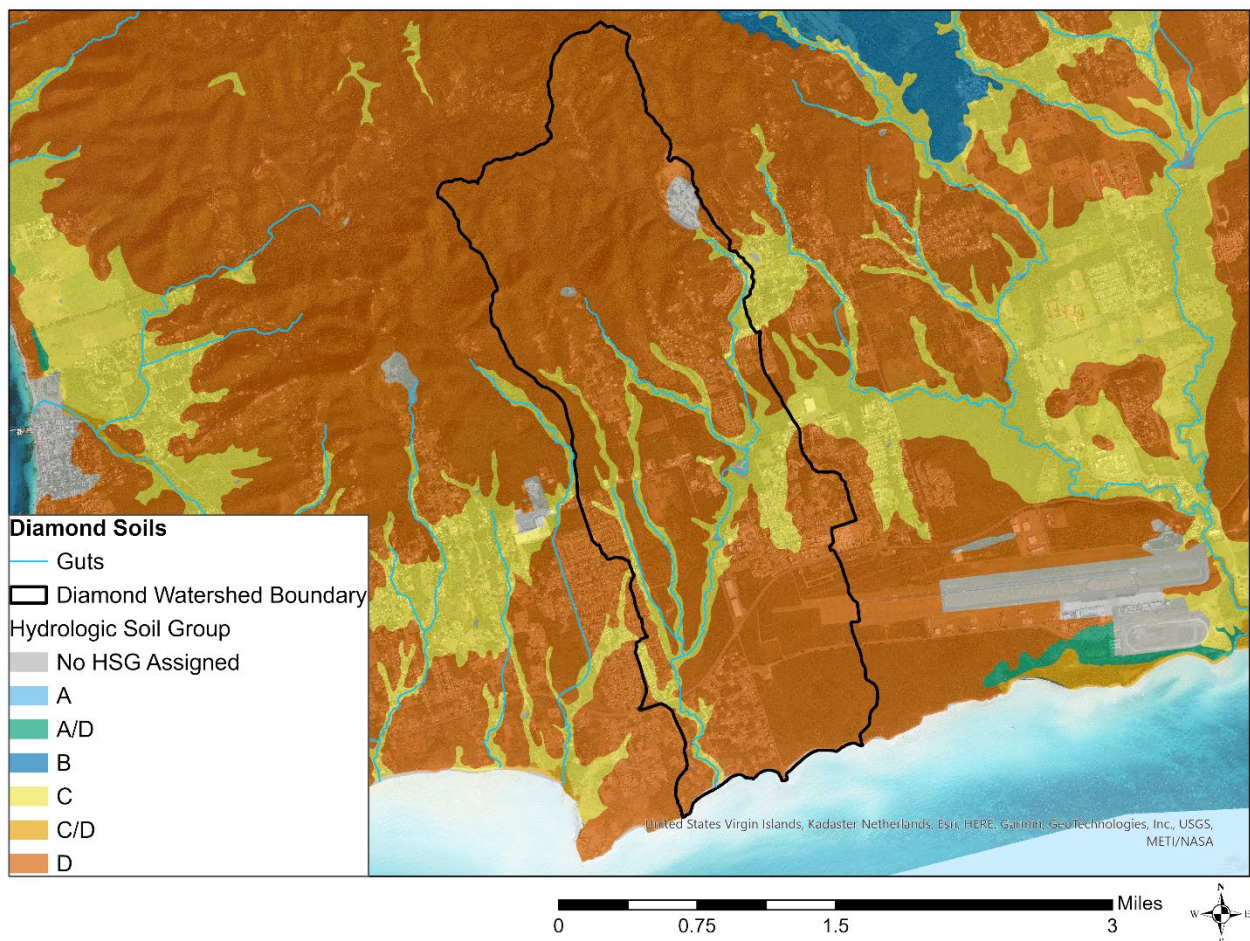
Figure 17. Hydrologic Soil Groups (HSG) in the Diamond watershed.

Figure 17 shows the distribution of HSG classes within the Diamond watershed and Table 4 provides a breakdown of the acres and percentages. The watershed consists predominantly of low infiltration soils in the flatter sloped, developed portion of the watershed, with 14.6% HSG-C and 83.9% HSG-D, indicating a high potential for stormwater runoff. As shown in Table 4, the percentage of total area attributed to HSG classes amounts to 99.9% of the watershed. The final 0.1% can be attributed to surface water in the watershed.

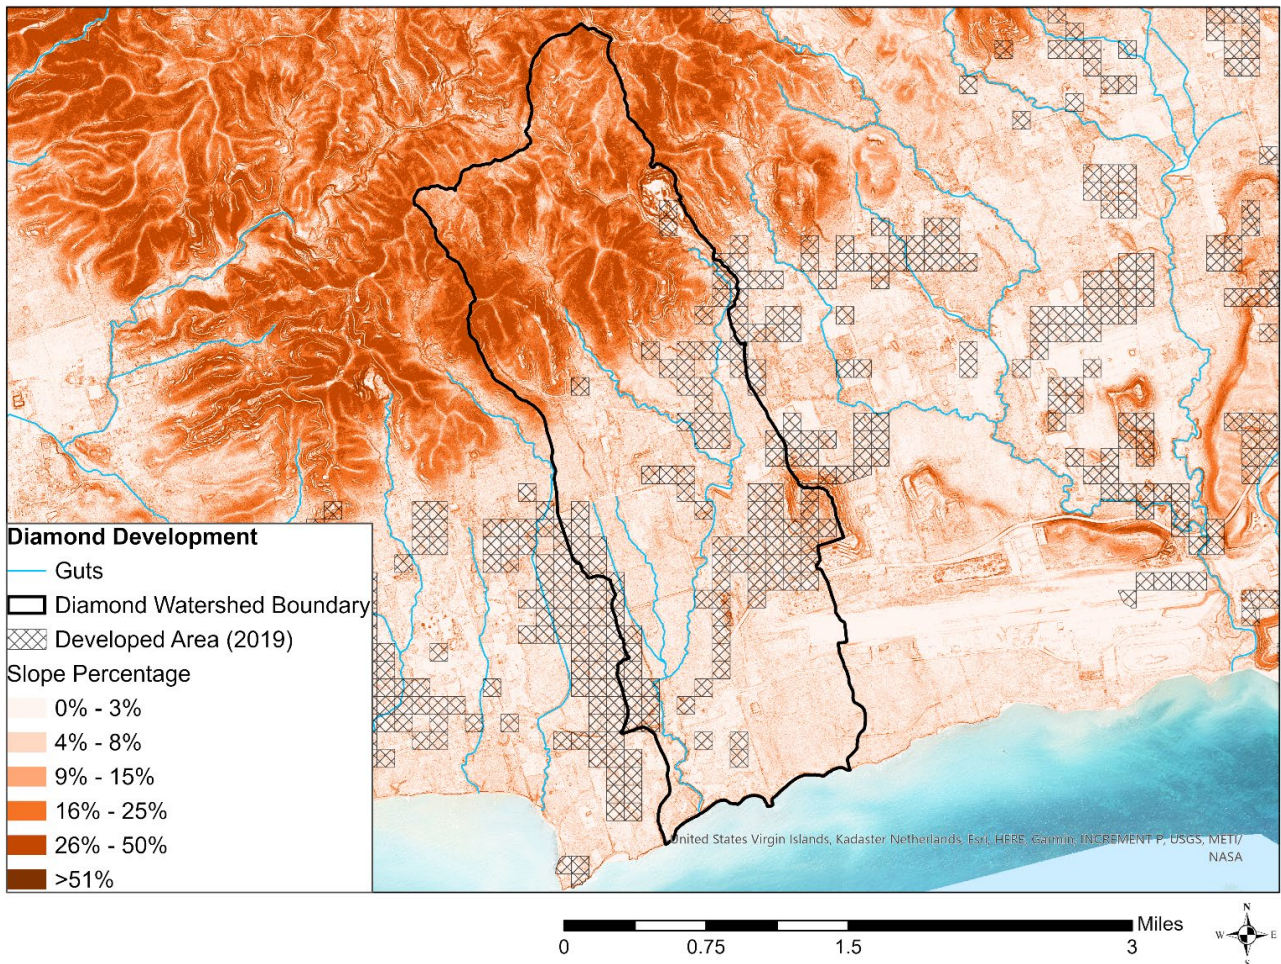
Figure 18. Developed areas and slope percentages in the Diamond watershed.

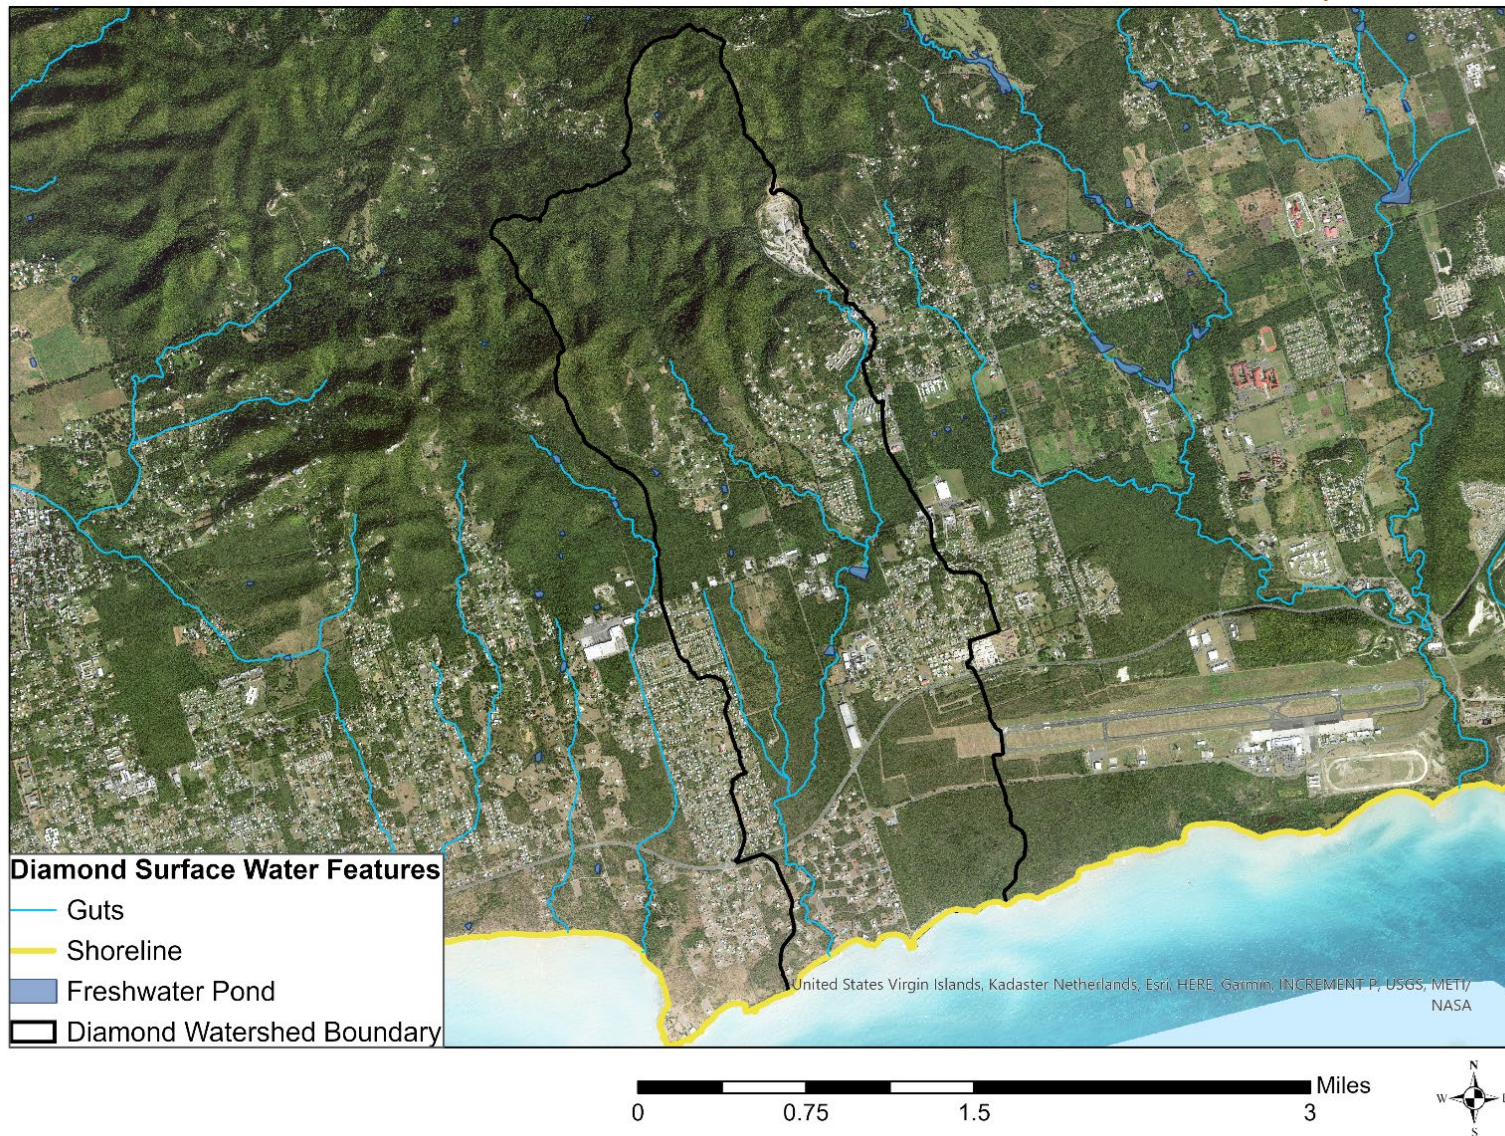
*Figure 19. Surface water features in the Diamond watershed.*

Within the Diamond watershed, there are 7.6 miles of guts, 5.0 acres of freshwater ponds, and 1.3 miles of shoreline along the Caribbean Sea (*Figure 19*). None of the coastal waters bordering any of the study watersheds on St. Croix fall within the jurisdiction of the National Park Service. Surface water feature data were obtained from USVI’s DPNR and from the National Wetlands Inventory (NWI) dataset.

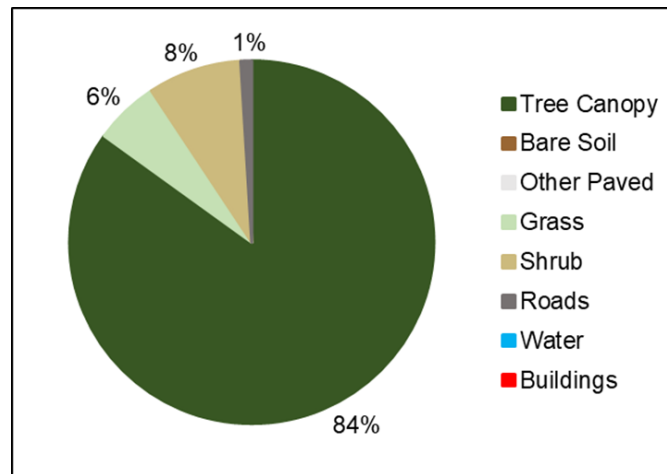
Figure 20. Existing land cover within a 25-foot buffer of guts in the Diamond watershed.

In the watershed, 84% of the existing land-cover within the riparian buffer zone is composed of tree canopy with the remaining riparian area consisting primarily of grass and shrub. It is noteworthy that only 1% of the riparian buffer zone consists of impervious cover (buildings, roads, and other paved areas), indicating minimal development along the guts (Figure 20).

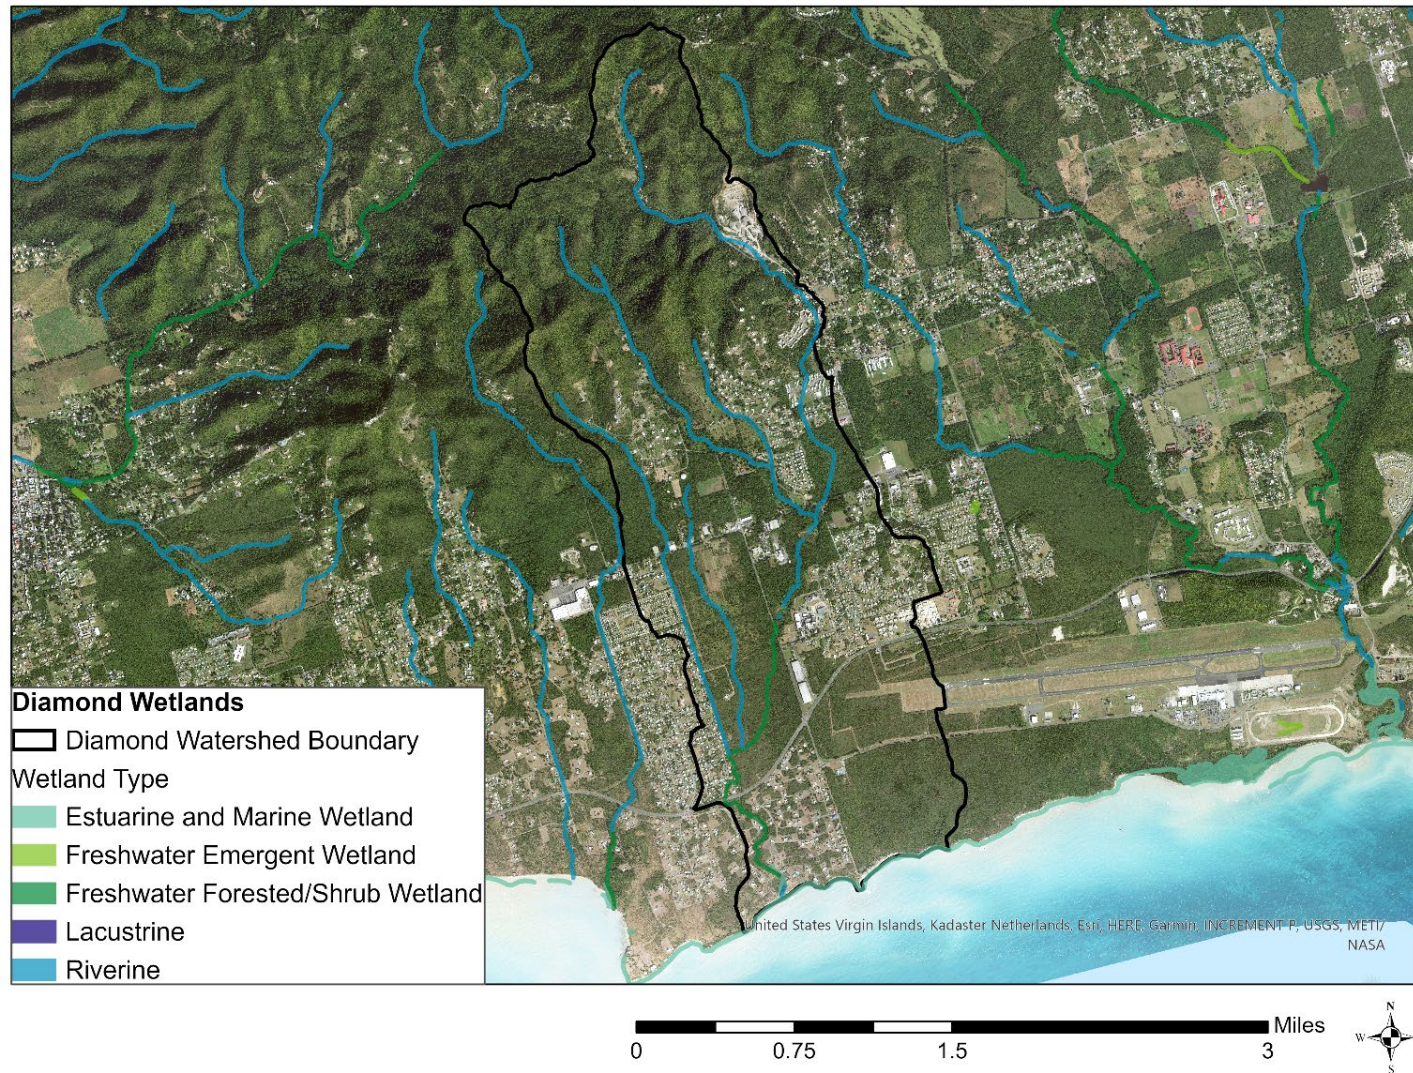
Figure 21. Wetlands in the Diamond watershed.

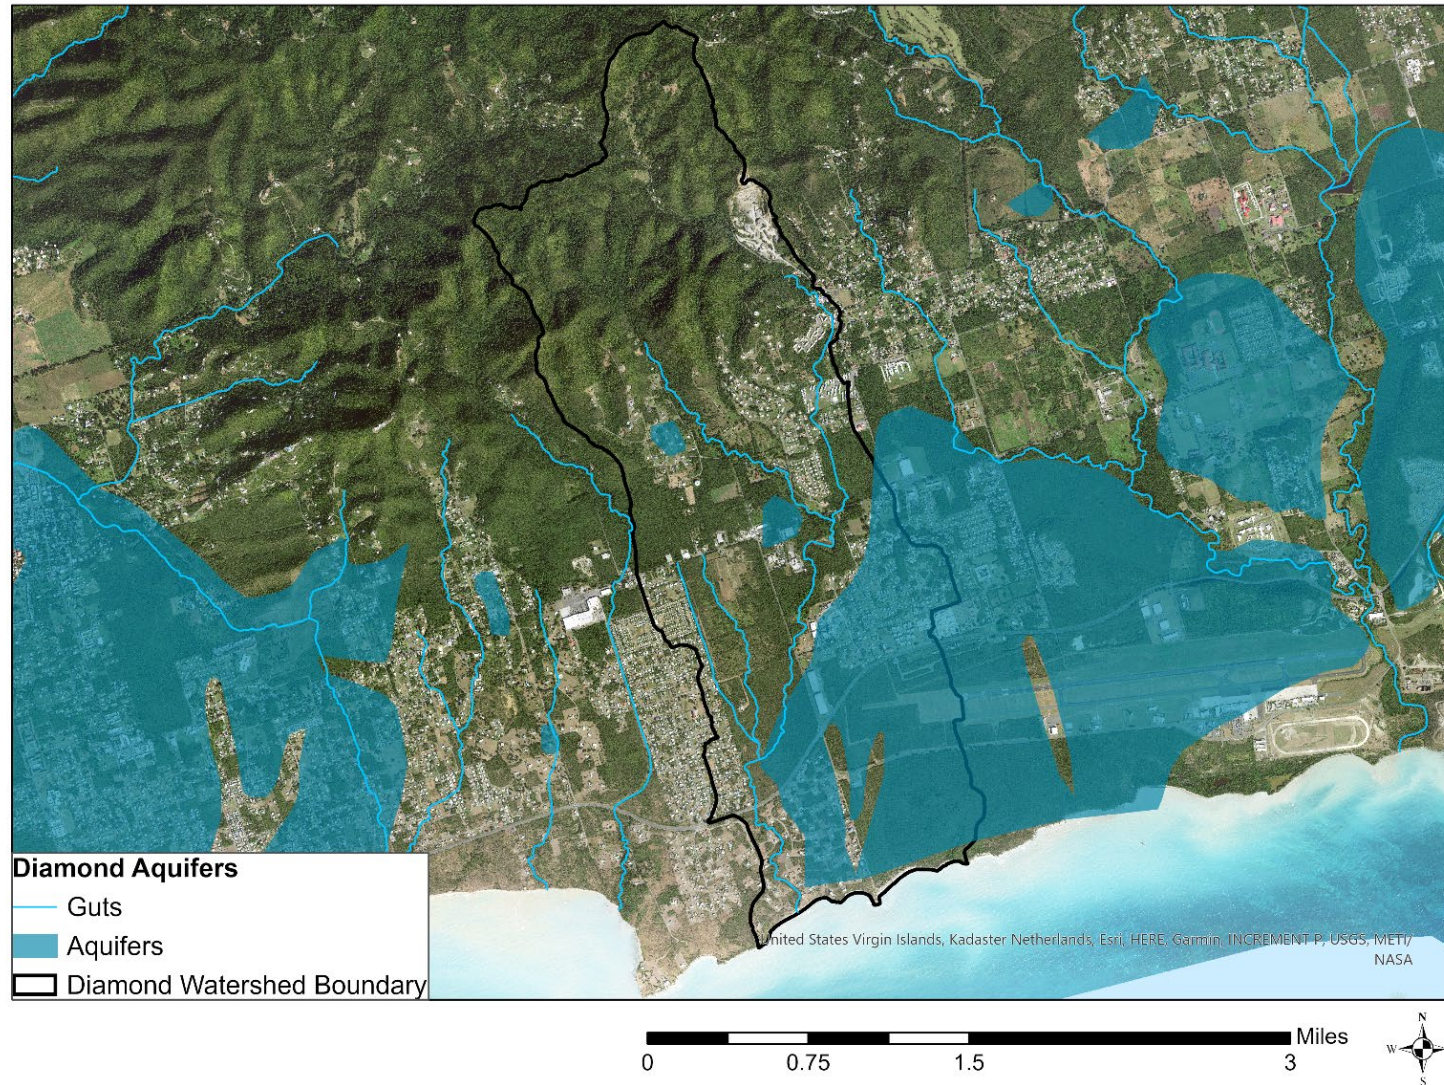
*Figure 23. Aquifers in the Diamond watershed.*

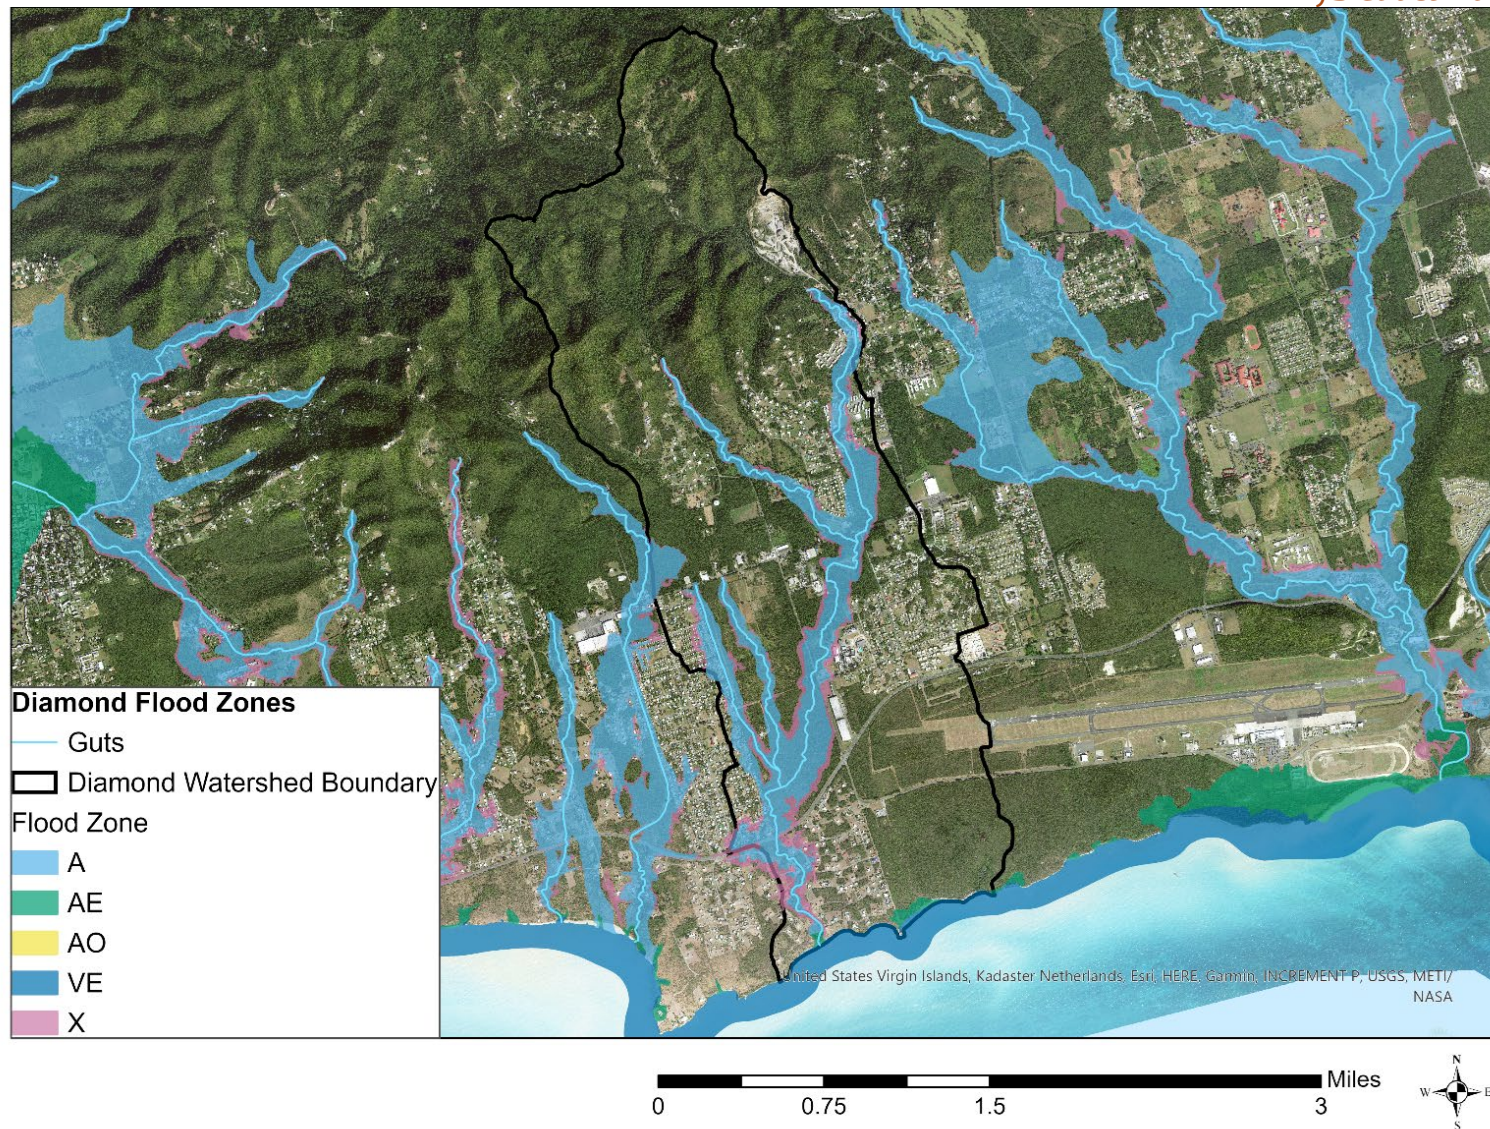
Figure 24. Flood zones in the Diamond watershed.

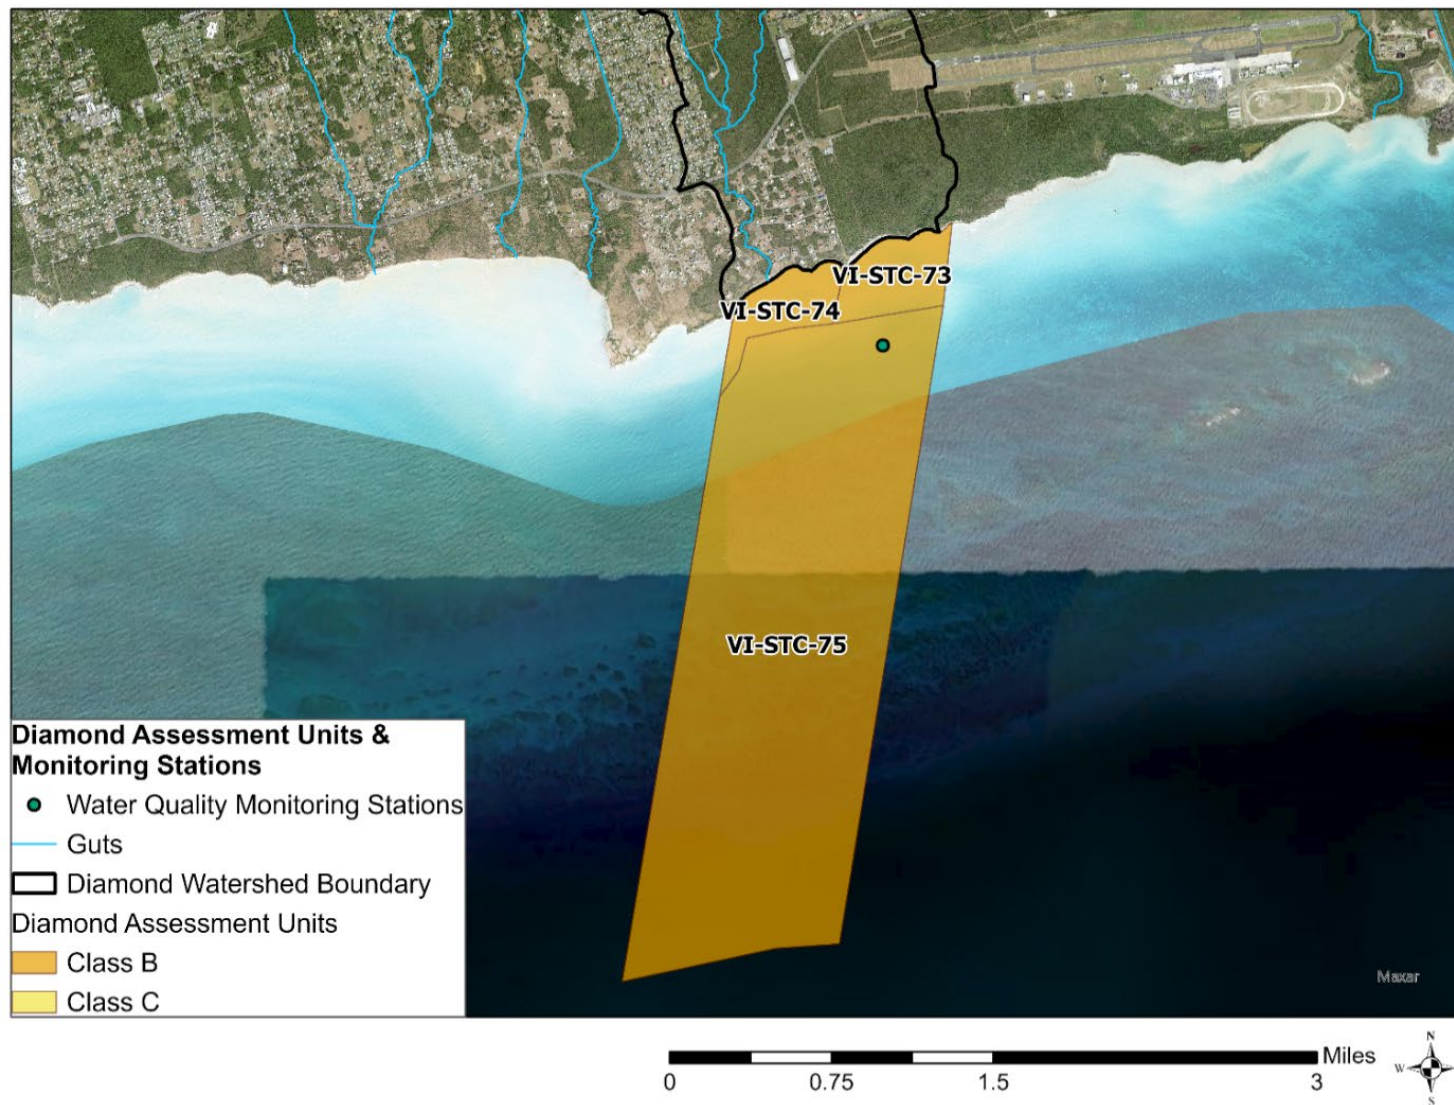
Figure 36. Assessment units and water quality monitoring stations in the watershed.

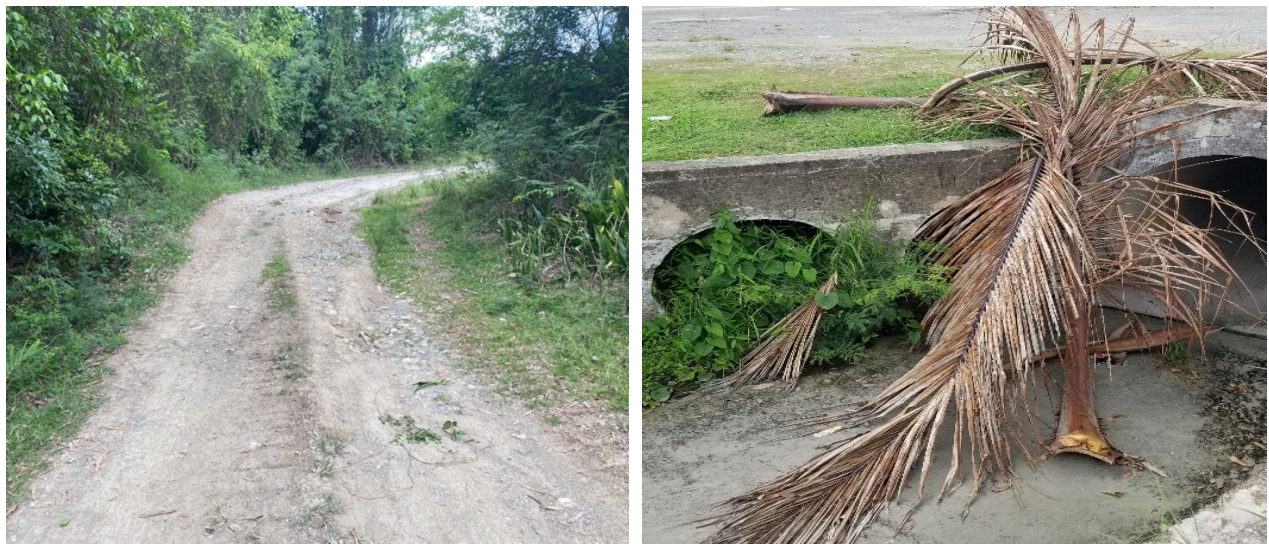
*Figure 37. Road erosion (left) and clogged stormwater infrastructure (right).*

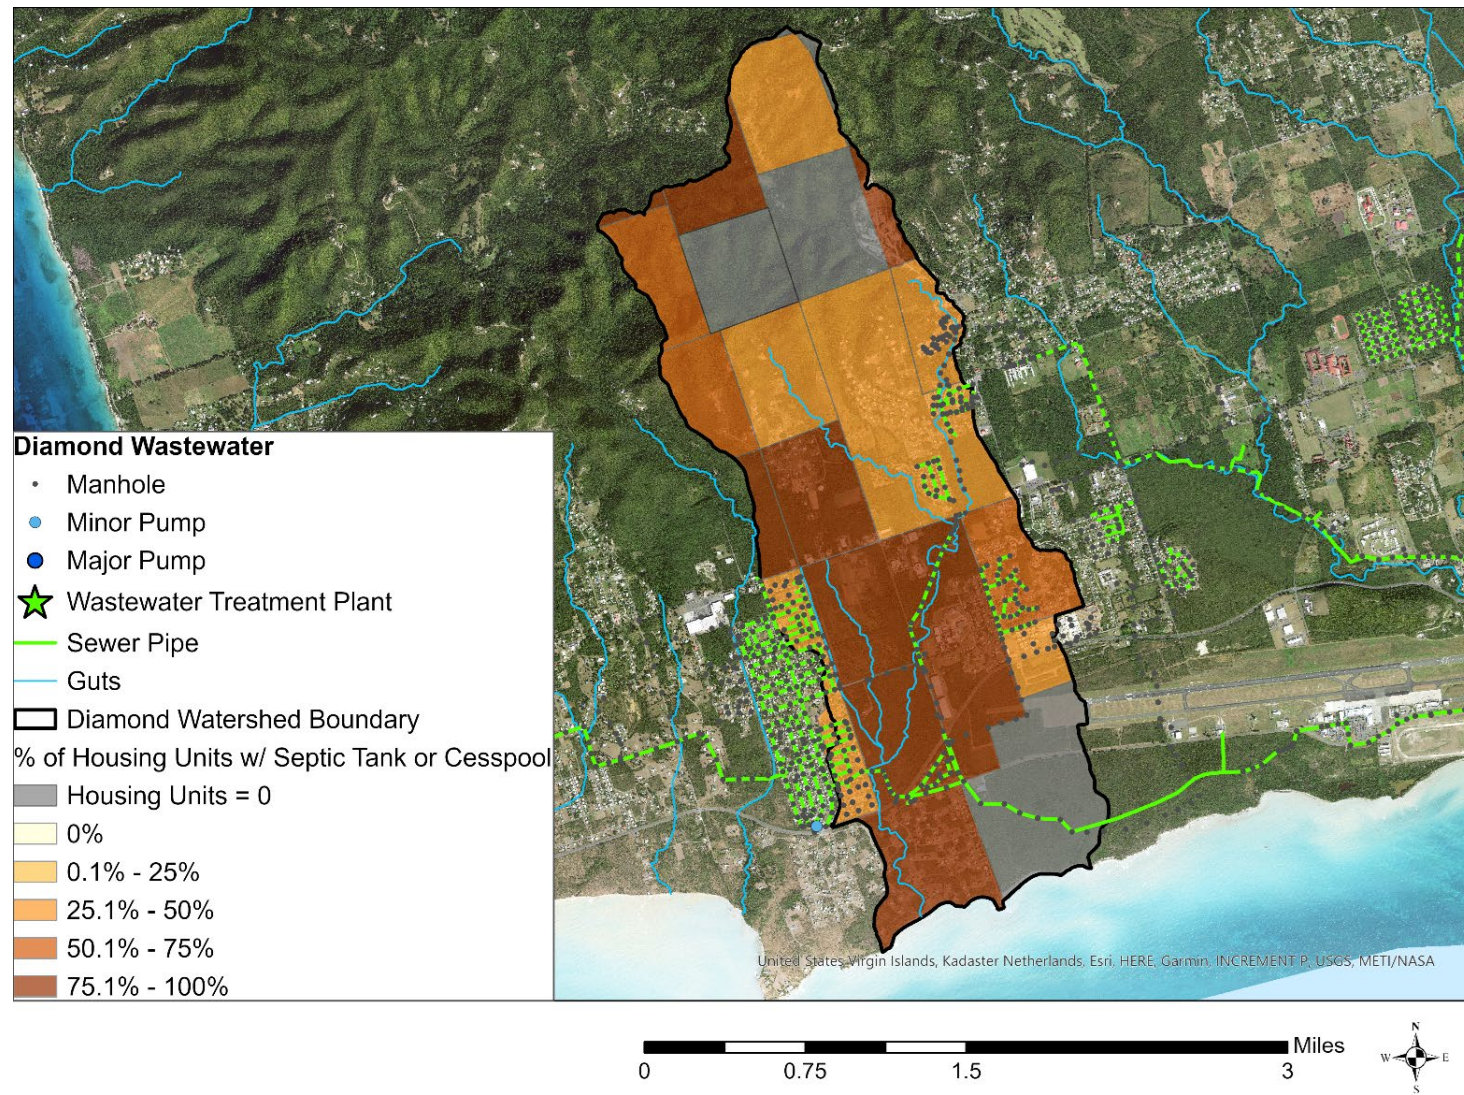
Figure 39. Sanitary sewer system and percent of housing units by estate with septic tanks or cesspools in the Diamond watershed (Sources: 2010 U.S. Census data, VIWMA).

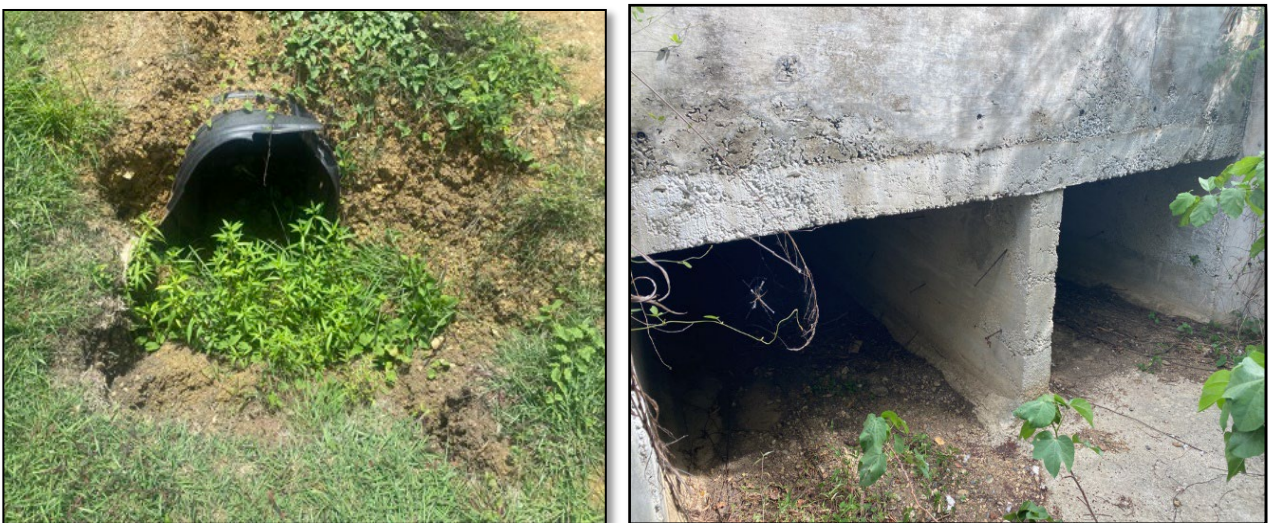
*Figure 45. Examples of stormwater infrastructure in the Diamond watershed.*

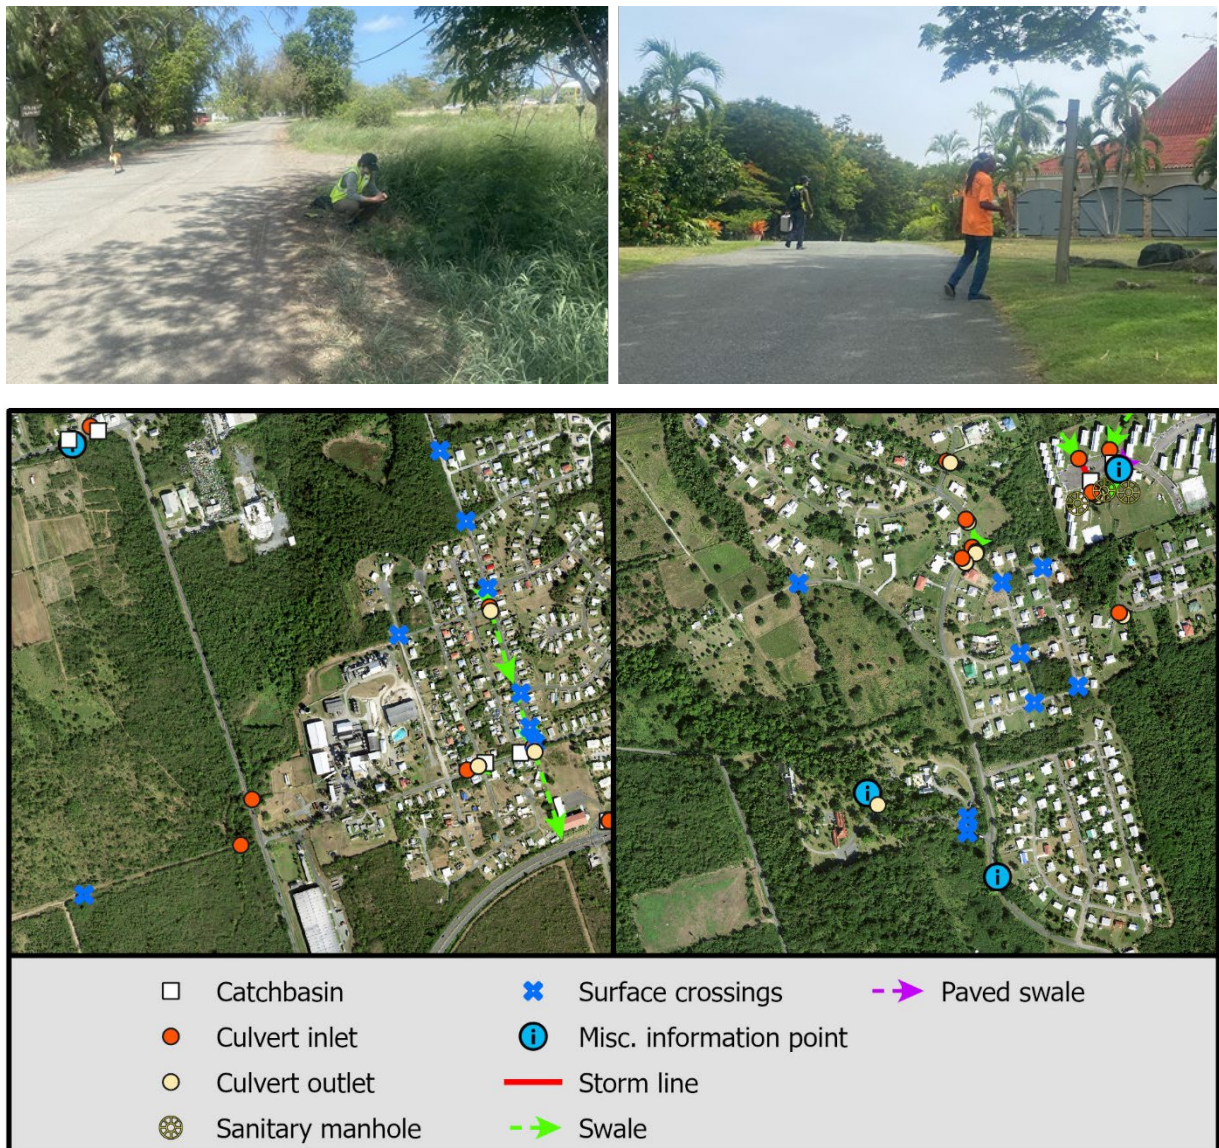
Figure 46. Inspection of existing stormwater infrastructure during field assessments (above) and an example of the maps produced (below).

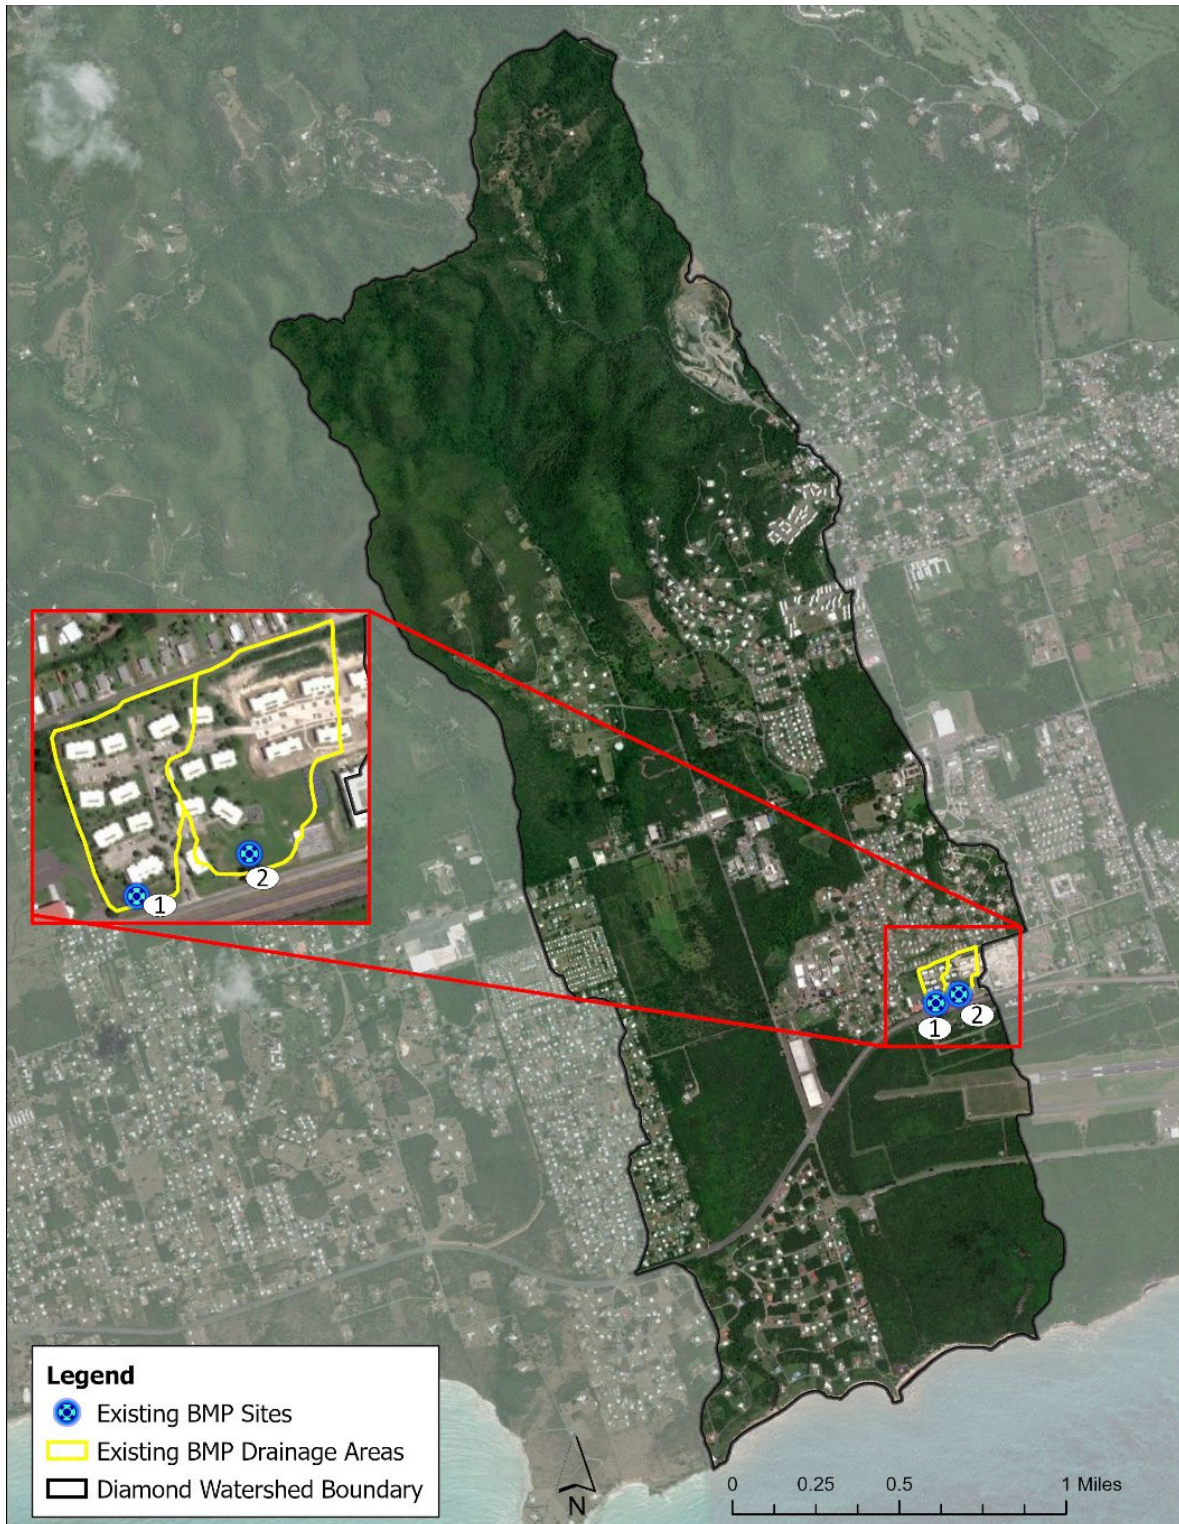
Figure 47. Existing BMPs identified within the Diamond watershed.

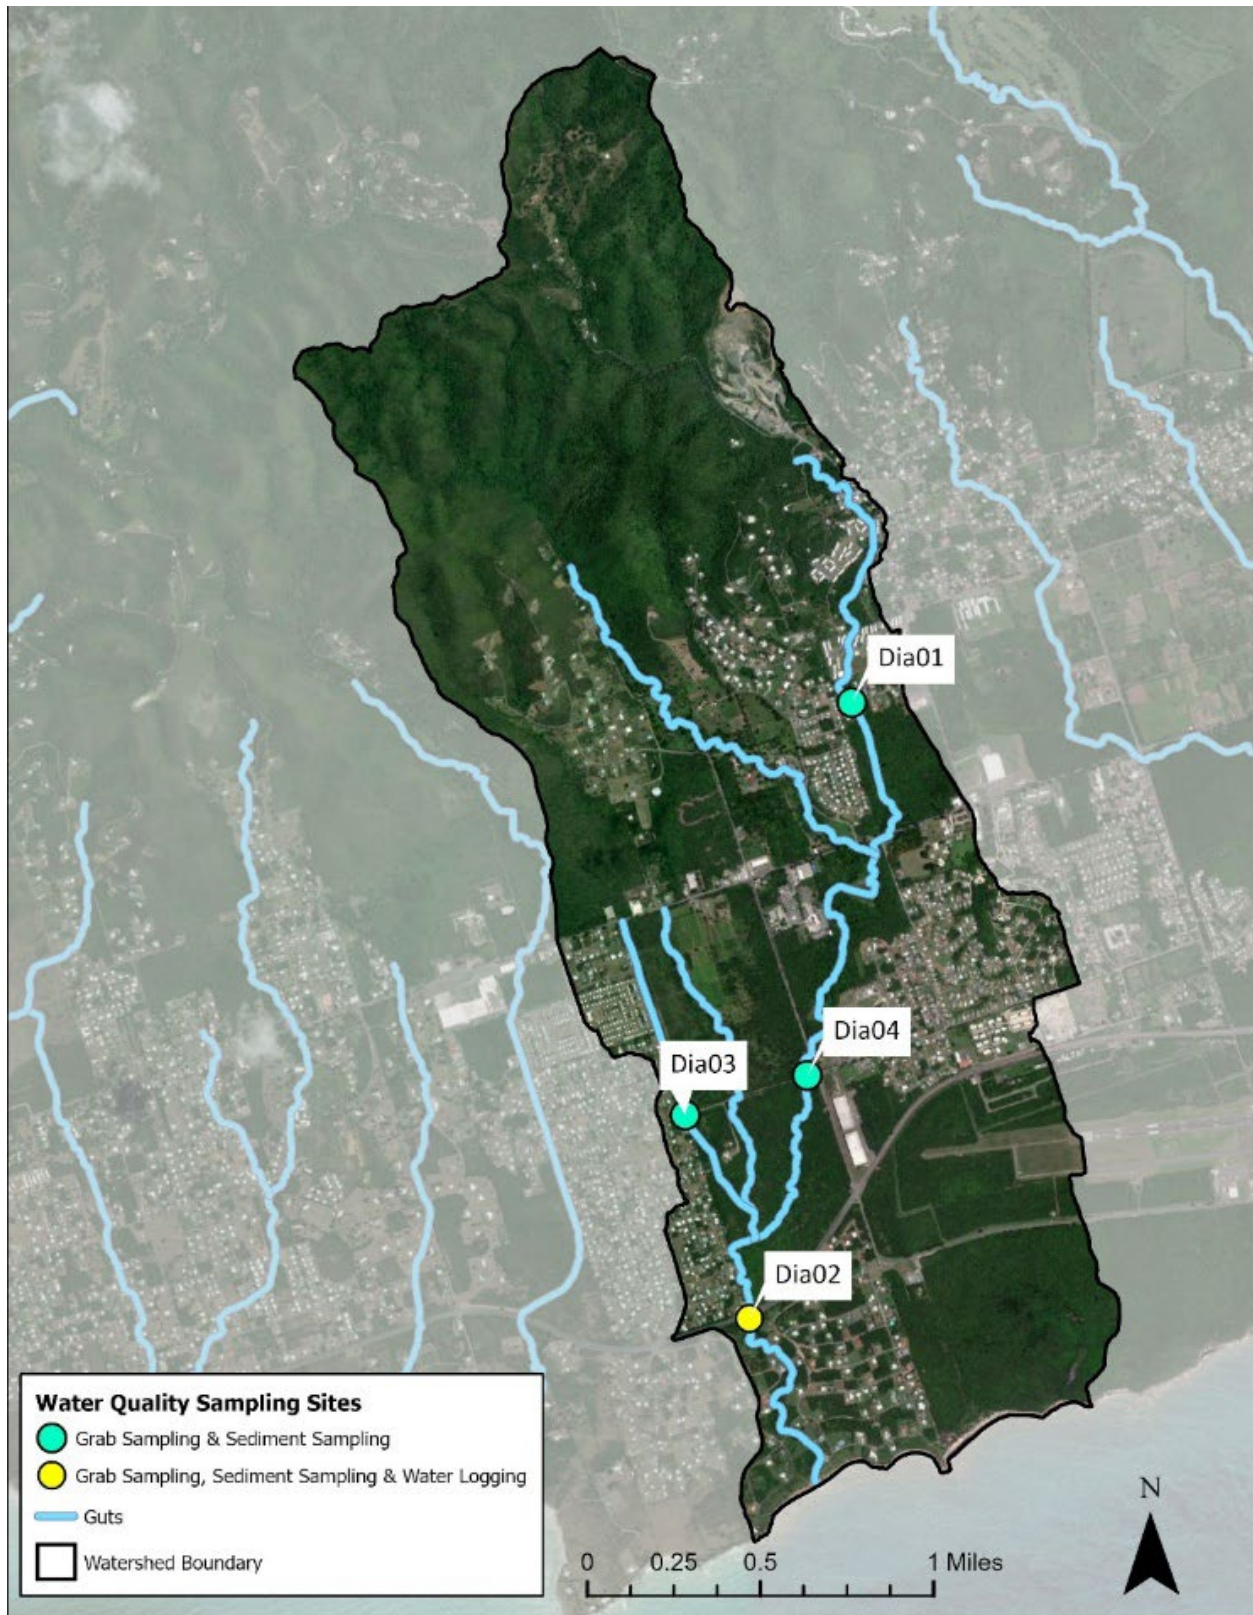
Figure 49. Grab sampling, sediment sampling, and water logging locations.

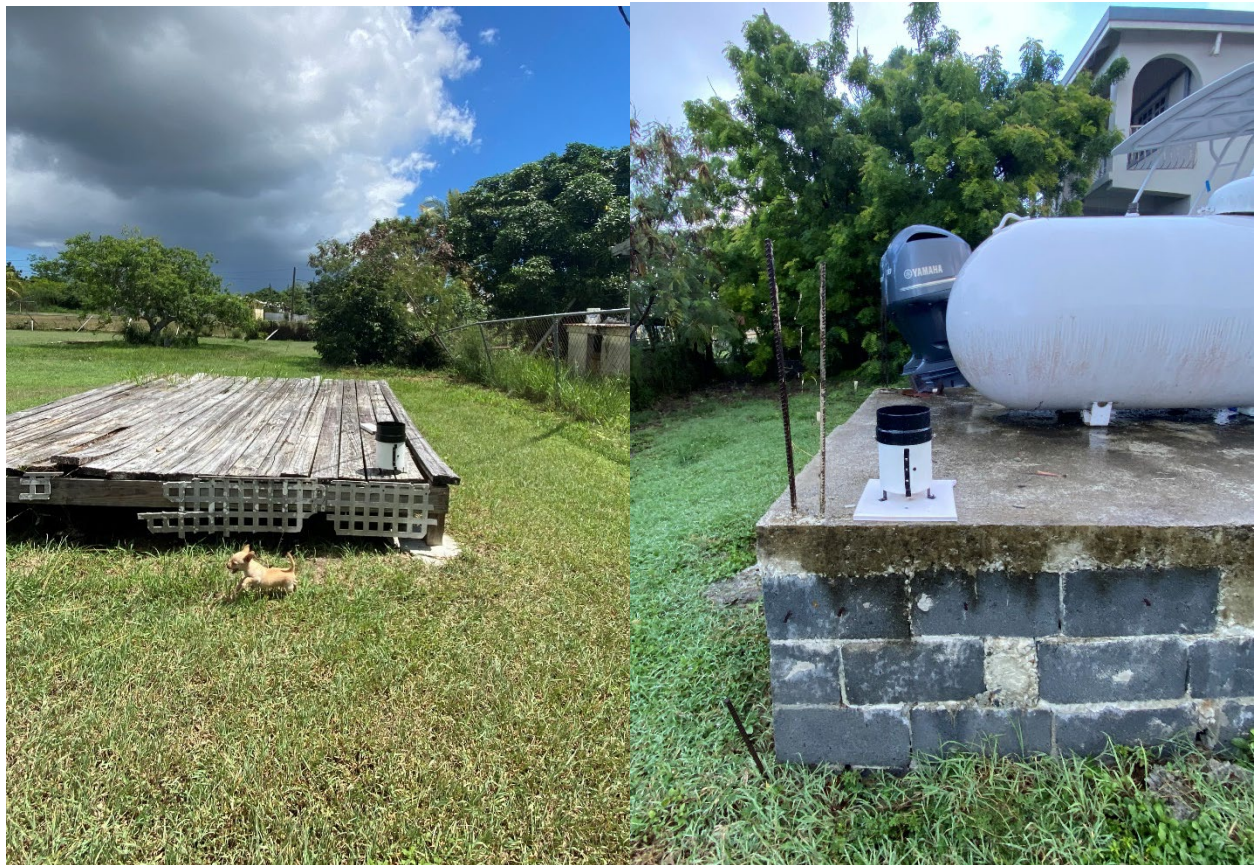
*Figure 50. JS rain gauge (left) and HQ rain gauge (right).*
