# WATERSHED MANAGEMENT PLAN FOR THE DIAMOND WATERSHED ST. CROIX, USVI

JUNE 2022

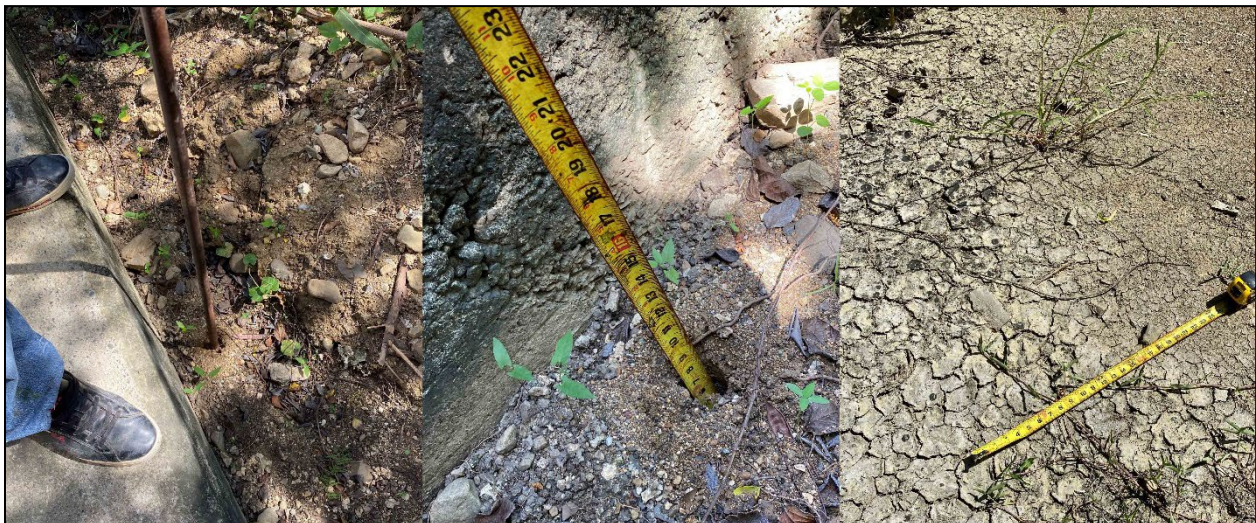
*Figure 54. A sediment core being collected from the Dia02 gut channel (left). The depth of the sediment core verified with measuring tape (center). A cross-section across the Dia02 gut channel measured to collect a scrape sample (right).*

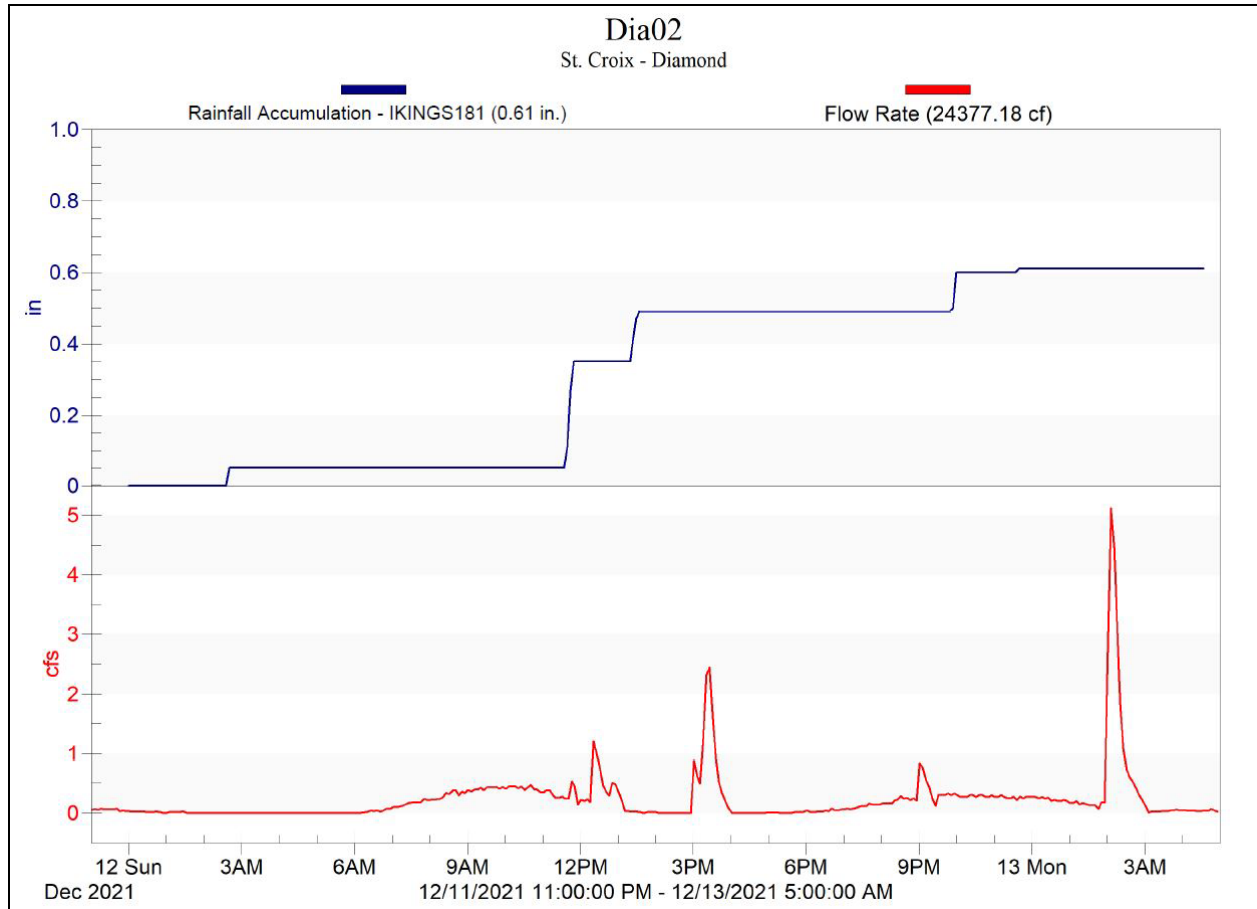
Figure 55. A hydrograph displaying flow at the Dia02 gut monitoring site (5.1 cfs) in red and the corresponding rainfall accumulation for the storm event (0.61 in.) in blue that occurred on December 12th, 2021.

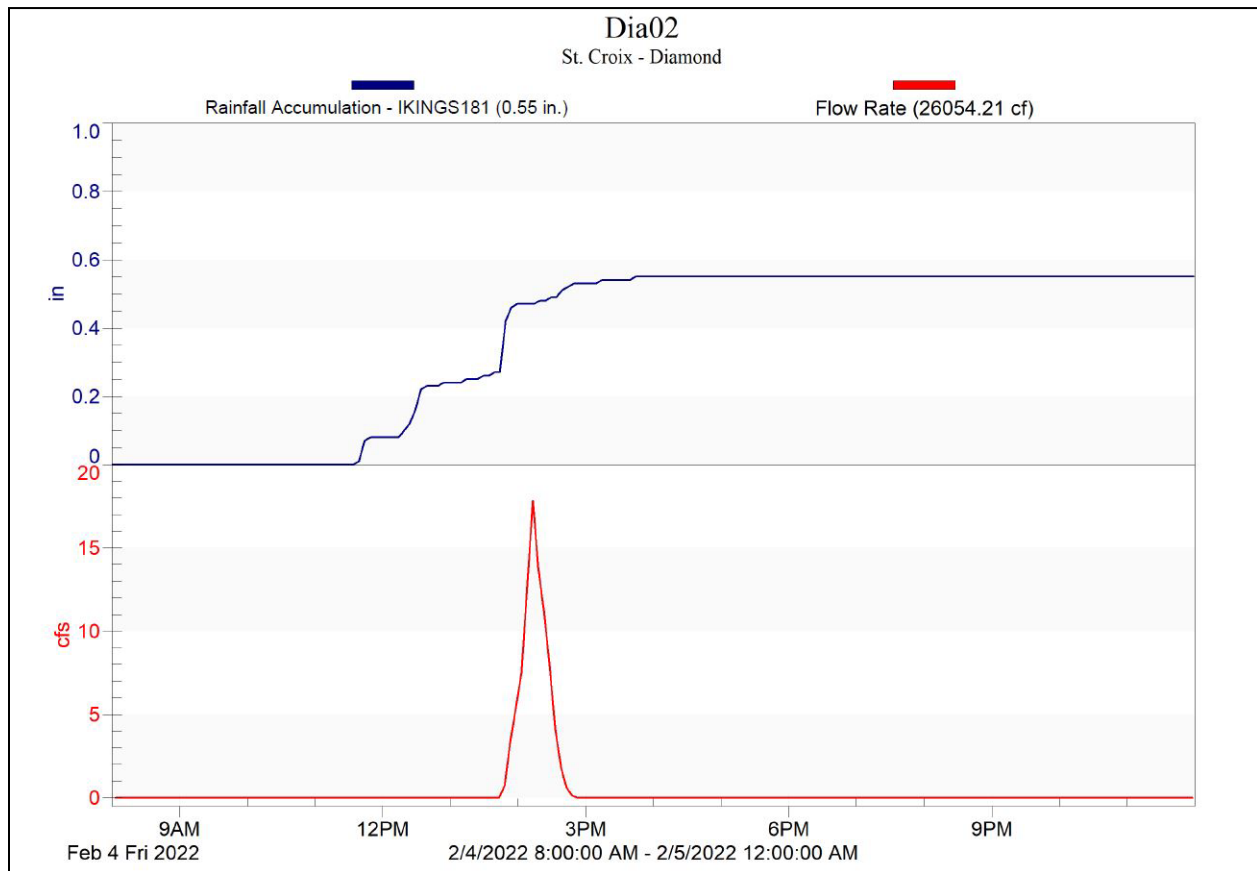
*Figure 56. A hydrograph displaying flow at the Dia02 gut monitoring site (18 cfs) in red and the corresponding rain accumulation for the storm event (0.55 in.) in blue that occurred on February 4th, 2022.*

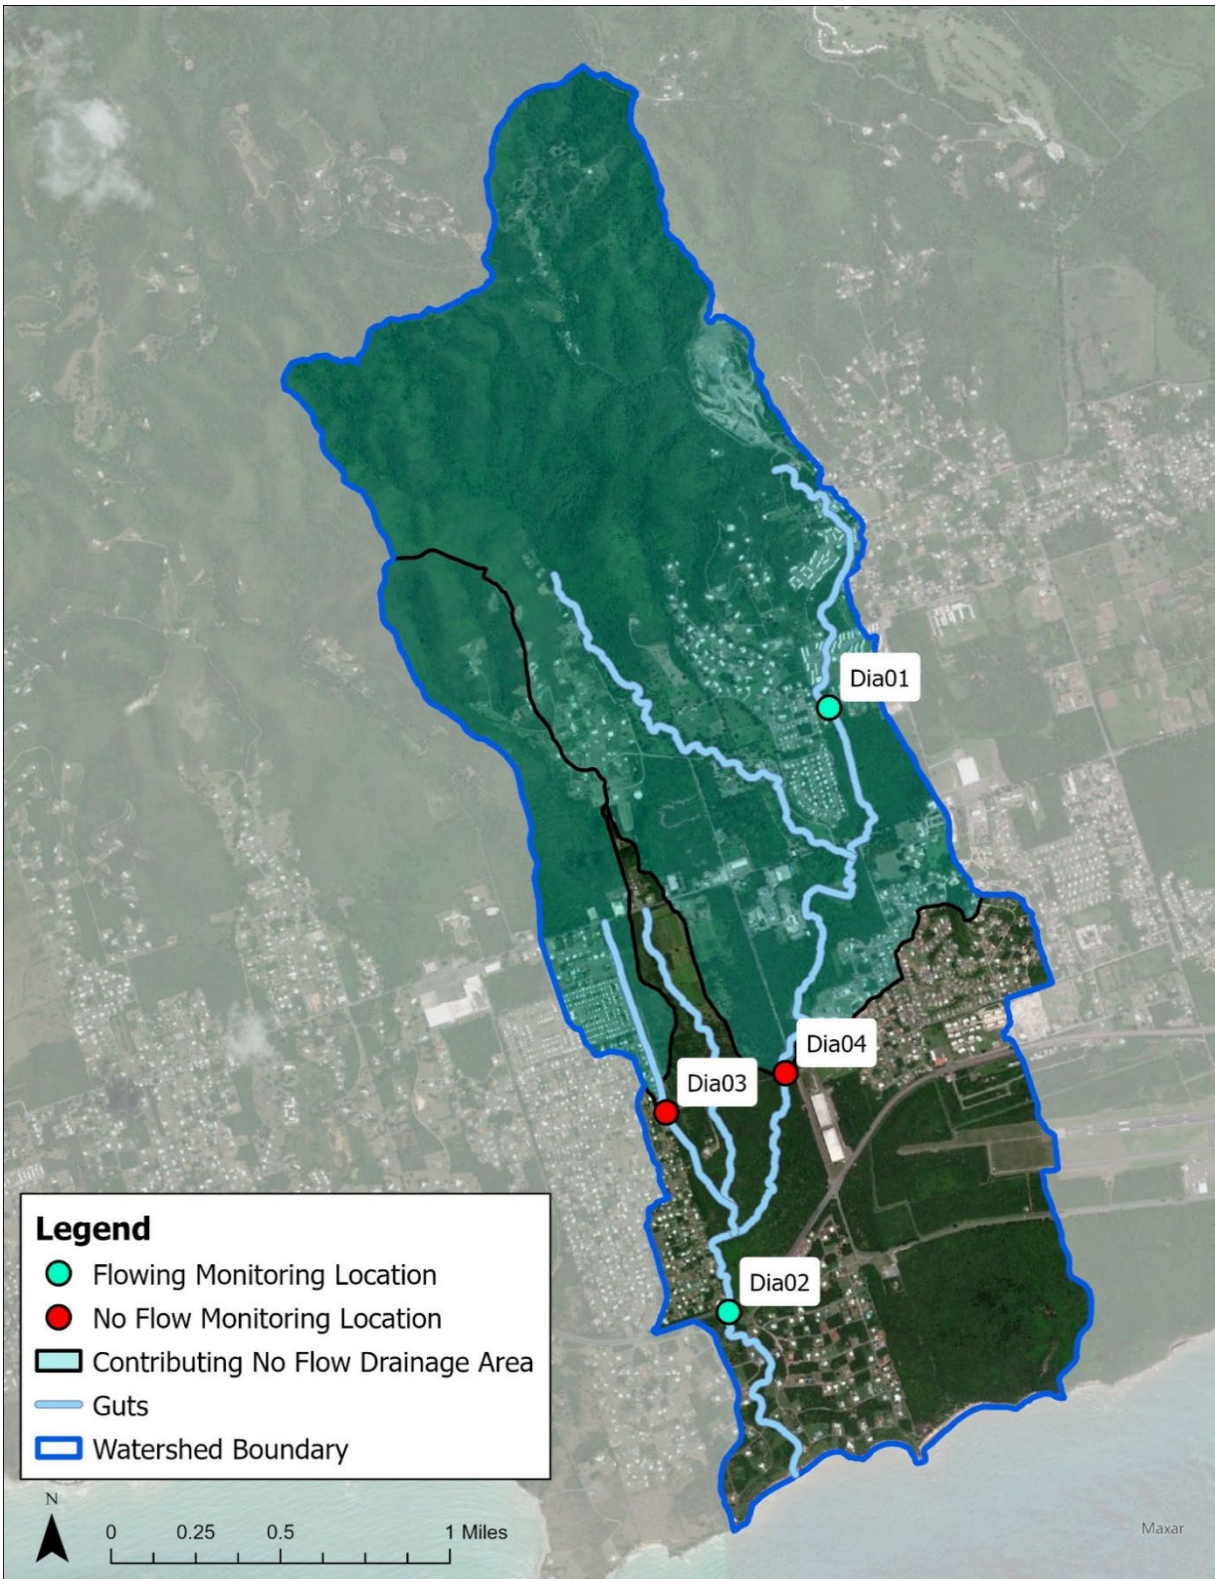
Figure 58. Two of the four monitoring locations within the Diamond watershed were confirmed to have no gut flow during at least two qualifying storm events in December 2021 and January 2022 (red). Each drainage area is delineated in blue.

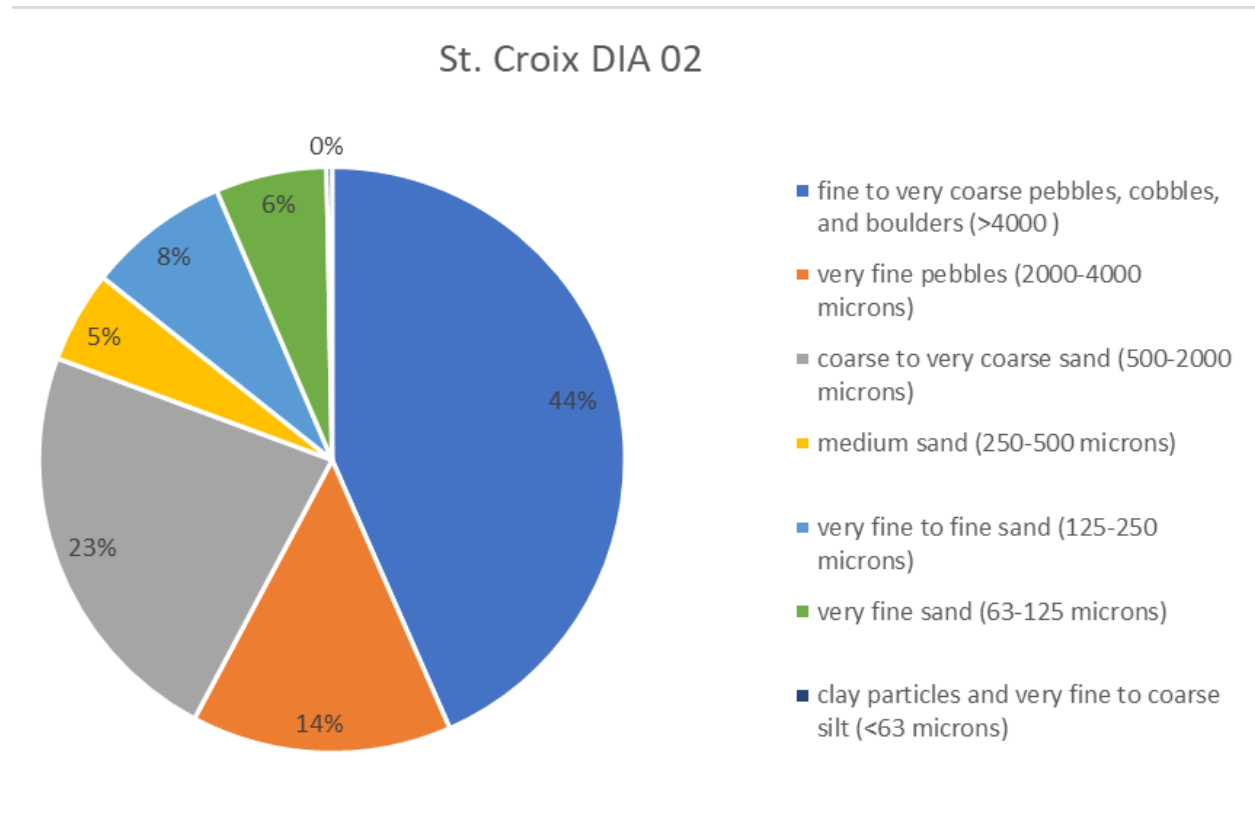
*Figure 63. The percent composition of the seven grain size categories within the Dia02 sediment sample.*

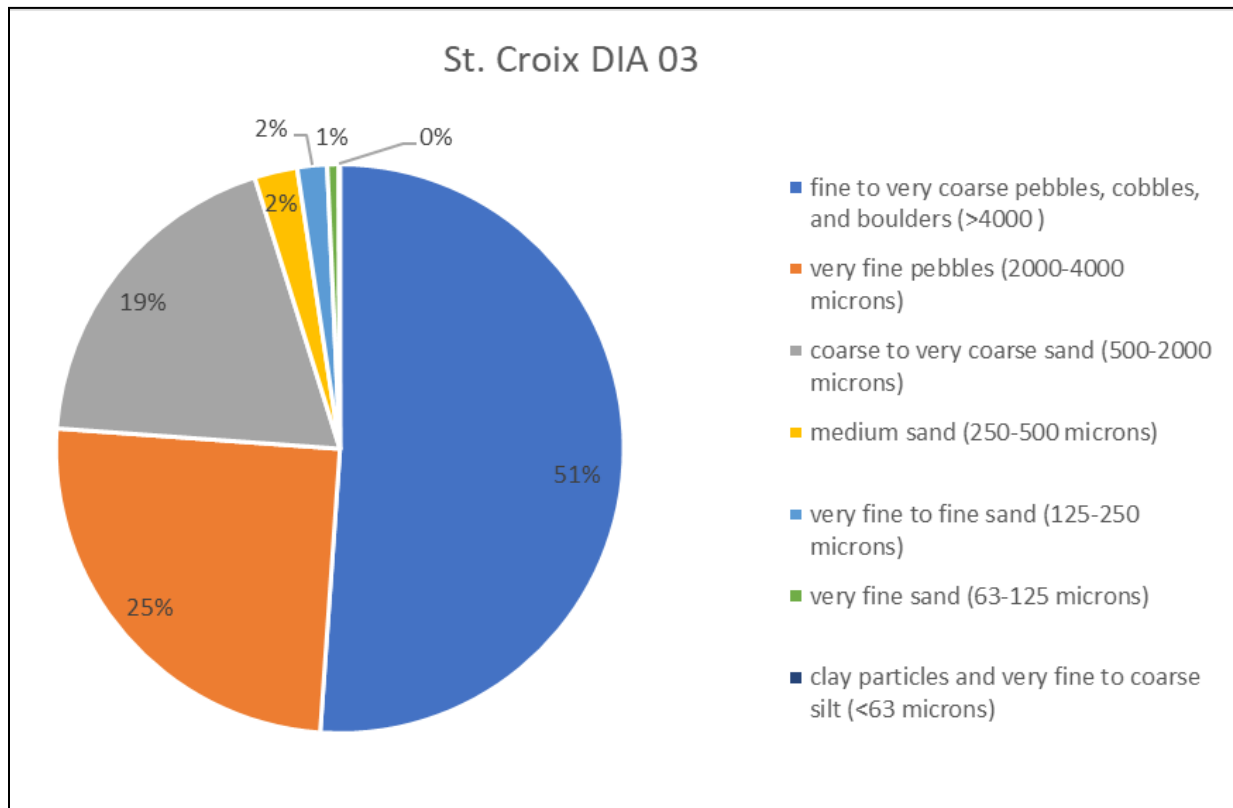
*Figure 64. The percent composition of the seven grain size categories within the Dia03 sediment sample.*

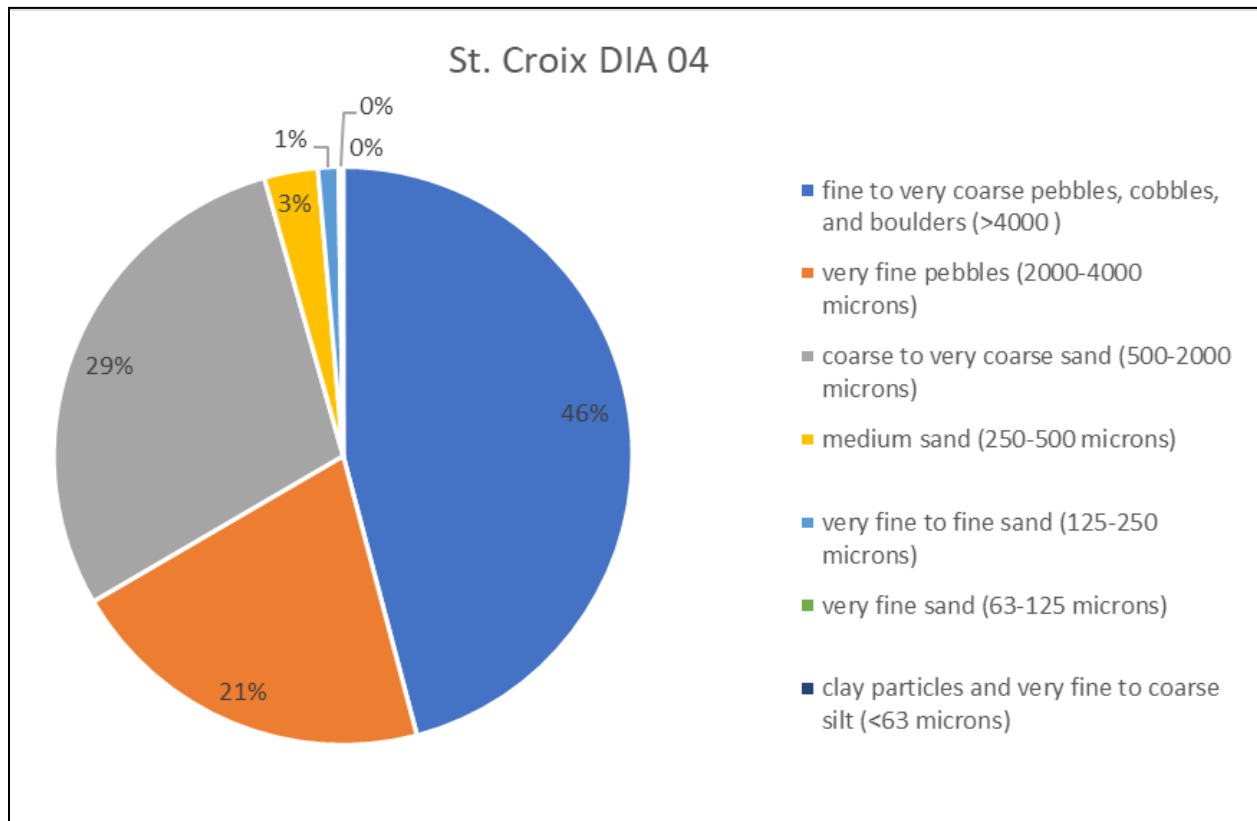
*Figure 65. The percent composition of the seven grain size categories within the Dia04 sediment sample.*

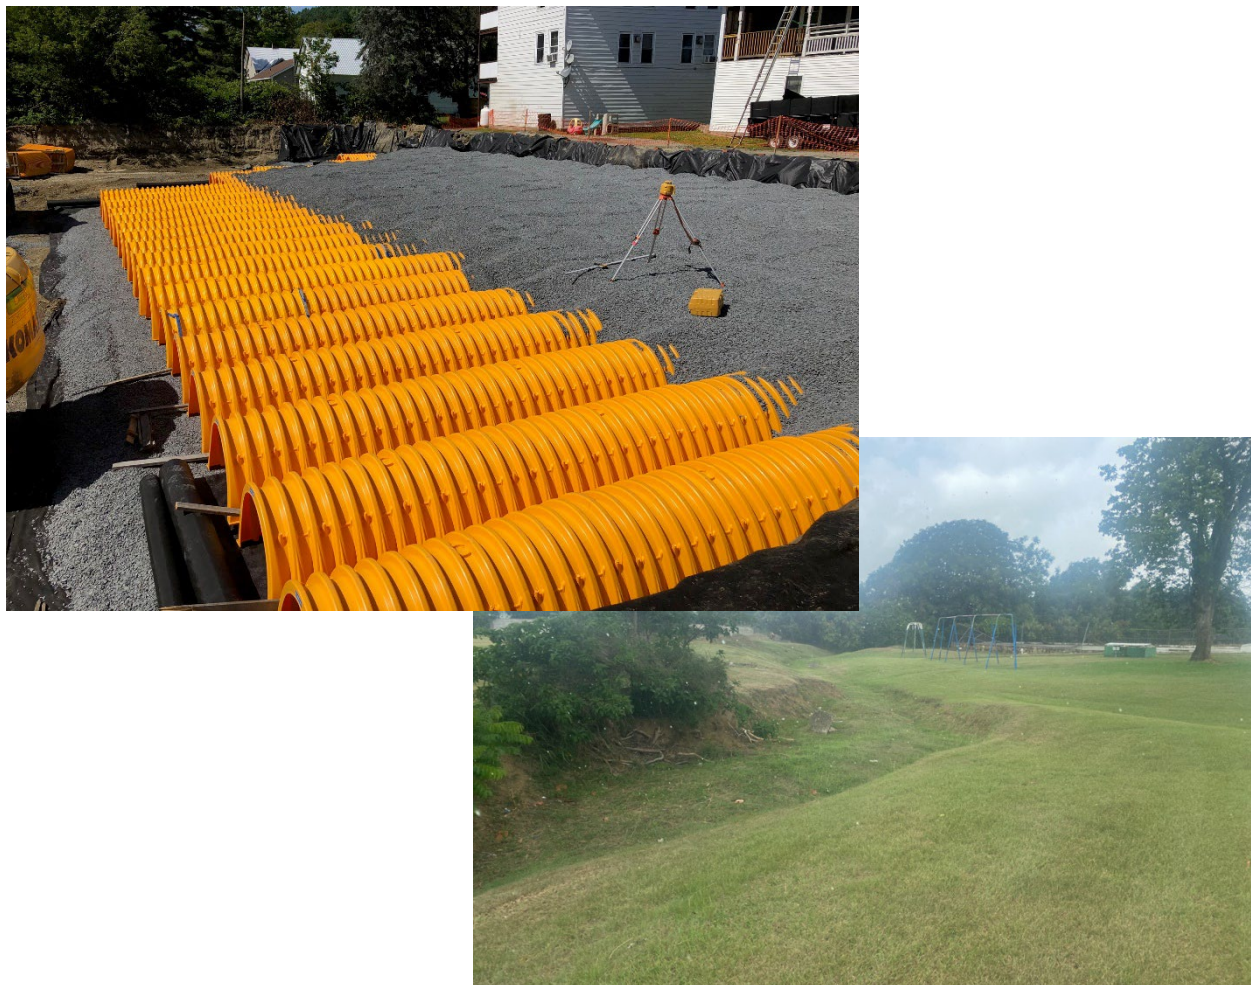
*Figure 72. Example photo of subsurface infiltration chambers (above) and greenspace at the Lorraine apartment complex (below).*

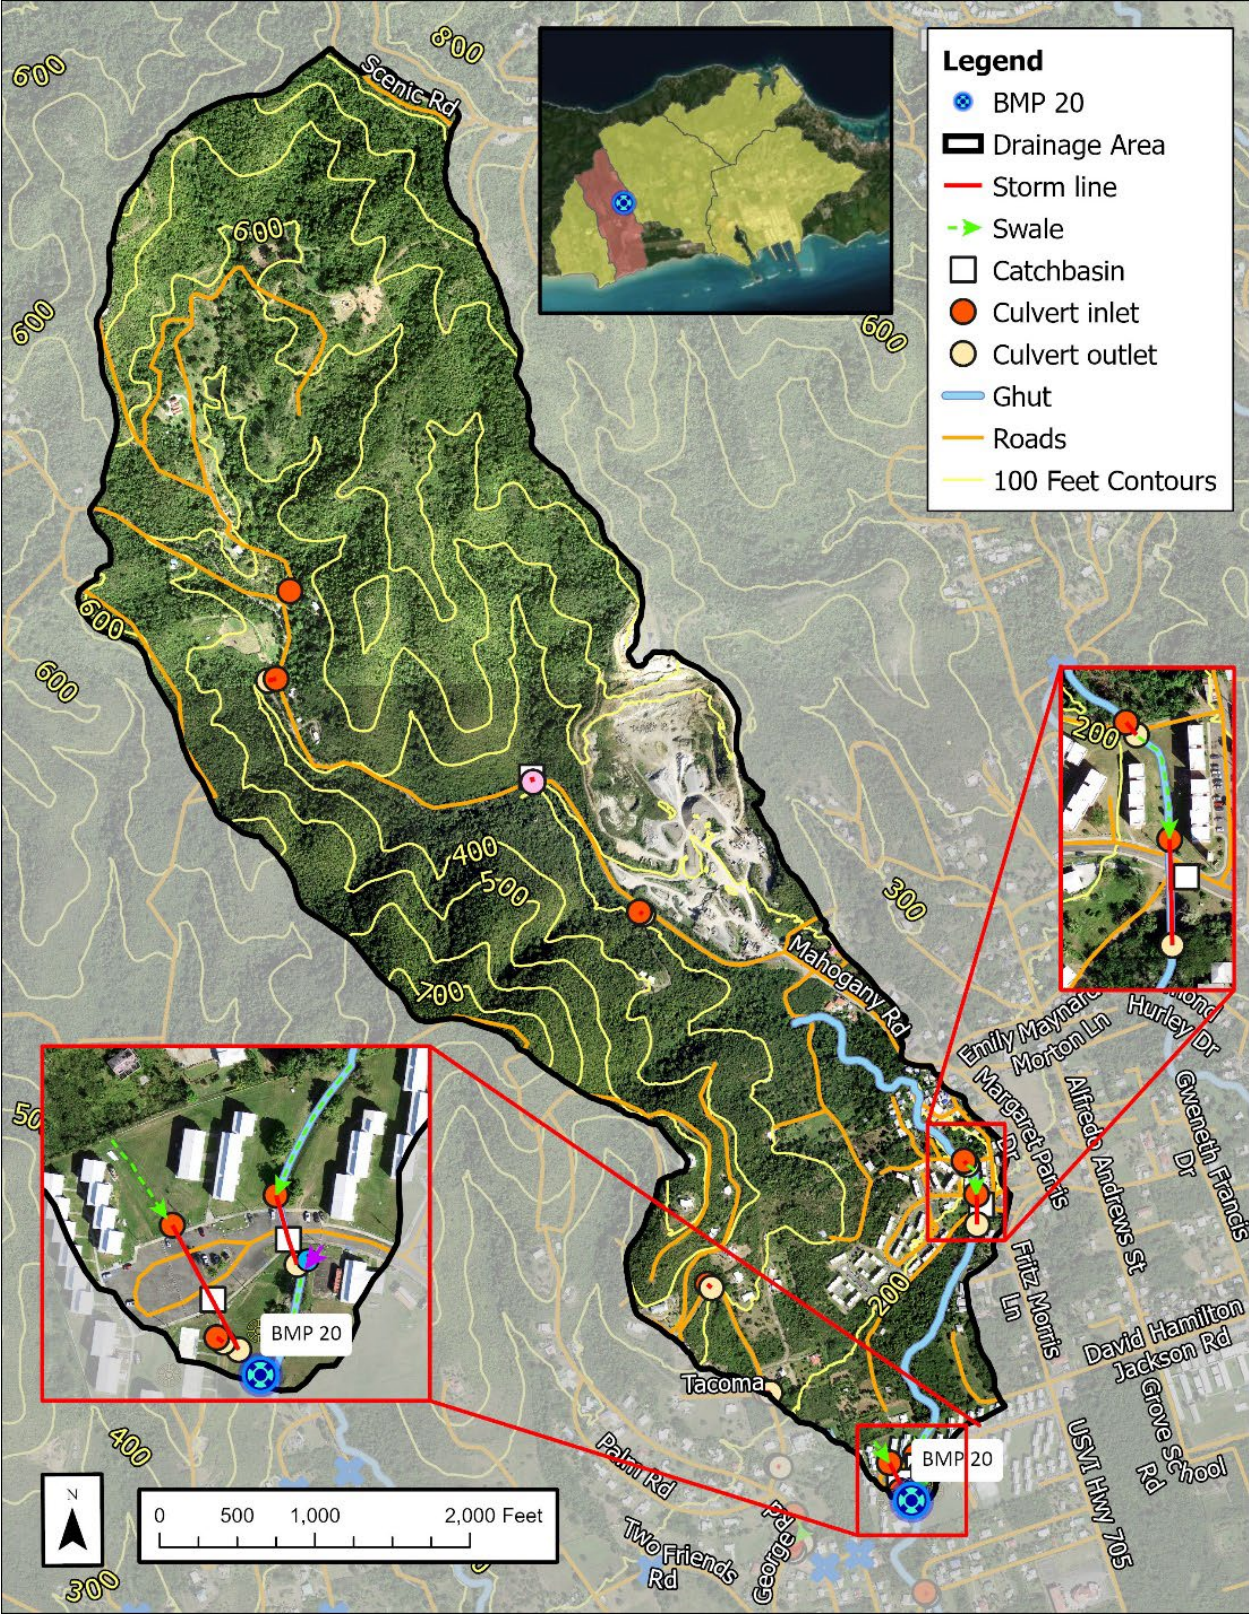
Figure 73. Drainage area to proposed BMP 20.

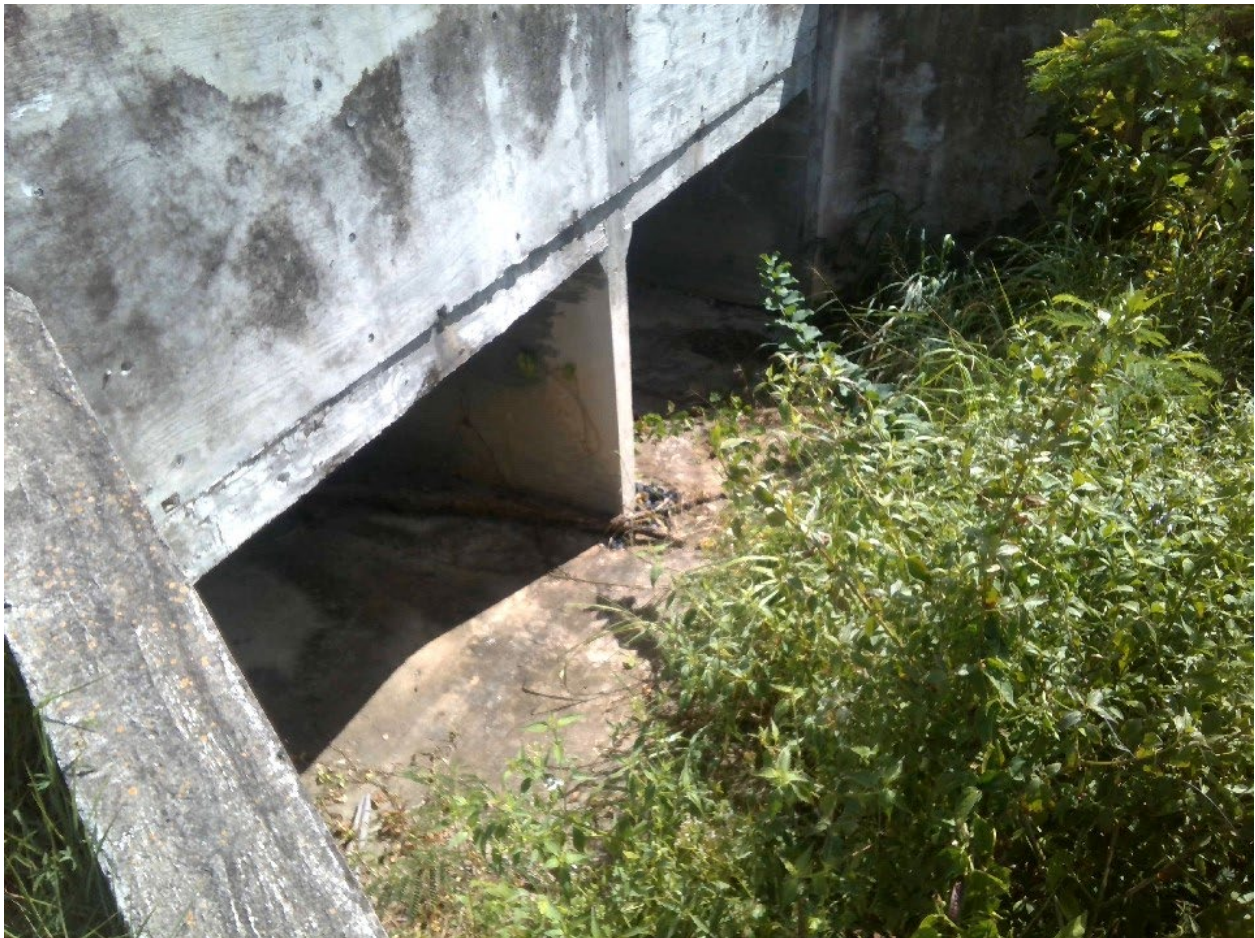
*Figure 74. Existing conditions of proposed BMP 29 site location. The photo above is of the existing culvert underneath the road.*

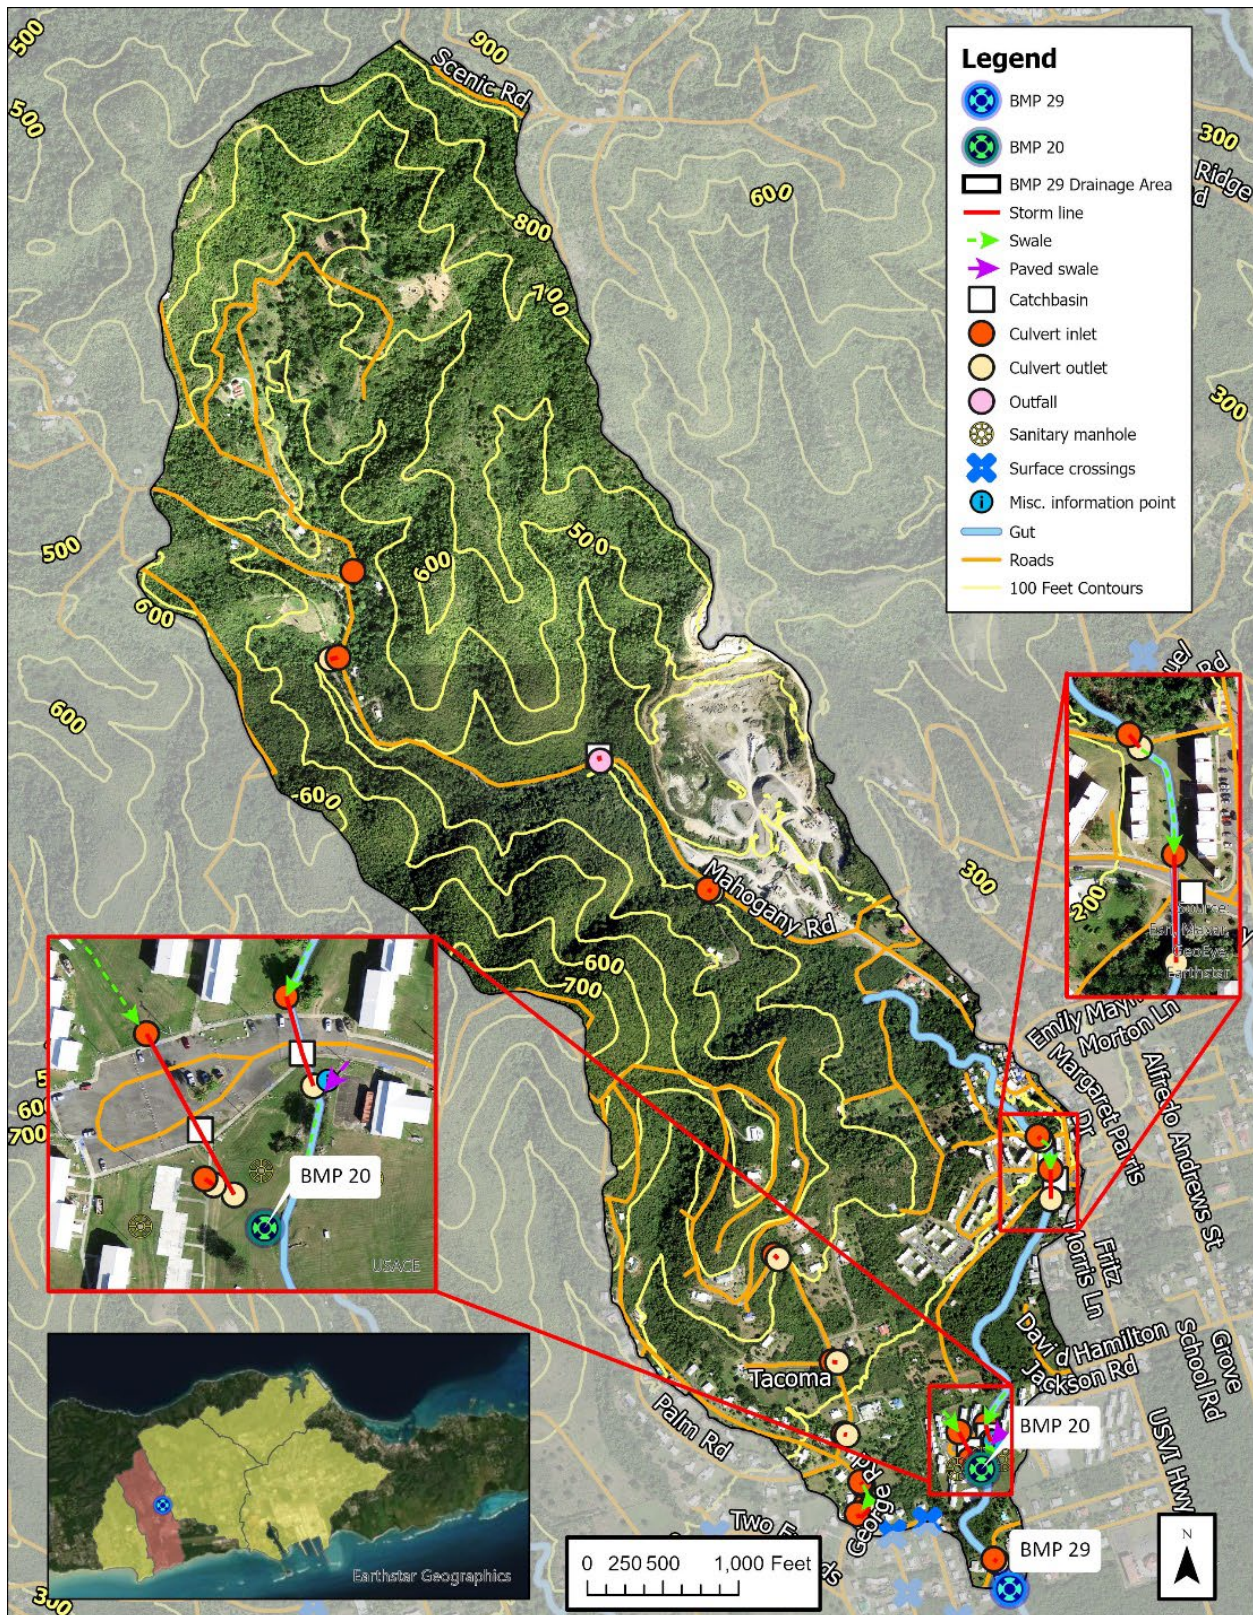
Figure 75. Drainage area to BMP 29.

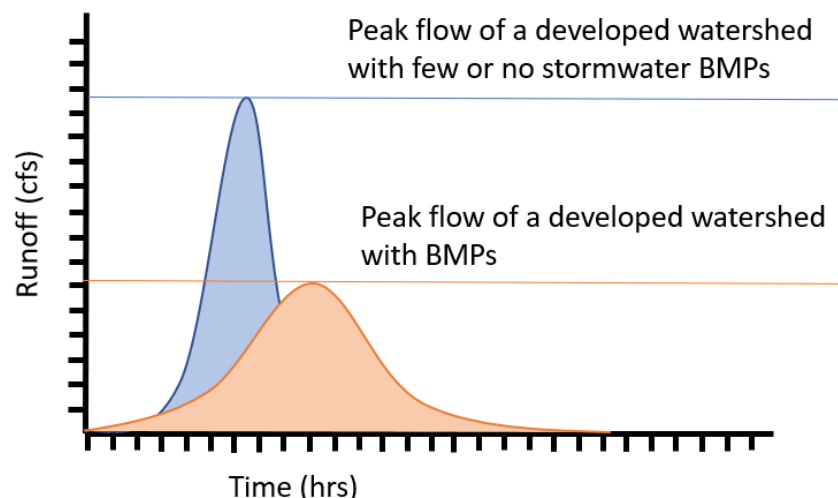
*Figure 76. Illustrative hydrographs demonstrating the peak flow reduction value of implementing BMPs.*

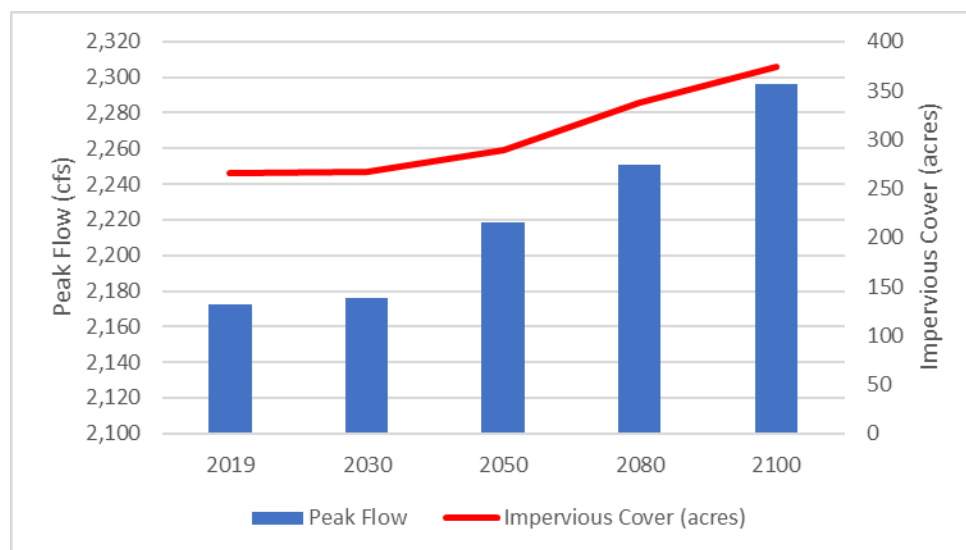
*Figure 77. Relationship between watershed scale peak flow (blue) and the predicted impervious cover (red) over time.*

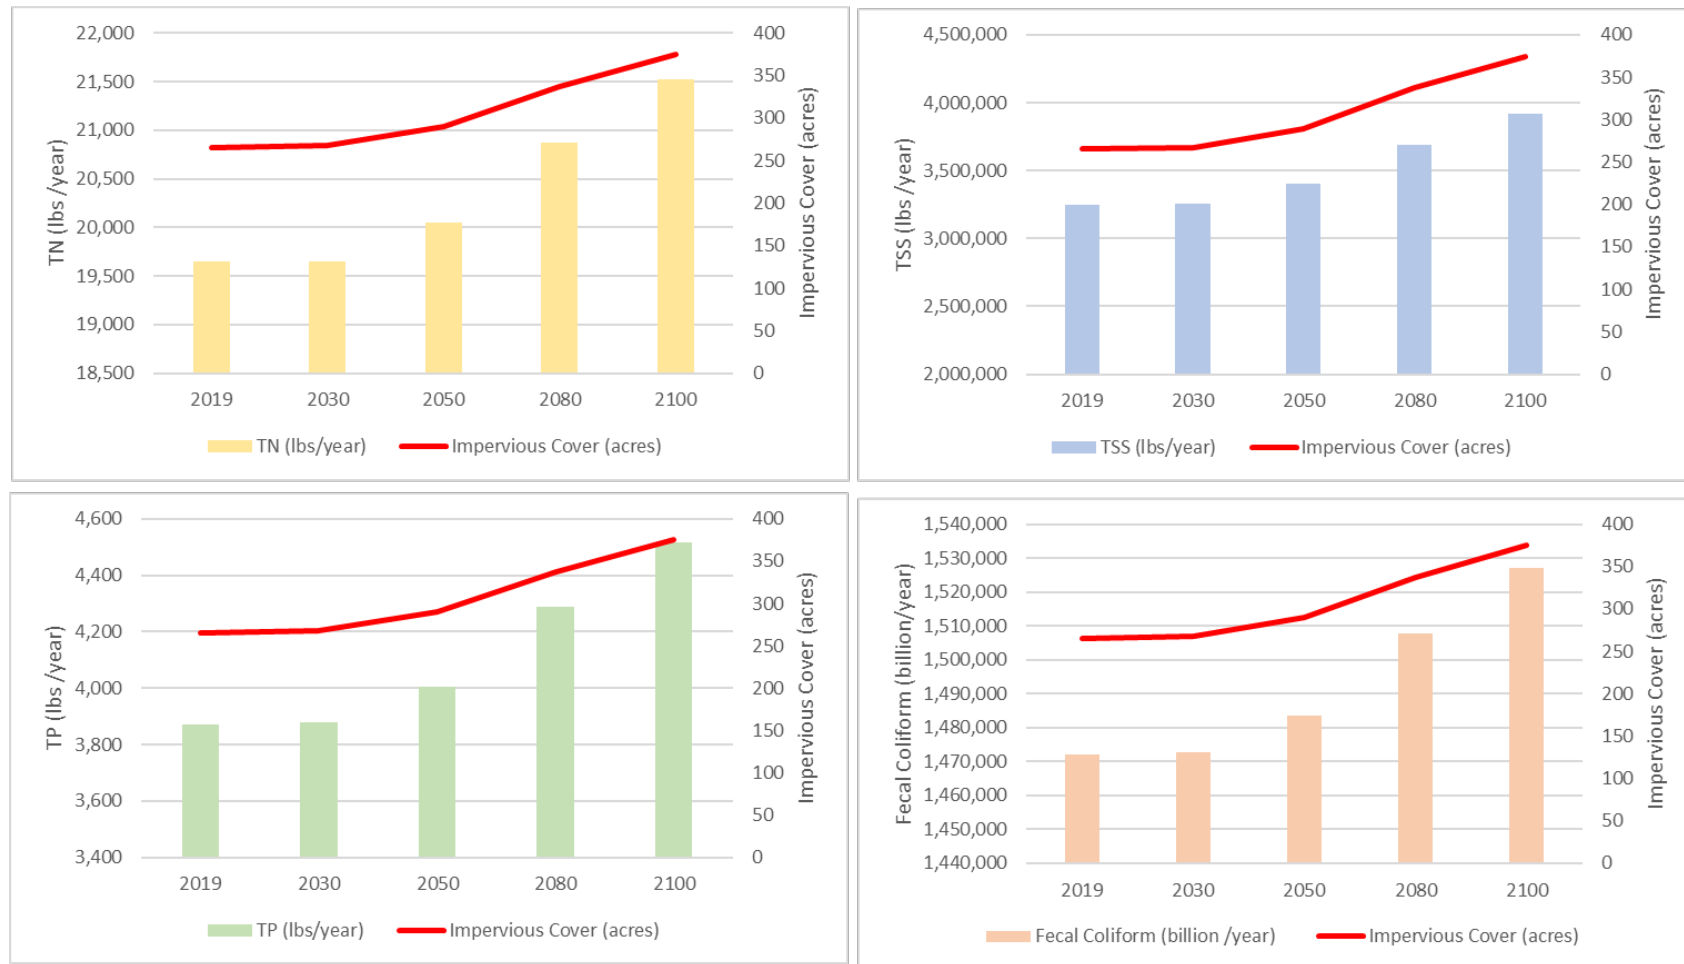
Figure 78. Relationship between watershed-scale pollutant loading for TN (yellow), TSS (blue), TP (green), and Fecal Coliform (orange) and the predicted impervious cover increase (red) over time.

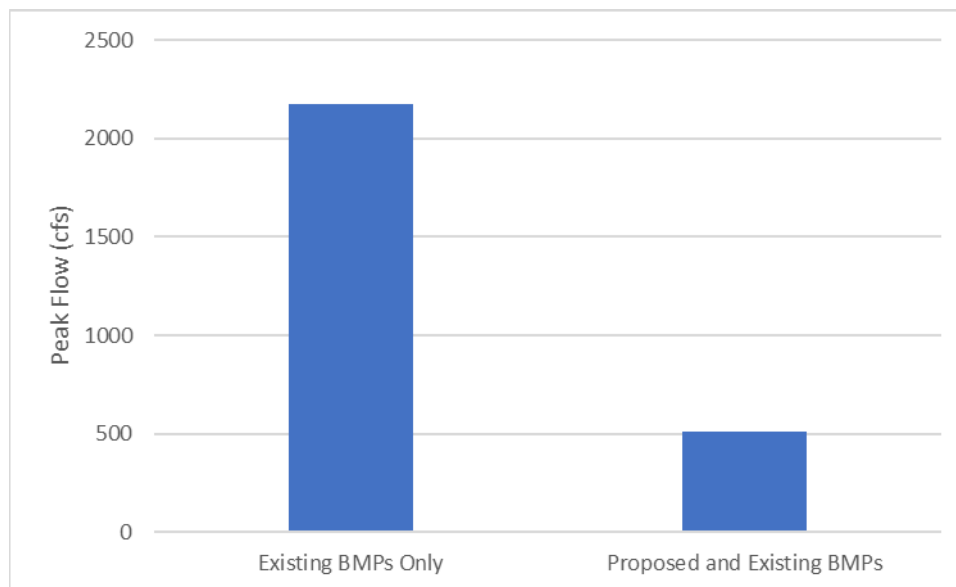
Figure 80. Peak flow was reduced at the watershed outlet from 2,178 cfs with existing BMPs to 513 cfs with addition of the Top 10 proposed BMPs.

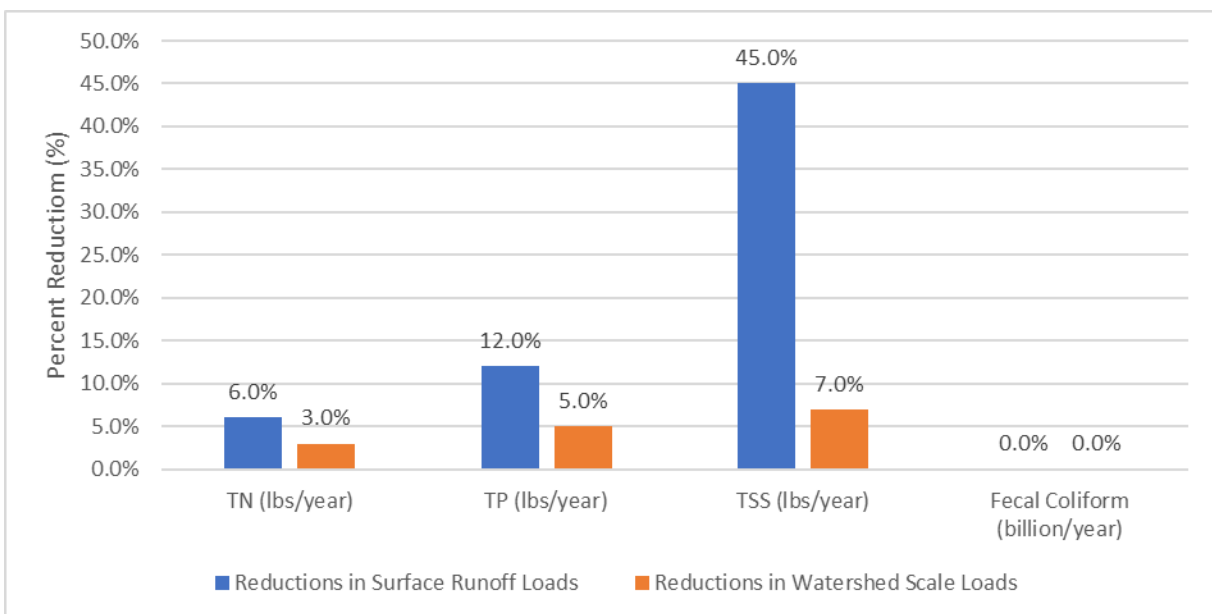
Figure 81. Pollutant load reductions attributable to the Top 10 BMPs for the Surface Runoff category (blue) and for all modeled watershed sources (orange).

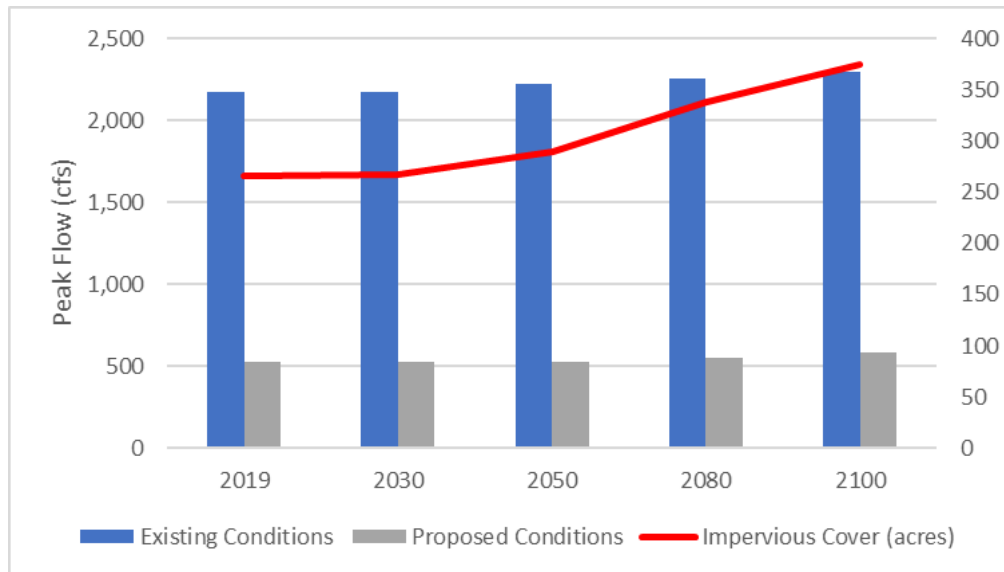
*Figure 82. Relationship between watershed peak flow for the existing conditions (light blue) and proposed conditions (gray), which includes the implementation of the Top 10 BMPs over time. The predicted impervious cover increase (red) over time is also shown.*

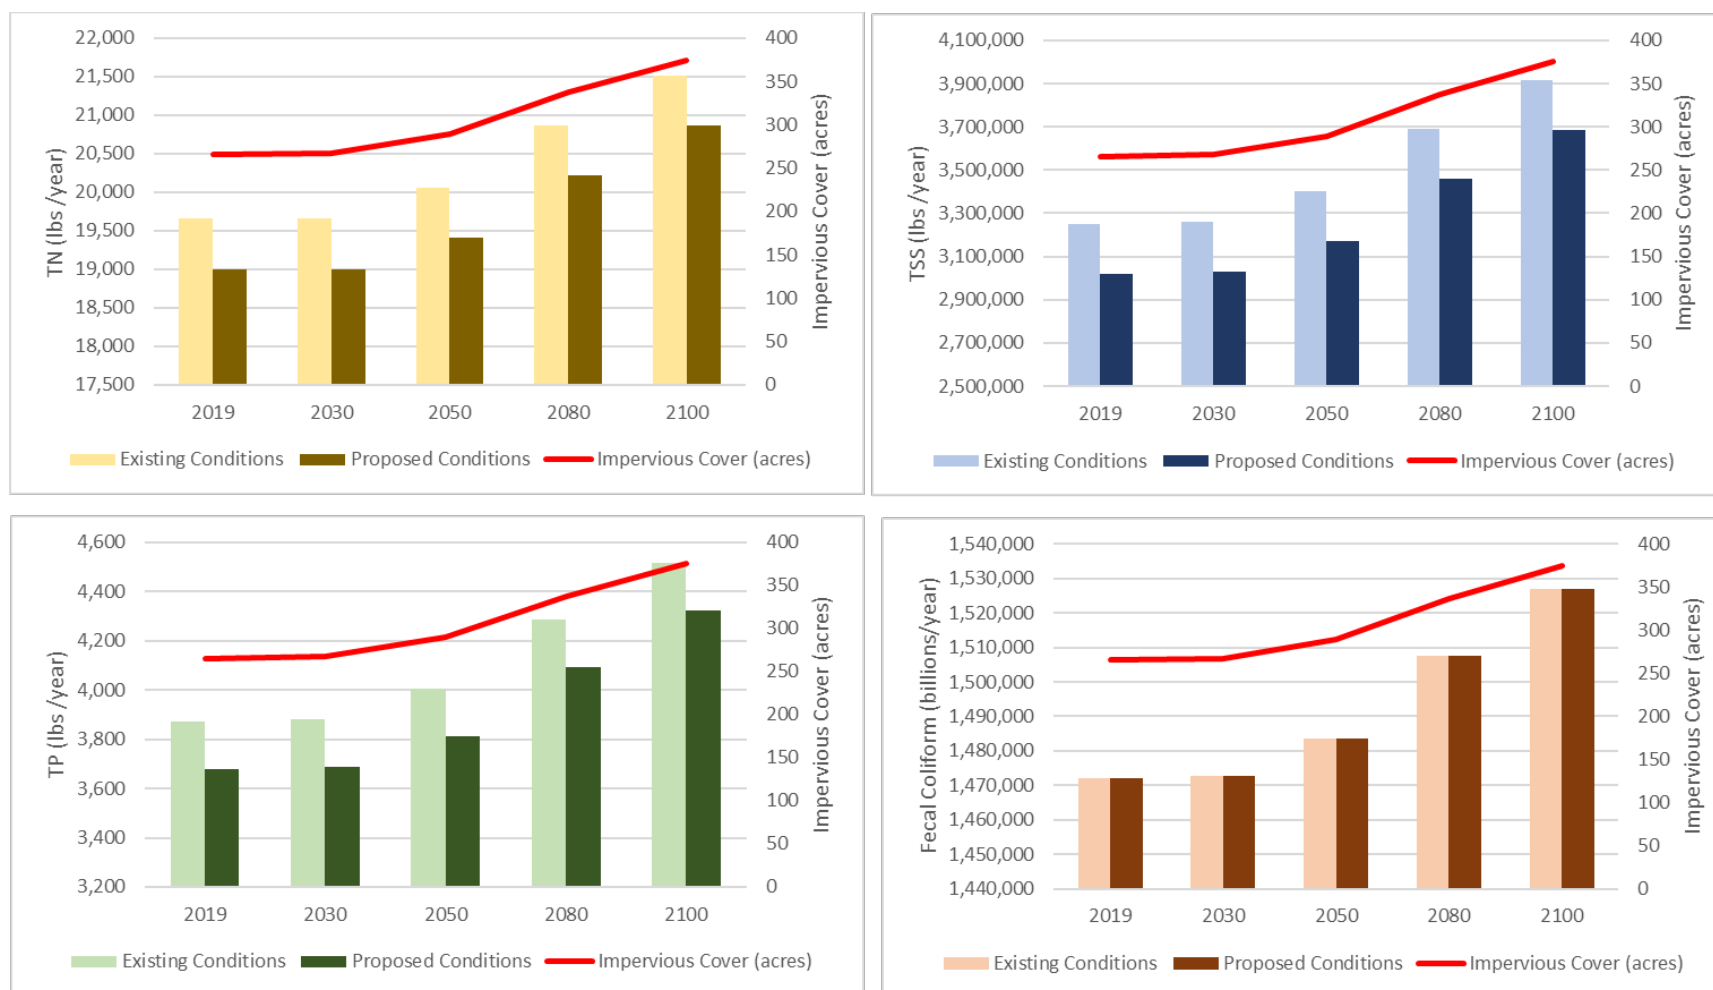
Figure 83. Relationship over time between watershed scale pollutant loading for the existing conditions (lighter colors) and proposed conditions (darker colors), which includes the implementation of the Top 10 BMPs. Loading is shown for TN (yellow), TSS (blue), TP (green), and Fecal Coliform (orange). The predicted impervious cover increase (red line) over time is also shown.
