# WATERSHED MANAGEMENT PLAN FOR THE HOVENSA WATERSHED ST. CROIX, USVI JUNE 2022

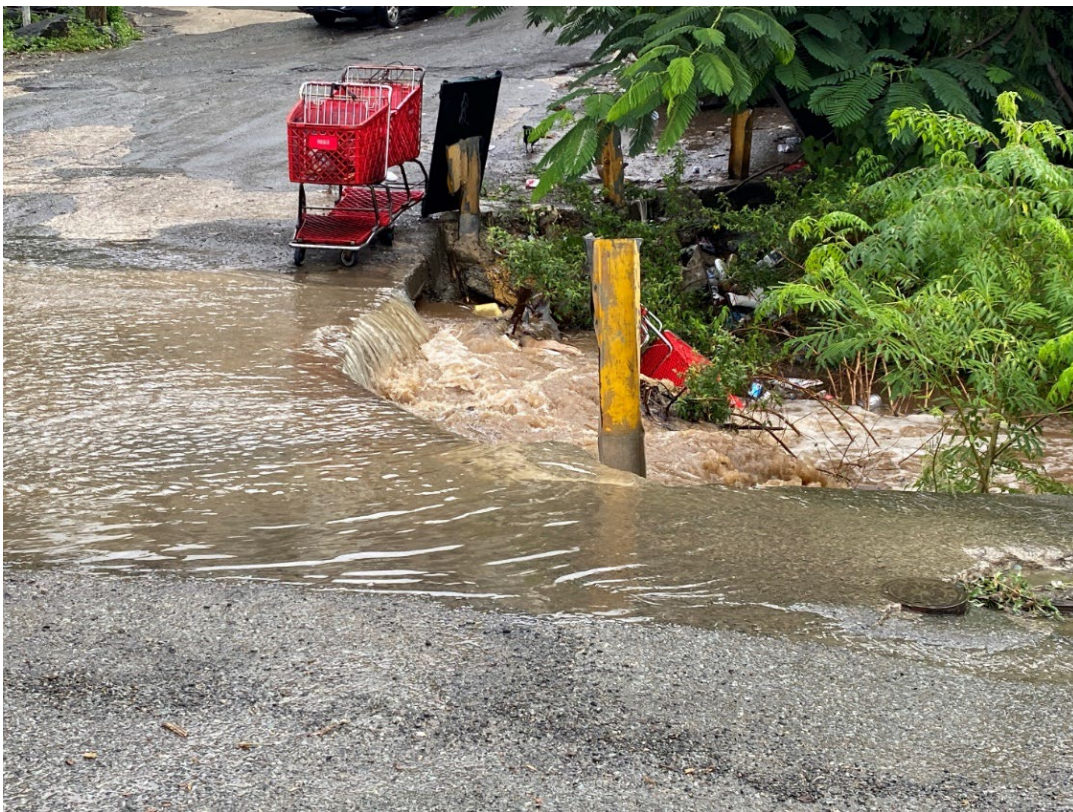
*Figure 5. Runoff from impervious surfaces such as a road contributes to flooding and water quality problems.*

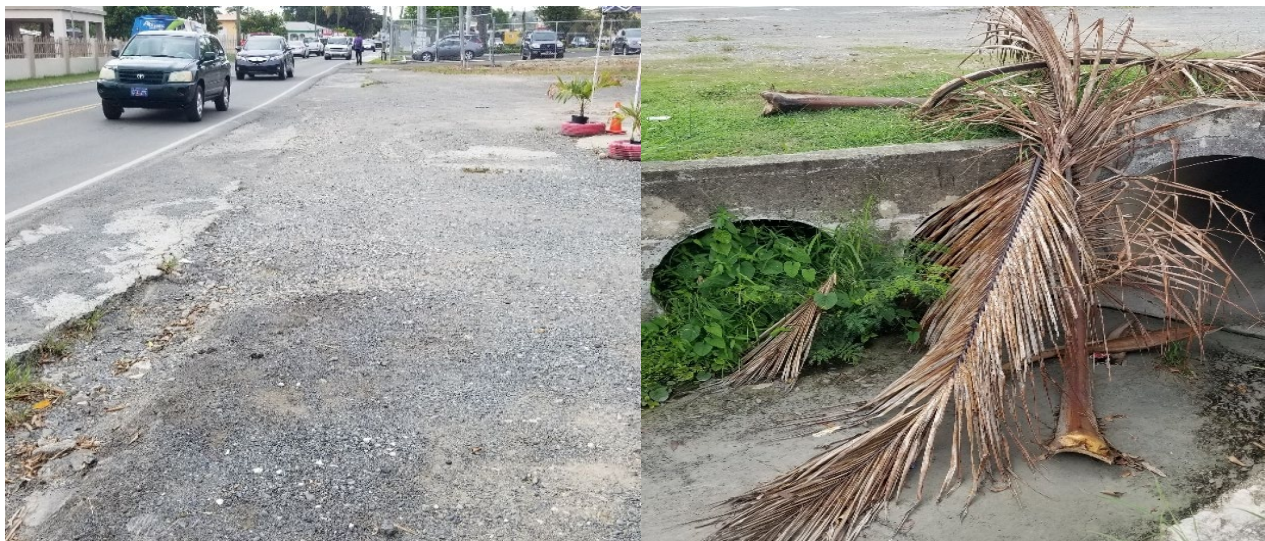
*Figure 38. Road erosion (left) and clogged stormwater infrastructure (right).*

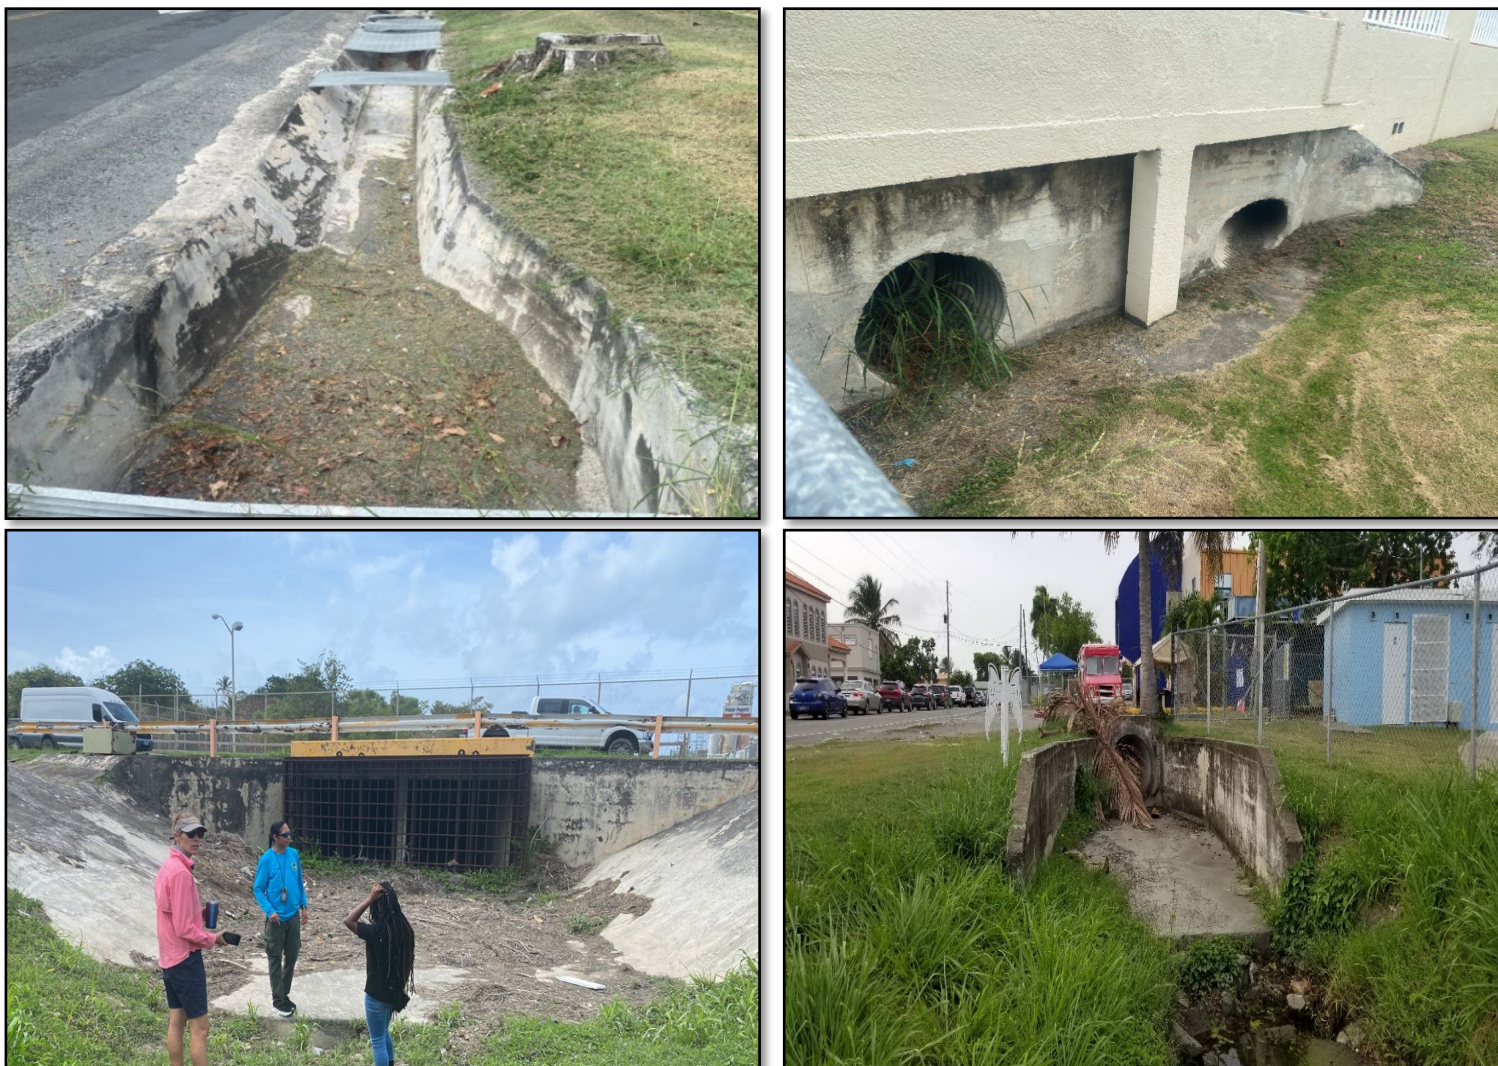
*Figure 49. Examples of stormwater infrastructure.*

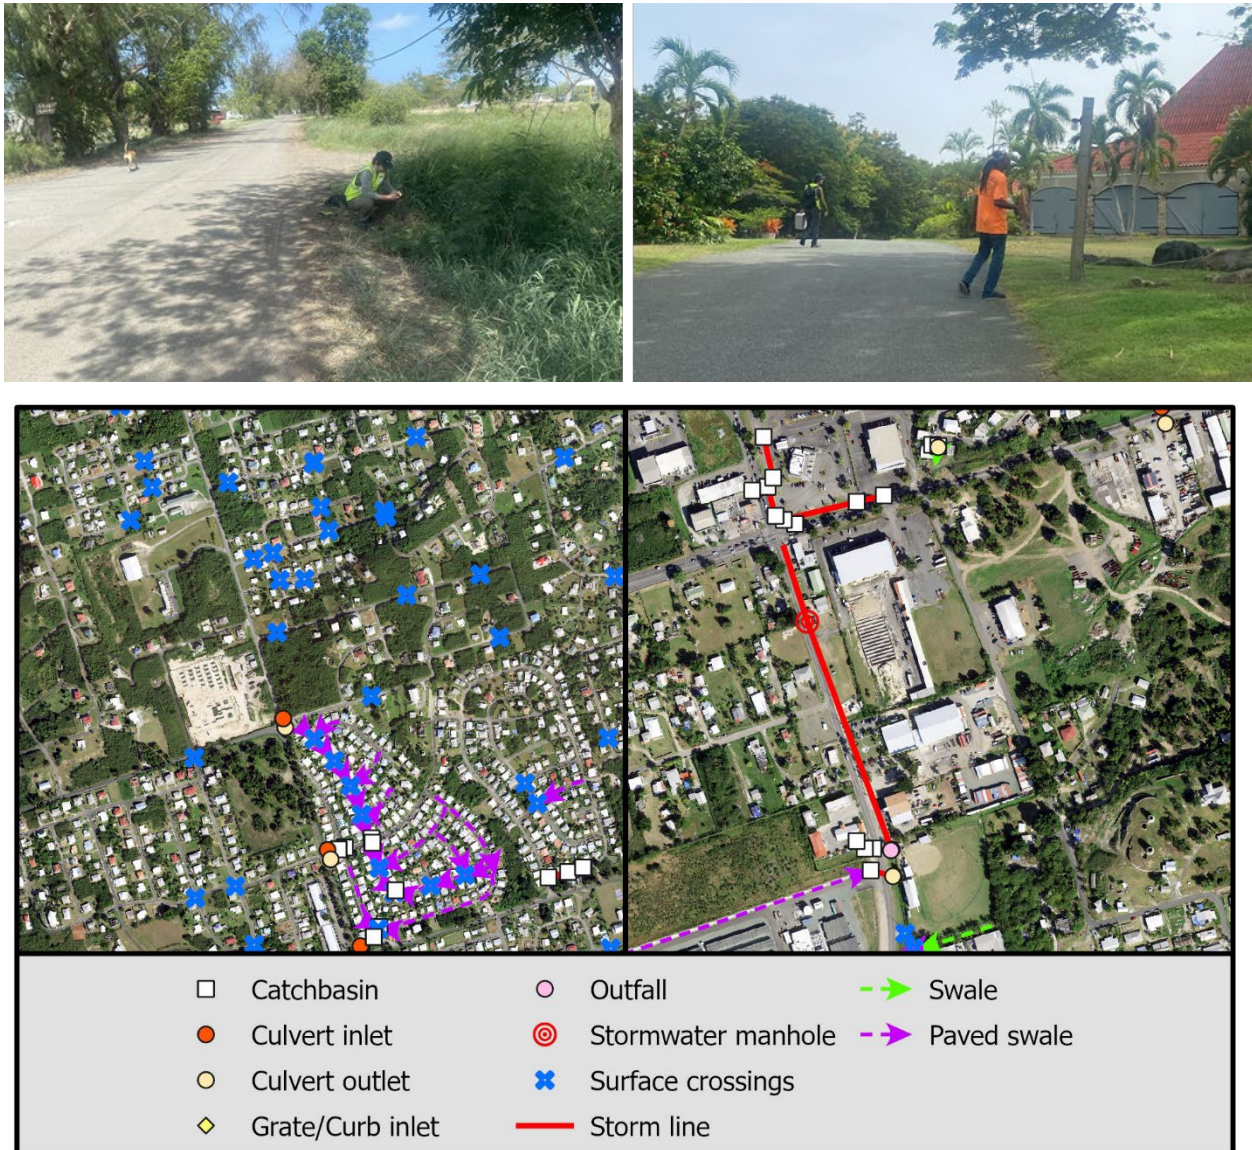
*Figure 50. Inspection of existing stormwater infrastructure during field assessments (above) and an example of the maps produced (below).*

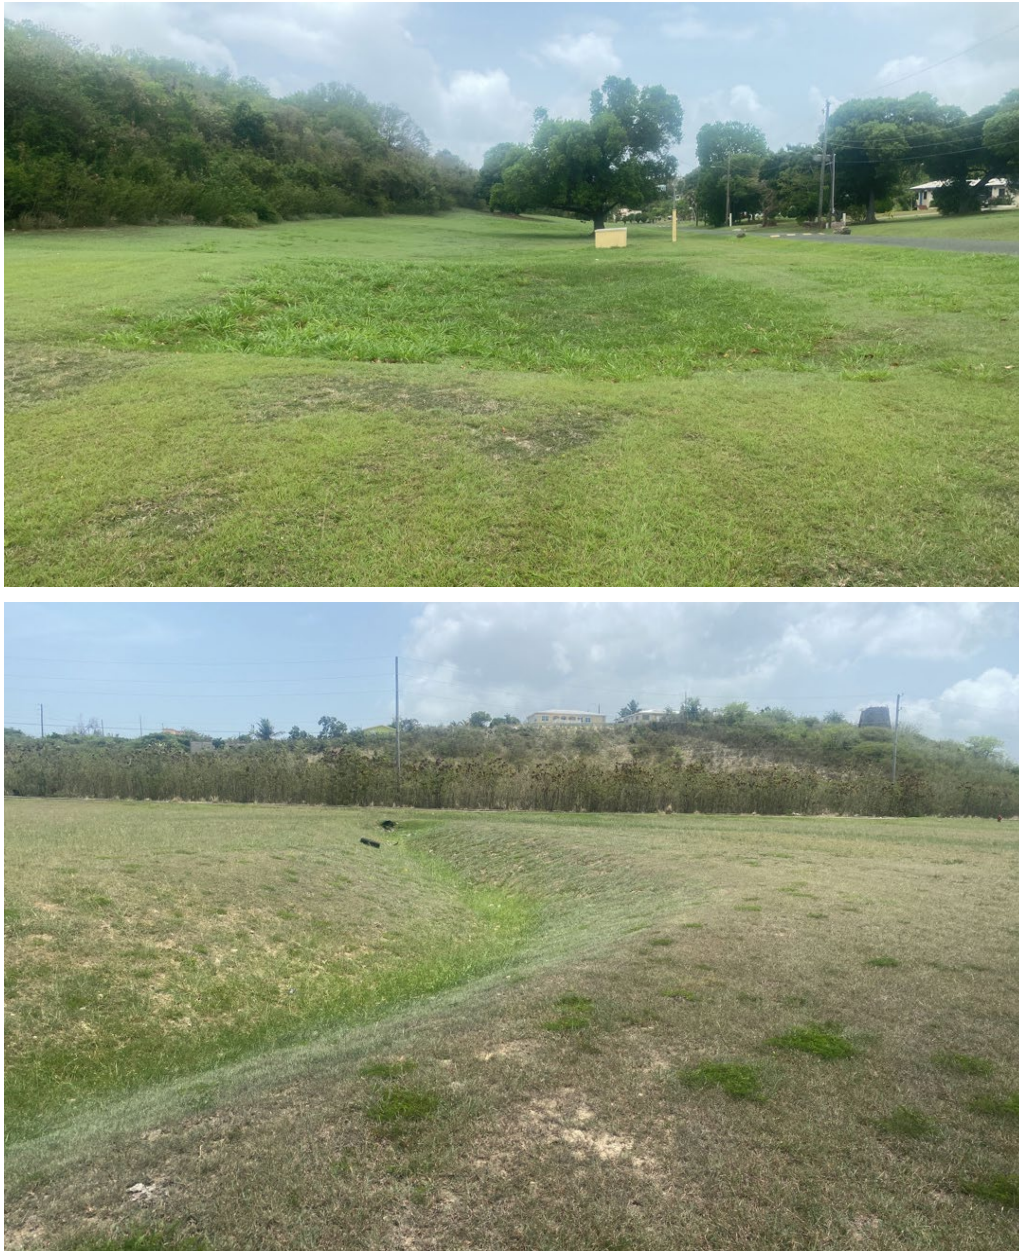
*Figure 52. Existing stormwater BMPs in Hovenssa. BMP #6 basin (above) and BMP #1 basin (below).*

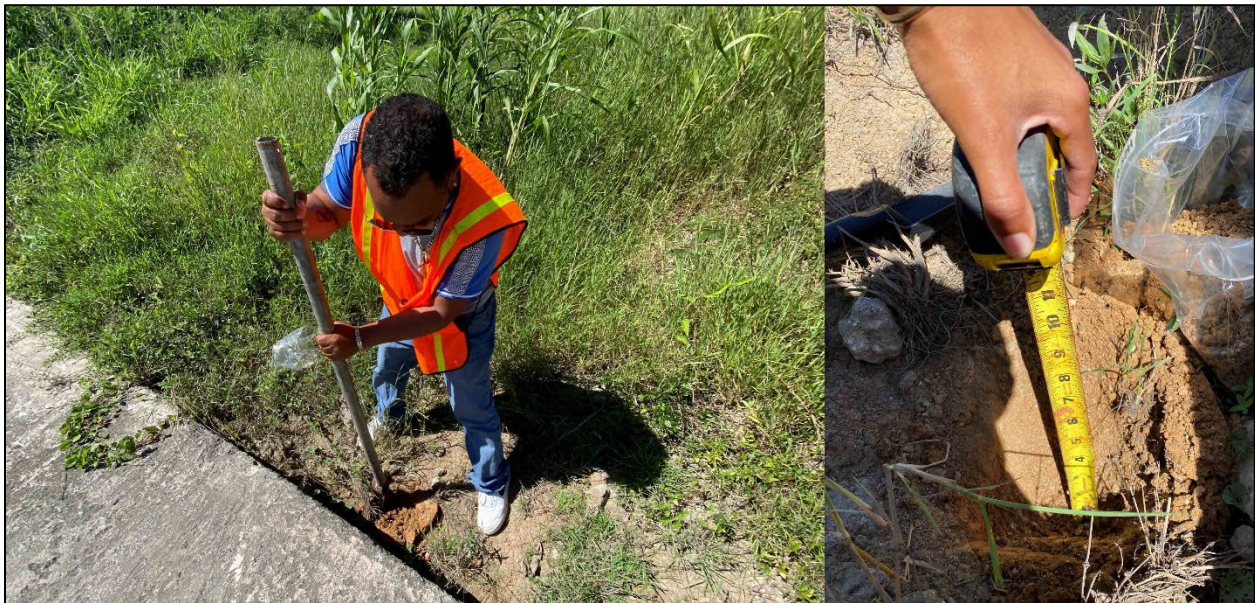
*Figure 59. A sediment core being collected from the Hov02 gut channel (left). The depth of the extracted sediment core verified with a tape measure (right).*

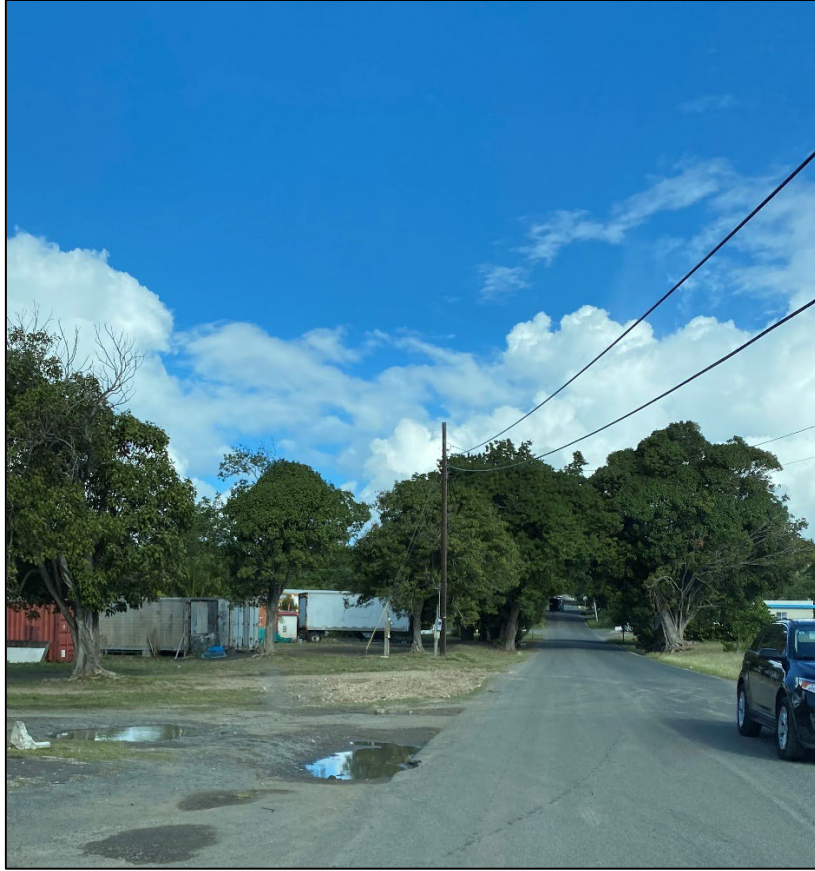
*Figure 66. Ponding observed on roads adjacent to the Hov05 monitoring location directly after a storm event.*

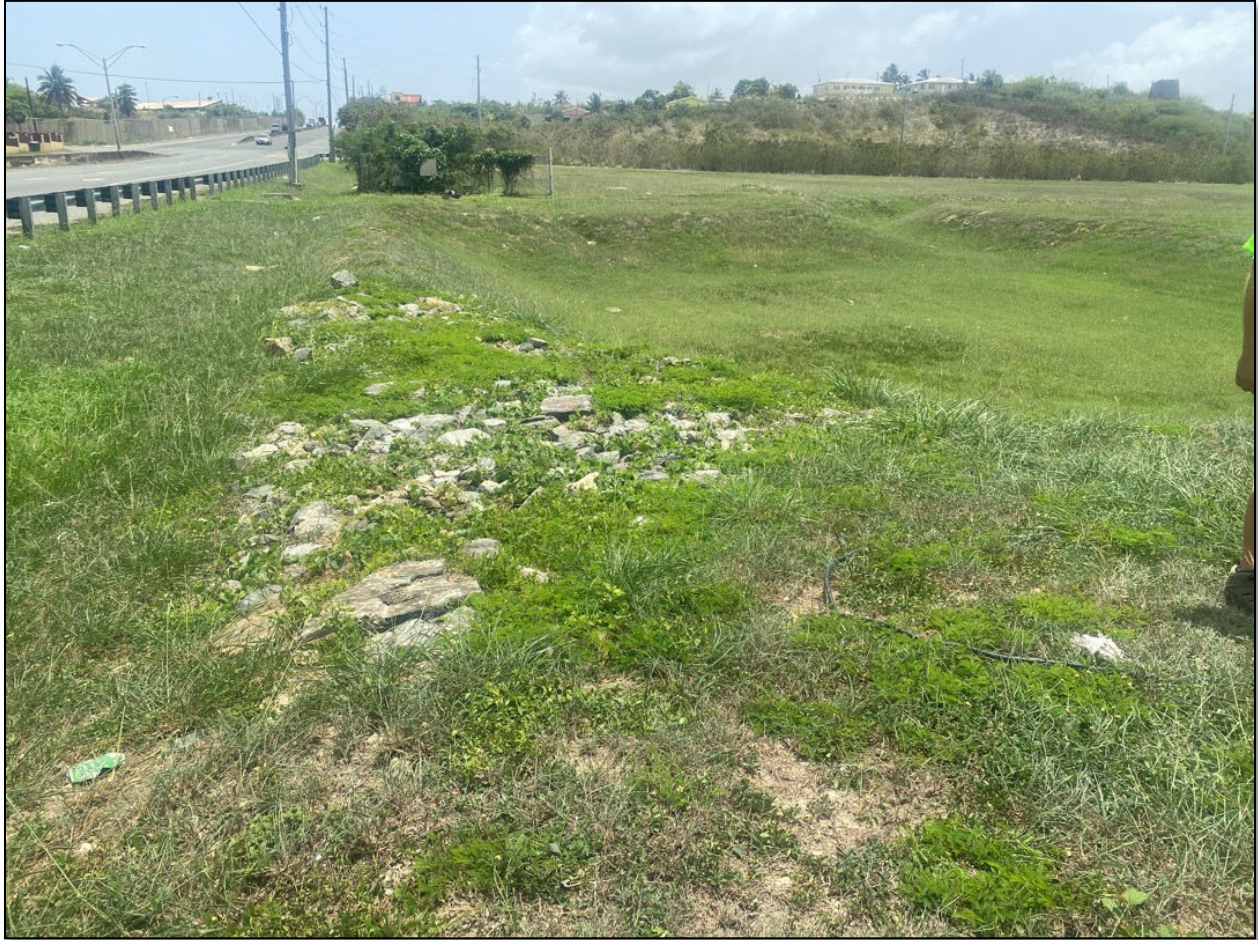
*Figure 83. Existing conditions of proposed basin (BMP 41).*

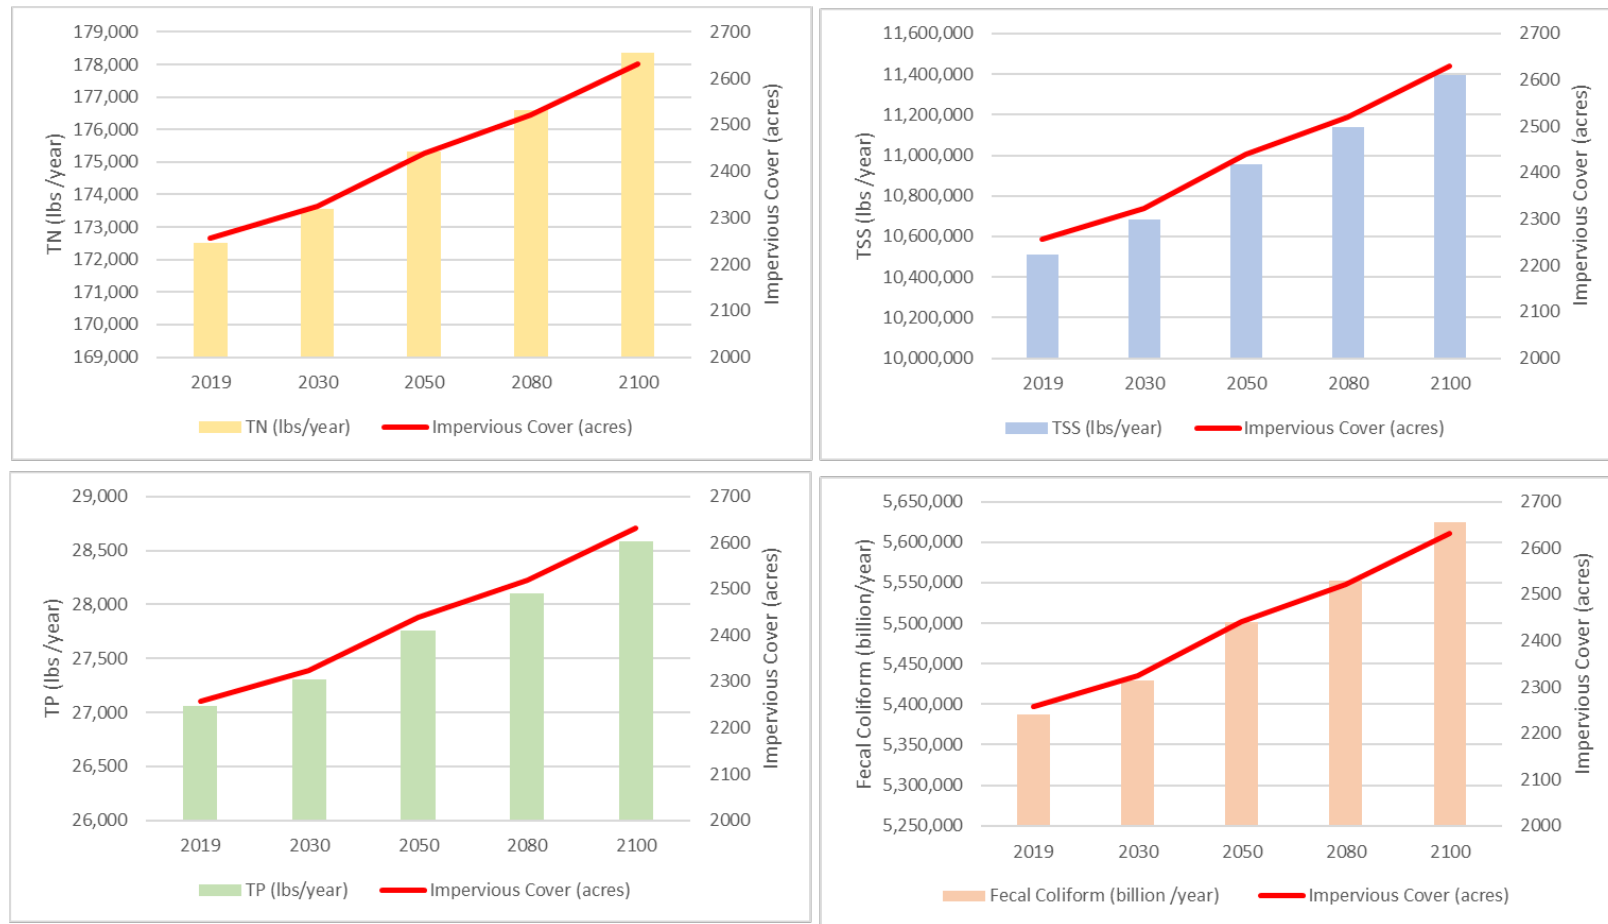
Figure 87. Relationship between watershed-scale pollutant loading for TN (yellow), TSS (blue), TP (green), and Fecal Coliform (orange) and the predicted impervious cover increase (red) over time

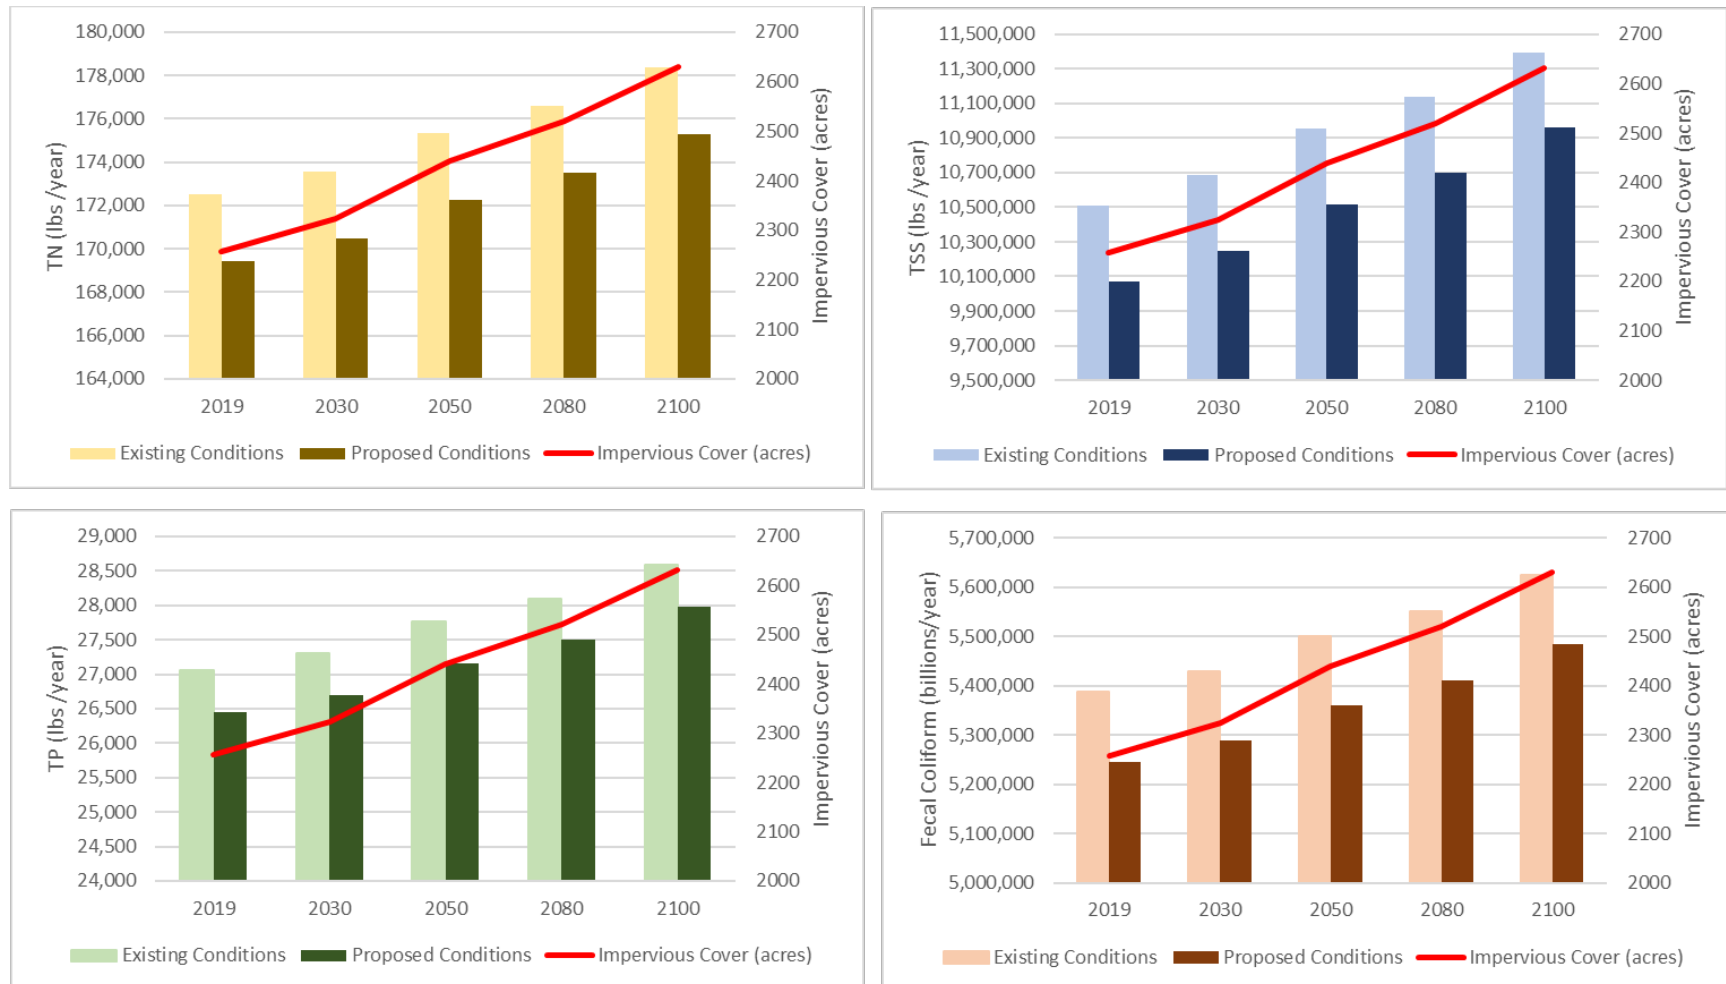
Figure 92. Relationship over time between watershed scale pollutant loading for the existing conditions (lighter colors) and proposed conditions (darker colors), which includes the implementation of the Top 10 BMPs. Loading is shown for TN (yellow), TSS (blue), TP (green), and Fecal Coliform (orange). The predicted impervious cover increase (red line) over time is also shown.
