WATERSHED MANAGEMENT PLAN FOR ST. THOMAS HARBOR ST. THOMAS, USVI

JUNE 2022

This watershed management plan (WMP) summarizes watershed-specific assessments and provides recommendations and design details to reduce flooding and improve water quality and resiliency. The three watersheds assessed on St. Thomas include Bolongo Bay, Cyril E. King Airport, and St. Thomas Harbor (Figure 1). The concurrent study on St. Croix includes the watersheds of Bethlehem, Diamond, Hovensa, Long Point Bay, and Salt River Bay.

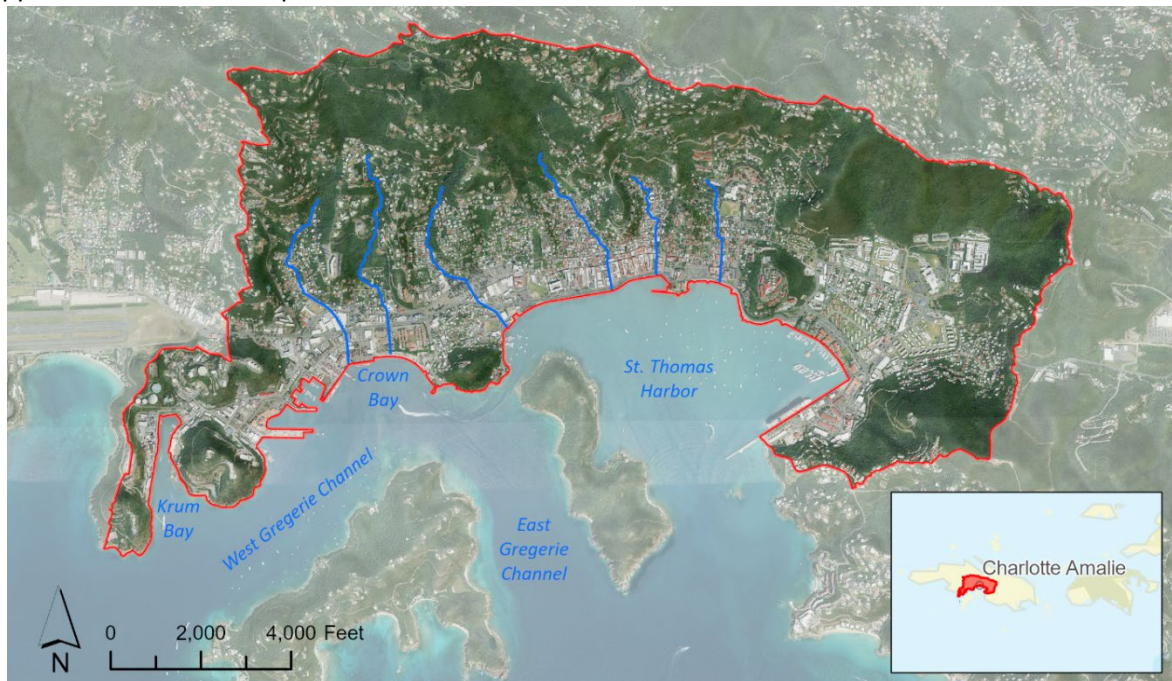
Figure 19. Overview map of the watershed.

St. Thomas Harbor is a 3.94 sq. mile watershed located on the southern coast of St. Thomas (Figure 19). The watershed encompasses the capital city of the USVI, Charlotte Amalie, as well as the surrounding neighborhoods. Charlotte Amalie is the largest city on St. Thomas with a population of approximately 18,481 according to the 2010 US Census. It is a hot spot of tourism and trade with multiple active cruise ship and shipping ports along the hardened shoreline.

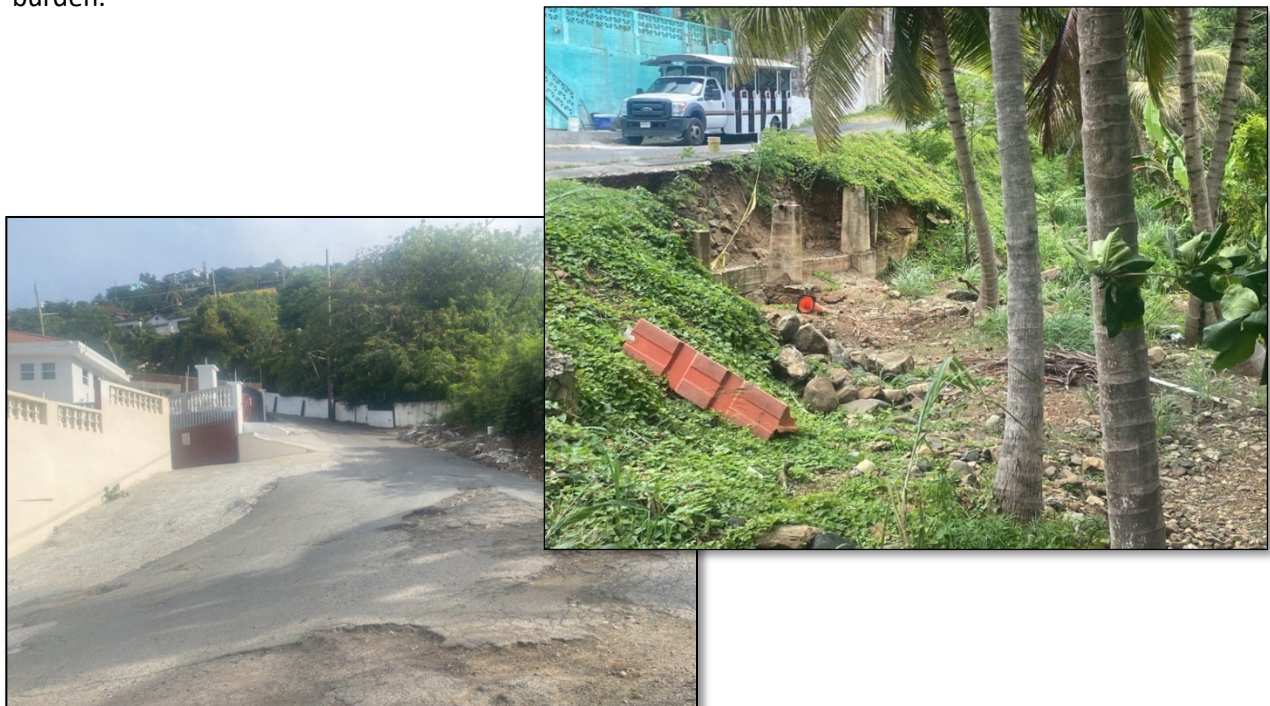
Figure 39. Road erosion (left) and undermined roadway due to unmanaged stormwater (right).

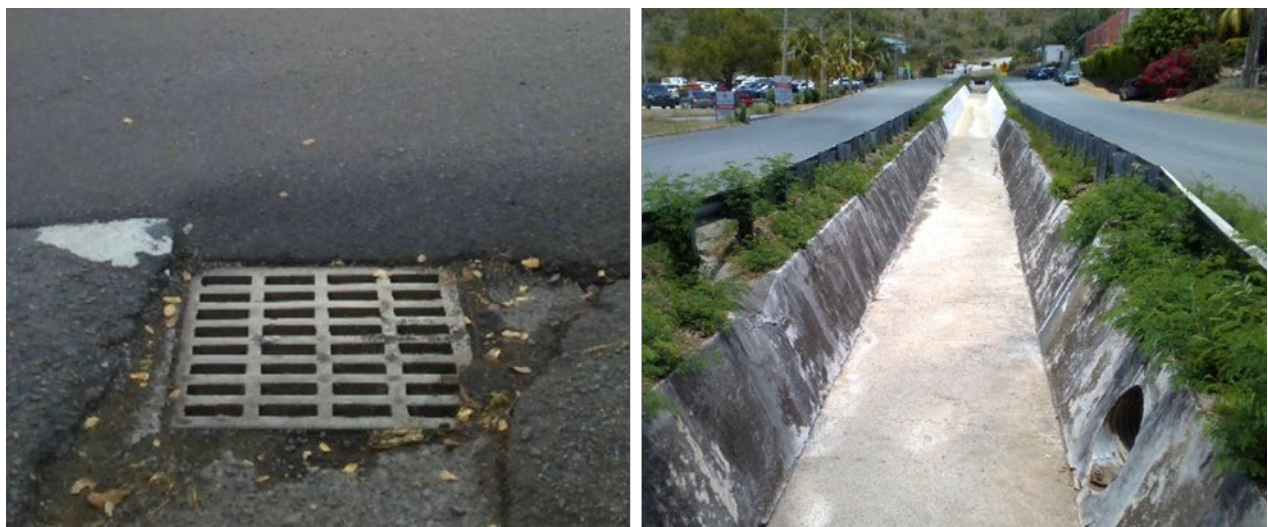
Figure 51. Examples of stormwater infrastructure. A catch basin (left) and a paved swale (right).

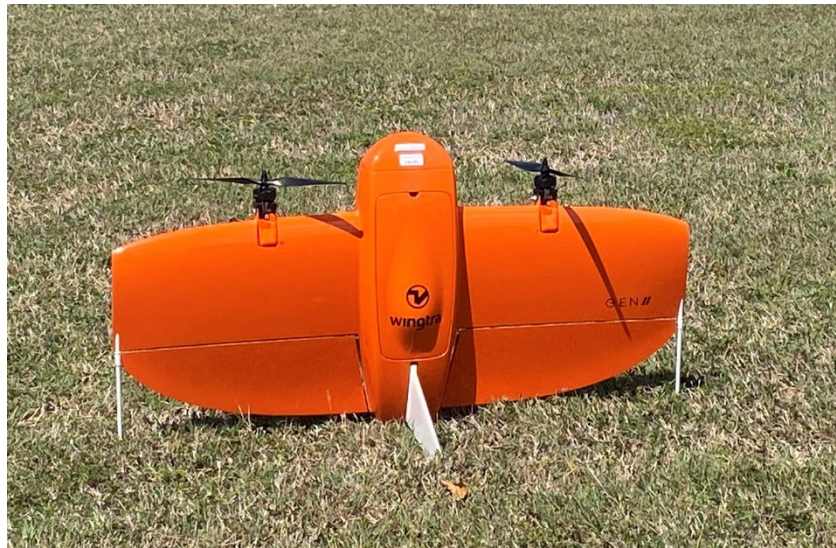
Figure 55. WingtraOne Gen II UAS utilized to collect data in the study watersheds.

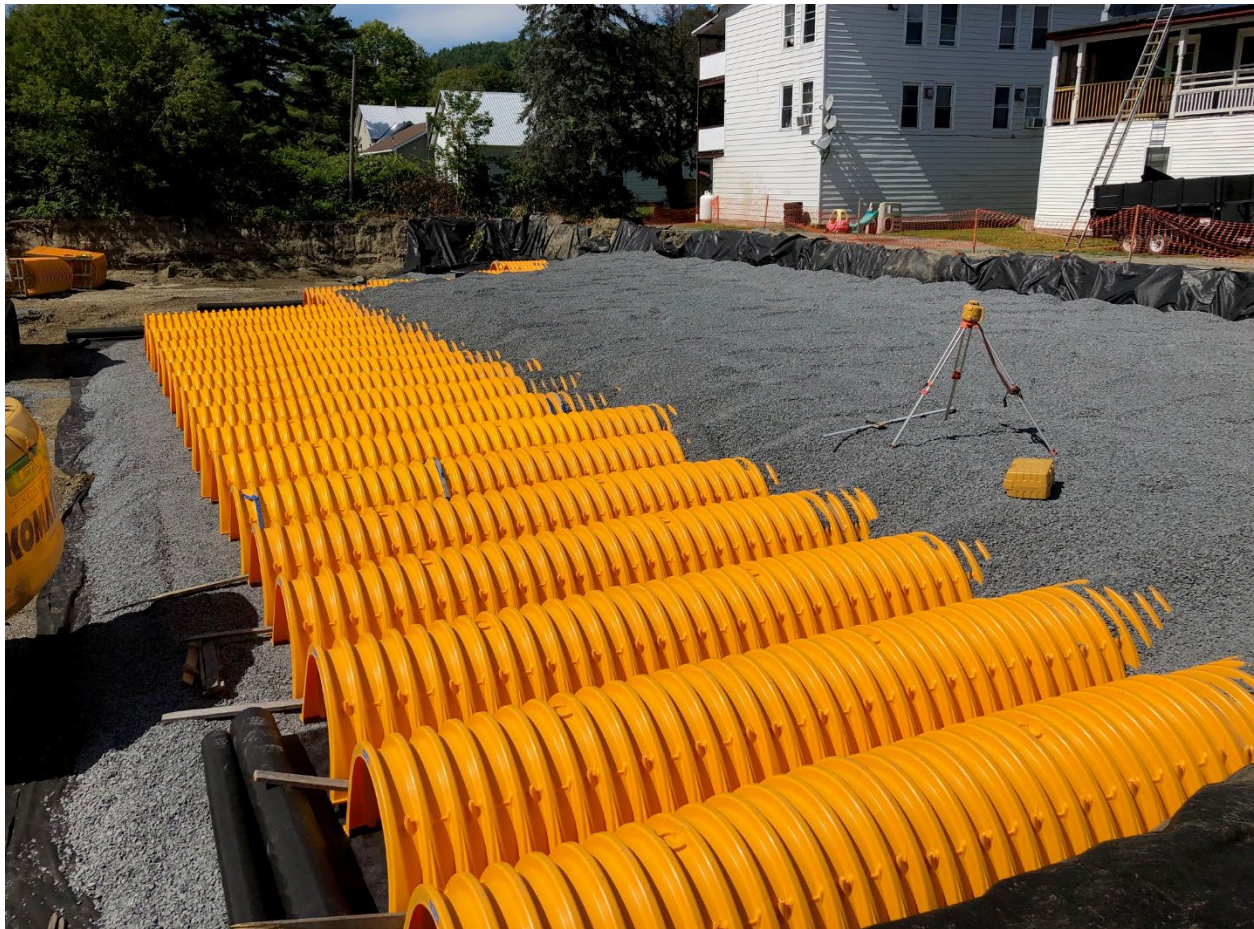
Figure 88. Example photo of subsurface infiltration chambers.

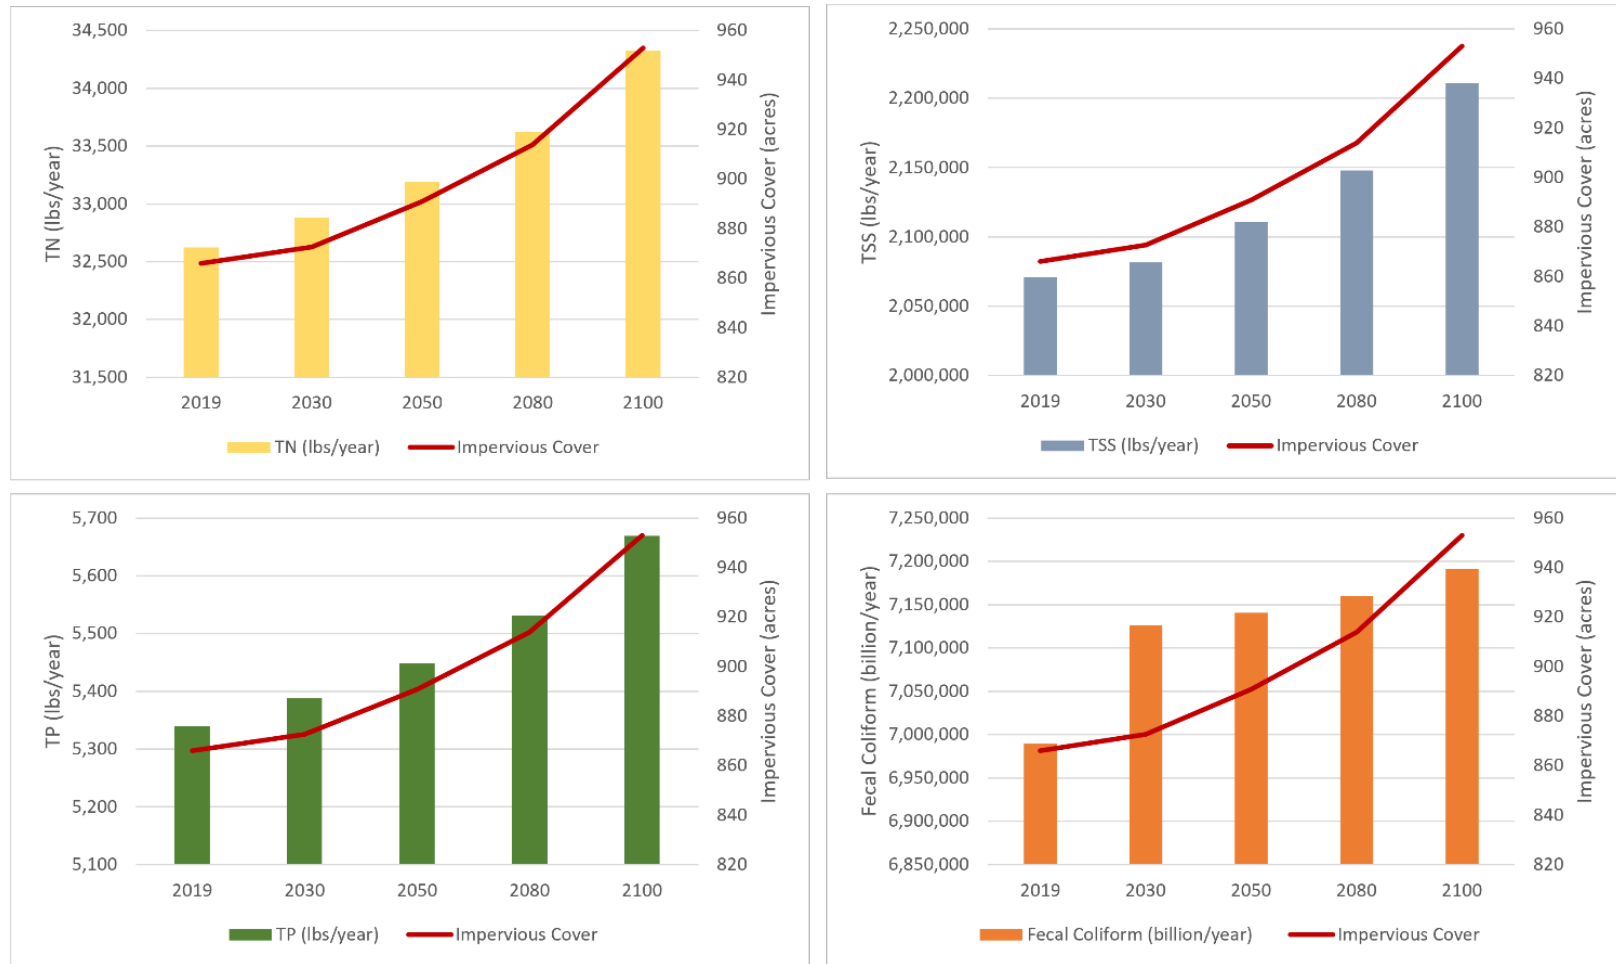
Figure 92. Relationship between watershed-scale pollutant loading for TN (yellow), TSS (blue), TP (green), and Fecal Coliform (orange) and the predicted impervious cover increase (red) over time.

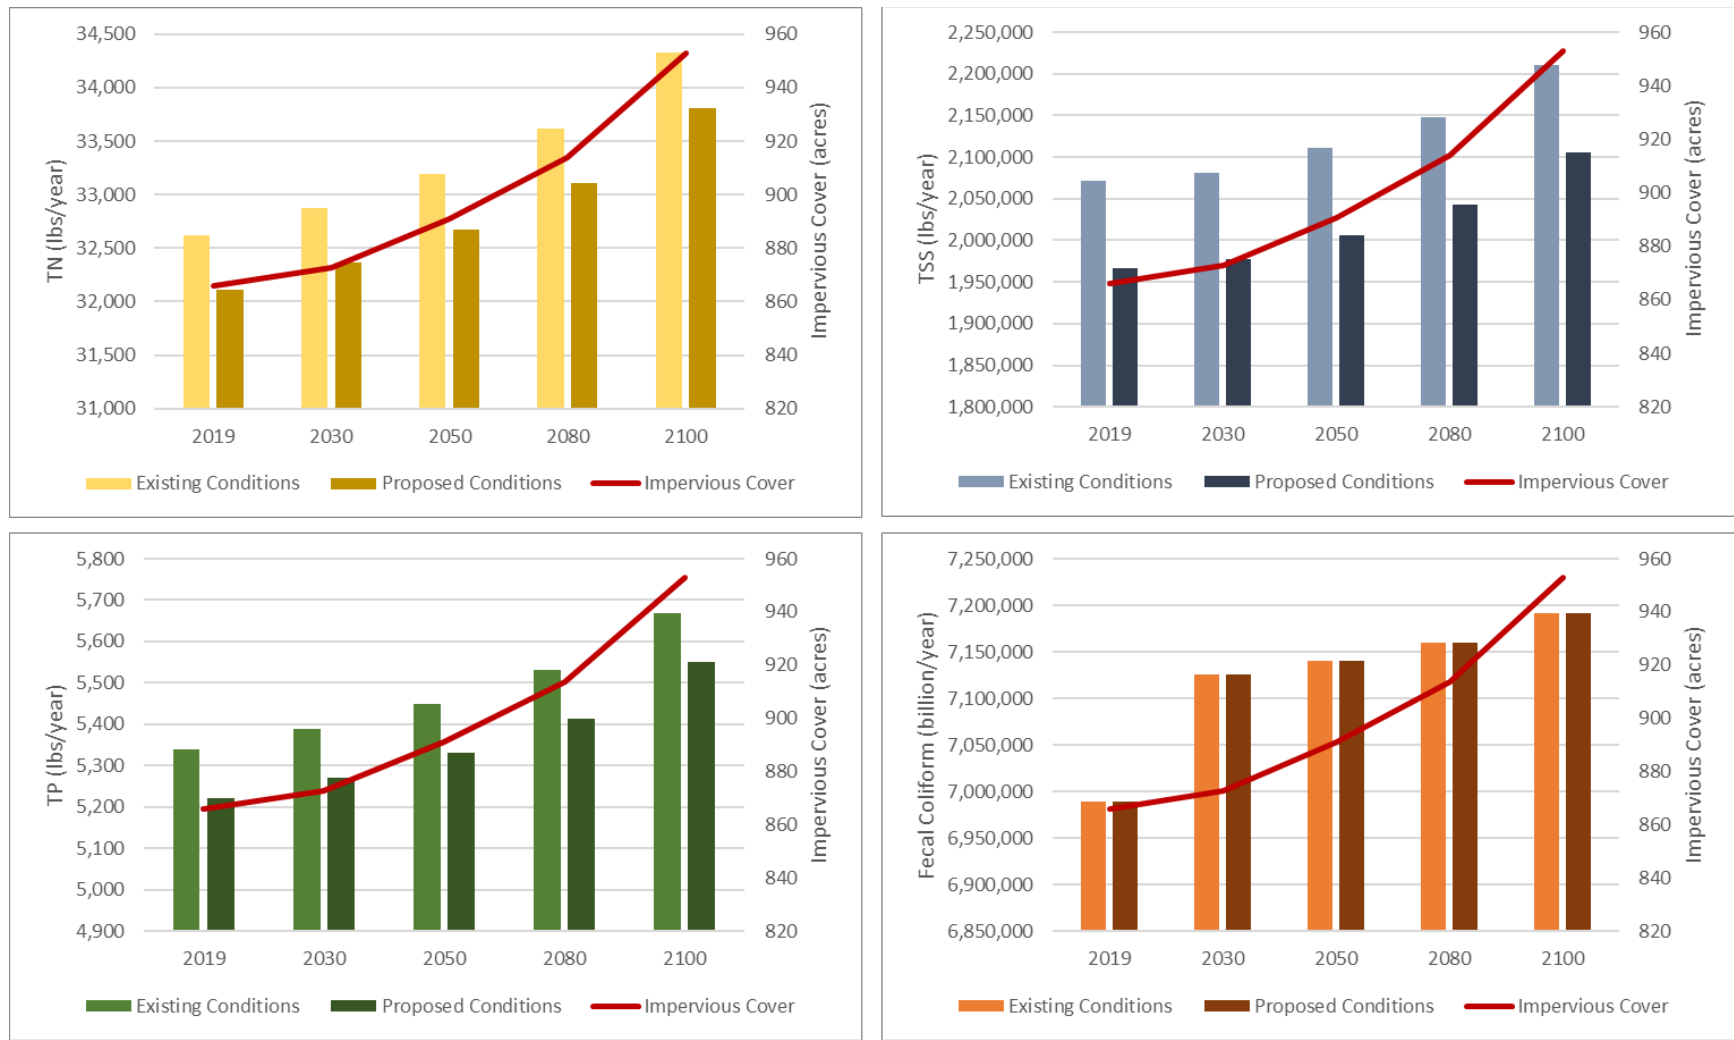
Figure 97. Relationship over time between watershed scale pollutant loading for the existing conditions (lighter colors) and proposed conditions (darker colors), which includes the implementation of the Top 10 BMPs. Loading is shown for TN (yellow), TSS (blue), TP (green), and Fecal Coliform (orange). The predicted impervious cover increase (red line) over time is also shown.
