# FLOOD HAZARD PERMIT

## Environmental Assessment Report

**Project:** VI ST ER STX(003): Storm Damage Repair to Roadways, Culverts, Embankments, Bridges, and Other Roadway Features on St. Croix, USVI

**Site:** Rt. 72 – MP 1.4 Midland Road Bridge

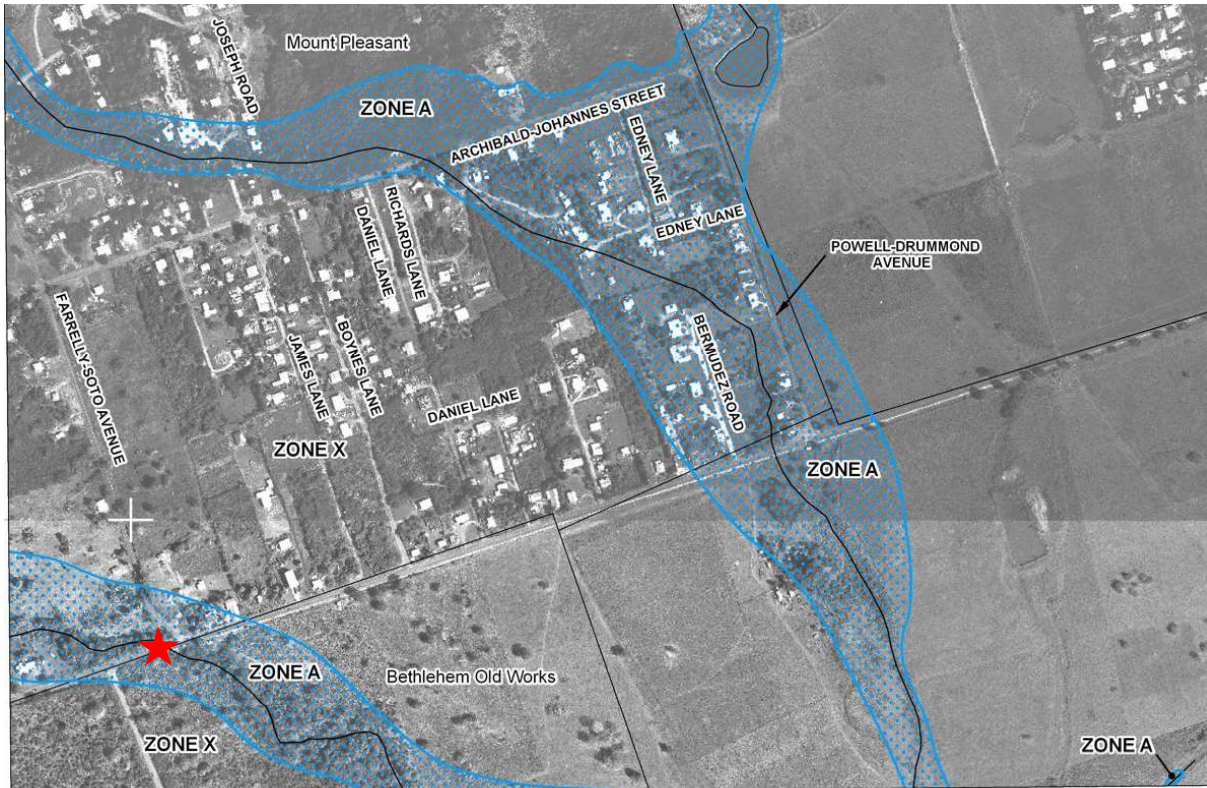
Figure 6.01.1 – Section of Flood Insurance Rate Map (FIRM) Panel 0069G, 69 of 94. April 16, 2007

Review of Federal Emergency Management Agency (FEMA) Flood Insurance Rate Maps (FIRM) for U.S. Virgin Islands Index indicate that the project area is within the flood zone rated A. See below in Figure 6.01.1 which is a portion of FIRM Panel 0069G, increased in size for clarity, depicting exact site location (red star icon) relative to flood zones. Possible flooding is anticipated for this section of roadway in its current use during flood conditions.

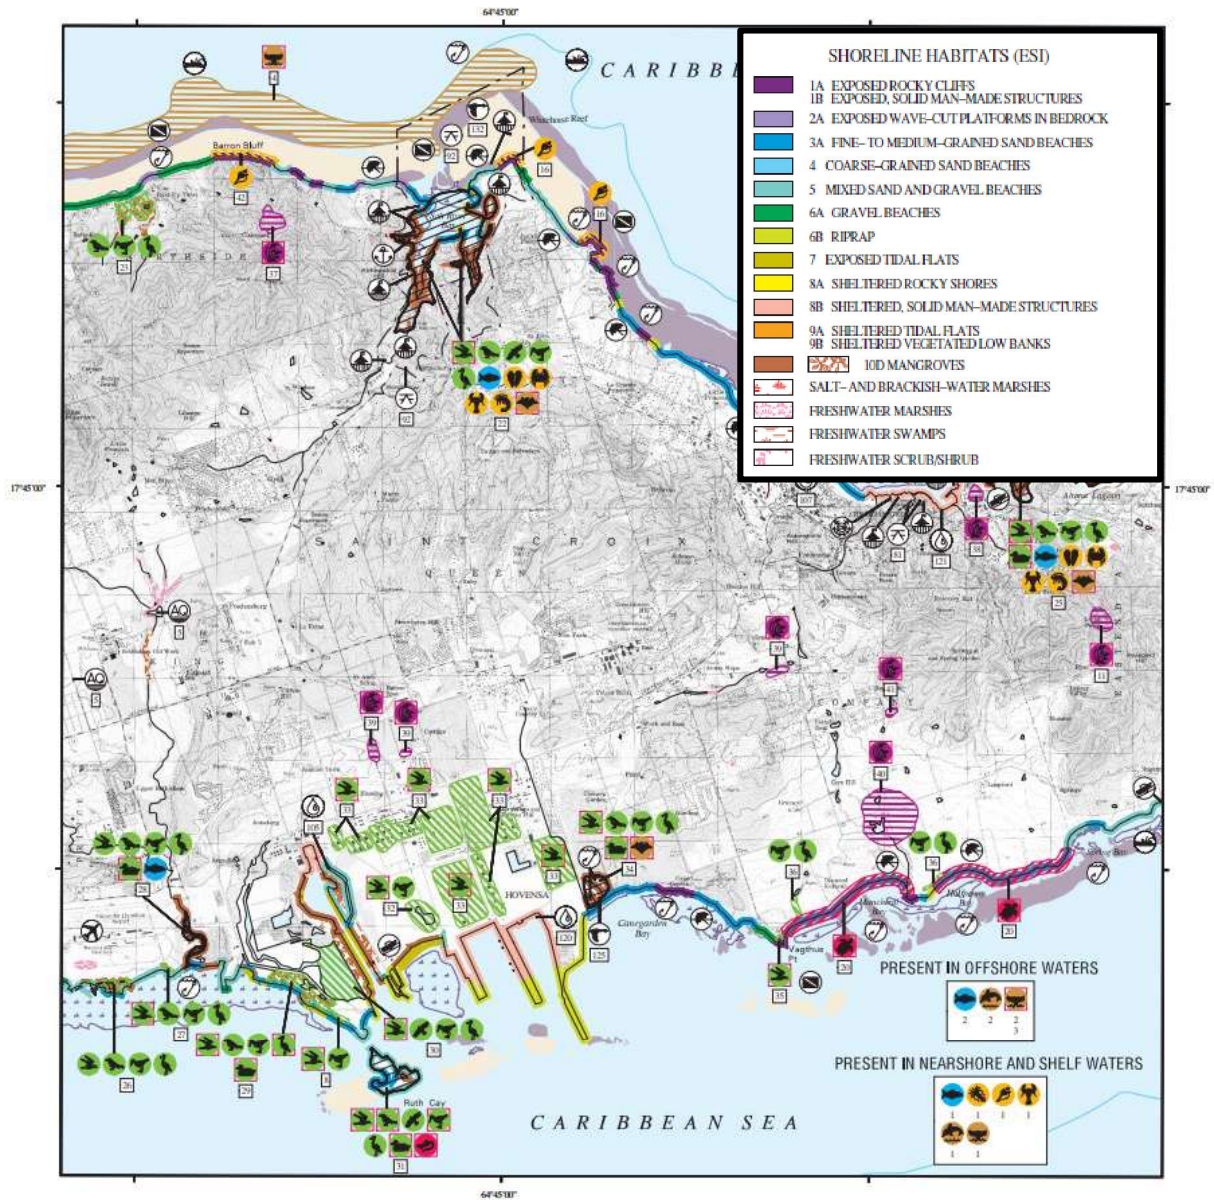
Figure 6.02.2 – Environmental Sensitivity Index Map VI-2, St. Croix, USVI

The Environmental Sensitivity Index Map below (Figure 6.02.2) indicates downstream Fredensborg Pond as habitat for aquaculture projects managed by the UVI Extension Service.

The Environmental Sensitivity Index (ESI) Map for the island of St. Croix notes no specific habitat of particular sensitivity in the area, as show in Figure 6.02.2 above.
