ENVIRONMENTAL ASSESSMENT REPORT
FOR
HAMPTON INN & SUITES HOTEL
PARCEL NO. 2 & 4 ESTATE THOMAS
ST. THOMAS, U.S. VIRGIN ISLANDS

SEPTEMBER 2022

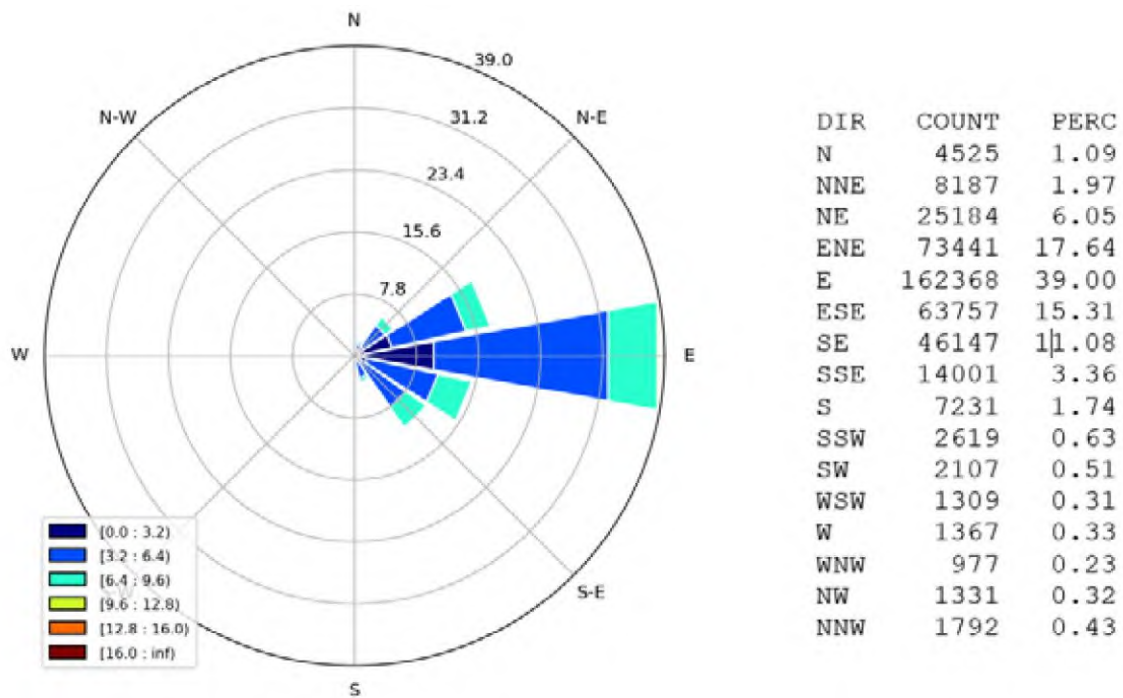
Figure 6.06.1 below, provides hourly wind speeds by both return period and direction from the Cyril E. King Airport from 1953 to 2020.

Figure 6.01.1 Hourly Wind Rose for Cyril E. King Airport, 1953-2020
(<https://weather.gov/data/obhistory/TIST.html>)

direction is provided in Figure 6.01.5 and Figure 6.01.6, respectively. This offshore station shows the same pattern as the Cyril E. King Airport Station (Figure 6.01.1), with winds predominantly from the East sector. Wind speed shows approximately 90% of measurements being less than 20 knots (10 m/s) with a mean hourly wind speed of 13.4 knots (6.9 m/s).

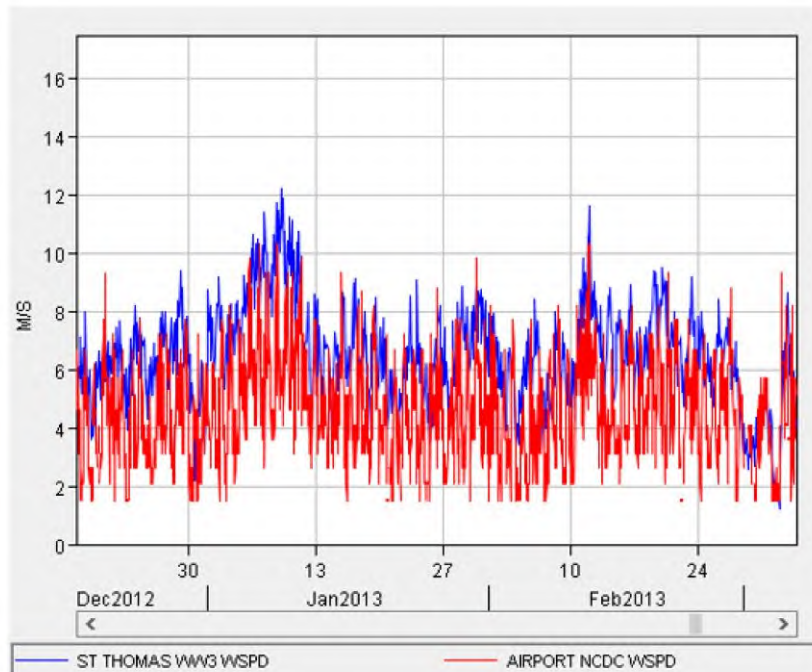
Figure 6.01.3 Comparison between recordings from Cyril E. King Airport and NOAA Wave Watch III (WW3) model under normal conditions.

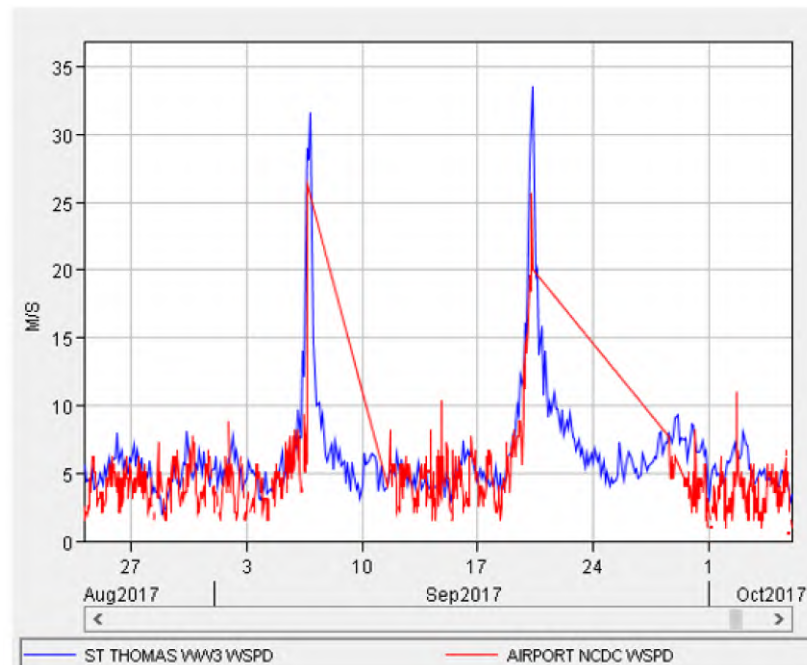
Figure 6.01.4 Comparison between recordings from Cyril E. King Airport and NOAA Wave Watch III (WW3) model under storm conditions.

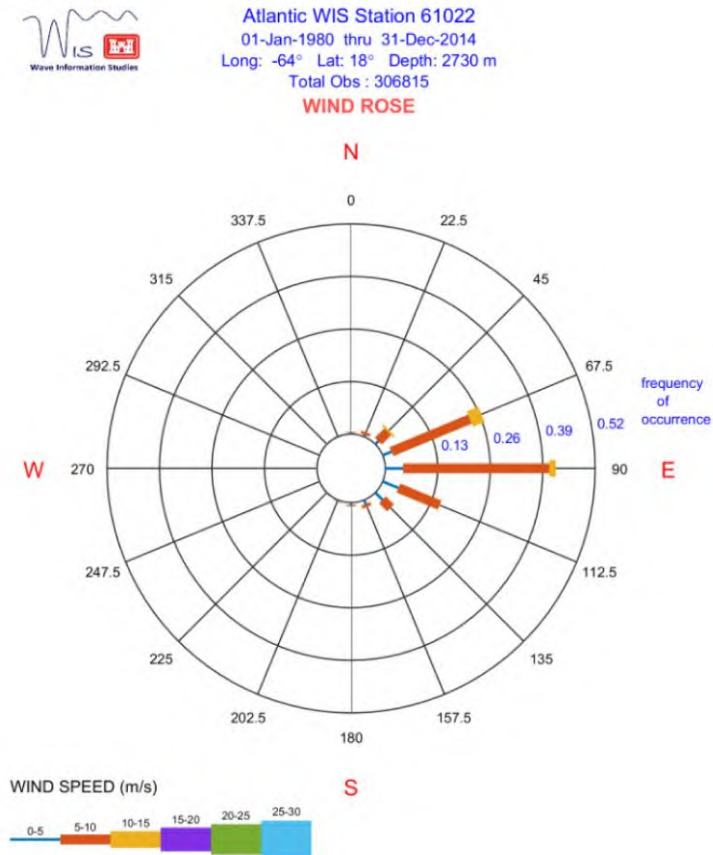
Figure 6.06.5 Wave Information Study Station #61022 Wind Rose (USACE 2020)

ATLANTIC HINDCAST WAM4.5.1C : ST61022_v03
 ALL MONTHS FOR YEARS PROCESSED : 1980 - 2014
 STATION LOCATION : (-64.00 W / 18.00 N)
 DEPTH : 2730.0 m

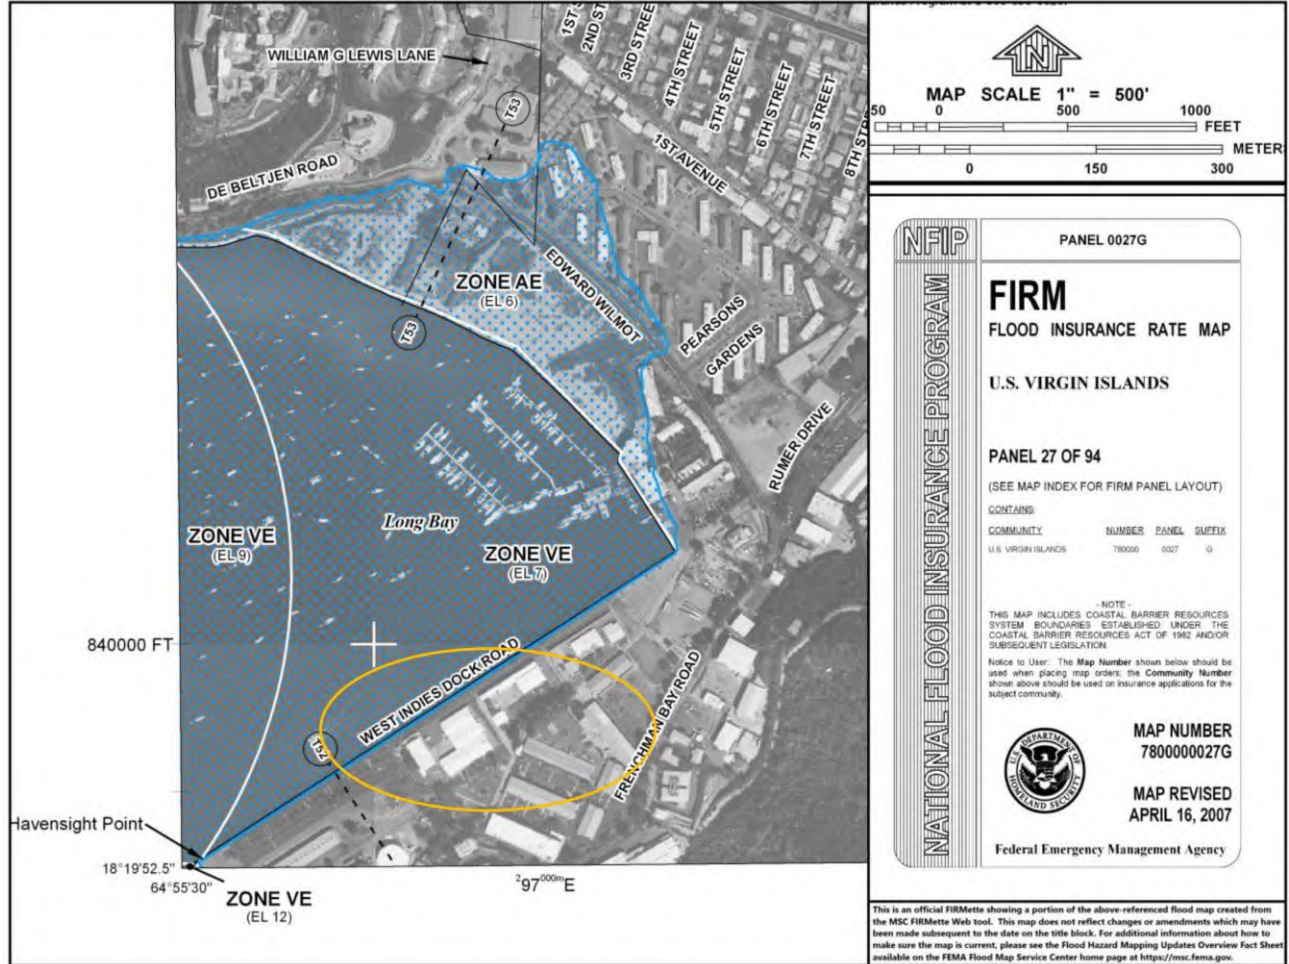
FEMA FIRM Map Panel 27 is shown below.

Coastal Flooding should have a negligible impact on the property.

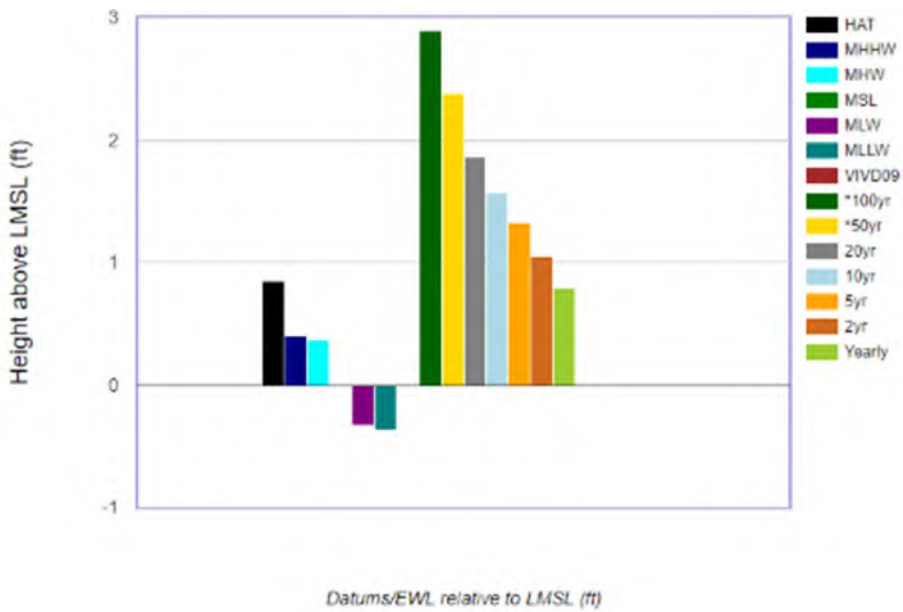
Figure 6.05.1 below and Table 6.05.1 show the extreme water levels at the Charlotte Amalie, VI station that were evaluated using the US Army Corps of Engineers' (USACE) calculator (version 5/17/2017) based on local tide gauge data – 32 years of record.

Figure 6.05.1 Tidal Datums and extreme water levels Station relative to VIVD09/MSL - Station 9751639

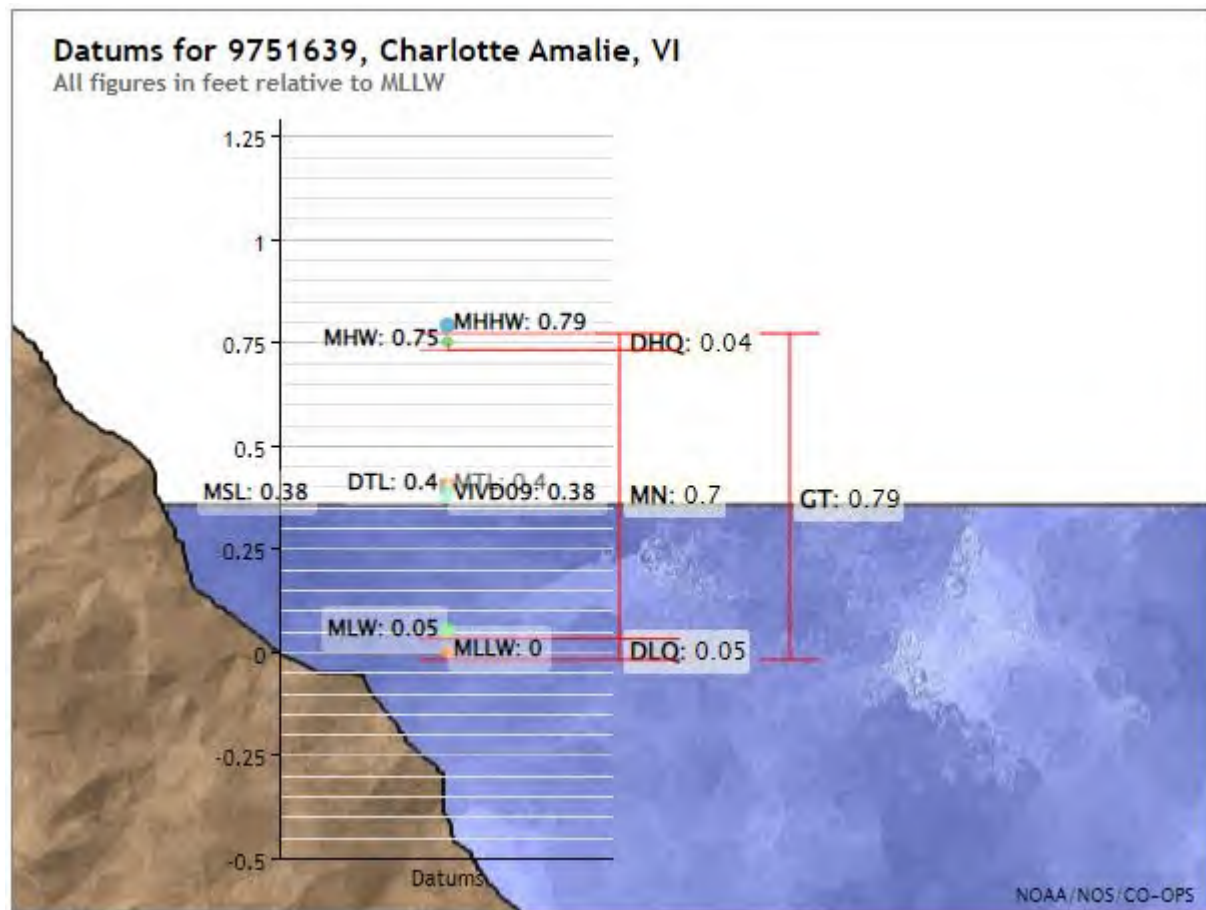
Figure 6.05.2 Station 9751639 Tidal Datums Relative to MLLW.

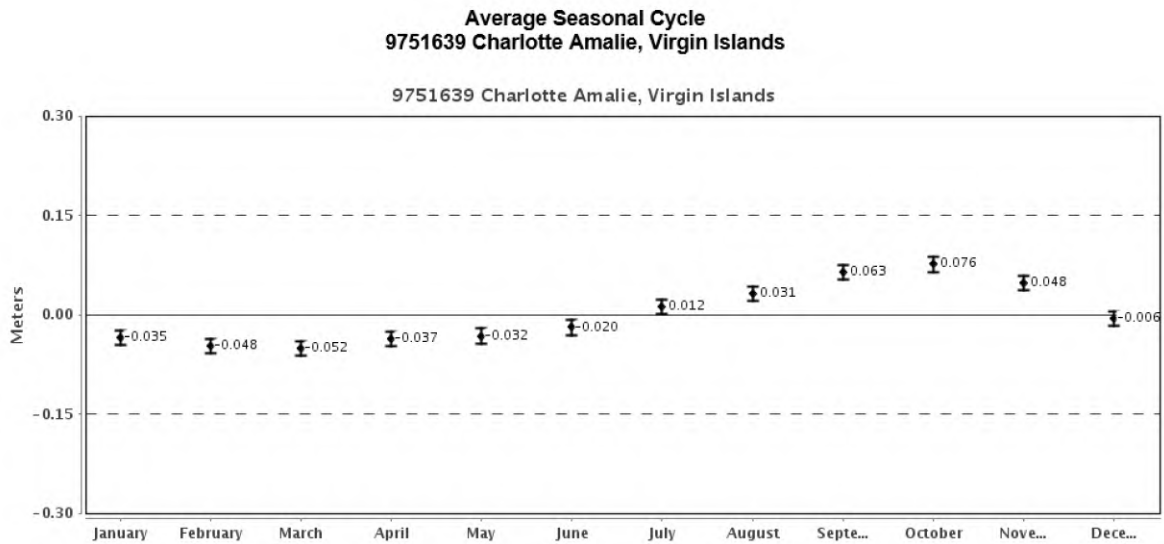
Seasonal water levels vary according to fluctuations in coastal temperatures, winds, pressures, and other factors (NOAA CO-OPS, 2020). Peak water levels at the Charlotte Amalie station typically occur during the month of October and are approximately 0.25 ft (0.076 m) higher than the mean (Figure 6.05.3). The lowest water levels occur during the spring and are approximately 0.17 ft (0.052 m) lower.

Figure 6.05.3 Seasonal Water Level Variations Relative to Mean Sea Level.

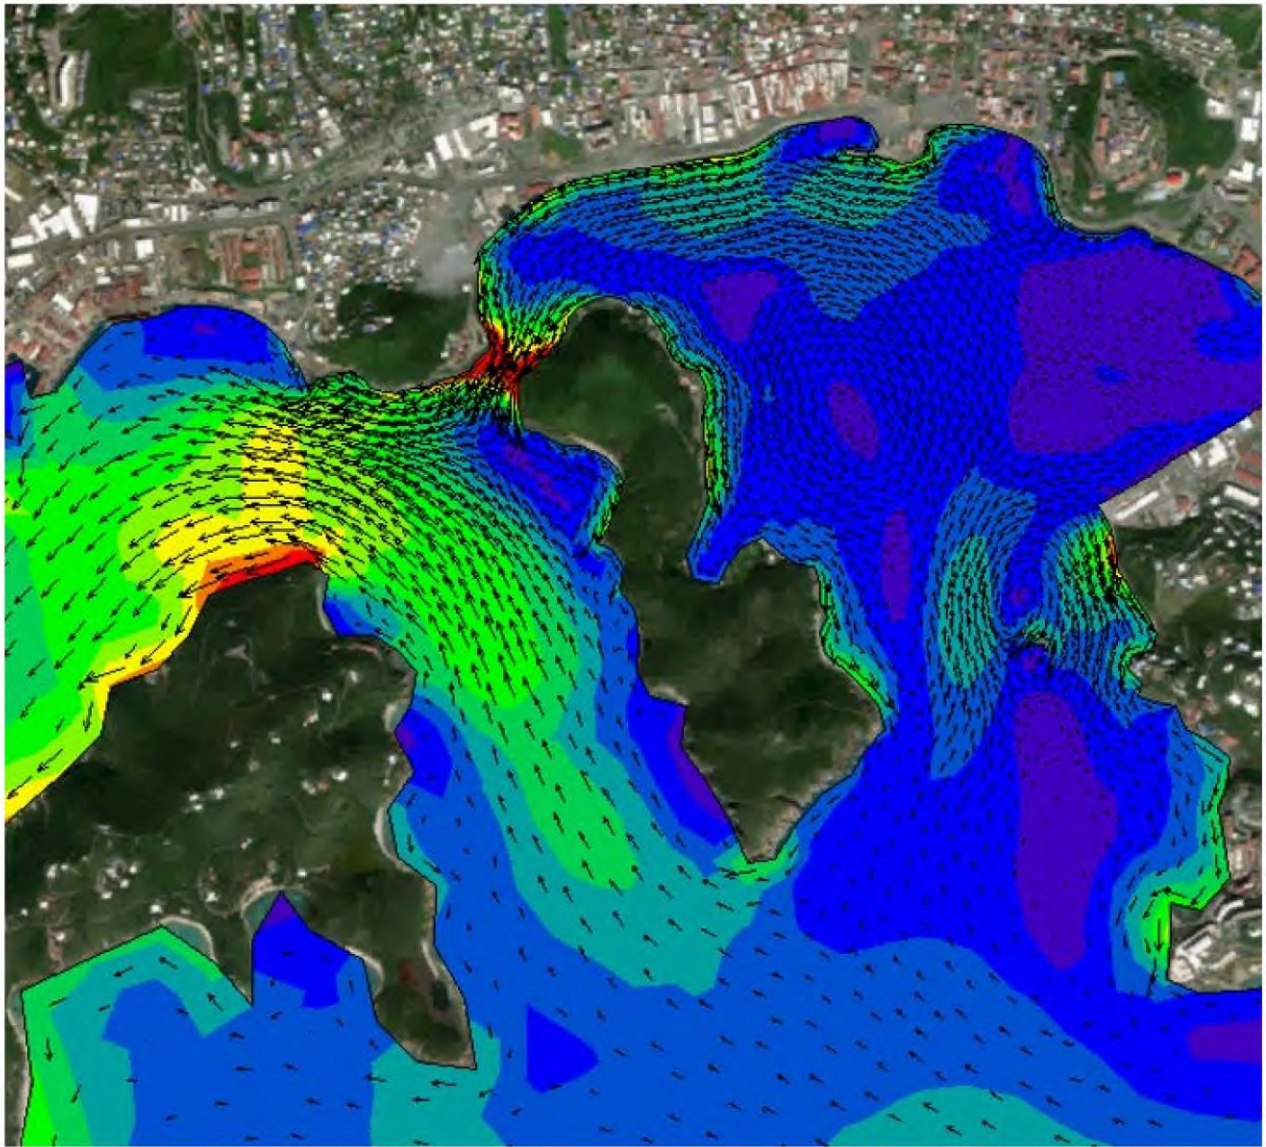
Figure 6.05.4 depicts the modeled current velocity in the harbor. The simulated current velocities were highest during peak flood tides and lowest during ebb. The area off shore of the hotel site is modeled to have the lowest currents and is depicted in blues and purples.

Figure 6.05.4 Modeled Currents in St. Thomas's Harbors (St. Thomas Flushing Model, GDH (2020))

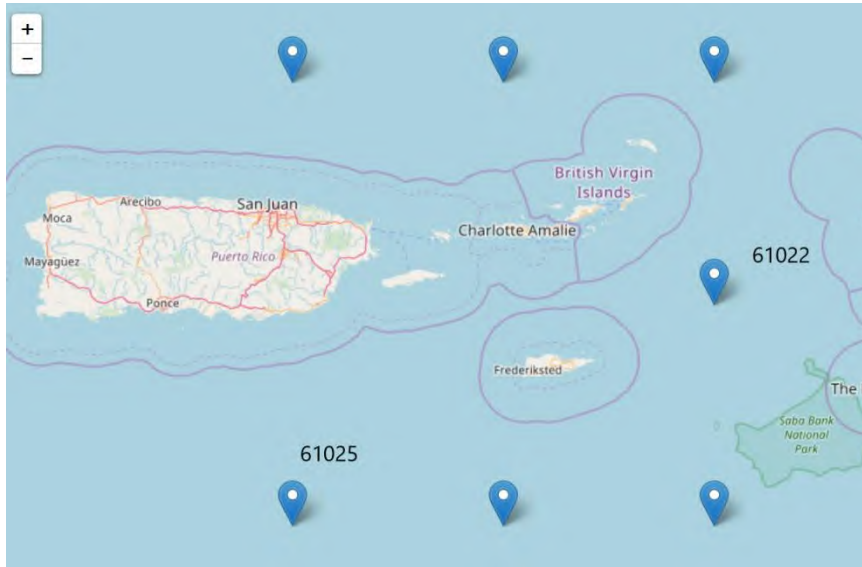
The USACE Wave Hindcast Models for Stations 61022 and 61025, the two stations which have direct line of sight to Charlotte Amalie Harbor, show that most waves are from easterly directions and are 1-2 ft in height.

Figure 6.05.5 Wave Hindcast Stations USACE Wave Hindcast site, locations of 61022 and 61025 (<http://wis.usace.army.mil/hindcasts.html?dmn=atlantic>).

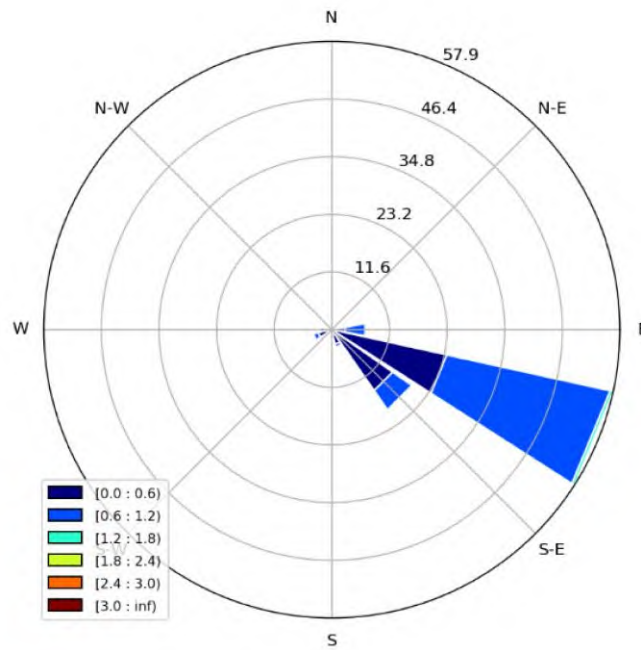
NOAA Wave Watch III (WW3) Station 246223 is located approximately 5 miles south of St. Thomas Harbor and provides wave hindcast data over a 15-year period from February 2004 to May 2019. A wave rose is provided in Figure 6.05.9 and shows that the highest frequency of large waves occurs from the SSE, with southerly waves occurring approximately 5% of the time. The two largest wave events during this time (2004 – 2019) occurred in September of 2017 and were generated by Hurricane Irma and Hurricane Maria. Figure 6.05.10 provides a time series of the wave height, period, and direction during this time. Note that the wave heights associated with these two passing hurricane events are smaller than those generated by Hurricane Hugo and Hurricane Lenny – which, as indicated previously, both impacted the region prior to the more recent period of record.

Figure 6.05.7 NOAA WW3 #246223 Wave Rose, Feb 2004-May 2019

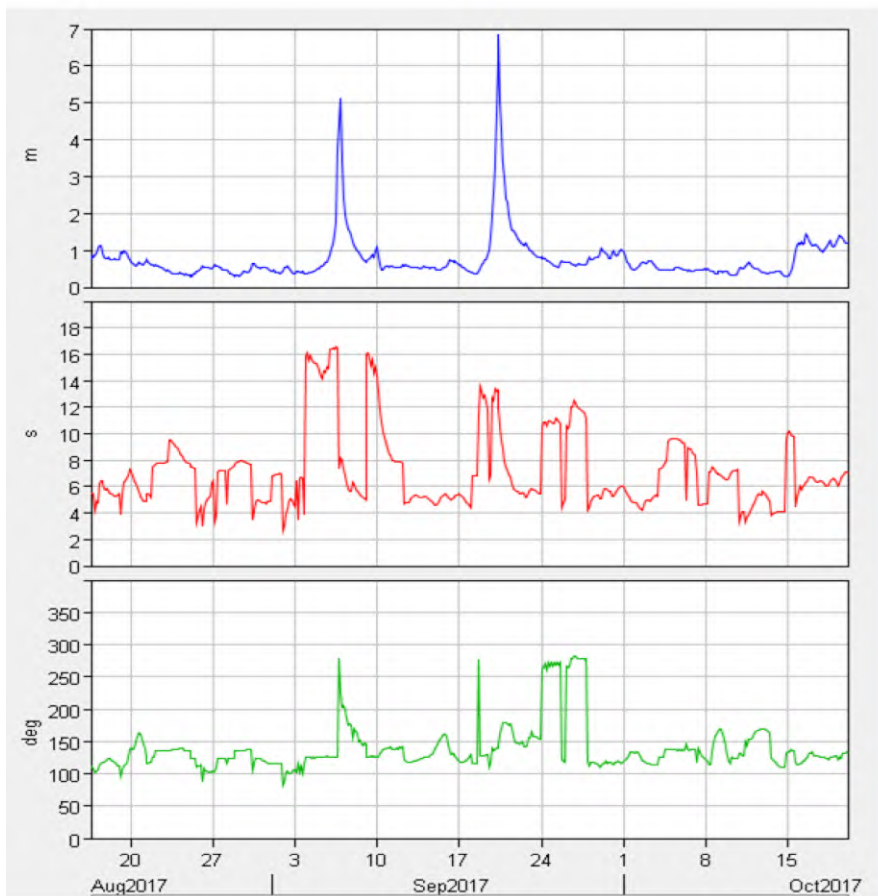
Figure 6.05.8 NOAA WW3 Station #246223 during Hurricanes Irma and Maria

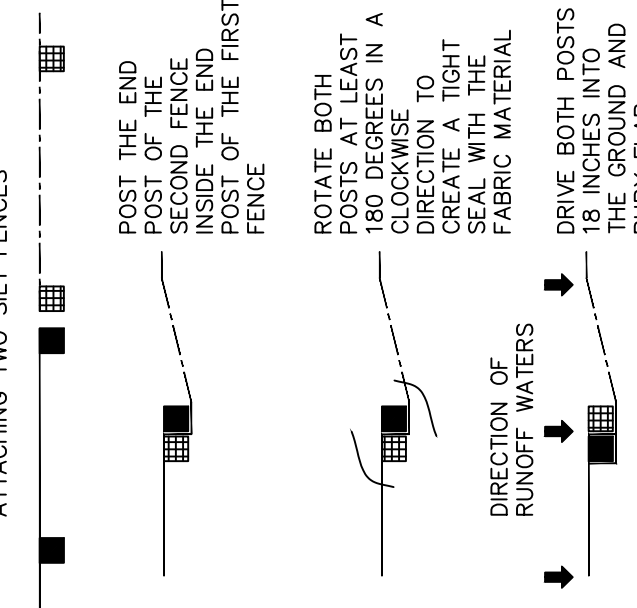
1 SILT FENCE SEDIMENT CONTROL DETAIL

- NOTES:
1. INSPECT AND REPAIR FENCE AFTER EACH STORM EVENT AND REMOVE SEDIMENT WHEN NECESSARY.
 2. REMOVED SEDIMENT SHALL BE DEPOSITED TO AN AREA THAT WILL NOT CONTRIBUTE SEDIMENT OFF-SITE AND CAN BE PERMANENTLY STABILIZED.
 3. SILT FENCE SHALL BE PLACED ON SLOPE CONTOURS TO MAXIMIZE PONDING EFFICIENCY.

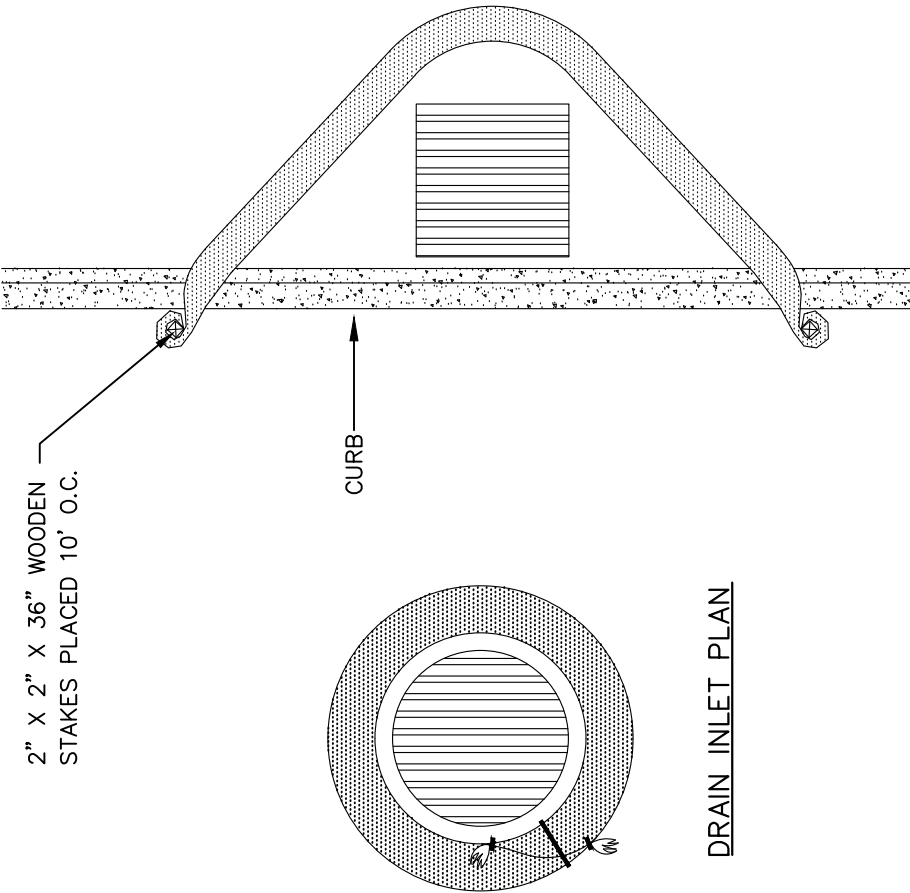
- NOTES:
1. ALL MATERIAL TO MEET FILTERREX® SPECIFICATIONS (OR APPROVED EQUAL).
 2. FILTER MEDIA FILL TO MEET APPLICATION REQUIREMENTS.
 3. COMPOST MATERIAL TO BE DISPERSED ON SITE, AS DETERMINED BY ENGINEER.

EXCESS SOXX™ MATERIAL TO BE DISPERSED ON SITE, AS DETERMINED BY ENGINEER.

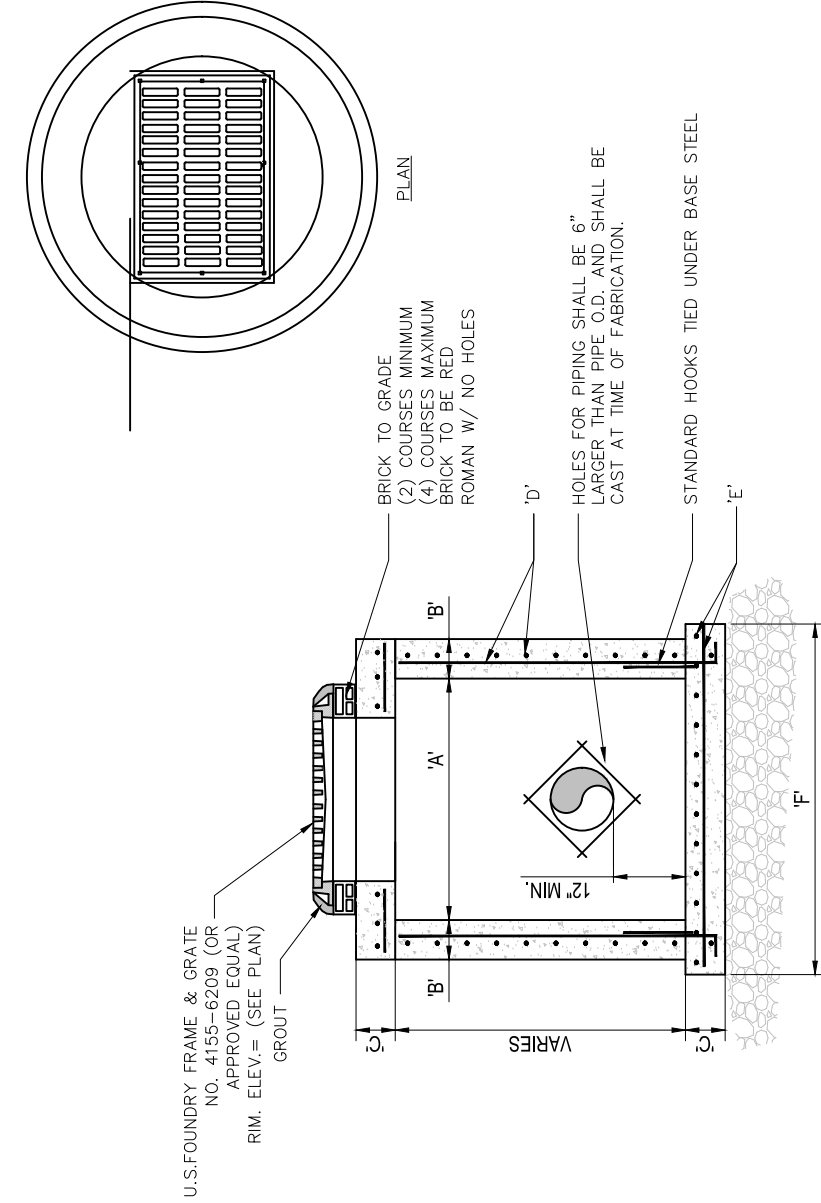
1 PRECAST CATCH BASIN
C210 NOT TO SCALE

TYPE	"A"	"B"	"C"	"D"	"E"	"F"
C-4	4'-0" ø	8"	# 4 @ 12" C.C.E.W.	# 4 @ 12" C.C.E.W.	# 4 @ 6" C.C.E.W.	6'-4" ø
C-5	5'-0" ø	8"	# 5 @ 12" C.C.E.W.	# 5 @ 12" C.C.E.W.	# 5 @ 6" C.C.E.W.	7'-4" ø
C-6	6'-0" ø	8"	# 6 @ 12" C.C.E.W.	# 6 @ 12" C.C.E.W.	# 6 @ 6" C.C.E.W.	8'-4" ø
C-7	7'-0" ø	8"	# 7 @ 12" C.C.E.W.	# 7 @ 12" C.C.E.W.	# 7 @ 6" C.C.E.W.	9'-4" ø
C-8	8'-0" ø	10"	2- W.W.M. W/ # 4 @ 12" C.C. BEST	# 5 @ 6" C.C.E.W.	# 5 @ 6" C.C.E.W.	10'-8" ø

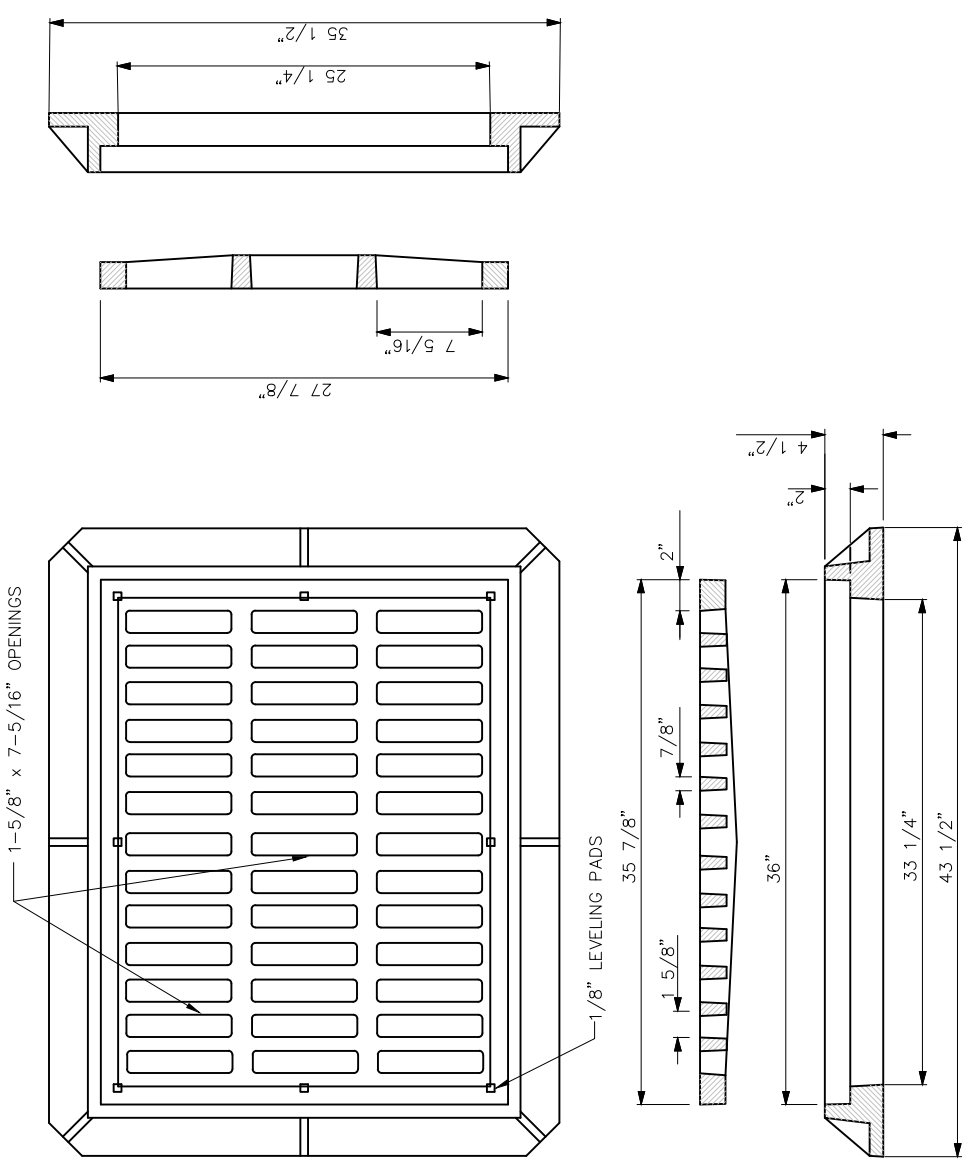
5 FRAME AND GRATE DETAIL
C210 NOT TO SCALE

1. GRATE TO BE TYPE U.S.F. No. 4155-8209

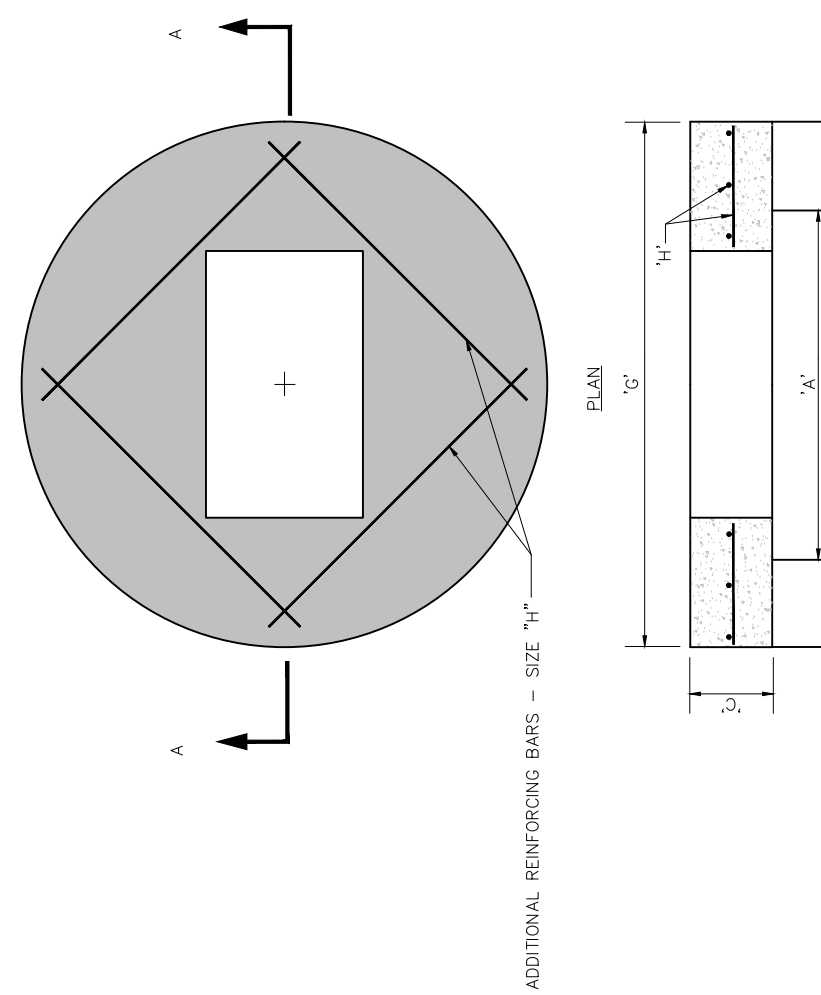
2 PRECAST CONCRETE TOP SLAB
C210 NOT TO SCALE

TYPE	"A"	"C"	"D"	"E"	"F"
C-4	4'-0" ø	8"	5'-4" ø	# 4 @ 6" C.C.E.W.	# 4 @ 6" C.C.E.W.
C-5	5'-0" ø	8"	6'-4" ø	# 5 @ 6" C.C.E.W.	# 5 @ 6" C.C.E.W.
C-6	6'-0" ø	8"	7'-4" ø	# 6 @ 6" C.C.E.W.	# 6 @ 6" C.C.E.W.
C-7	7'-0" ø	8"	8'-4" ø	# 7 @ 6" C.C.E.W.	# 7 @ 6" C.C.E.W.
C-8	8'-0" ø	10"	9'-8" ø	# 8 @ 6" C.C.E.W.	# 8 @ 6" C.C.E.W.

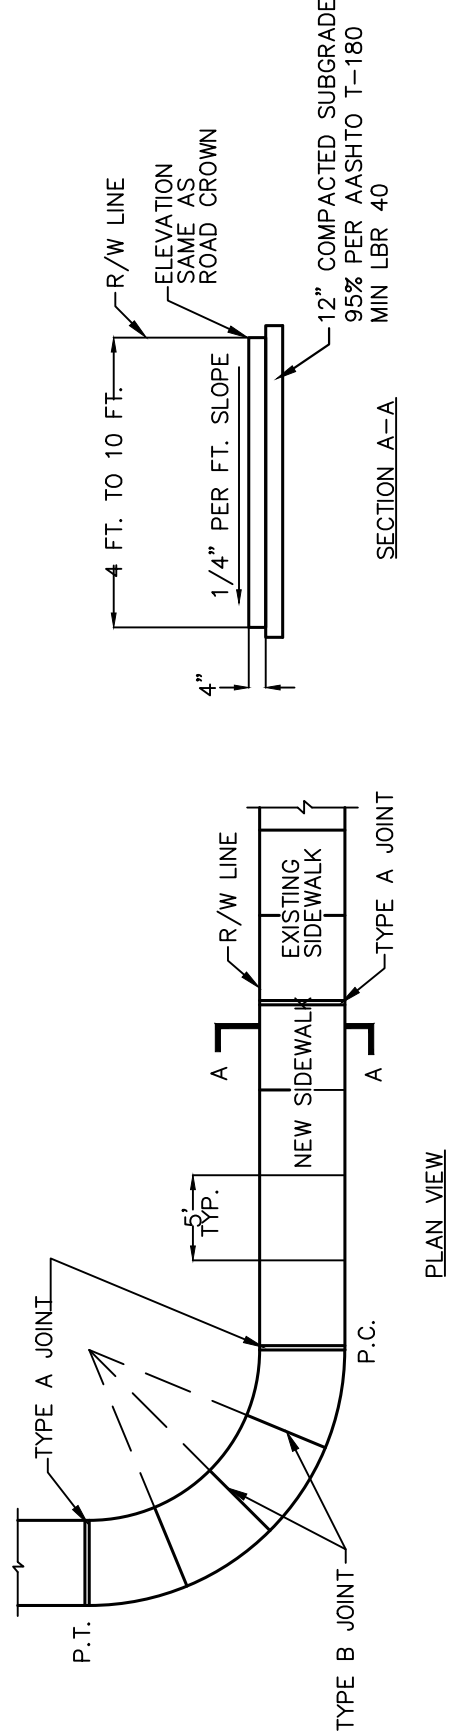
7 CONCRETE SIDEWALK DETAIL
C210 NOT TO SCALE

TABLE OF SIDEWALK THICKNESS - T	
LOCATION	T
STANDARD SIDEWALK	5"
AT DRIVEWAYS AND OTHER AREAS	5"

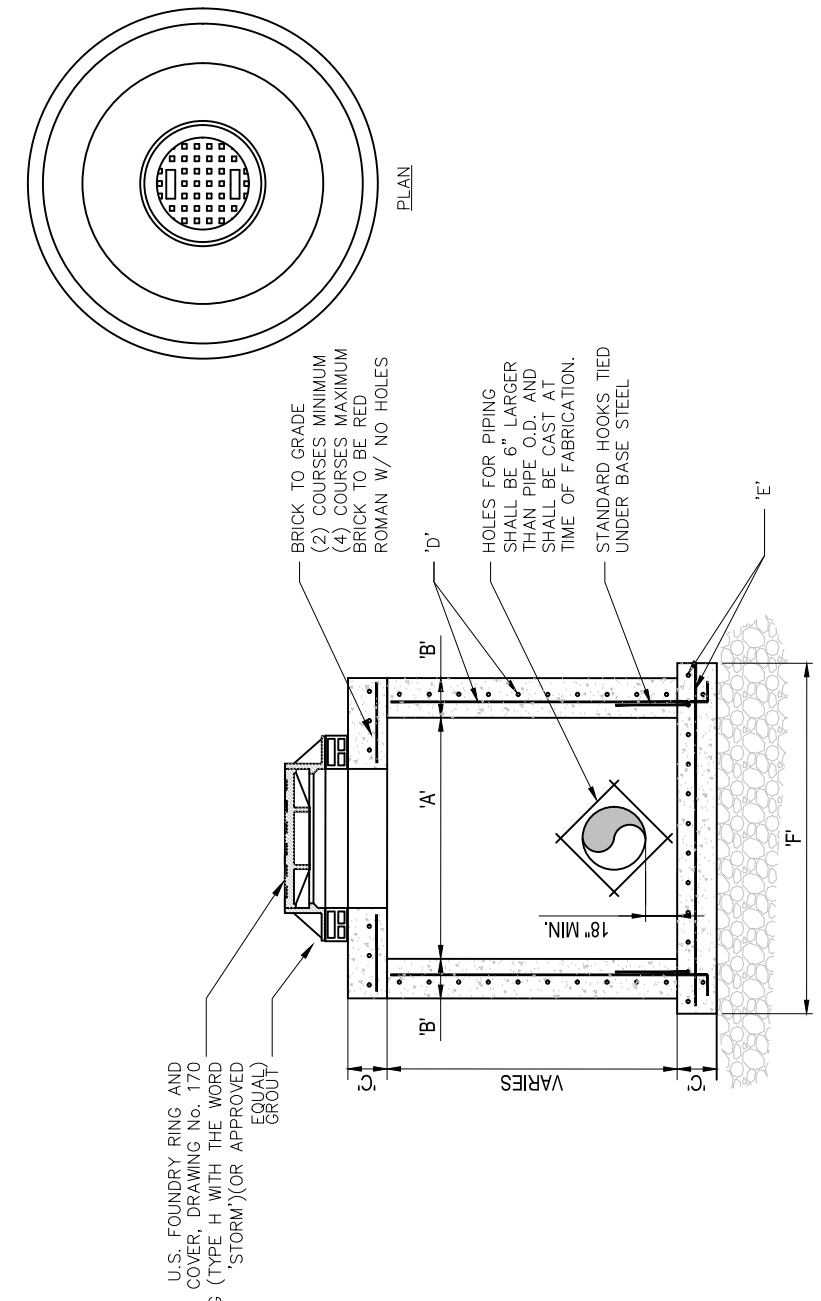
3 PRECAST STORM DRAINAGE MANHOLE
C210 NOT TO SCALE

TYPE	"A"	"B"	"C"	"D"	"E"	"F"
M-4	4'-0" ø	8"	# 4 @ 12" C.C.E.W.	# 4 @ 12" C.C.E.W.	# 4 @ 6" C.C.E.W.	6'-4" ø
M-5	5'-0" ø	8"	# 5 @ 12" C.C.E.W.	# 5 @ 12" C.C.E.W.	# 5 @ 6" C.C.E.W.	7'-4" ø
M-6	6'-0" ø	8"	# 6 @ 12" C.C.E.W.	# 6 @ 12" C.C.E.W.	# 6 @ 6" C.C.E.W.	8'-4" ø
M-7	7'-0" ø	8"	# 7 @ 12" C.C.E.W.	# 7 @ 12" C.C.E.W.	# 7 @ 6" C.C.E.W.	9'-4" ø
M-8	8'-0" ø	10"	2- W.W.M. W/ # 4 @ 12" C.C. BEST	# 8 @ 6" C.C.E.W.	# 8 @ 6" C.C.E.W.	10'-8" ø
