# U.S. Virgin Islands Coastal Vulnerability Index

February 2023

This report presents a first assessment of coastal vulnerability in the U.S. Virgin Islands, following and adapting the method developed by the USGS in the late 1990s. It presents a detailed inventory of coastal geomorphic types and coastal infrastructure, estimates of the flooding risk due to sea-level rise and storm surge, and of the wave climate around the islands. The report also presents estimates of rates of accretion and erosion for select beaches. The final estimate of coastal vulnerability shows that St. Croix is the most vulnerable of all islands because of the preponderance of long stretches of sandy beaches and higher wave climate. We also find that on all islands, and on St. Thomas and St. John specifically, economically important beaches, some of them near hotels, are highly vulnerable. Finally, we find that many beaches and wetlands are moderately to highly vulnerable to coastal hazards, especially to sea-level rise and storm surge. Based on these findings, we provide a series of recommendations to better understand these vulnerabilities and develop adaptation and mitigation activities to protect beach

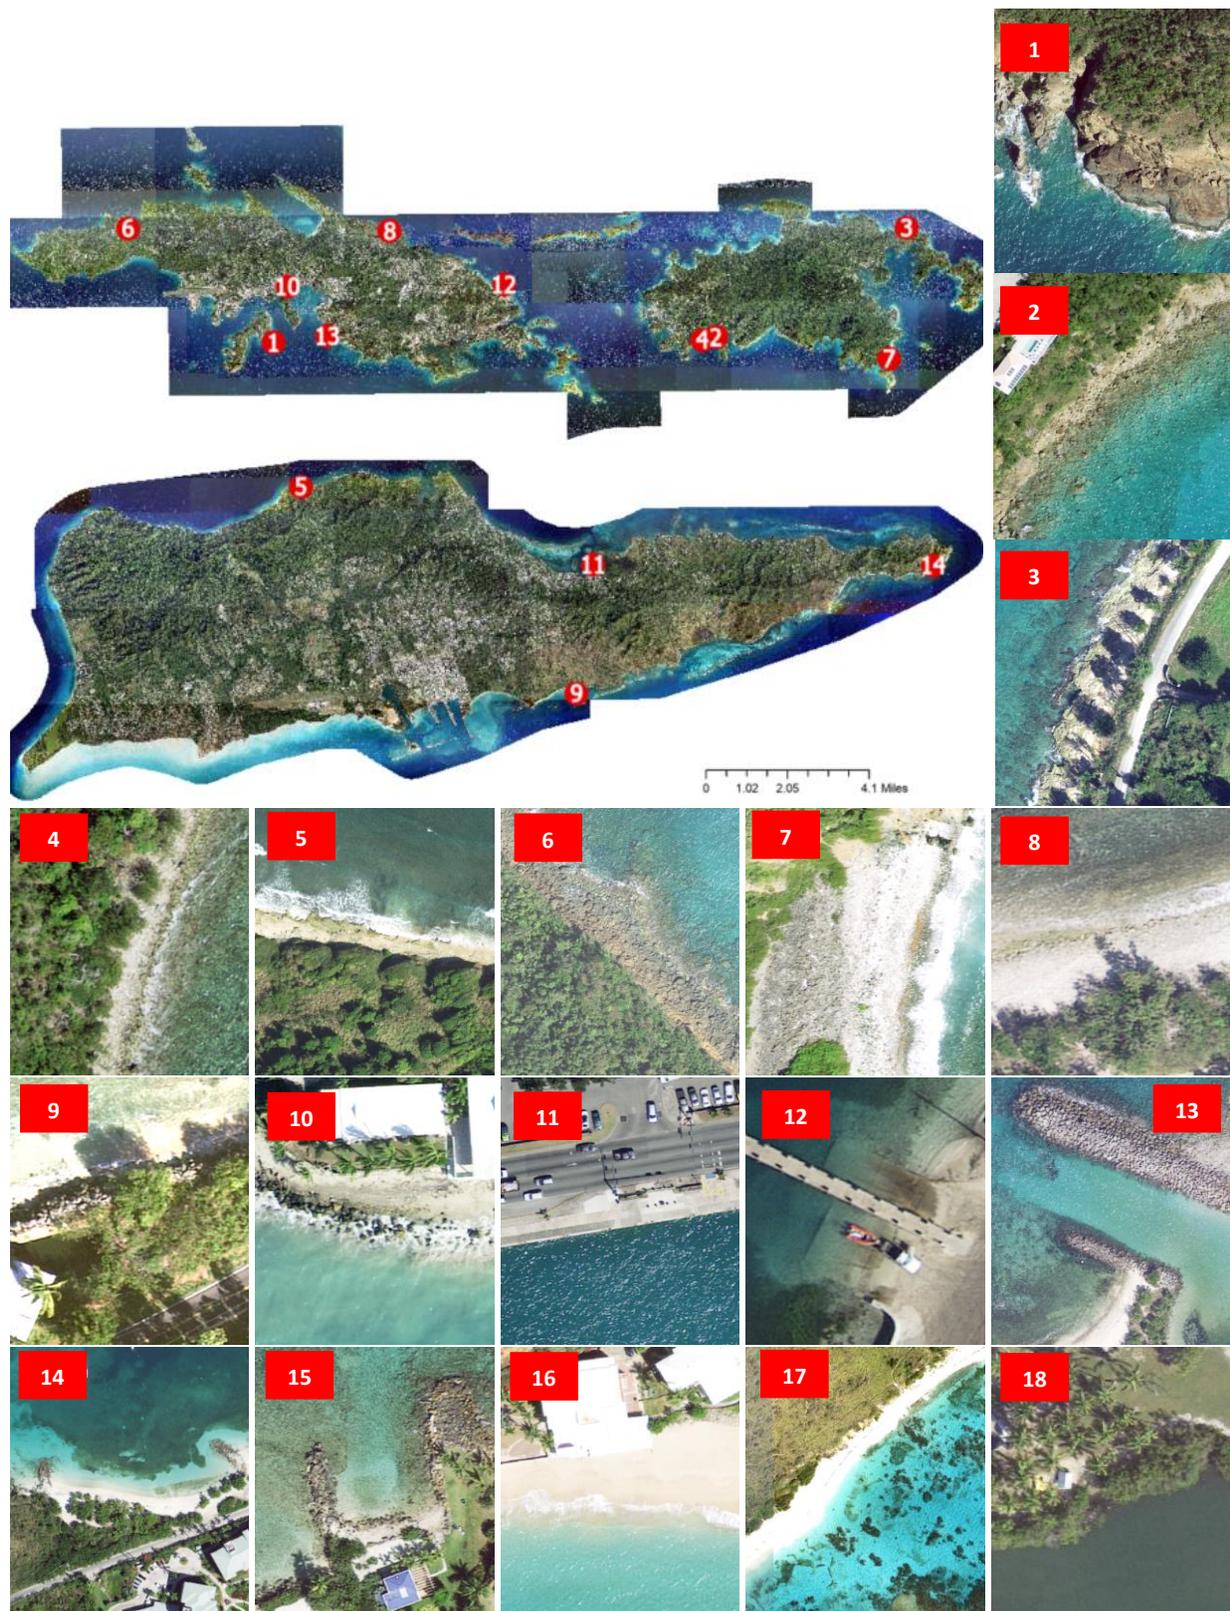
Figure 2: Aerial imagery of different shoreline types. Shot 1: High rocky cliff (rank 1); shot 2: medium erodible cliff (rank 2); shots 3 to 6: Low erodible cliff (rank 3); shot 7 and 8: gravel beach (rank 4); shot 9 and 10: riprap revetment (rank 3 or 4); shot 11: bulkhead or seawall (rank 1); shot 12: pier and boat ramp (rank 1); shot 13: jetty built with riprap (rank 2 to 3); shots 14 and 15: groin built with riprap (rank 2 to 3); shots 16 and 17: sandy beach (rank 5); shot 18: vegetated shoreline (rank 5).

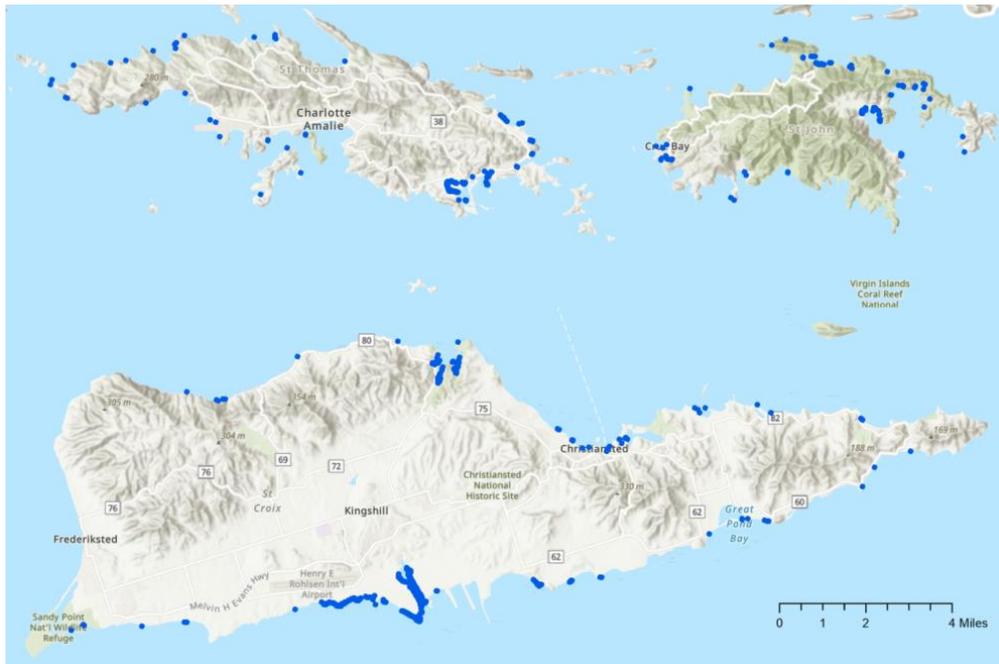
Figure 13: Regions experiencing tidal flooding 100 ft from the shoreline assuming a 1 ft sea-level increase.

As illustrated in Figure 13, we find that the most vulnerable areas to sea level rise inundation are Mangrove Lagoon and Smith Bay on St. Thomas, which are home to extensive wetlands. On St. John, Coral Bay and most of the northern coast of the island are also vulnerable to tidal flooding. This is due to the fact that many of the longest beaches of St. John are on the northern coast. On St. Croix, the central southern coast, home to mangroves and beaches, and Salt River Bay, a wetland, are most at risk. In other words, aside from the loss of footprint for many beaches and coastal areas, the most extreme impacts of sea level rise will be felt by mangroves and some beaches. Given the fact that roads and other infrastructure are built landward of these important habitats, it is likely that the territory will experience an irreversible loss of wetlands and of beaches, to a lesser extent. It is also likely that impacts from coastal hazards on the infrastructure buffered by these habitats will be more pronounced.

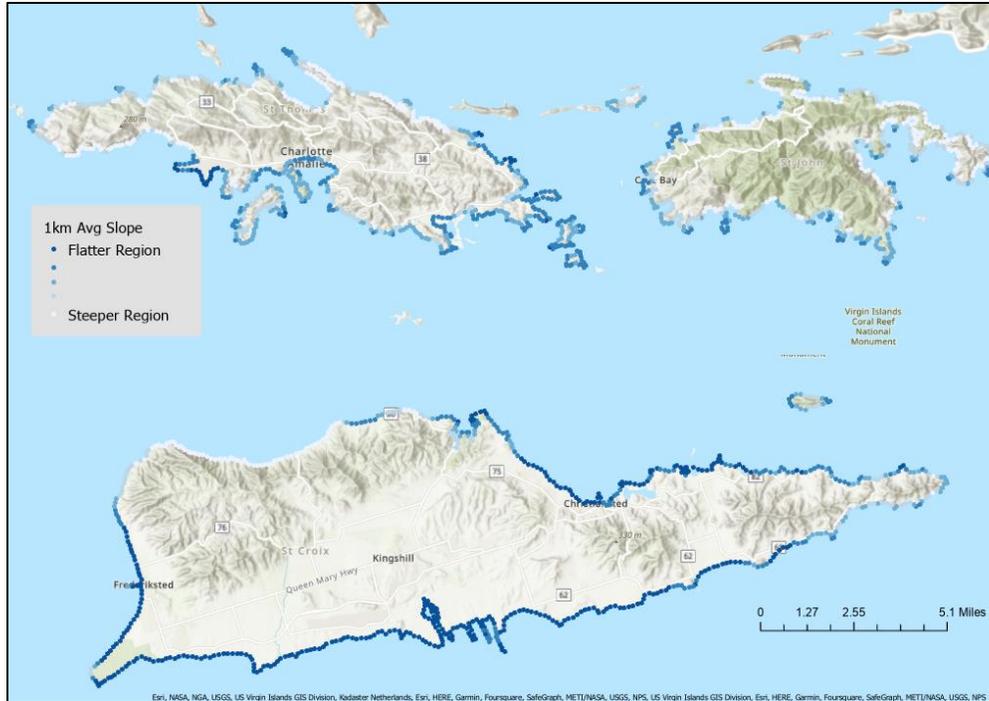
Figure 15: Distribution of coastal slopes (quartile approach) around the USVI.

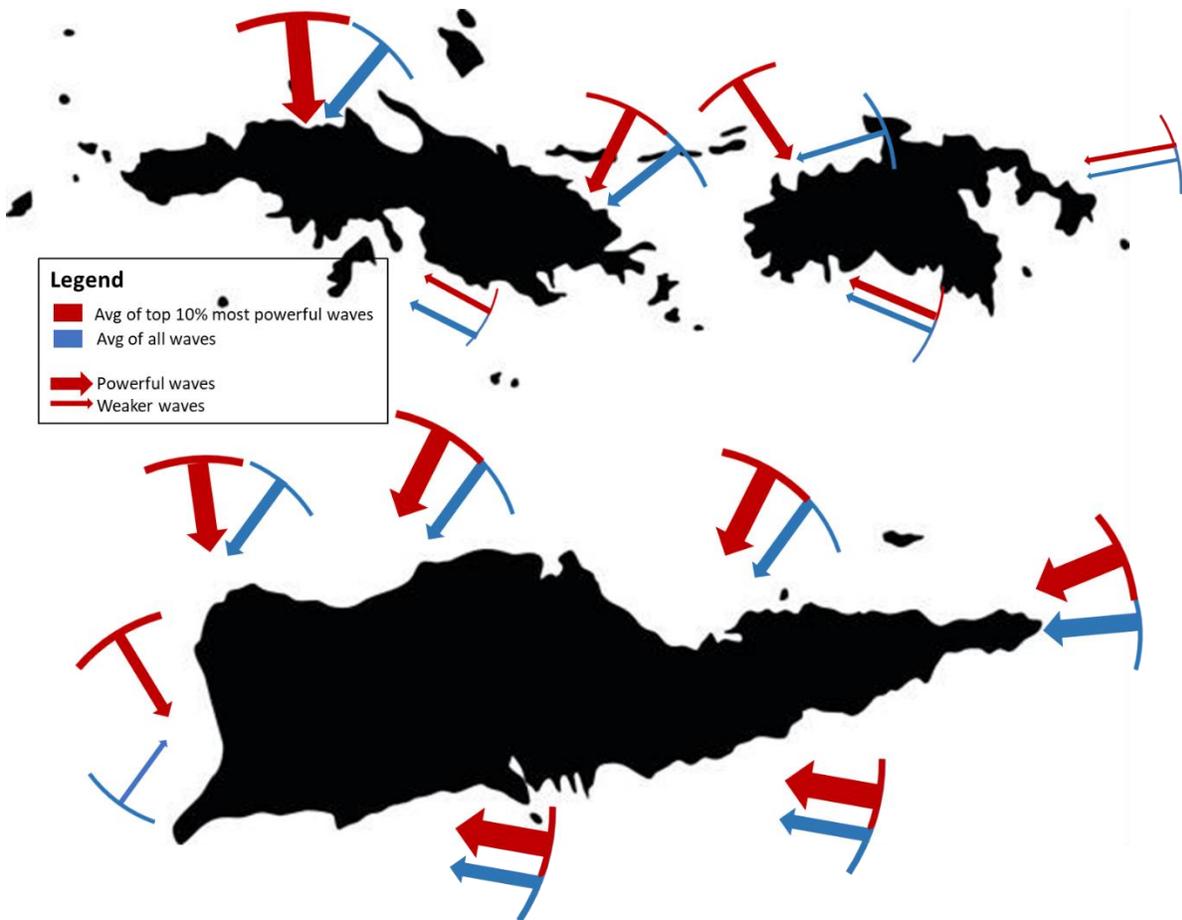
Figure 19: Wave Climate of the USVI

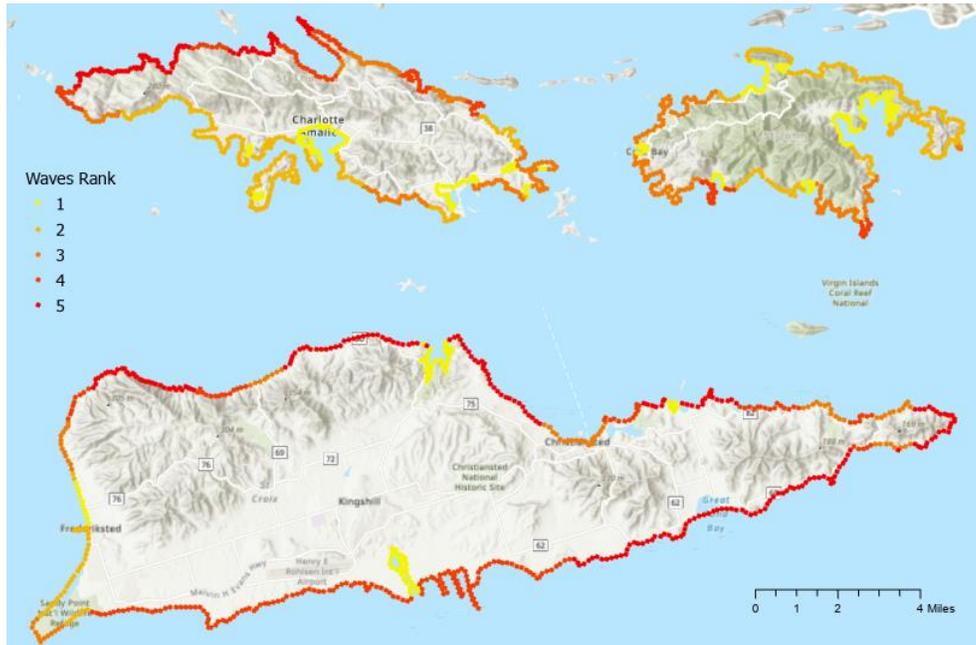
Figure 20: Wave power ranking for the USVI.

around the islands. Figure 20 shows the wave power ranking for the islands, created using the average wave height distribution.

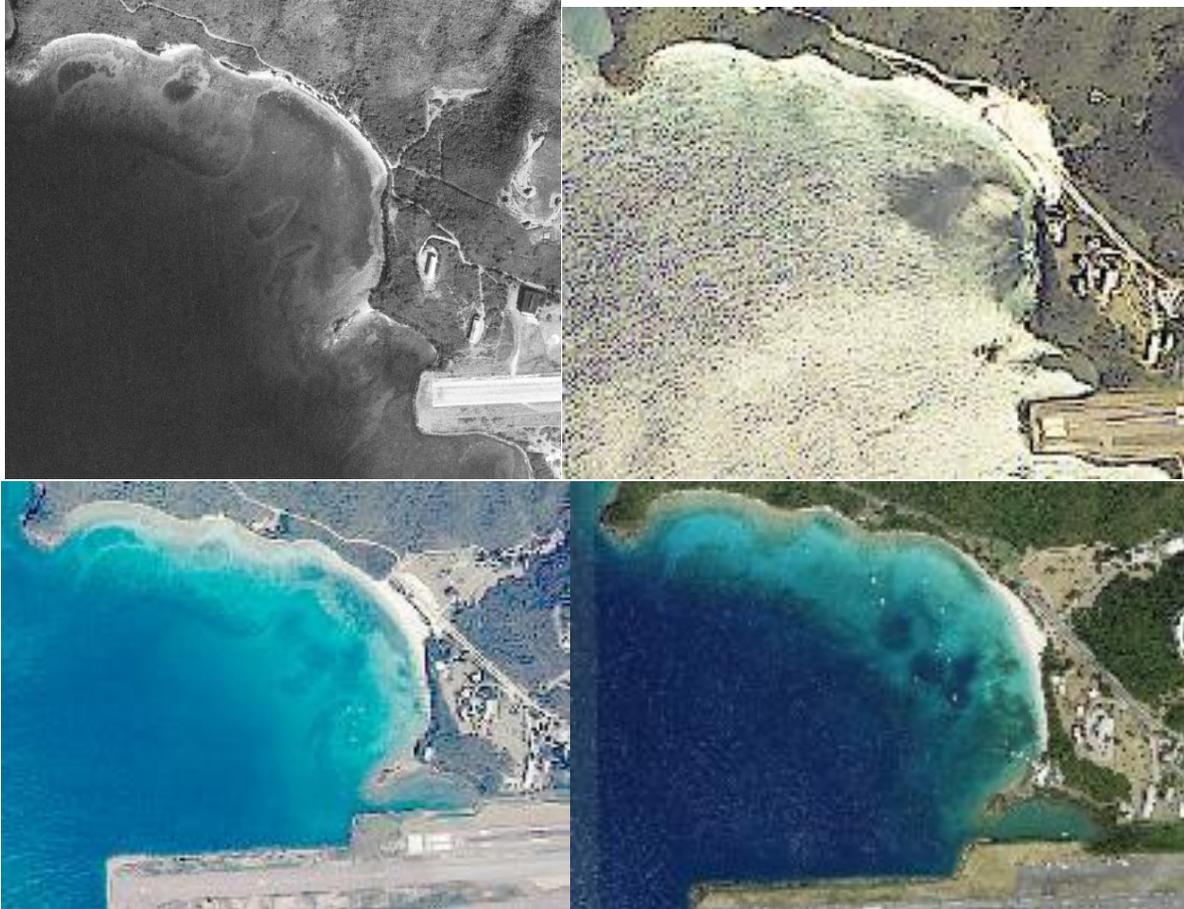
Figure 21: St. Thomas airport and Brewers Bay in 1954 (top left), 1970 (top right), 1980 (bottom left), and 2020 (bottom right).

On St. Thomas, we find that most of the coastal change has been driven by the construction of the airport, roads, and port facilities. Most of the development also occurred on the south side of the island, probably because of its milder wave climate and proximity to Charlotte Amalie. The Cyril E. King airport runway extension occurred in the late 1970s, early 1980s (Figure 21). Brewers Bay seemed to have at that time a sandy beach on its northern side, and a wetland on southern side. The wetland seems to have been damaged by the extension of the runway. However, the new runway seems to now act as a major breakwater for waves, and moderates the wave climate in Brewers Bay as they mostly move from the southeast to the northwest. As a result, sand moved from the west side of the beach to the east.

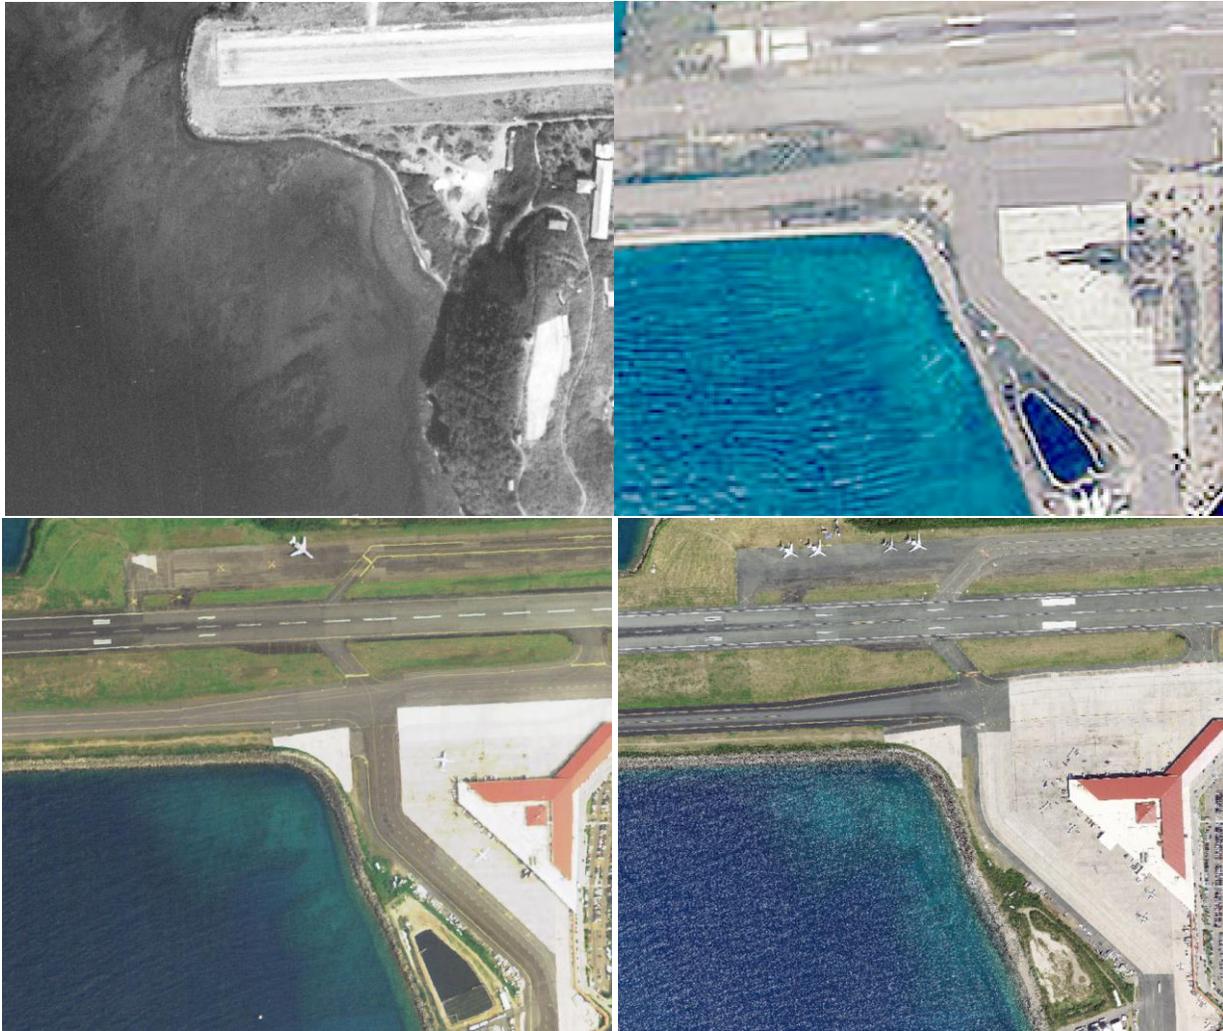
Figure 22: St. Thomas airport, south side of the runway in 1954 (top left), 1980s (top right), 1990s (bottom left), and 2020 (bottom right).

On the other side of the runway, it appears that the land was also filled and leveled to expand the terminal and other facilities (Figure 22). The whole airport and surrounding land has been armored to protect the newly placed fill.

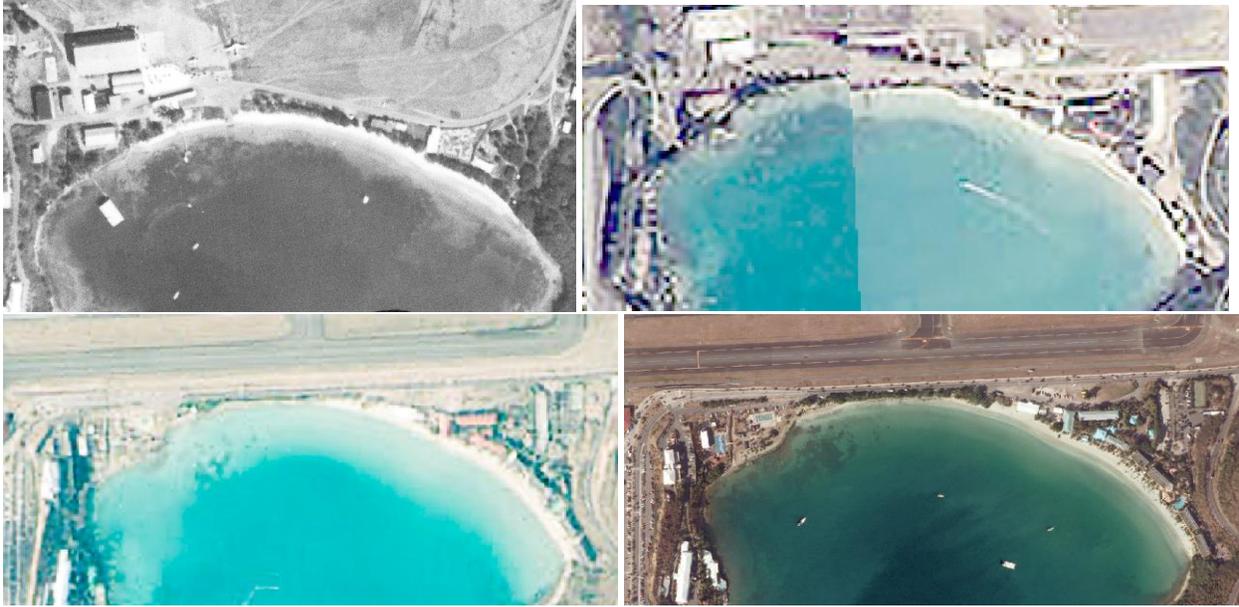
Figure 23: Lindberg Bay and the construction of the road infrastructure for the airport in 1954 (top left), 1980 (top right), 1990 (bottom left), and 2010 (bottom right).

The road to the airport along Lindbergh Bay was built shortly after the expansion of the runway, and new infrastructure and buildings were built at the same time (Figure 23). The construction of the road was followed by the armoring of the beach area sometime in that period.

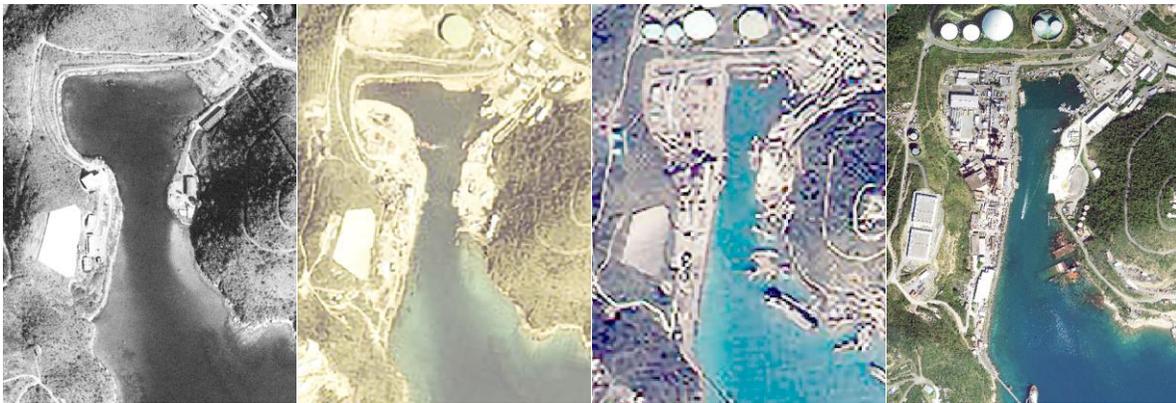
Figure 24: Krum Bay and WAPA power plant construction in (from left to right): 1954, 1970, 1990, and 2010

Krum Bay, where WAPA facilities are located, was filled and armored to accommodate the construction of the power plant in the 1970s (Figure 24). Further construction and armoring of the shoreline continued into the 2010s.

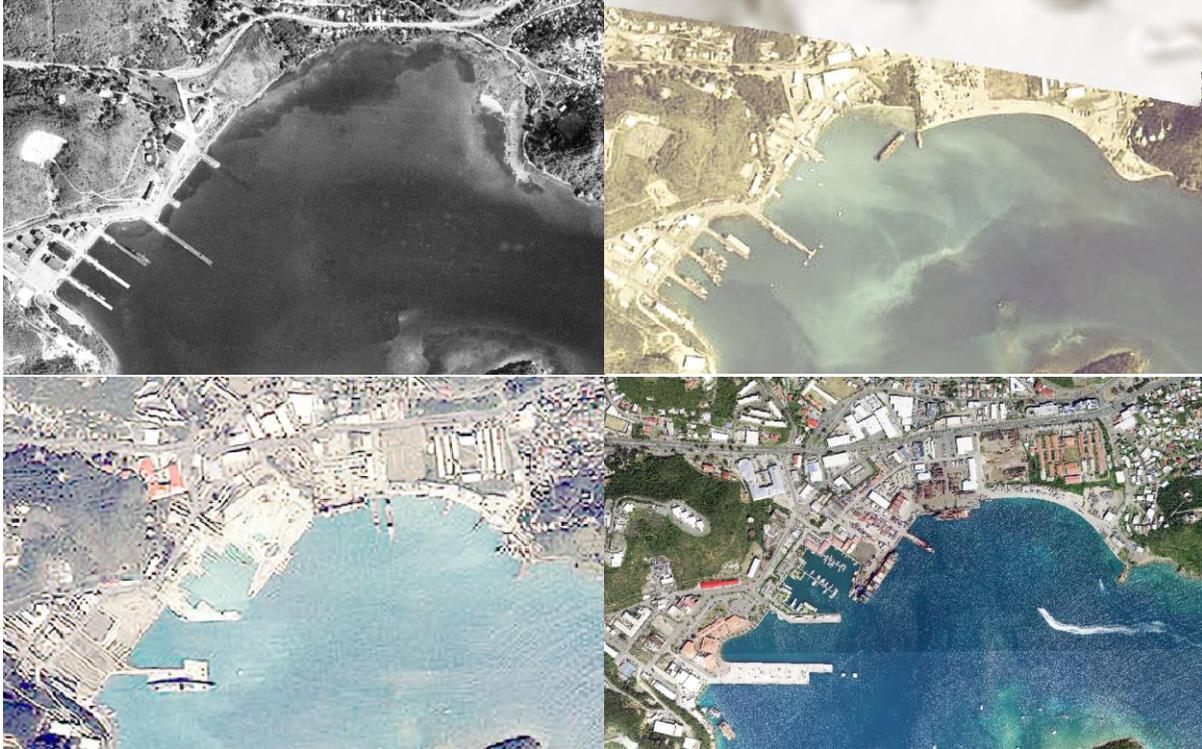
Figure 25: Expansion of the port infrastructure in St. Thomas from 1954 (top left), 1970 (top right), 1980 (bottom left), to 2020 (bottom right).

In Crown Bay and Little Krum Bay, the Port was expanded sometime in the 1960s, on top of what appears to be a vegetated shoreline (Figure 25). Significant filling activities occurred in the 1980s to build the marina and other port facilities, including a cruise ship terminal. The terminal was further expanded on fill in the 1990s, and construction was finalized in the late 1990s/early 2000s.

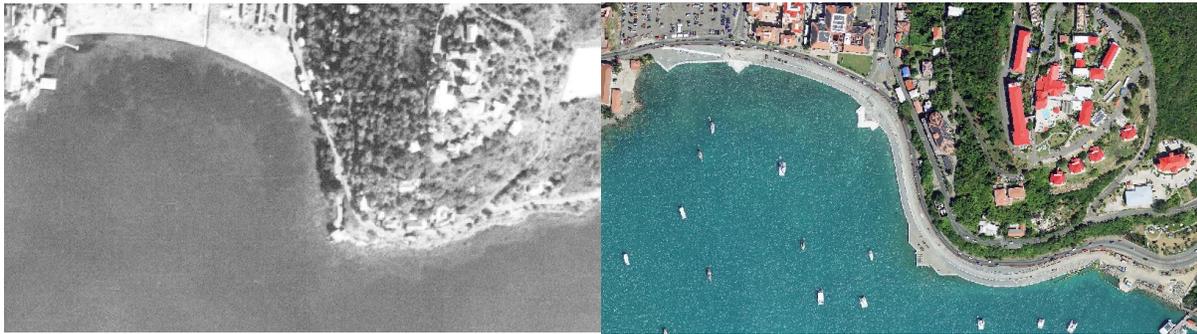
Figure 26: Veteran’s Drive in 1954 and 2020

Veteran’s Drive, which runs along the waterfront, was built on fill and has remained untouched, for the most part, prior to the road extension that was finalized in 2019/2020 (Figure 26).

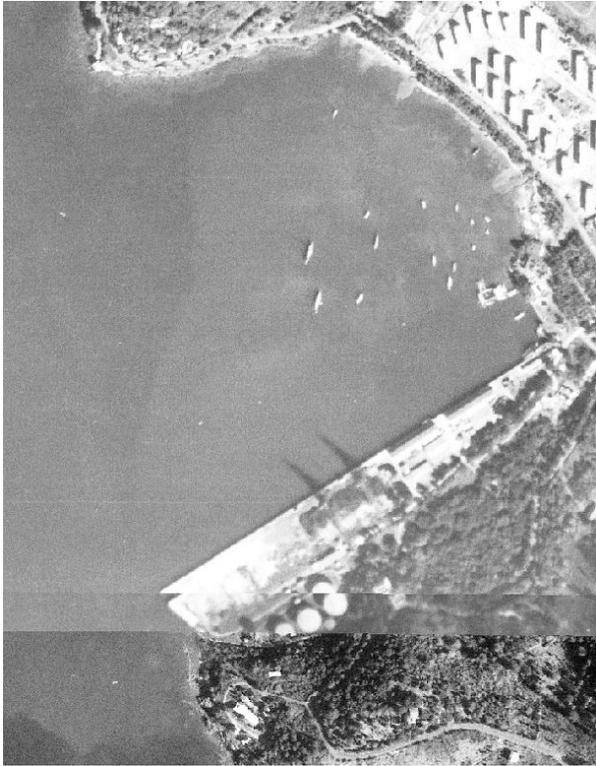
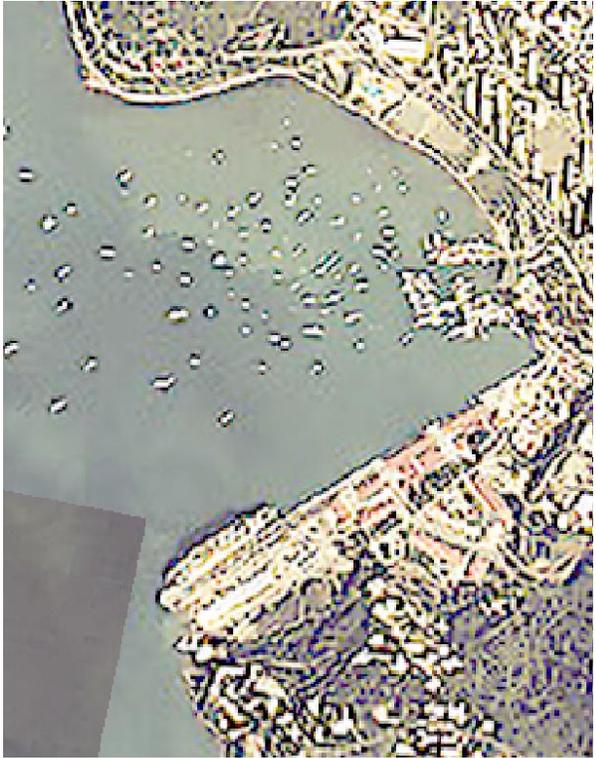
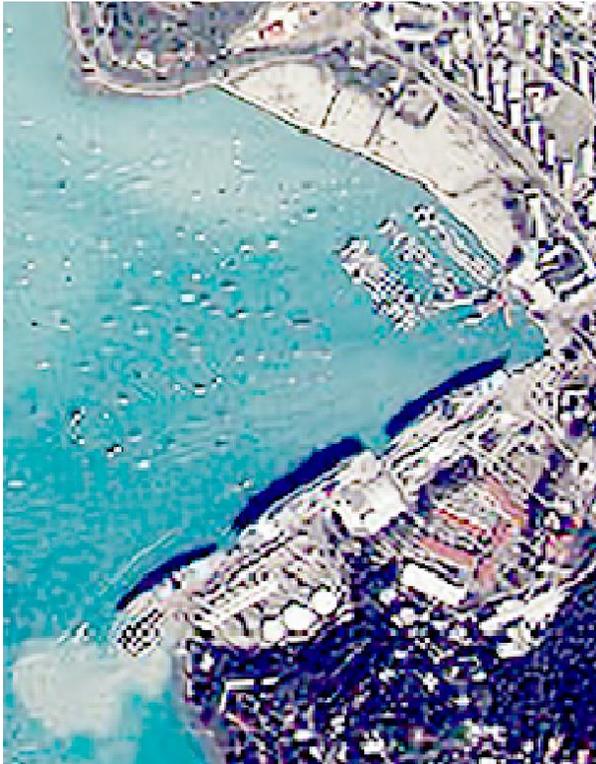
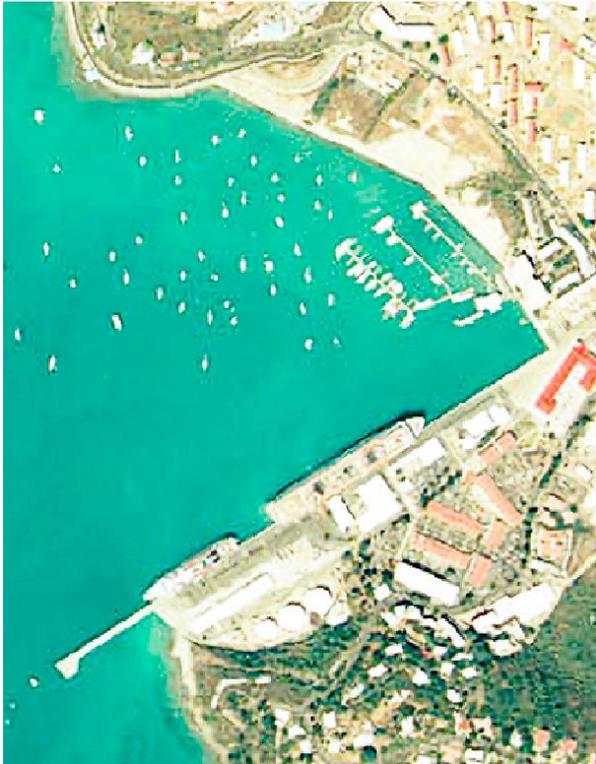
Figure 27: Long Bay Yacht Heaven Grande in 1954 (top left), 1970s (top right), 1980s (center left), 1990s (center right), 2010s (bottom left) and 2020 (bottom right).

Another major shoreline change on St. Thomas is the construction of Yacht Haven Grande (Figure 27). In the 1950s it was a beach with some moorings, a small dock, and a larger dock to the west. In the 1970s, this area had a small marina. In the 1980s, the coastline was filled to build what is now a larger marina. In the 1990s, the cruise ship dock was extended.

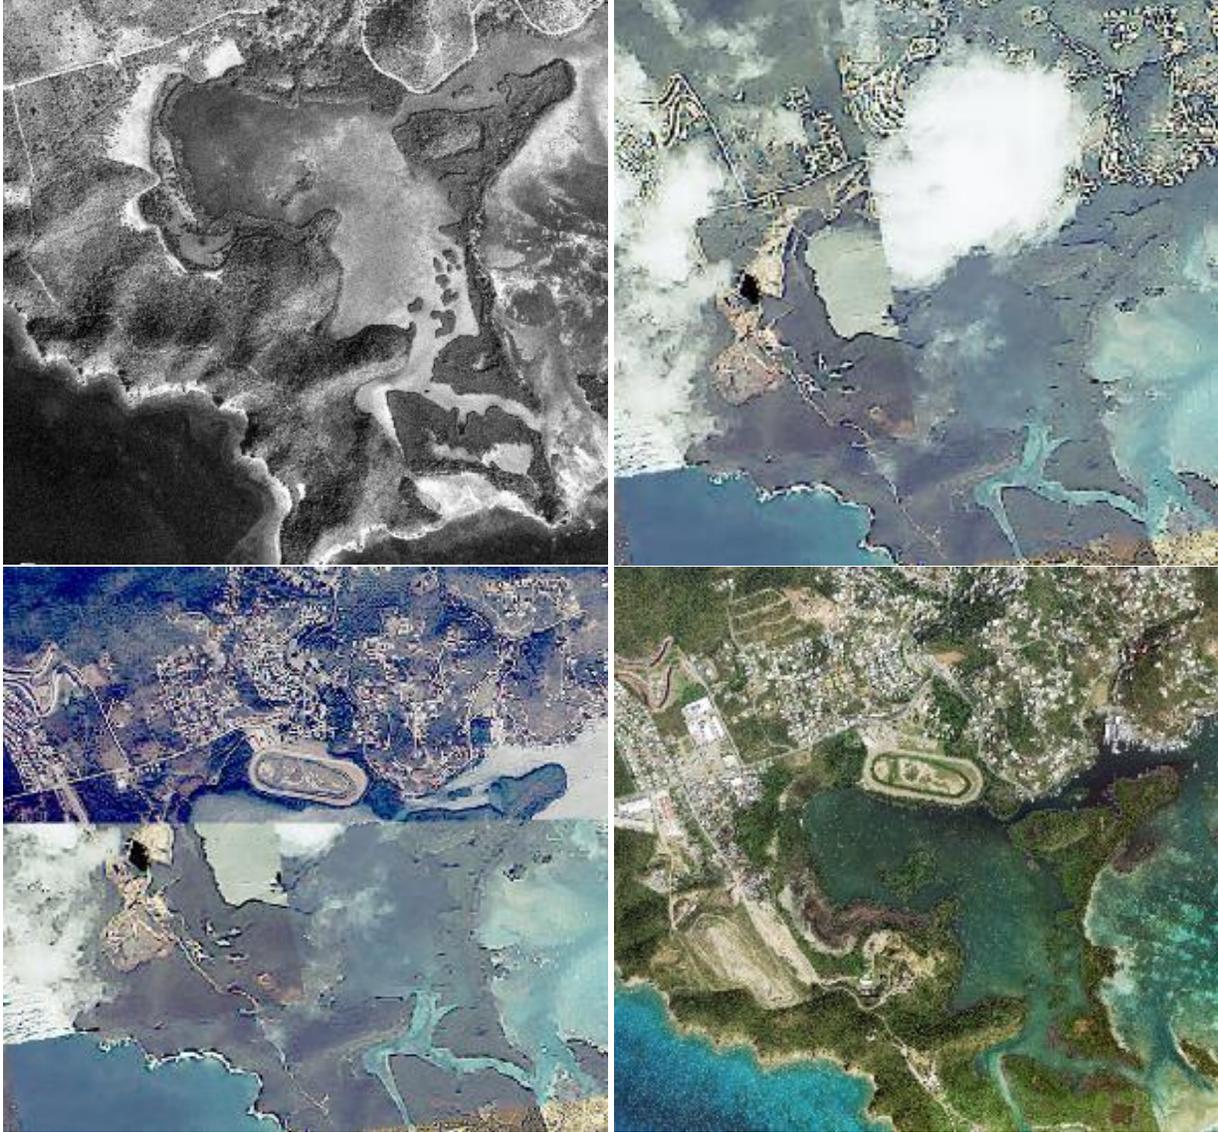
Figure 28: Mangrove Lagoon in 1954 (top left), 1970s (top right), 1980s (bottom left), and 2020 (bottom right).

The landfill and the racetrack were also built sometime in the 1960s, altering the wetlands in the process (Figure 28). The construction of the landfill significantly cut into the wetlands as well. The marina in the lagoon eastward was built in the 1980s, further encroaching on the mangroves through time (Figure 29).

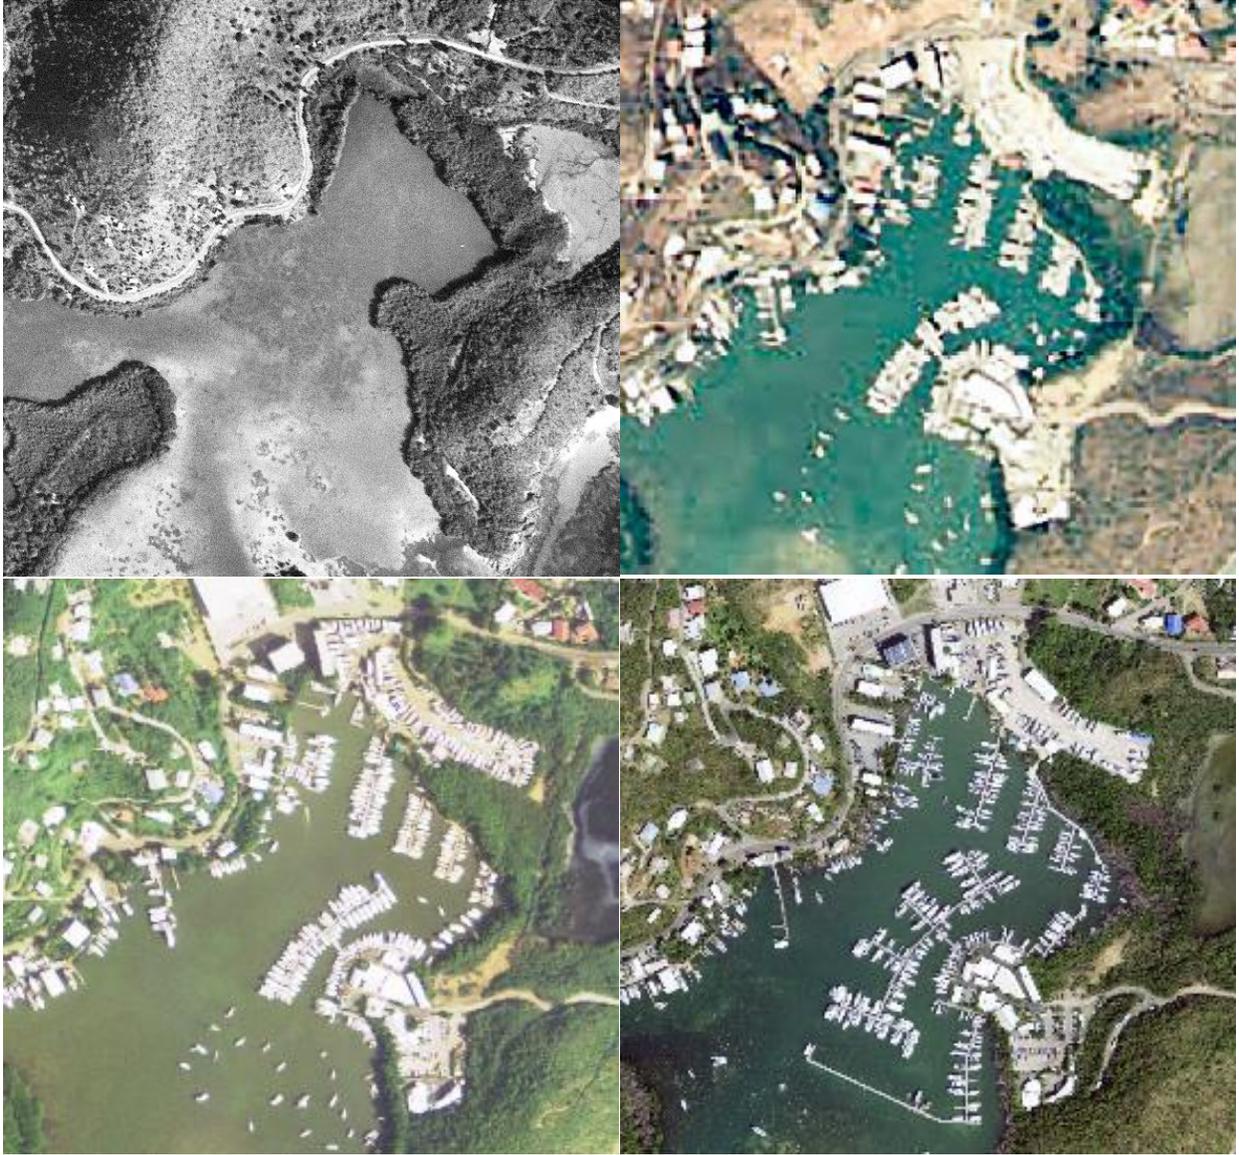
Figure 29: Mangrove Lagoon in 1954 (top left), 1990s (top right), 2010s (bottom left), and 2020 (bottom right).

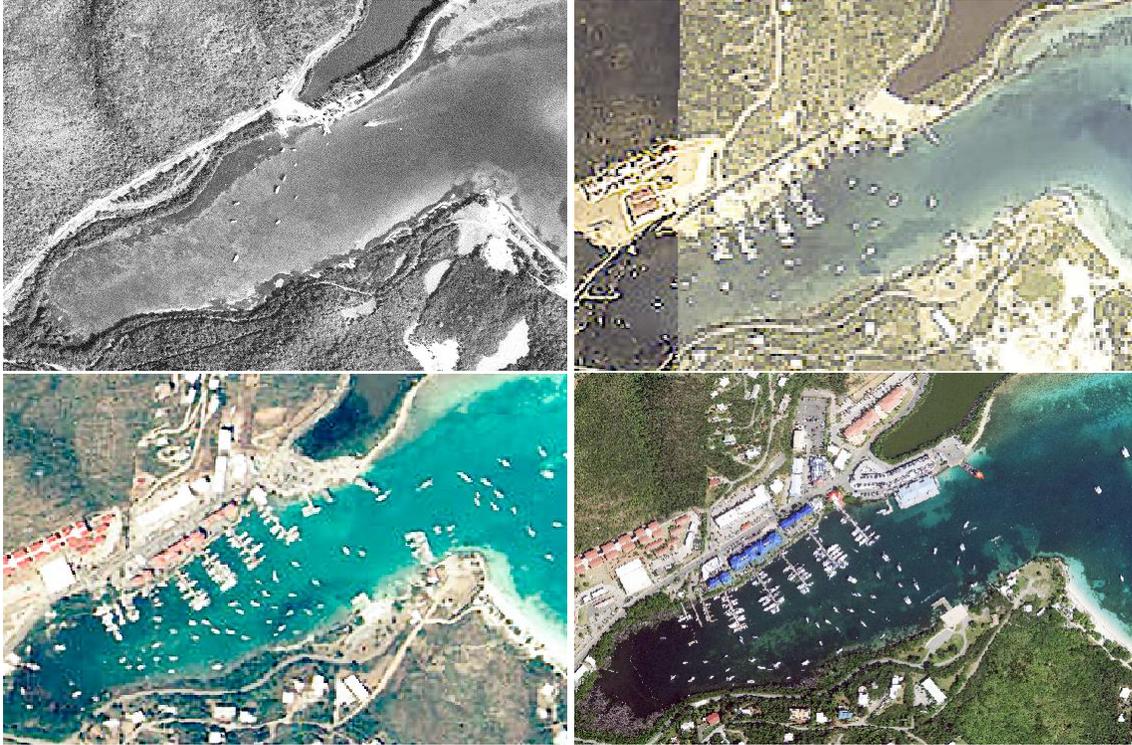
Figure 30: Red Hook in 1954 (top left), 1970s (top right), 1990s (bottom left), and 2010s (bottom right).

The Red Hook region also saw some significant changes due to the construction of the port facilities, in the 60s and 70s, the expansion of the port area to the east with the construction of a dock in the 1980s, and the accompanying filling of part of the bay (Figure 30). In the late 2000s, early 2010s, a car ferry dock was also built on a wetland and/or beach.

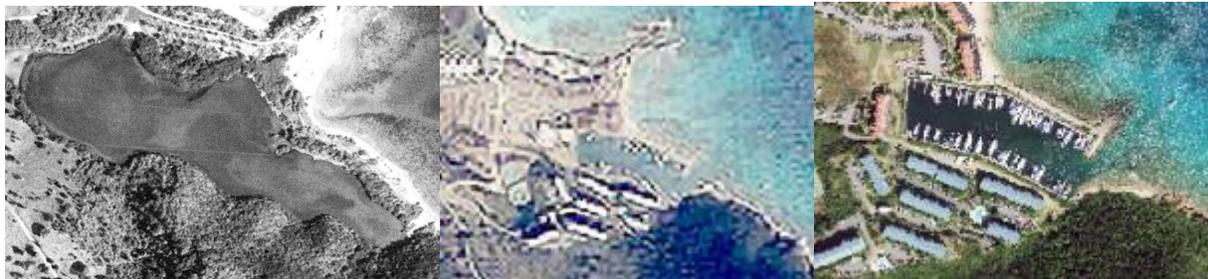
Figure 31: Construction of Sapphire Beach marina from (left to right) 1954, 1980, and 2000

One exception to the filling of land was the construction of the Sapphire Beach marina, which led to the opening of a lagoon to the sea in the 1960s (Figure 31).

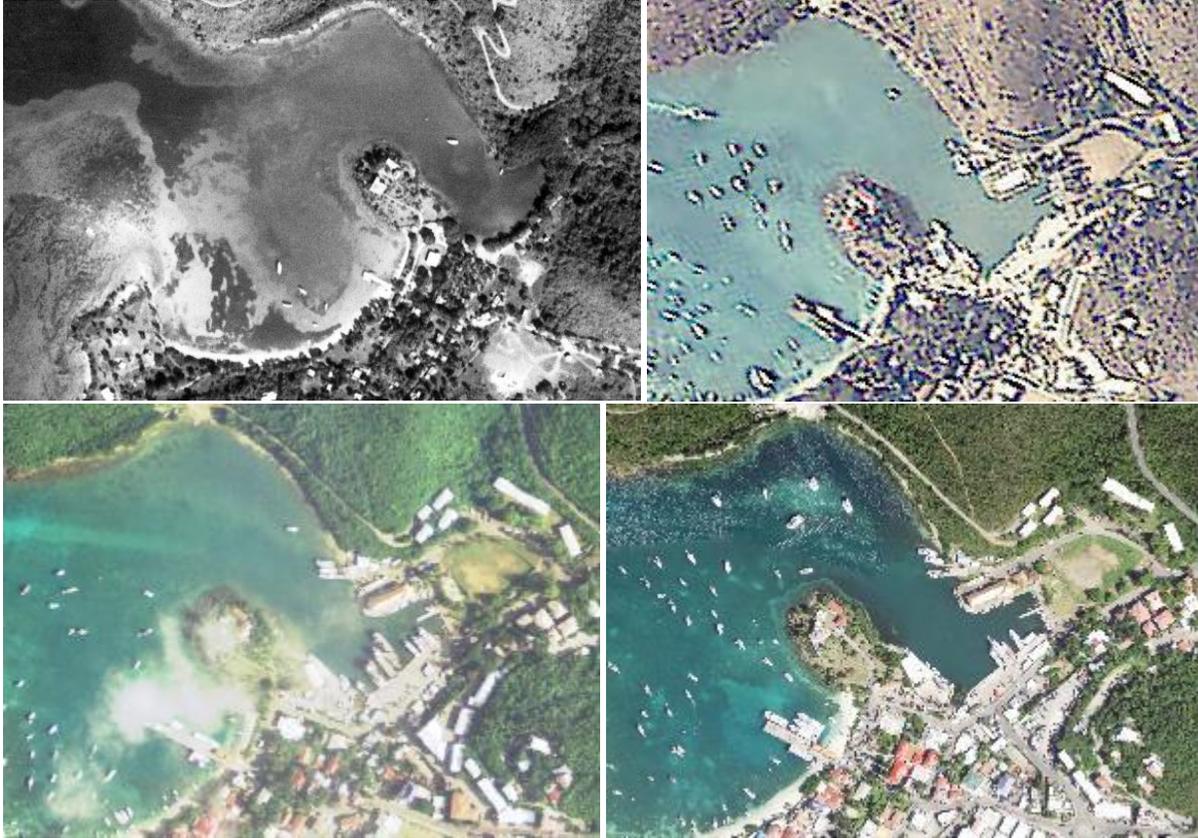
Figure 32: Crux Bay in 1954 (top left), 1980s (top right), 2000s (bottom left), and 2020s (bottom right).

On St. John, changes are mostly limited to two major projects to improve maritime connections between the islands. The first major shoreline modification occurred in the 60s with the expansion of the Cruz Bay lagoon to accommodate more vessel traffic (Figure 32). The area continued to expand with the construction the National Park Service facilities in the 70s and 80s, and other infrastructure thereafter.

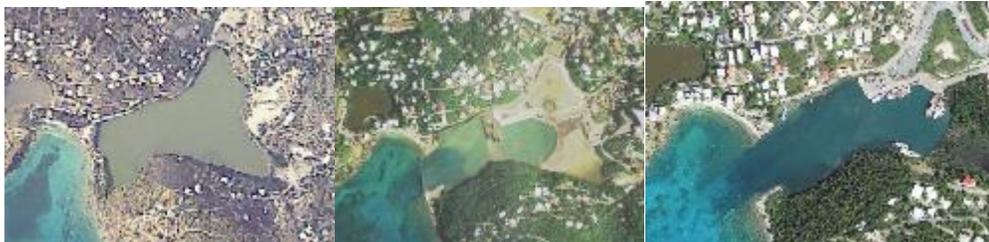
Figure 33: Large Pond in (from left to right) 1970s (top left), 2004, and 2020

Also, in the early 2000's the Car Ferry Dock was built where a sand barrier between the sea and Large Pond was opened (Figure 33). The pond was partially filled, dredged, and opened to the sea.

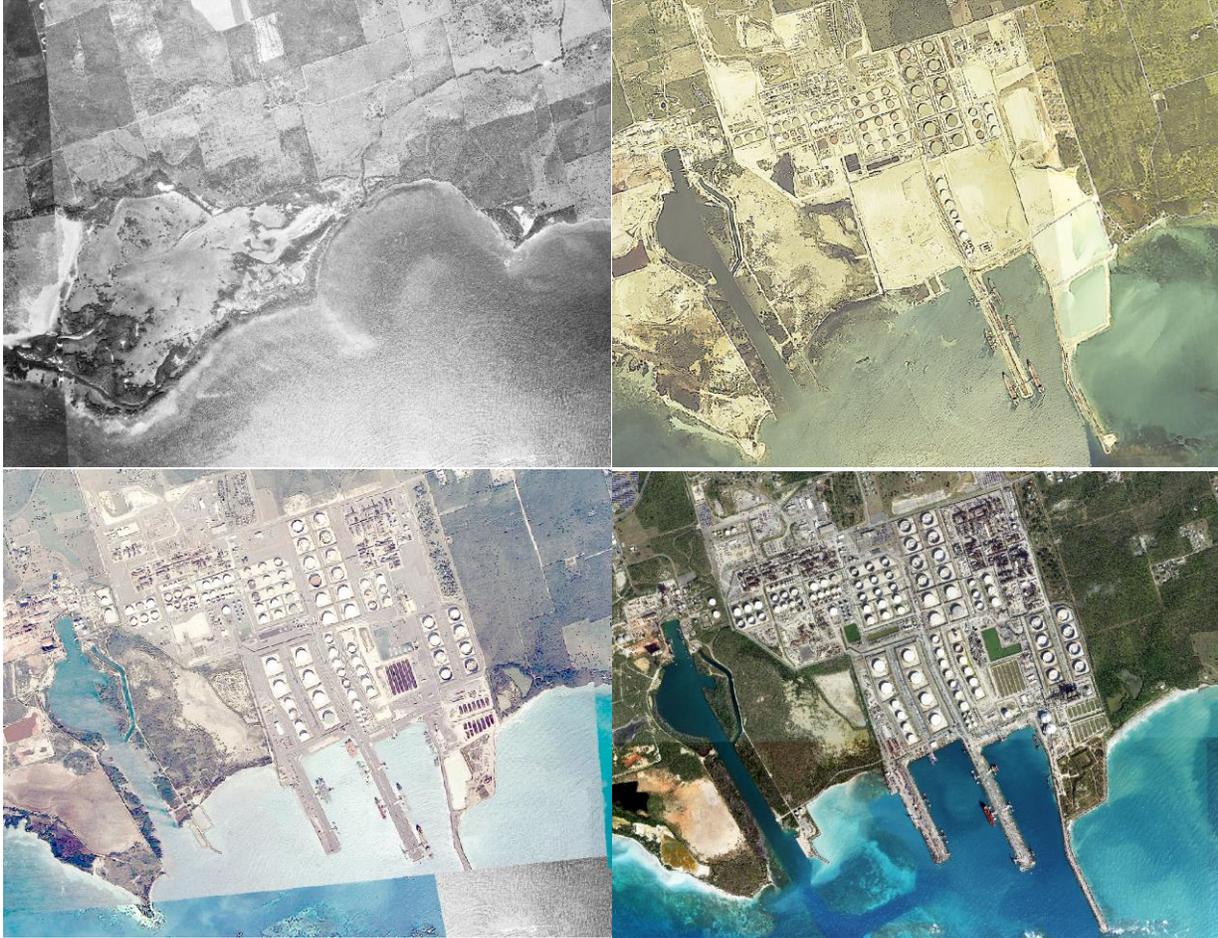
Figure 34: Hovensa and Limetree Refinery construction in 1954 (top left), 1970 (top right), 1990 (bottom left), and 2020 (bottom right).

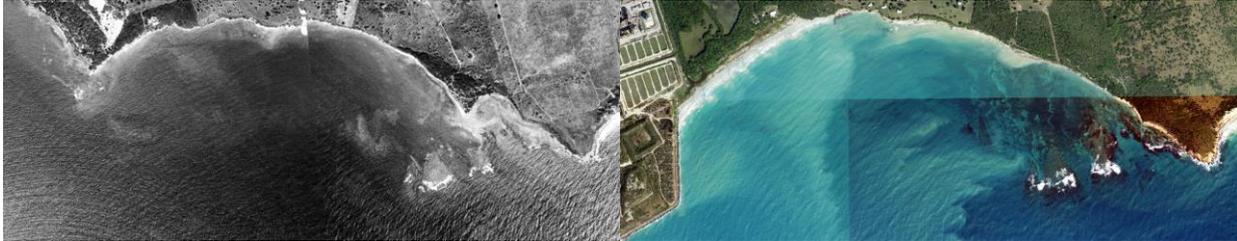
Figure 35: Canegarden Bay in 1954 and 2020.

Like what was observed near the St. Thomas airport, the construction of the port infrastructure has changed the nearby coastal area. Over the years, east of the facility (Canegarden Bay), the shoreline smoothed out (Figure 35). This is probably caused by a change in coastal currents. West of the facility (Negro Bay, Manning Bay and west), the shoreline also changed (Figure 36). Mangroves in front the racetrack receded, but sediment also piled up slightly westward and a spit formed eastward. It is unclear if these changes are a result of sediment transport modifications caused by the presence of the facility, the filling of the bay using dredged material, or both. Further west, the shoreline also shows signs of erosion, but again the role of the refinery is not clear, as waves in the area also probably play a role, especially since the reef has degraded and thus plays a reduced protection role (Figure 37).

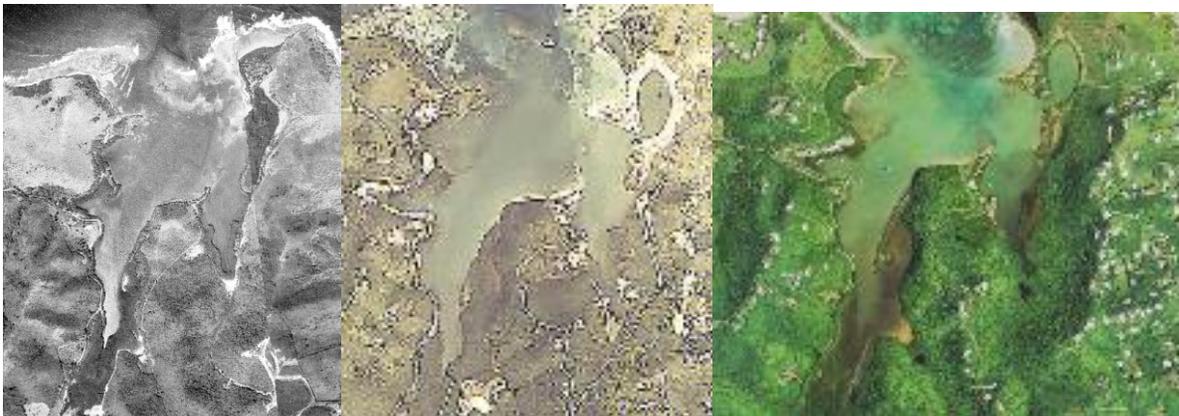
Figure 38: Salt River in 1954 (left), 1980s (center) and 2020 (right).

On the north side of the island, the Salt River system changed shape through time, but it seems that this change was caused by mangrove growth and recession (Figure 38). The construction of hard infrastructure did not seem to impact the bay.

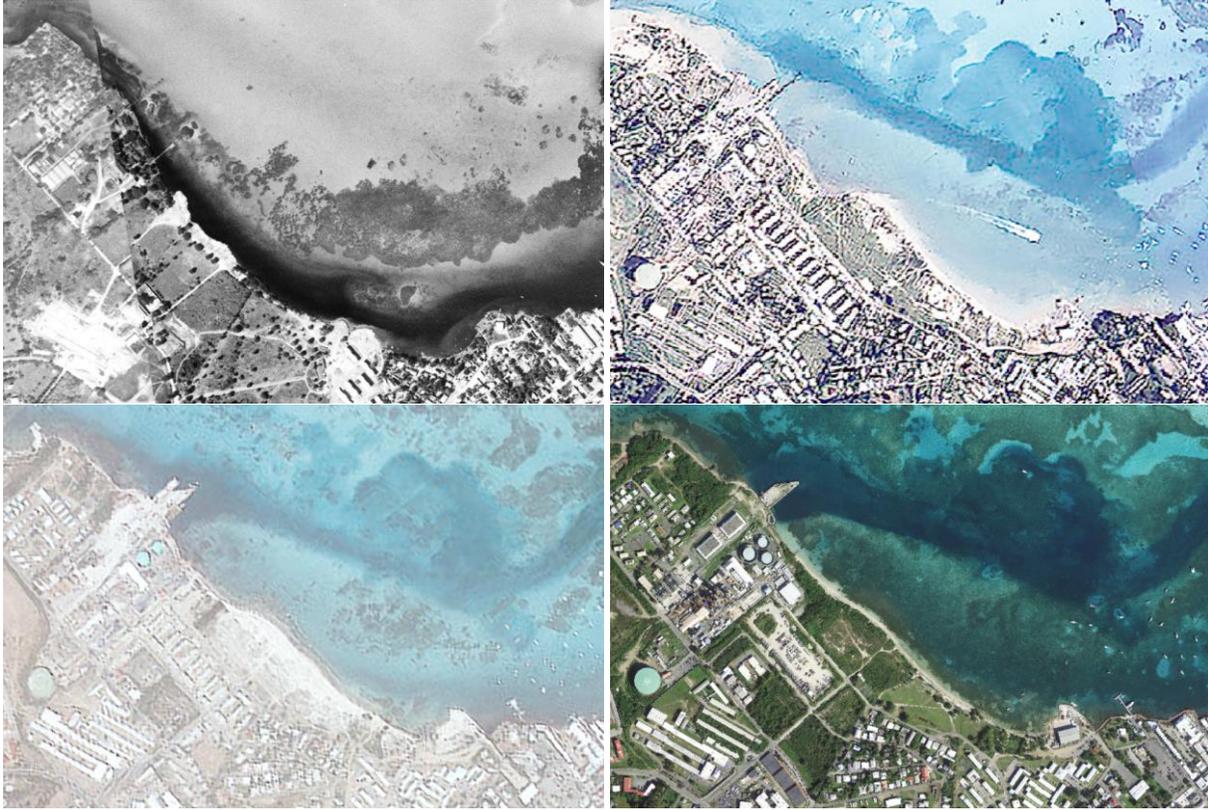
Figure 39: West side of Christiansted Harbor in 1954 (top left), 1970 (top right), 1980 (bottom left), and 2020 (bottom right).

North of the island, the land near Christiansted was filled sometimes in the 1960s or 70s, and port facilities were built up (Figure 39). East the harbor, the port of St. Croix was built and Altona beach was filled on the lagoon side. The beach has been slowly eroding since (Figure 40).
