# U.S. Virgin Islands Coastal Vulnerability Index

February 2023

This report presents a first assessment of coastal vulnerability in the U.S. Virgin Islands, following and adapting the method developed by the USGS in the late 1990s. It presents a detailed inventory of coastal geomorphic types and coastal infrastructure, estimates of the flooding risk due to sea-level rise and storm surge, and of the wave climate around the islands. The report also presents estimates of rates of accretion and erosion for select beaches. The final estimate of coastal vulnerability shows that St. Croix is the most vulnerable of all islands because of the preponderance of long stretches of sandy beaches and higher wave climate. We also find that on all islands, and on St. Thomas and St. John specifically, economically important beaches, some of them near hotels, are highly vulnerable. Finally, we find that many beaches and wetlands are moderately to highly vulnerable to coastal hazards, especially to sea-level rise and storm surge. Based on these findings, we provide a series of recommendations to better understand these vulnerabilities and develop adaptation and mitigation activities to protect beach

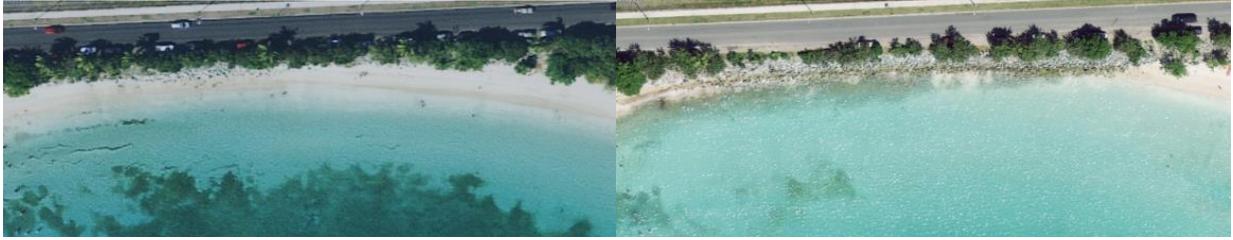
Figure 41: Lindbergh Bay and riprap revetment protecting the road in early 2017, pre-hurricanes, and in 2020.

In addition to these large scale changes, there are many small scale changes caused by structures. On St. Thomas, the construction of the riprap revetment along the airport road altered the cross-shore

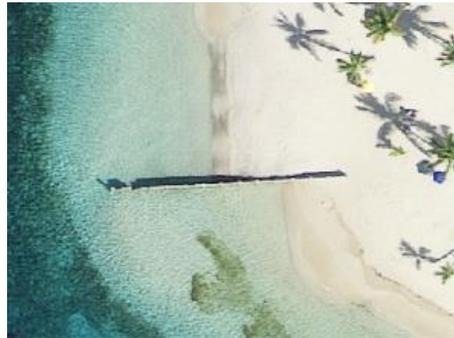
Figure 42: Groin in Protestant Cay

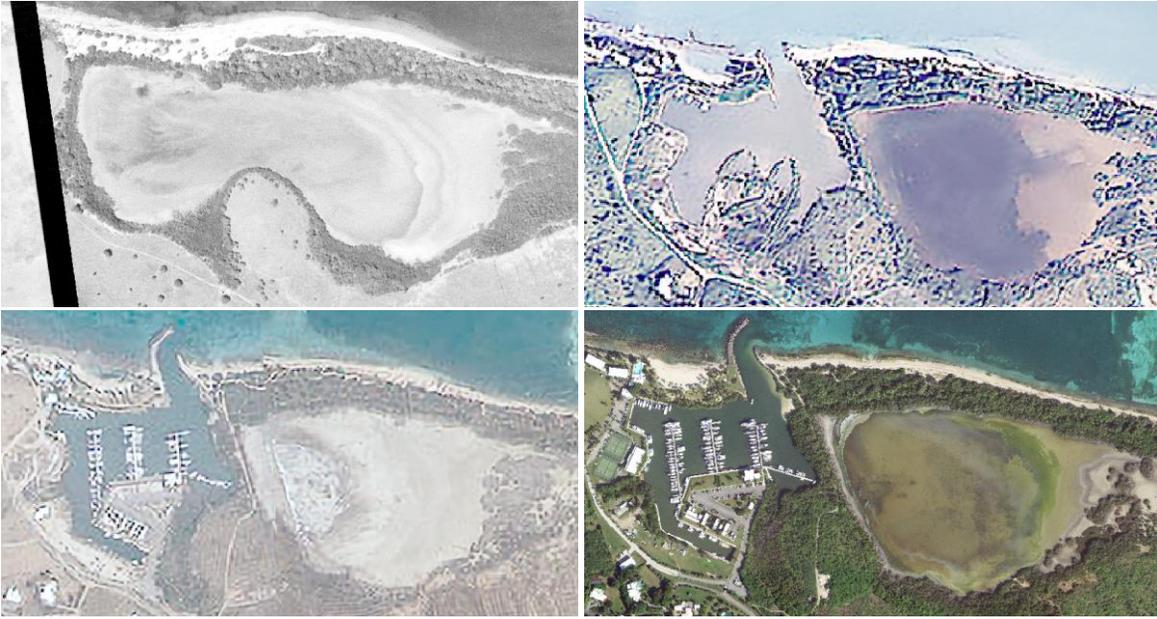
Figure 43: Green Cay marina in 1970s (top left), 1970s (top right), 1990s (bottom left) and 2020 (bottom right).

On Protestant Cay, a groin is altering longshore transport and help keep some of the sand from moving southward. It is unclear why this groin was created however, as its impacts seem to be limited in space (Figure 42). Further east, Green Cay Marina was built by opening a portion of a lagoon to the sea and closing a portion of it (Figure 43). The marina expanded and led to the construction of new hard infrastructure where natural systems used to be. To help maintain navigation depths, a jetty was also built, which altered the longshore sediment transport in that location. Areas west of the jetty seemed to have lost some sediment, which has been accumulating next to the jetty. Areas east of the jetty did not seem to have changed much, which indicates that most of the sediment transported longshore was probably accumulating in the lagoon.

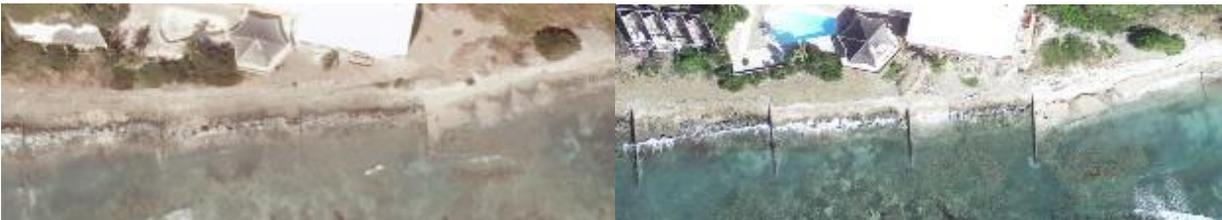
Figure 44: Groins built in front of the Grapetree Bay Hotel and Villas do not seem to stop the (probably cross-shore) movement of sand and coastal erosion (1990 picture on the left, and 2020 on the right).

On the south side of the island, in Grapetree Bay, the construction of groins in front of the Grapetree Bay Hotel and Villas seems to have altered the longshore transport of sediment. Sediment has accumulated east of the first groin (Figure 44), but the beach has eroded further west, especially in regions far from the first groin. In Figure 45, we can observe a drastic reduction of shoreline width, which caused the groins to be fully submerged. Hurricane Maria further accelerated the erosion of the coastline in that region (Figure 45).

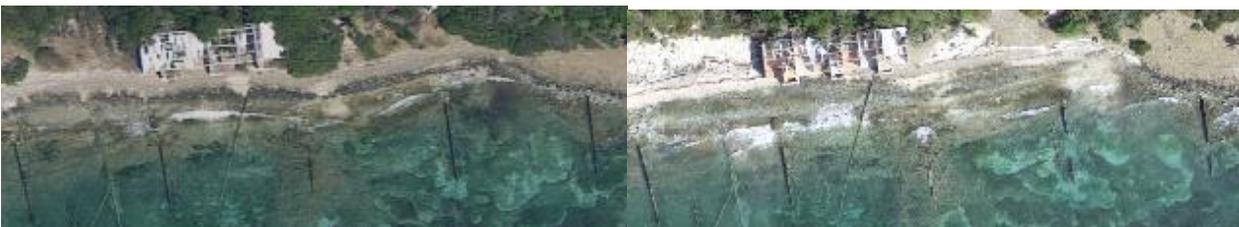
Figure 45: Groins west of the Grapetree Bay Hotel and Villas did not prevent erosion at this location (2010 on the left, 2020 on the right).

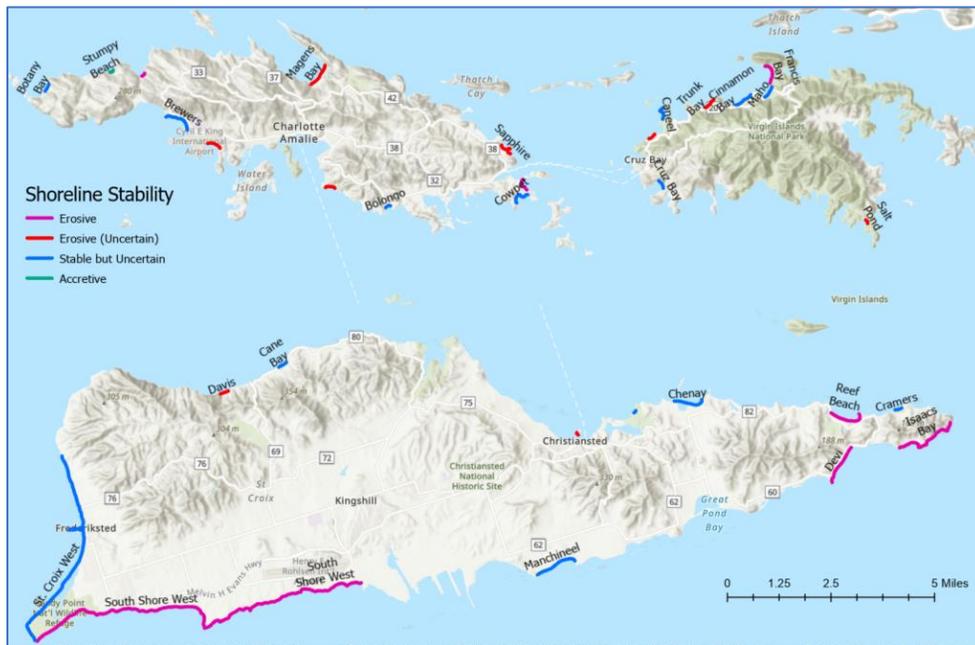
Figure 46: Estimates of stability of select beaches

The nearly constant loss of sand on the various beaches of St. Croix, and the USVI in general, can have many causes. As mentioned above, shoreline construction and modification can play a role. Degradation of offshore reefs and ensuing increase in wave climate can also play a role. But the steady increase in sea-level rise cannot be neglected in the loss of shoreline footprint.
