**ENVIRONMENTAL ASSESSMENT REPORT
FOR THE IMPLEMENTATION OF MEASURES TO PRESERVE
THE BEACH
ST. THOMAS, US VIRGIN ISLANDS**

THE RITZ-CARLTON CLUB

**BIOIMPACT, INC.
P.O. BOX 132
KINGSHILL, ST. CROIX, VI 00851**

FEBRUARY 2022

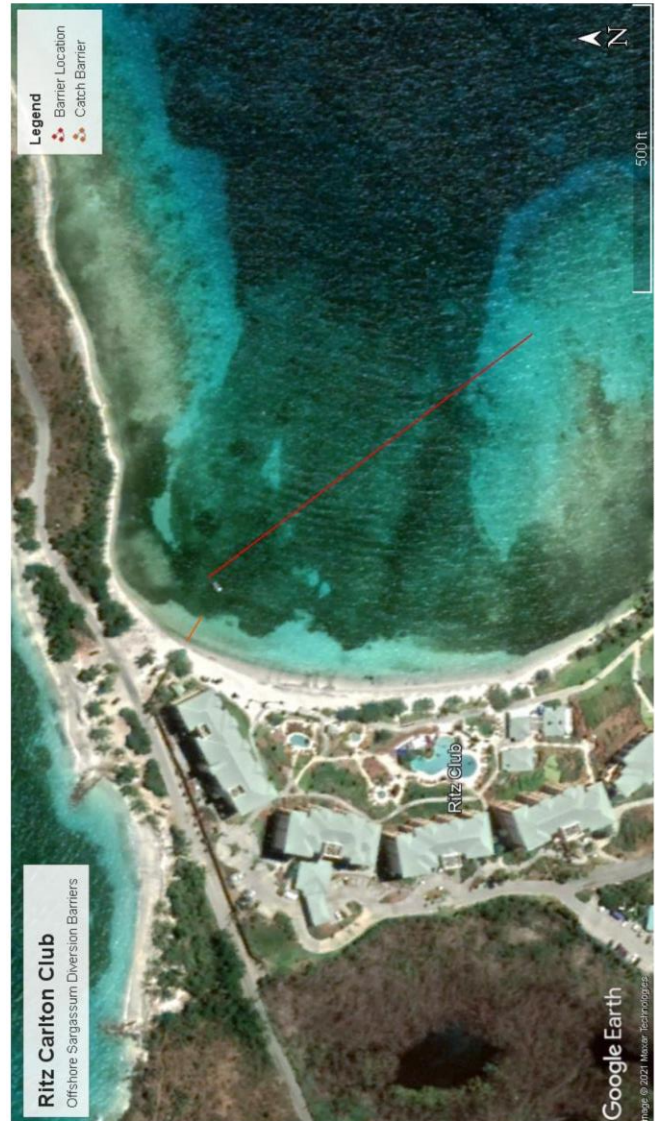
Ritz Carlton Club
Offshore Sargassum Diversion Barriers

22' CIRCUMFERENCE GEOTUBE - 11 1/2 FT EACH
SAND VOLUME IN GEOTUBE AND SCOUR TUBE
880 CY
880 CY
880 CY

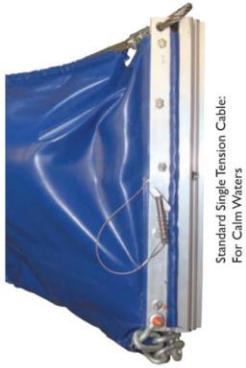
Standard Single Tension Cable:
For Calm Waters

Screw anchors and floated lines are being utilized to minimize impact to the seagrass resources. During trials with the barriers it was found that the manufactures recommendation of steel cables made it difficult to keep the up off the seafloor and that floated lines worked just a well and had no impact on the seafloor.

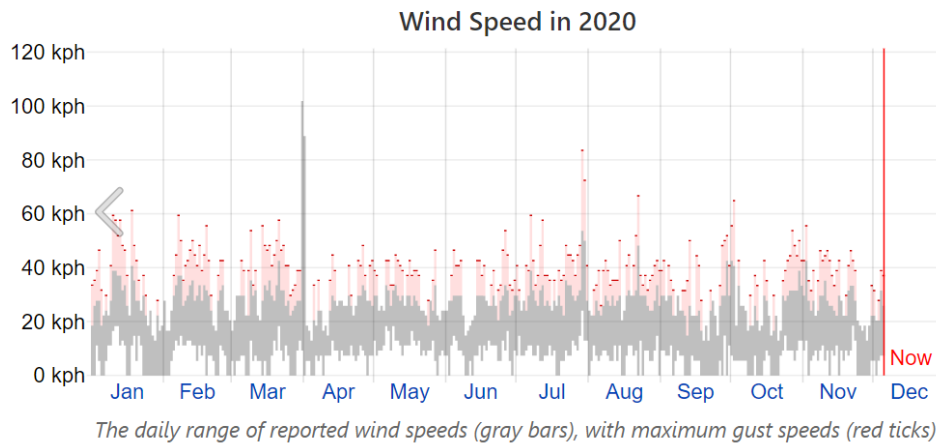
Figure 6.01.1 Wind speed and Gust reported at the Cyril E. King Airport, U.S. Virgin Islands in 2020 averages (<https://weatherspark.com/y/28234/Average-Weather-inCharlotte-Amalie-U.S.-Virgin-Islands>).

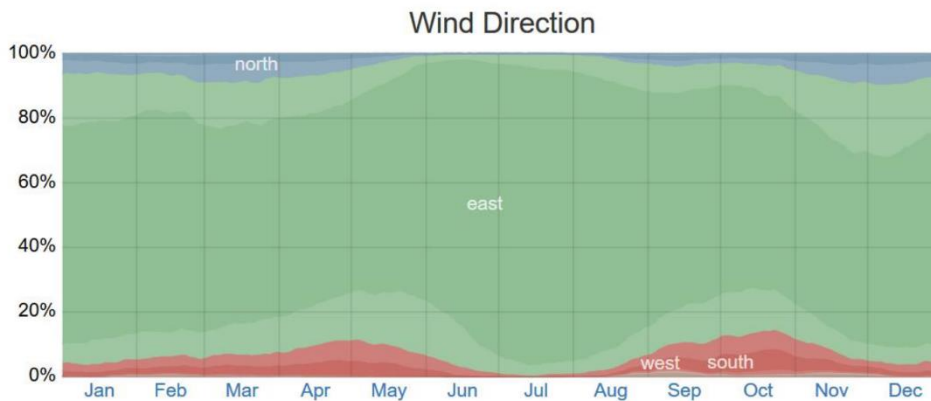
Figure 6.01.4 Wind averages (<https://weatherspark.com/y/28234/Average-Weather-inCharlotte-Amalie-U.S.-Virgin-Islands>)

The percentage of hours in which the mean wind direction is from each of the four cardinal wind directions (north, east, south, and west), excluding hours in which the mean wind speed is less than 1 mph. The lightly tinted areas at the boundaries are the percentage of hours spent in the implied intermediate directions (northeast, southeast, southwest, and northwest).

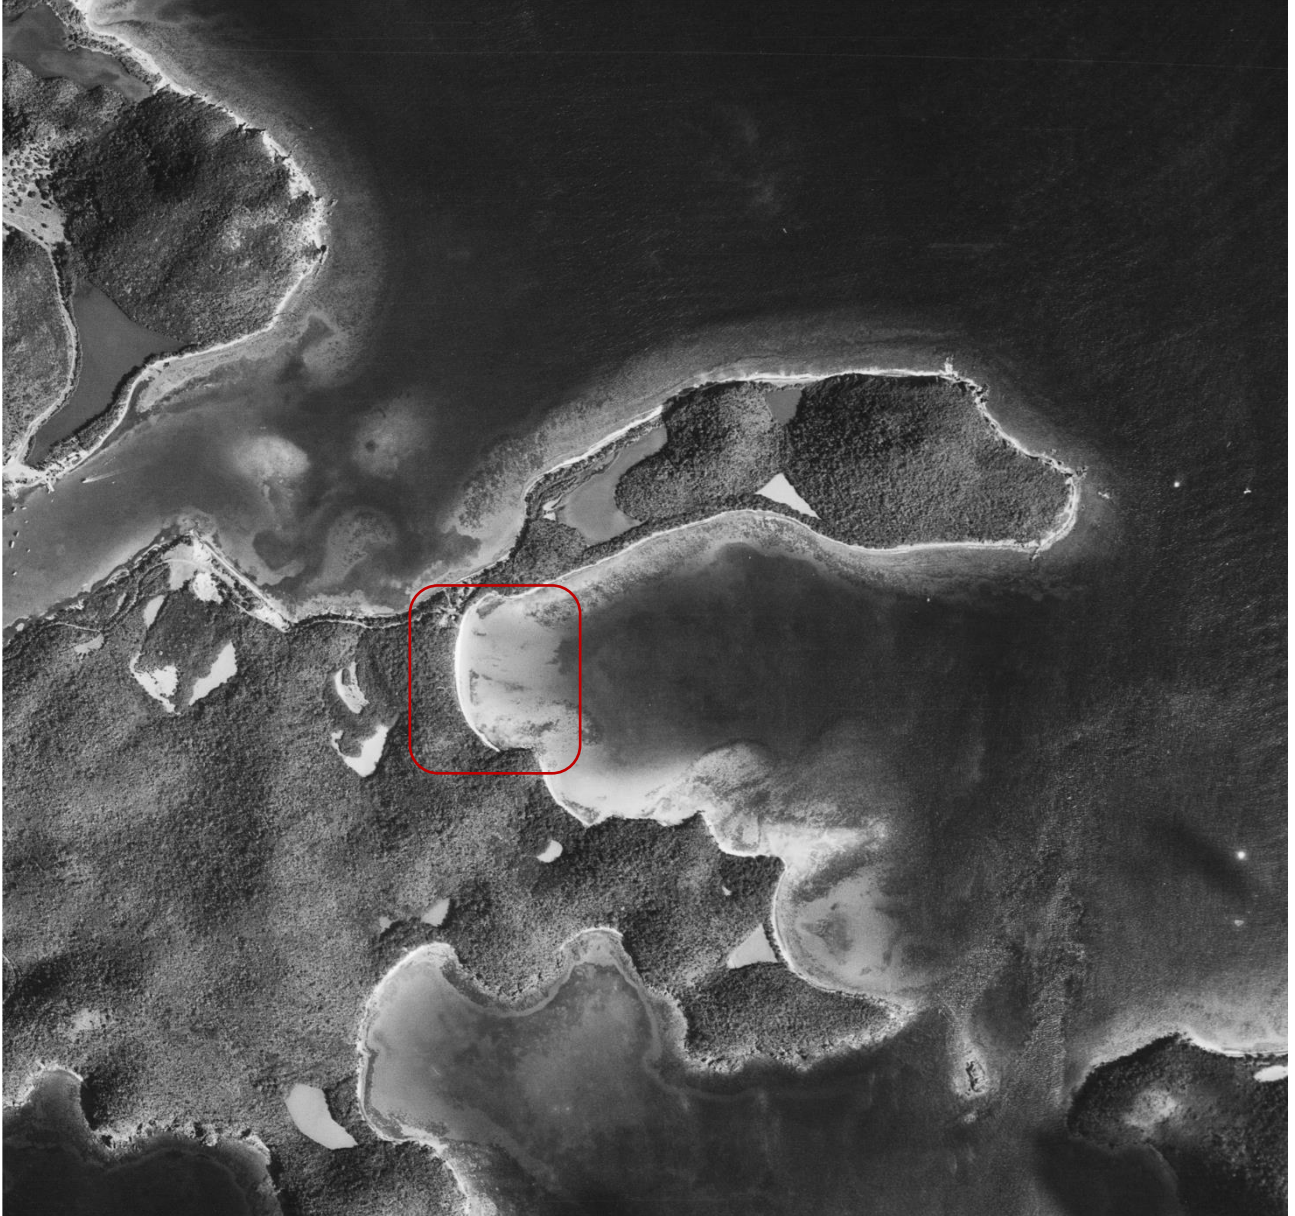
The 1954 aerial shows the undeveloped area and the salt ponds which lie to the west. The narrow sandy beach is present.

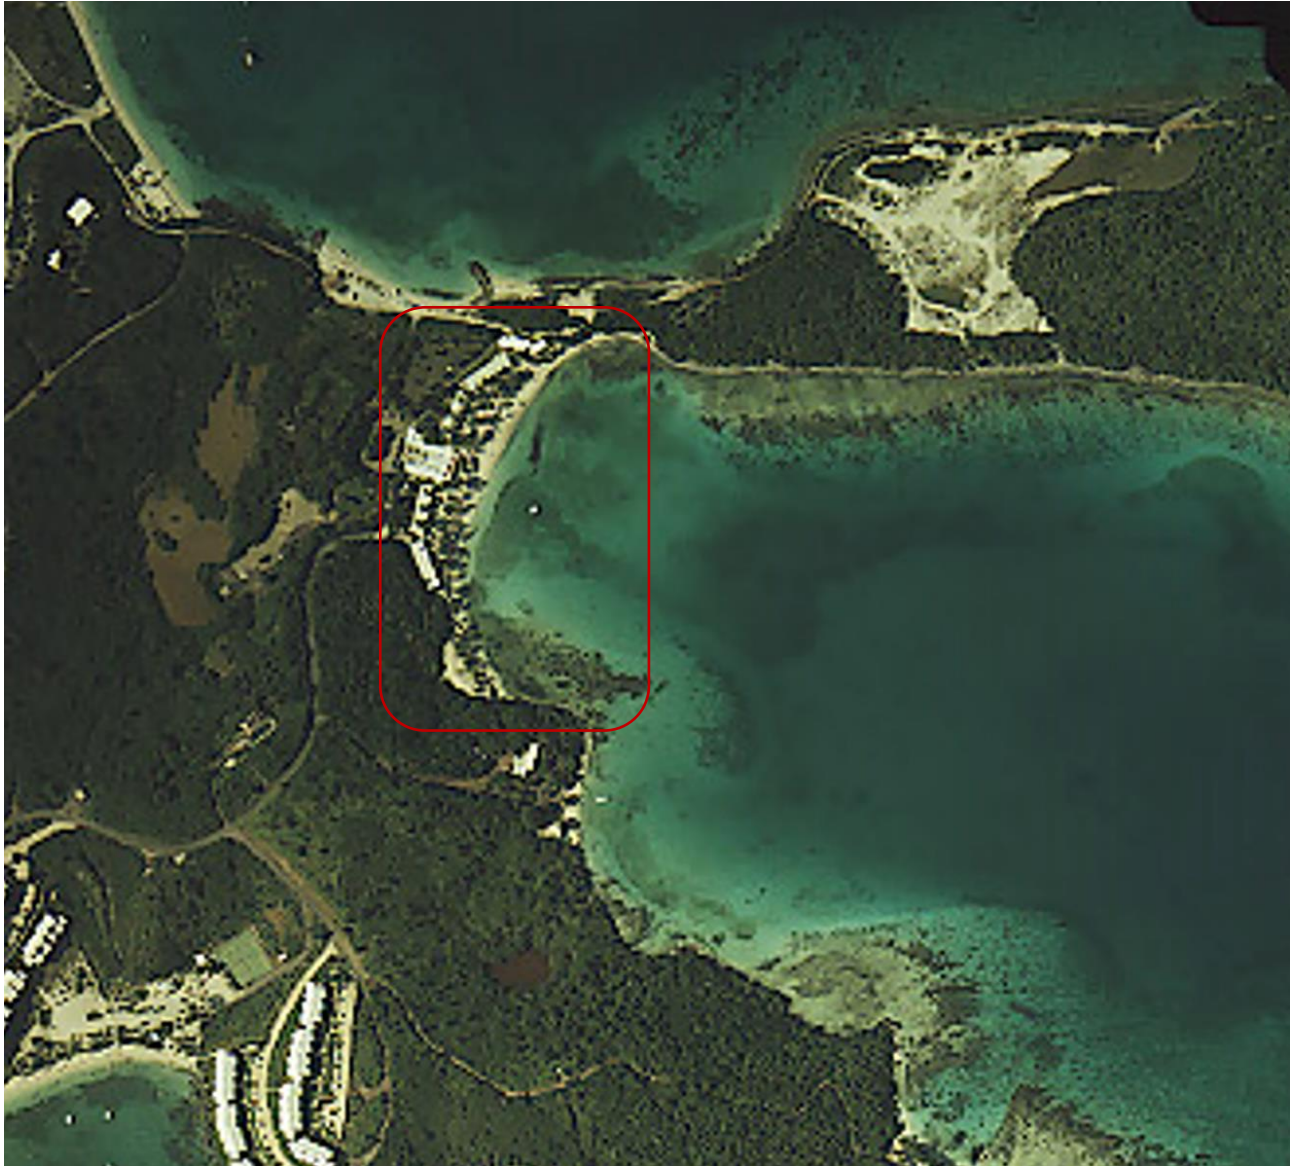
By 1972 the Grand Palazzo had been constructed on the site.

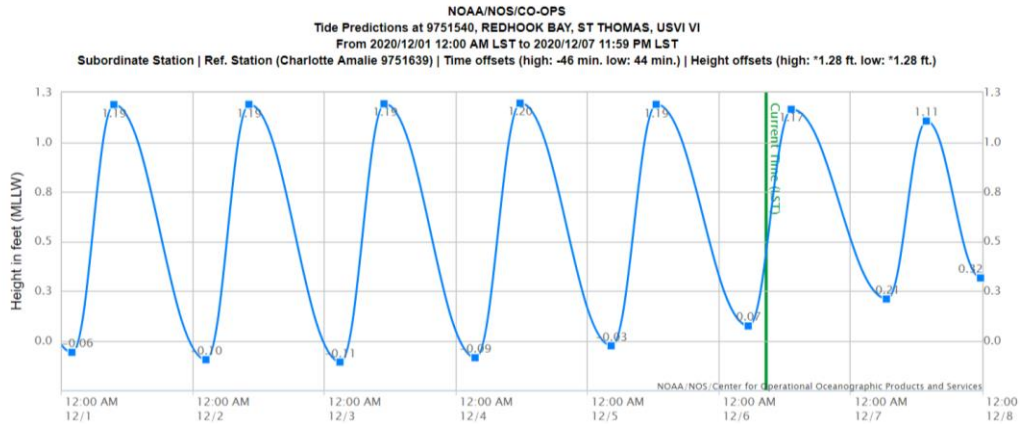
Note: The interval is High/Low, the solid blue line depicts a curve fit between the high and low values and approximates the segments between.
 Disclaimer: These data are based upon the latest information available as of the date of your request, and may differ from the published tide tables.

There is also a Tide Station in Red Hook (Station ID: 9751540), the station is located at latitude 18° 19.6 N and longitude 64° 51.1 W and has a mean tidal range of 0.82ft and a diurnal range of 1.09ft.

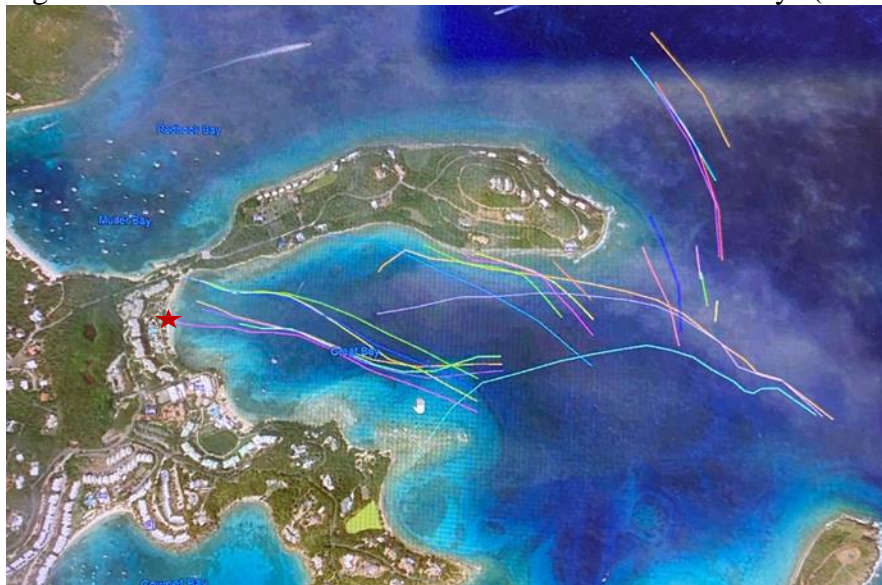
Figure 6.05.3. Drogue tracks during 2020/2021 Sargassum study. The property is shown by the red star.

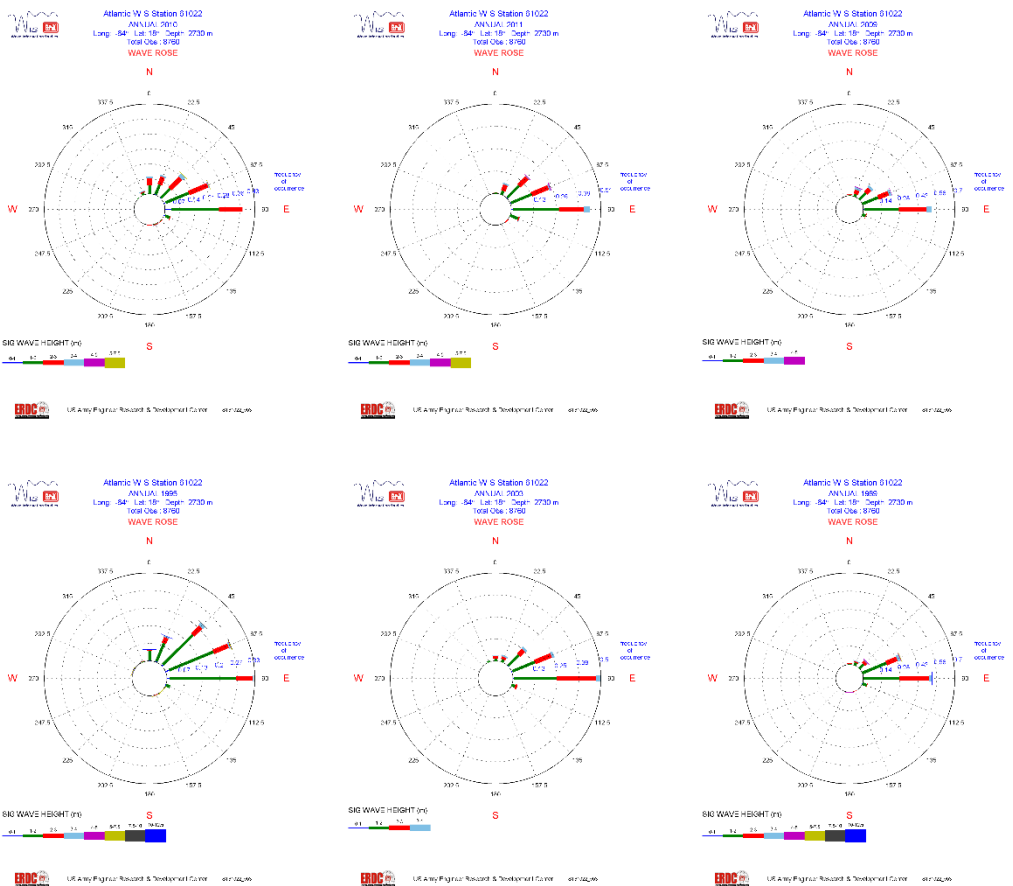
Figure 6.05.4. Wave Roses from the USACE Wave Information Studies for buoy 61022.

of 1 to 5 feet. The USACE Hindcast Studies for buoy 61022 the two buoy whose waves patterns directly affect the project site, shows that a majority of the waves which occurred approach from easterly directions.

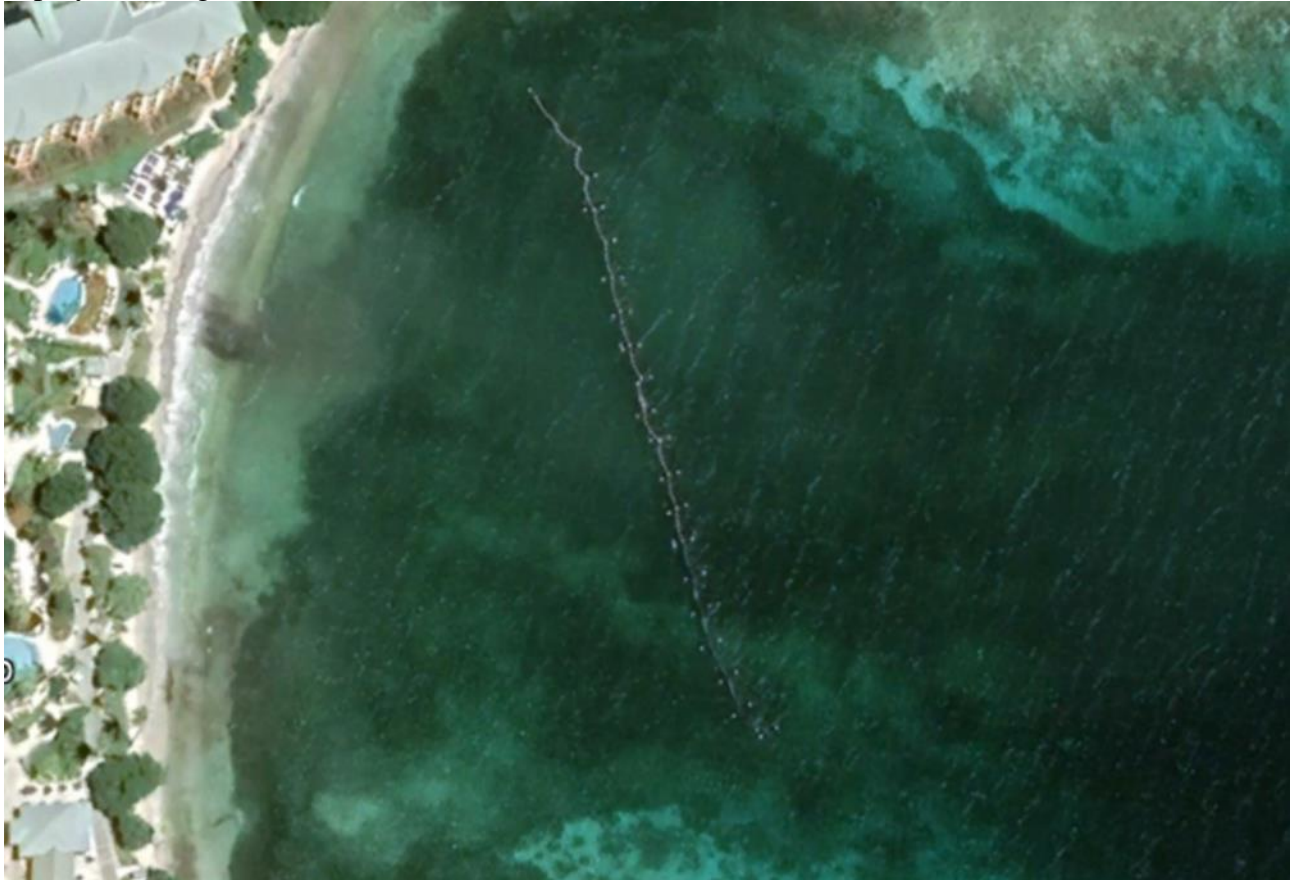
A Google Earth aerial caught an excellent picture of the sargassum barriers while they were deployed during the trial.

Figure 6.06.1 Google Earth September 2021

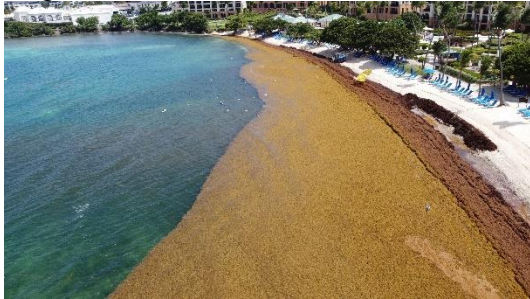
June 18, 2021

No action – If nothing is done the beach will continue to be inundated during large sargassum blooms.

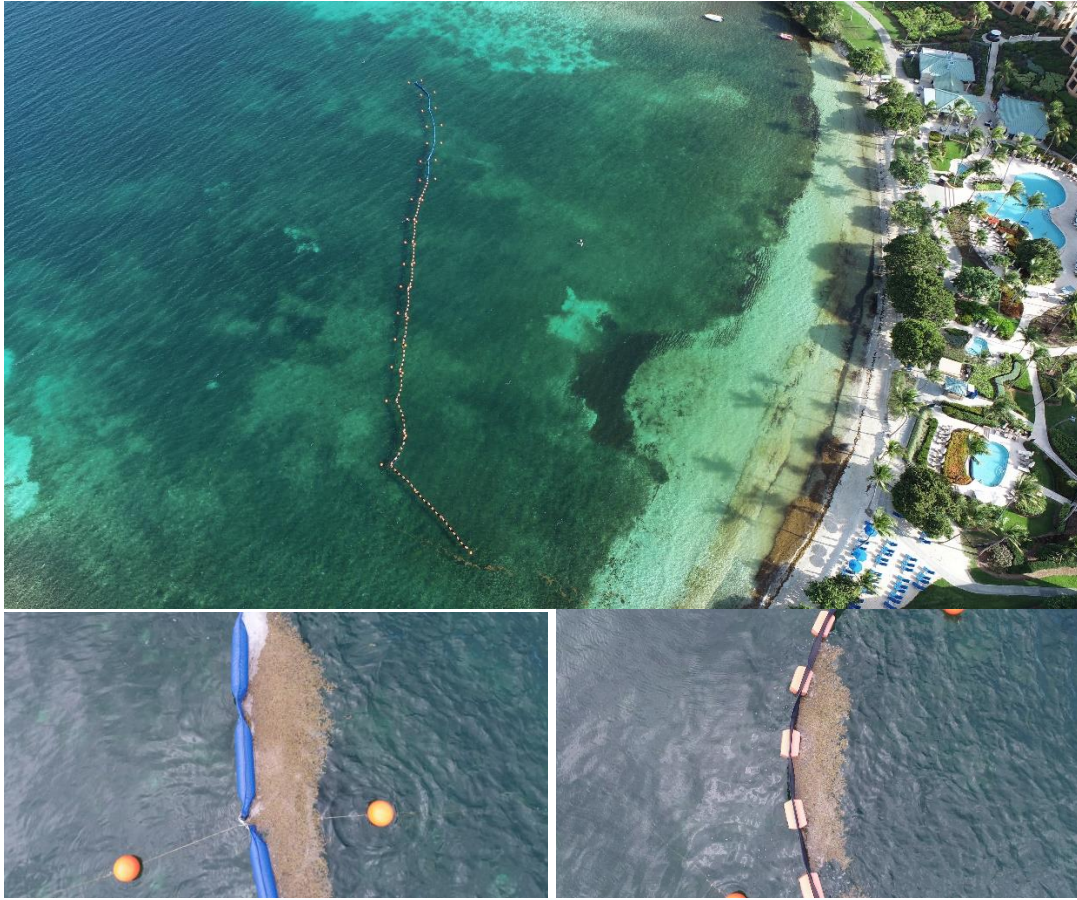
Two barrier types were tried, and the smooth blue barrier was found to capture all the sargassum and then the sargassum would move along the barrier toward the intended location.

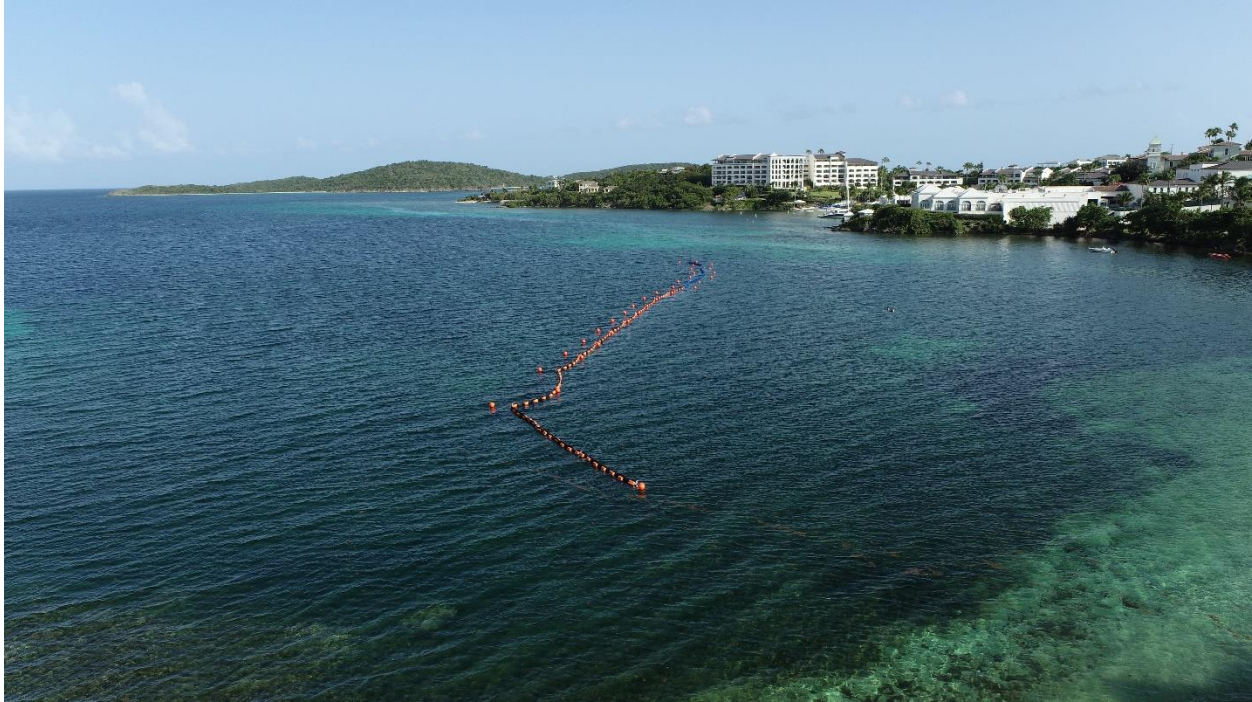
Barrier Attachments – The manufacture wanted the barriers to be attached by metal cables which were placed a distance out from the barriers, the cable has the potential of impacting the seafloor and were difficult to deploy and remove. Floated lines did not impact the seafloor and were easy to install and remove.

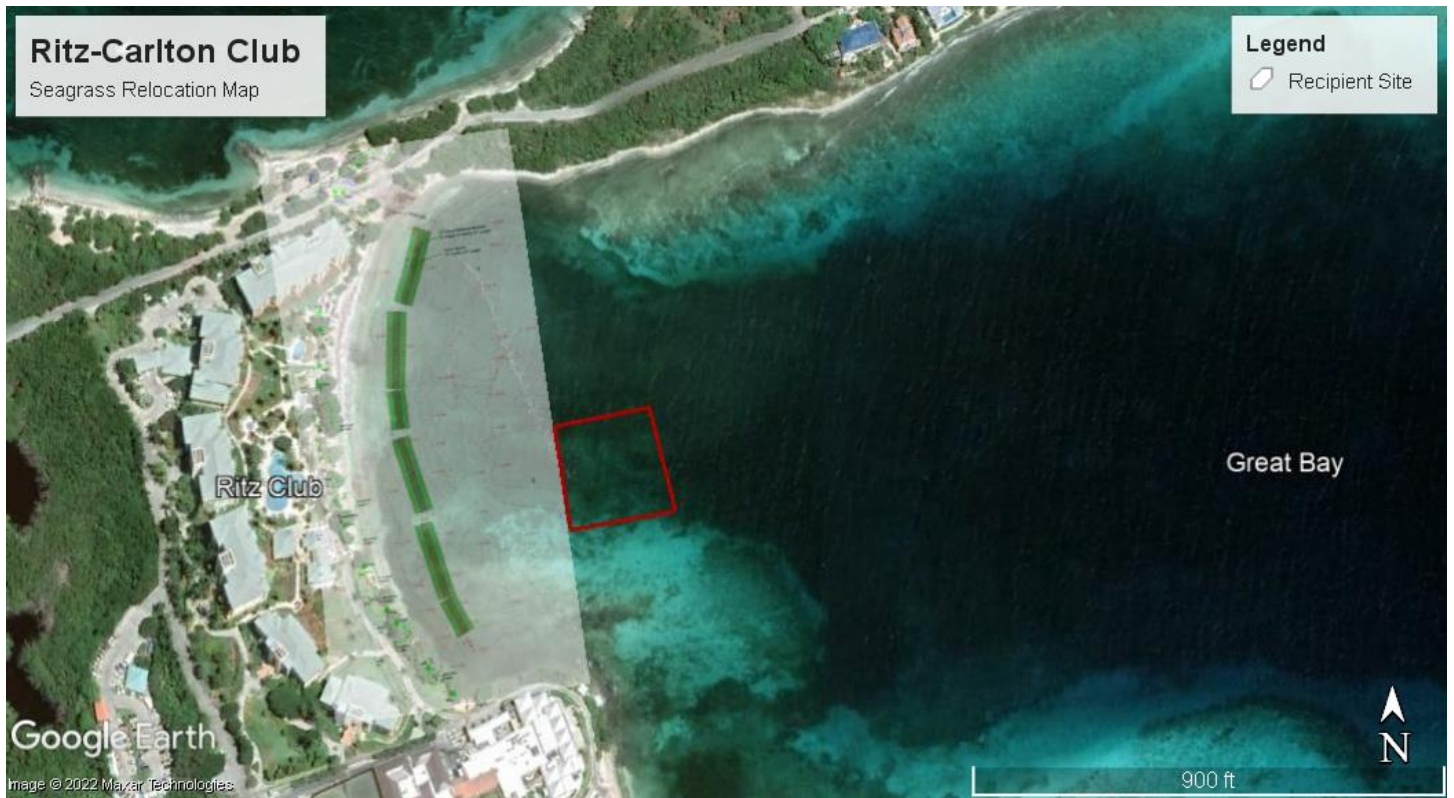
Figure 1. Location of transplant site shown by the red box, the approximate location of the geotubes is shown.

The plan proposes to transplant the seagrasses into blowouts and scars to the east of the beach which were partially created by the passage of the 2017 hurricanes. The site is in the immediate vicinity and the transplant would serve to restore the seagrass bed which serve as habitat for both fish and invertebrates. Figure 1 shows the location of the proposed recipient site.

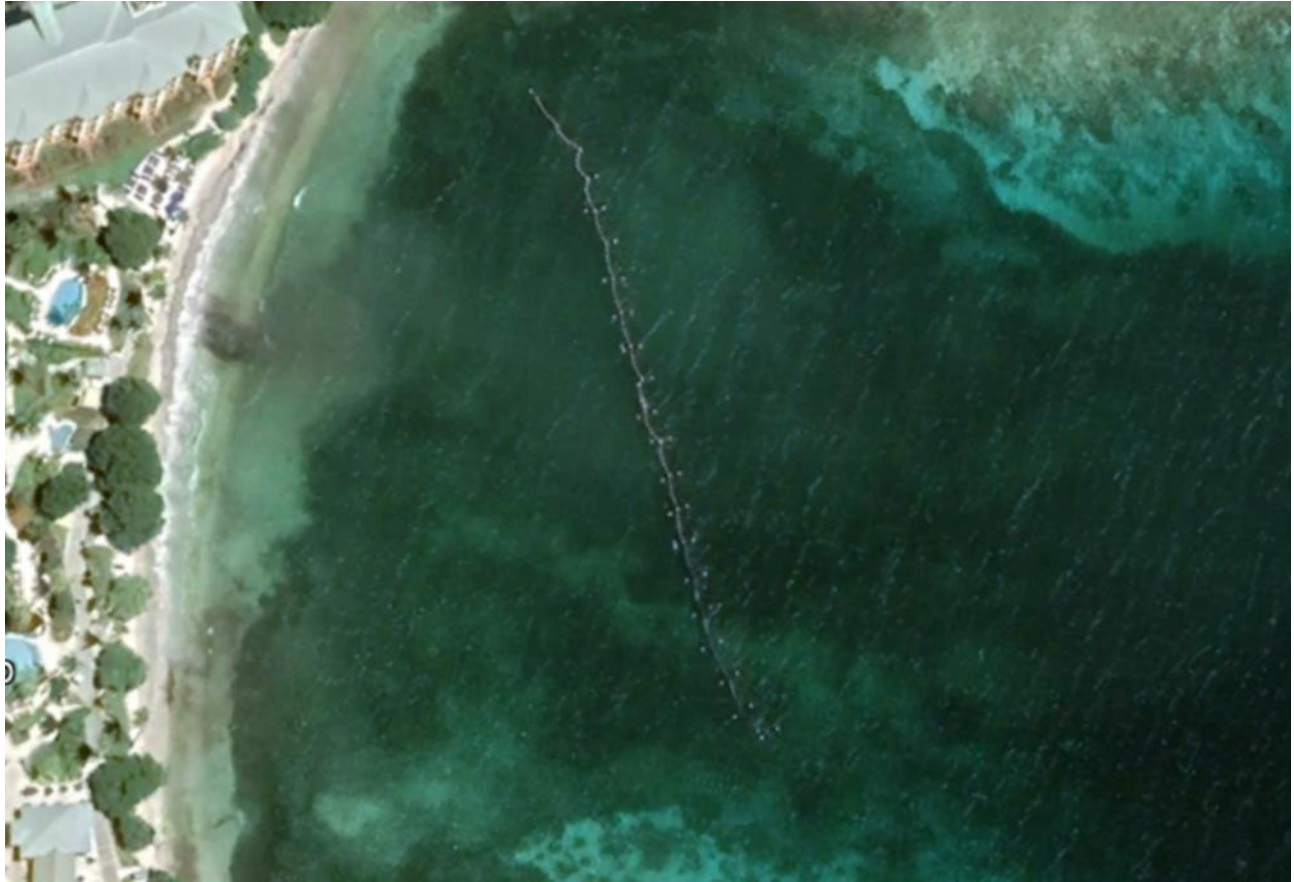
Figure 1. Google Earth September 2021

A Google Earth aerial caught an excellent picture of the sargassum barriers while they were deployed during the trial.

A trial conducted in 2021 showed that the sargassum can be directed successfully into one corner of the beach. It was also found that the barrier angle may need to shift due to wave approach to best accomplish the movement of the sargassum along the barriers. The Club is therefore requesting permission to install up to 750ft of boom offshore and up to 75ft of barrier as a “catch” barrier to prevent sargassum from moving back along the beach. The barrier in stalled will be the Smooth Blue beach bouncer barrier which as a 24” skirt to prevent sargassum from moving below the barrier. The barrier would be installed utilizing screw anchors and would utilize floating lines. Screw anchors would be installed every 25ft, and pair anchors will be used to minimize wave impacts. The Club would like permission to install up to sixty-five (65) 3’ screw anchors to allow for adjustment of the angle as necessary. A quick release has been designed into the barriers, so they may be rapidly removed or deployed. The screw anchors will remain in place year-round, but the barriers would only be deployed as necessary to prevent sargassum inundation on the beach.
