# WATERSHED MANAGEMENT PLAN FOR THE SALT RIVER BAY WATERSHED

## ST. CROIX, USVI

JUNE 2022

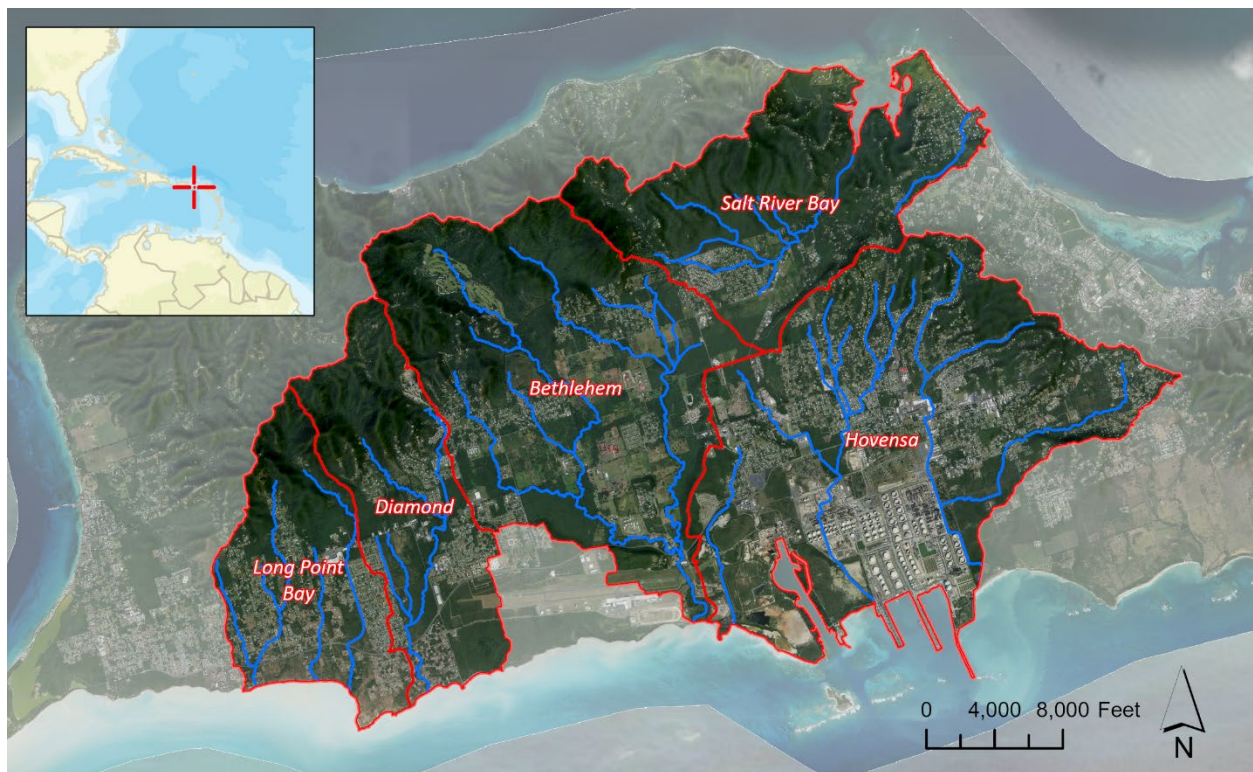
Figure 1. The five study watersheds on St. Croix are outlined in red.

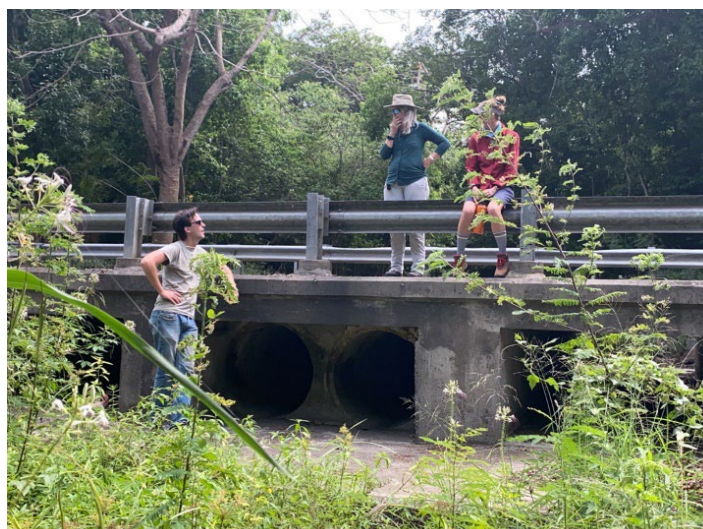
*Figure 49. Culverts in the Salt River Bay watershed.*

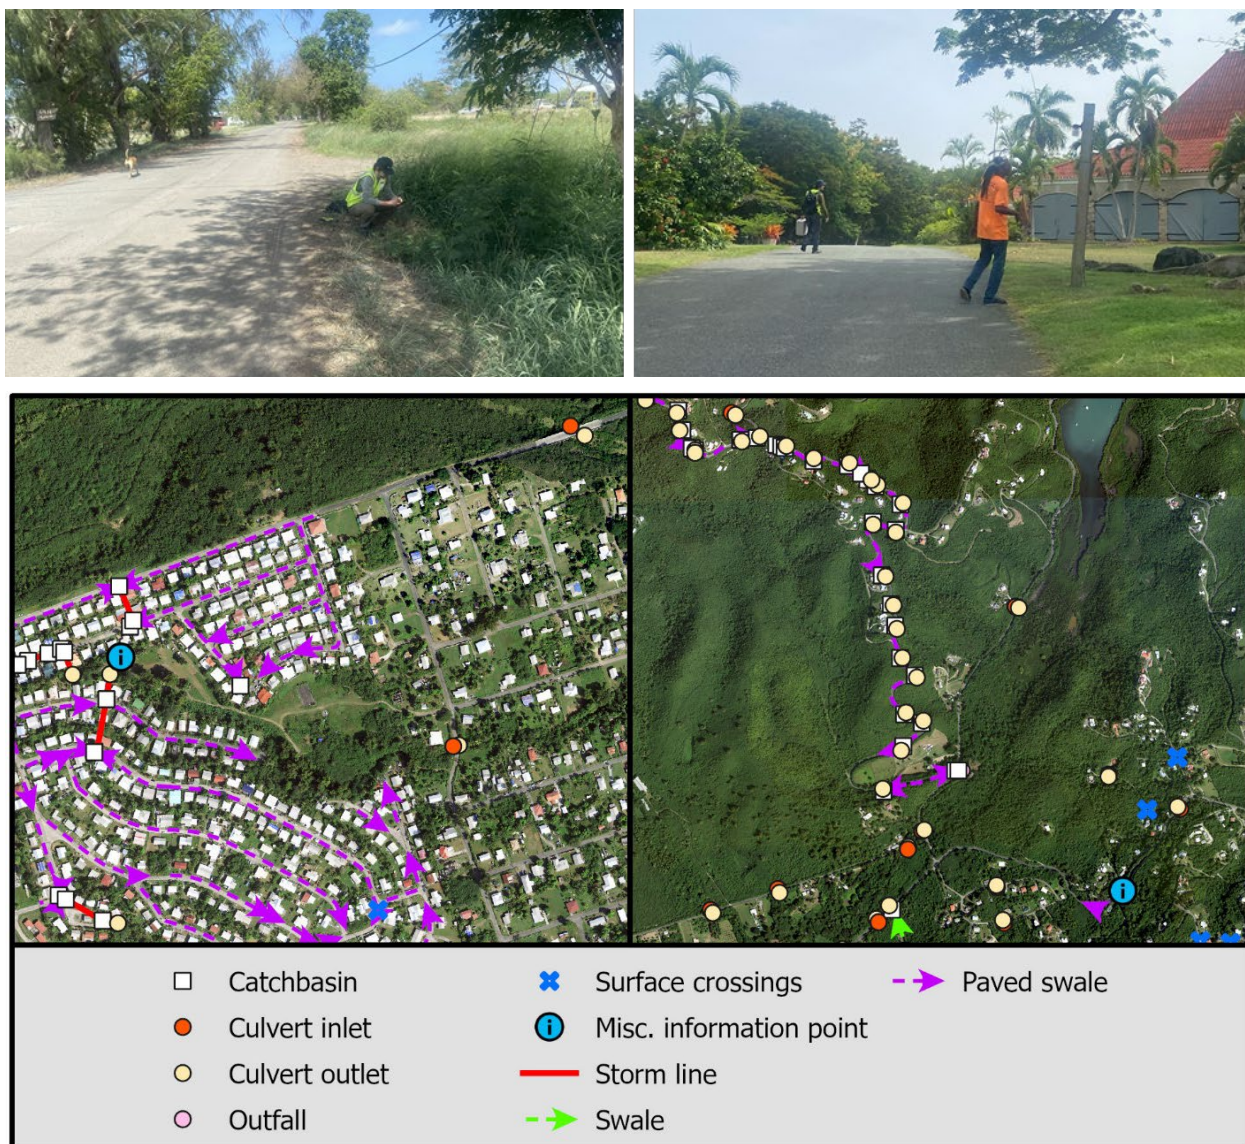
*Figure 50. Inspection of existing stormwater infrastructure during field assessments (above) and an example of the maps produced (below).*

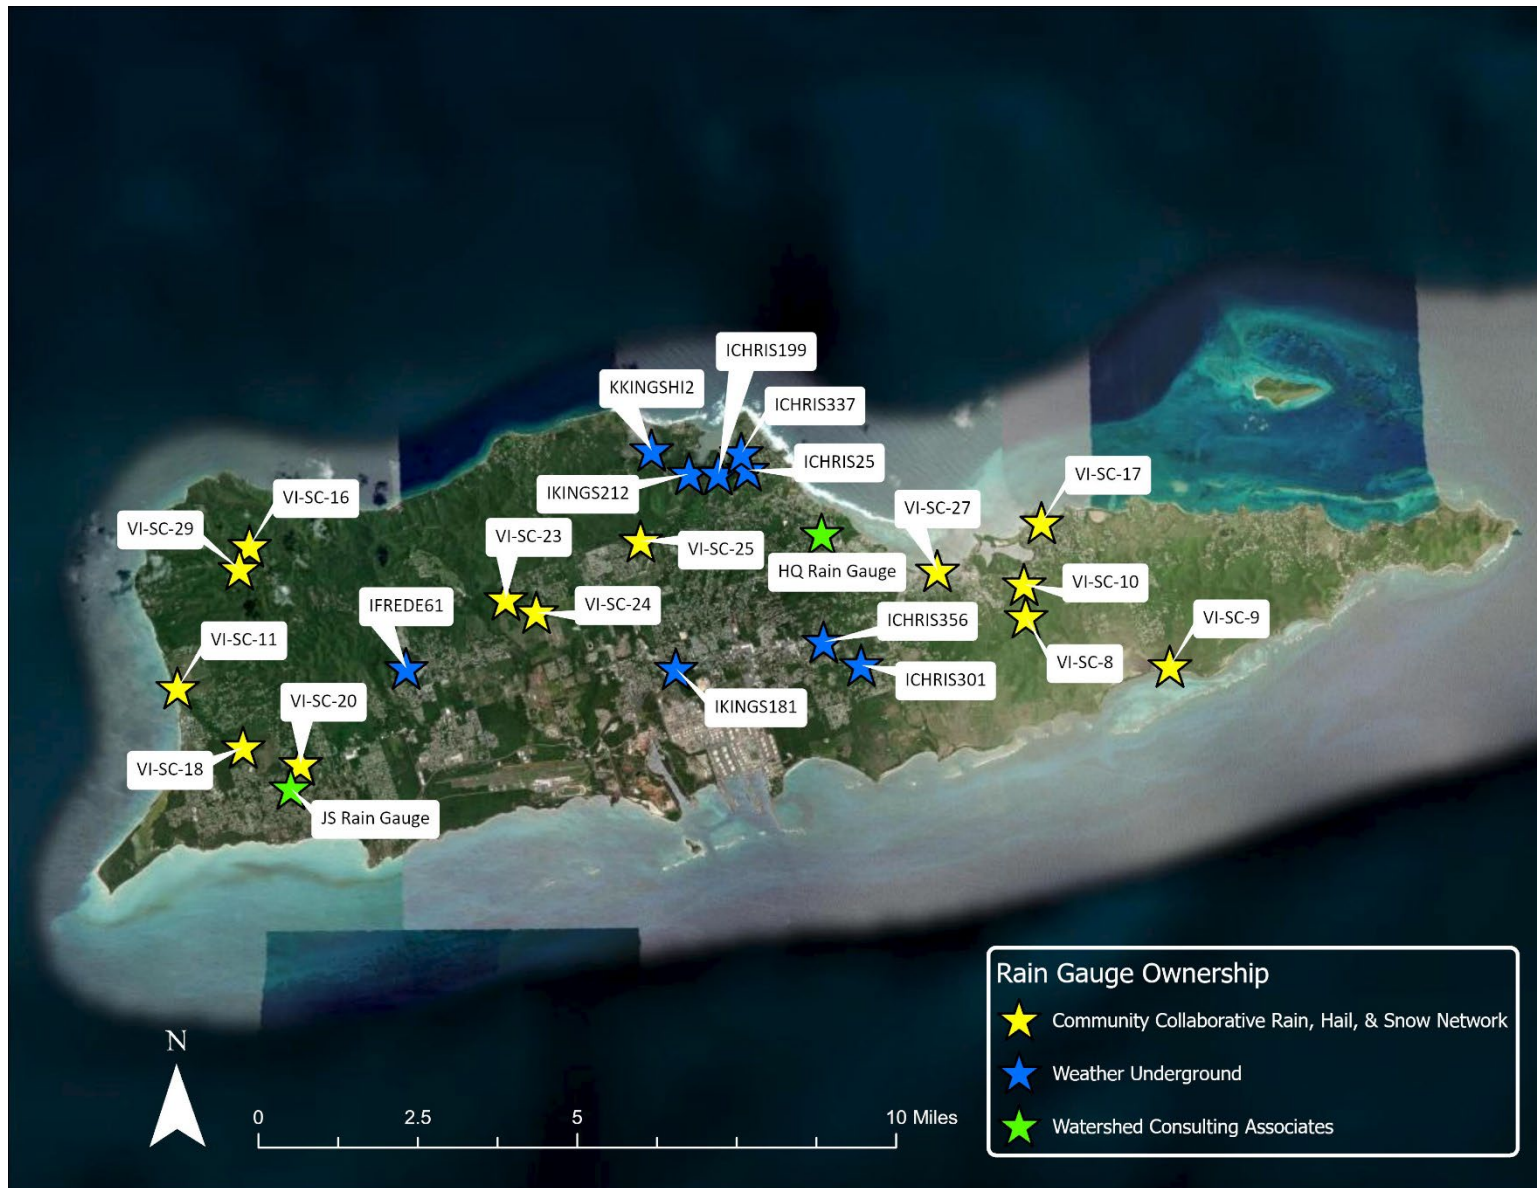
Figure 53. Rain gauge locations on St. Croix.

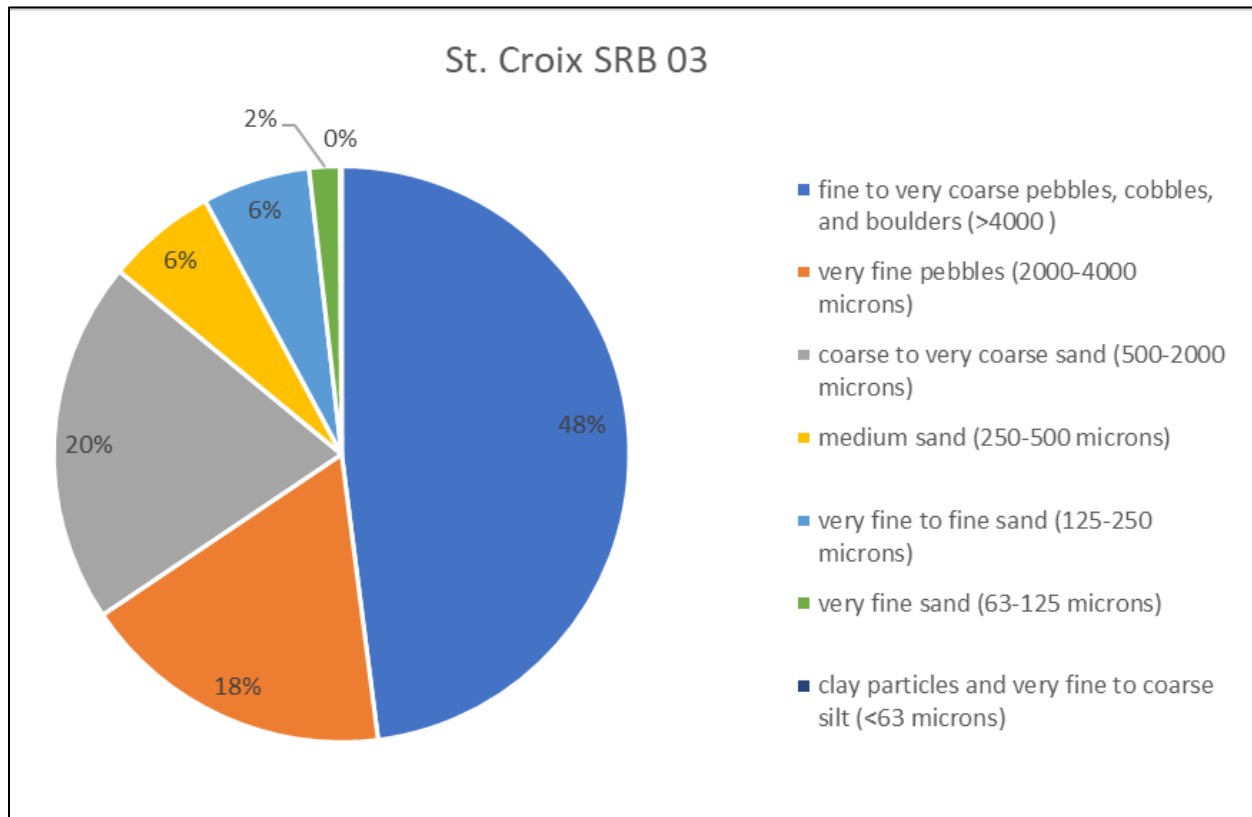
Figure 64. The percent composition of the seven grain size categories within the SRB03 sediment sample.

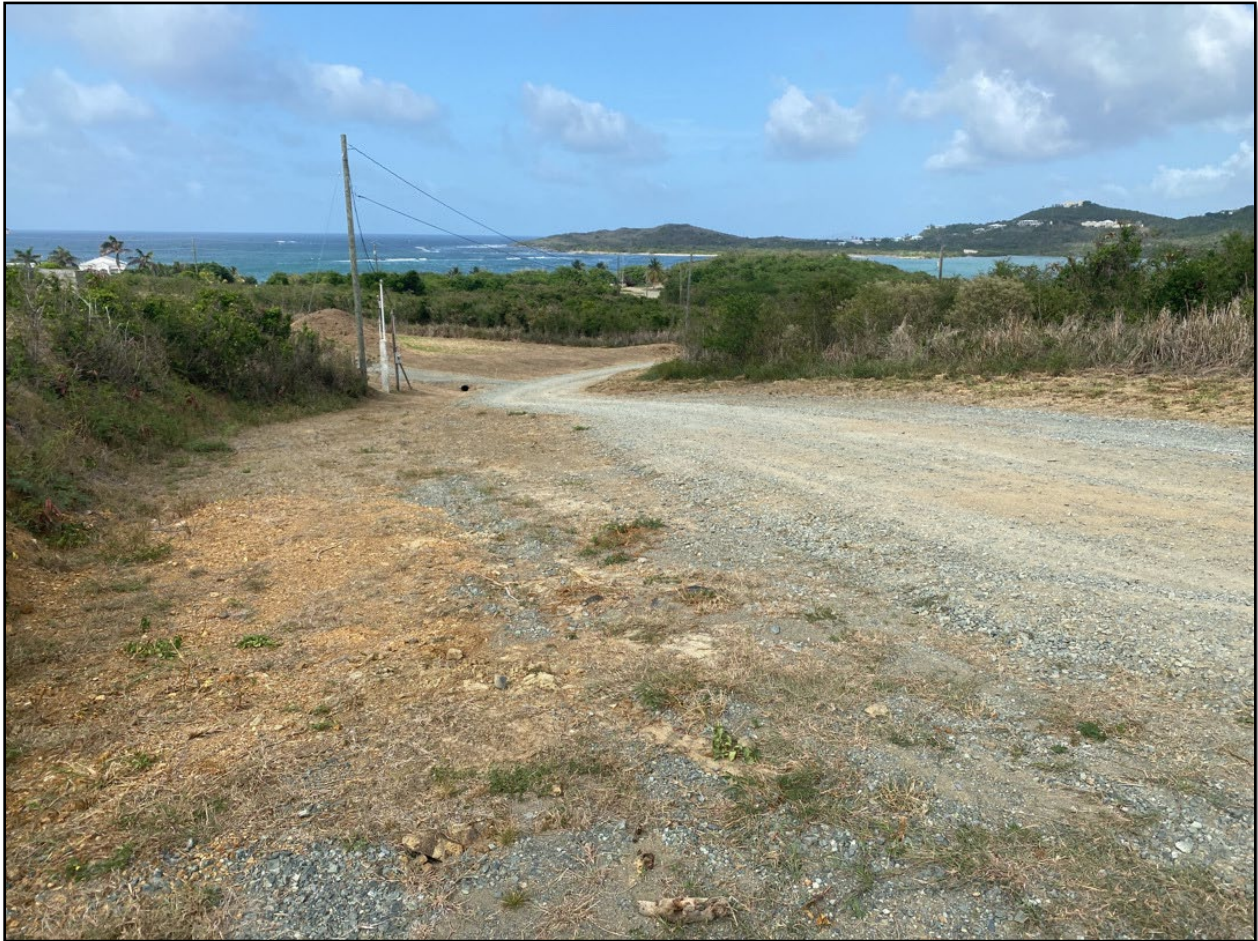
*Figure 70. Existing site conditions of proposed BMP 40.*

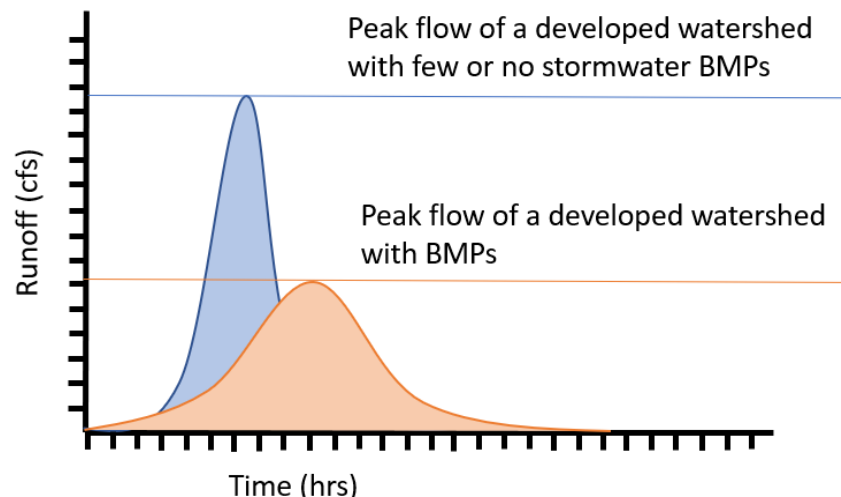
Figure 74. Illustrative hydrographs demonstrating the peak flow reduction value of implementing BMPs.

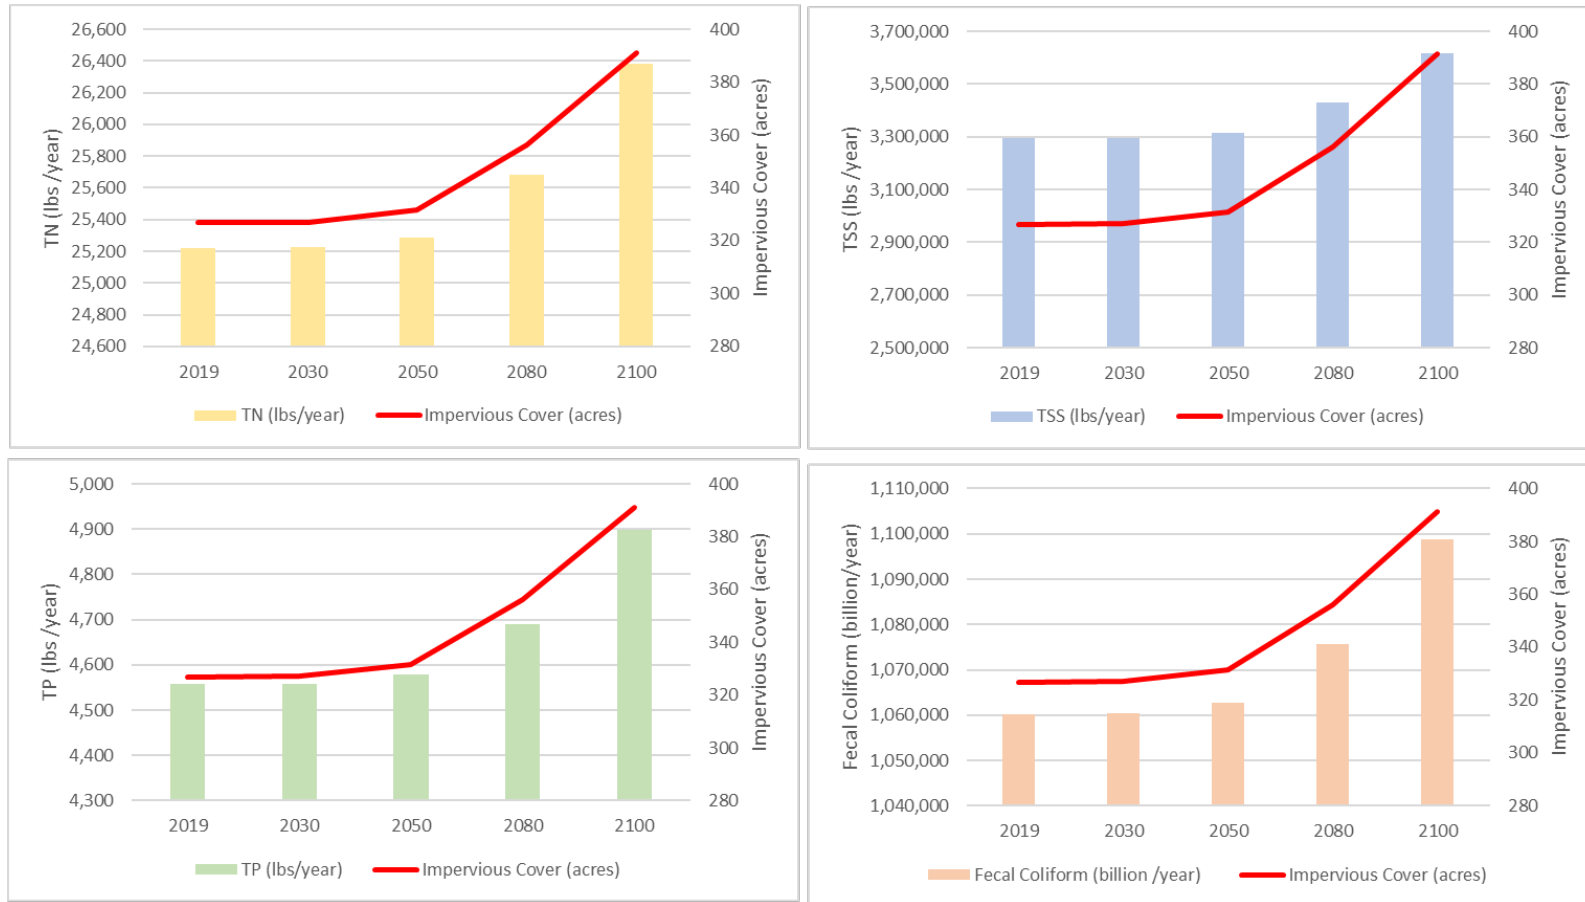
Figure 76. Relationship between watershed-scale pollutant loading for TN (yellow), TSS (blue), TP (green), and Fecal Coliform (orange) and the predicted impervious cover increase (red) over time.

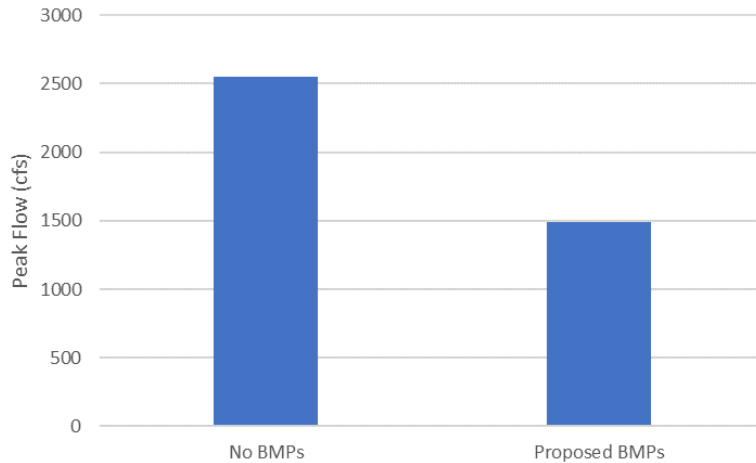
Figure 78. Peak flow reduction associated with the 10 proposed BMPs.

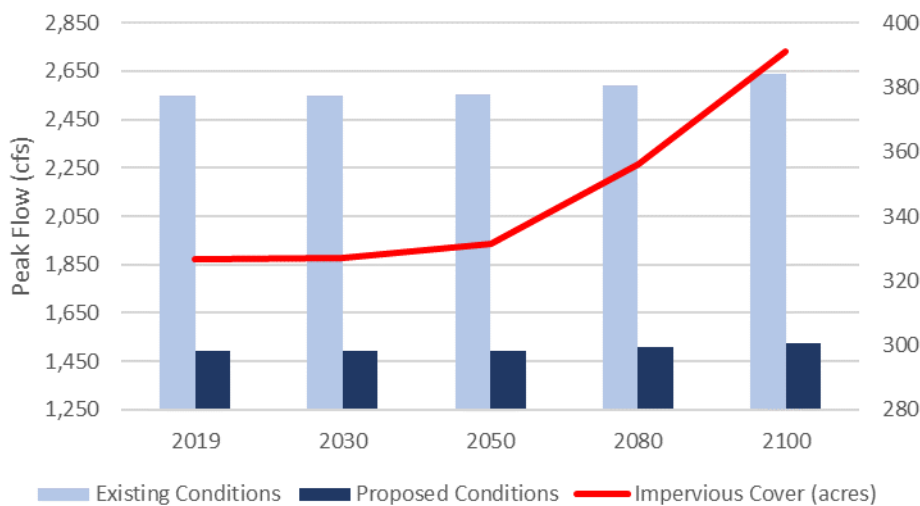
Figure 80. Relationship between watershed peak flow for the existing conditions (light blue) and proposed conditions (dark blue), which includes the implementation of the Top 10 BMPs over time. The predicted impervious cover increase (red) over time is also shown.
