MAJOR CZM LAND ENVIRONMENTAL ASSESSMENT REPORT PLOT 73 ESTATE CLAIRMONT ST. CROIX, U.S. VIRGIN ISLANDS

BIOIMPACT, INC. P.O. BOX 132 KINGSHILL, ST. CROIX, U.S.VIRGIN ISLANDS 00851

SEPTEMBER 2023

PROPOSED 100-FT MONOPALM STEALTH TOWER

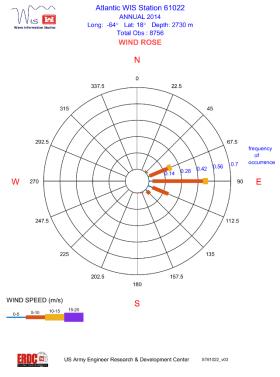
Figure 6.01.1 A wind rose from station ST61022 showing the frequency of occurrence of wind speed and direction in 2014. (ERDC, USACE Research and Development Center wis.usace.army.mil/hindcasts.html?dmn=atlantic)

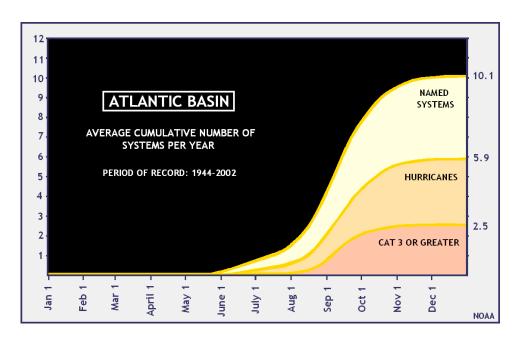
Figure 6.01.2 Tropical Cyclone Frequencies in the Atlantic (National Weather Service).

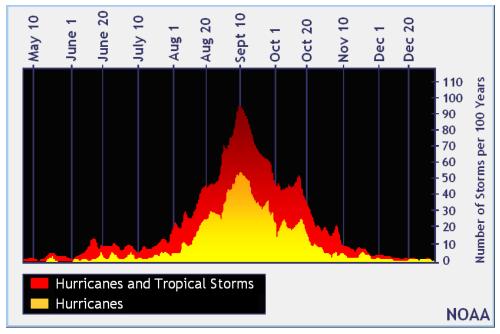
6.01.3 Tropical Storm and Hurricane Occurrences in the Atlantic (National Weather Service).

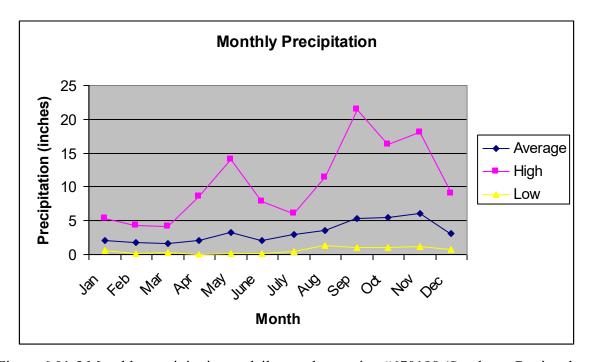
Figure 6.01.5 Monthly precipitation at daily weather station #670198 (Southeast Regional Climate Center, 1971-2000).

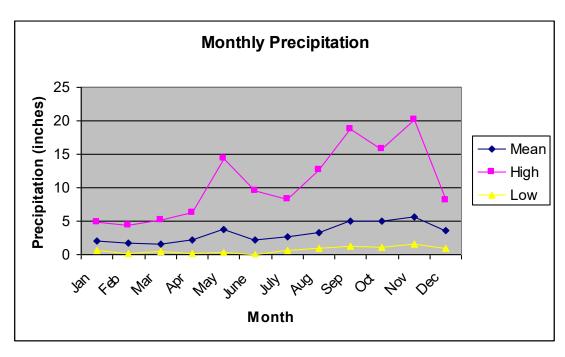
Figure 6.01.6 Monthly precipitation at daily weather station #673677 (Southeast Regional Climate Center, 1971-2000).

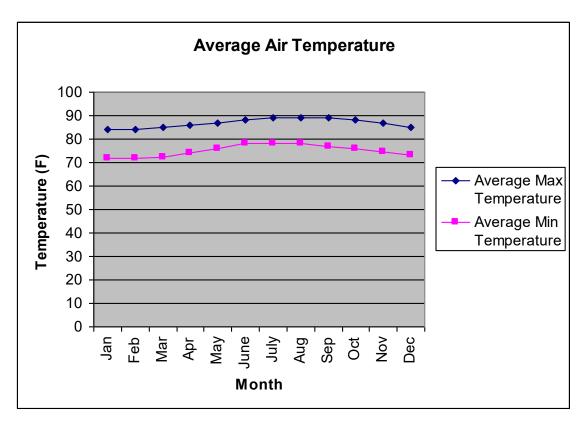
Figure 6.01.7 Average monthly air temperature at daily weather station #670198 (Southeast Regional Climate Center, 1971-2000).

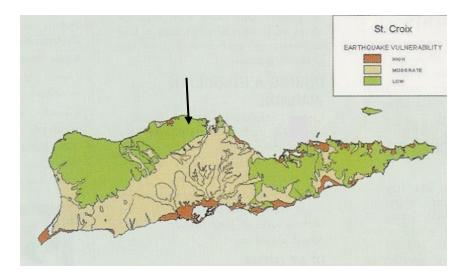
The U.S. Virgin Islands lie in one of the most earthquake prone areas of the world, and are susceptible to ground shaking, earthquake-induced ground failures, surface fault ruptures and tsunamis (tidal waves) (Hays, 1984). The activity is mostly associated with large-scale tectonic activity or faulting, originating in the Anegada Trough to the northeast of the islands. The year 2023 marks the 156th anniversary of the last major earthquake in the islands. This quake, which occurred in 1867, had an identified intensity of VIII on the Modified Mercalli Scale. Earthquakes of this magnitude have generally been associated with epicentral ground accelerations of between 0.05 and 0.35 gravities. Over the last several years numerous minor tremors have been felt on the island. Many feel that this increased activity is associated with the volcanic eruptions that have been occurring to the southeast on the island of Montserrat. Below is the earthquake probability map for St. Croix produced by UVI Conservation Data Center. The tower is located in the lowest probability area for St. Croix.

Figure 6.02.1 Earthquake probability map, UVI Conservation Data Center. SOILS

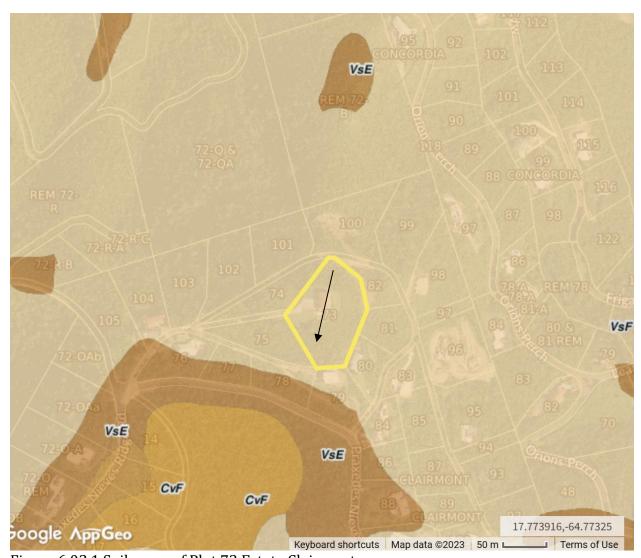
Site is entire Victory-Southgate soils 40-70% slopes as shown in the Soil Resource Report for Virgin Islands of the United States. The soils are found on summits and side slopes of volcanic hills and mountains, the soil is well drained, and bedrock is found in 20 to 40 inches of depth.

Figure 6.02.1 Soils map of Plot 73 Estate Clairmont.

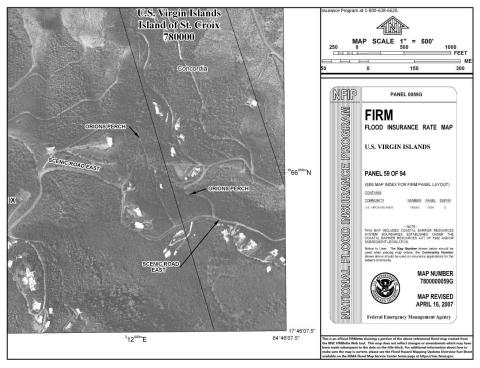
The project site is within Zone X, areas where 100-year coastal flooding is not expected (Flood Insurance Rate Map, Panel 78 of 94, revised April 16, 2007).

Figure 6.03.1 FEMA FIRM MAP

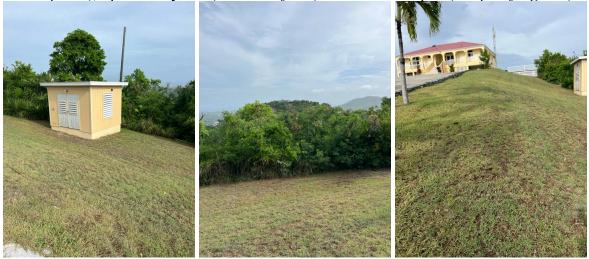
The large black mampoo is seen here to the south of the existing generator building. The area which will be impacted is shown in the center photograph. There is an existing tower (~40ft) to the south of the two-story residential structure.

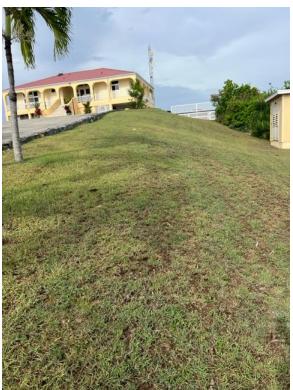
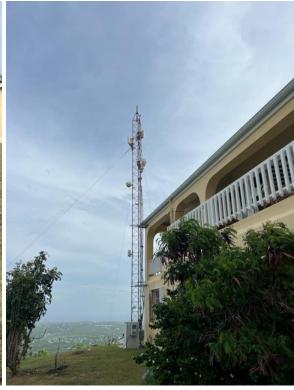
Infra Towers, LLC will be installing a monopalm to minimize the visual impact of the tower. The property already has a tower which is approximately 40ft in height to the south of the residential structure.

Existing tower on the property.
