ENVIRONMENTAL ASSESSMENT REPORT FOR COWPET BAY WEST CONDOMINIUMS

Estate Nazareth, St. Thomas U.S. Virgin Islands

AUGUST 2023

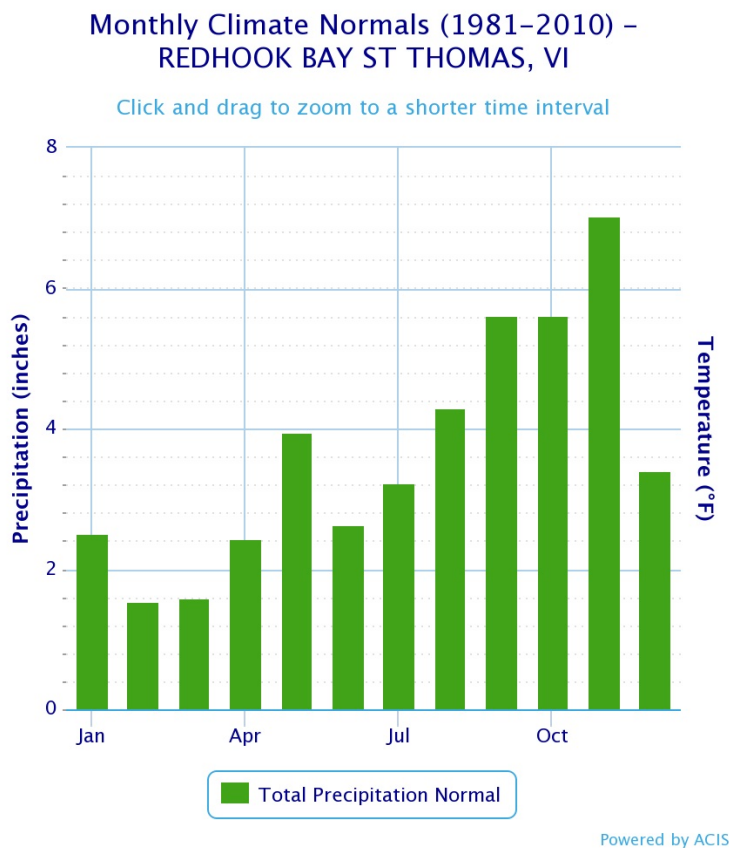
Figure 6.01.7 Rainfall Normals for Red Hook, St. Thomas.

Major rainfall events are associated with weather systems that enhance the uplift of moist air in the region. Orographic lifting of moist air over hilly terrain is the most common cause of rainfall in St. Thomas. The amount of rainfall increases with increasing elevation. The total annual rainfall differs substantially at various locations throughout the island. The average annual rainfall on St. Thomas is approximately 45 inches, ranging from 35 inches toward the eastern end of the island to more than 55 inches at the higher elevation to the west. Leeward aspects receive greater amounts of rain because clouds develop over the slopes on a daily basis. In general, days have a higher incidence of rainfall than nights. St. Thomas's wettest period generally is from September to November, and the driest period is from January to June. Occasionally, intense rainfall occurs during the drier period (USGS 1998). Cowpet Bay West receives around 30 inches of rainfall annually (Jordan 1971). Rainfall data from 1981 to 2010 for the Red Hook (Closest Weather Station) is presented below, in Figure 6.01.7.

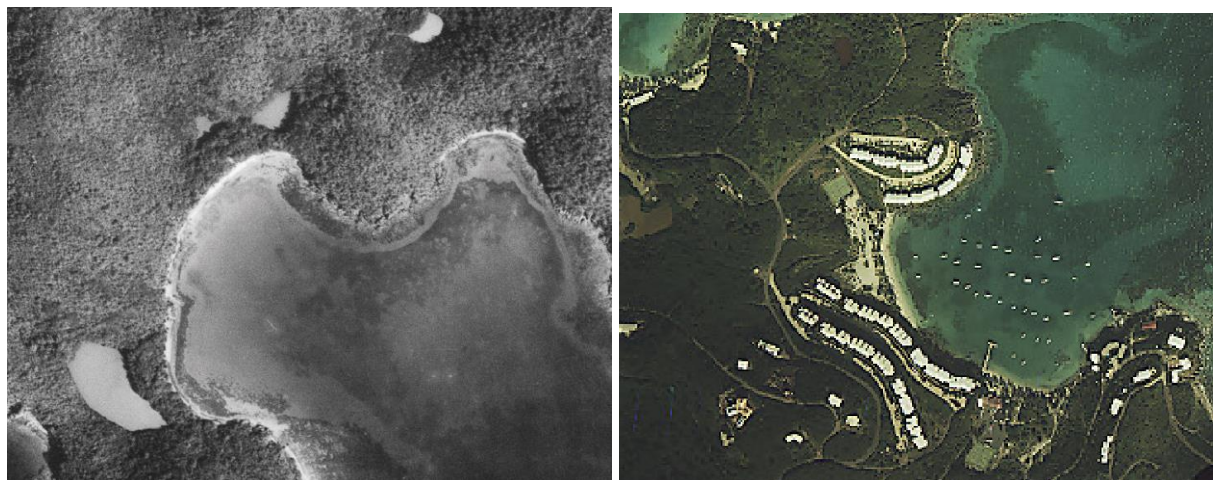
The area was undeveloped in 1954 and construction on the condominiums started in the early 1960s (1972 aerial shown above) before Coast Zone Act was enacted in 1978 in the U.S. Virgin Island.

Figure 6.02 Historical Aerials of the Cowpet Bay West.

The 1954 USGS aerial below show the area was heavily wooded before development and that were scattered ponds in the area, including within the Cowpet Bay West footprint.

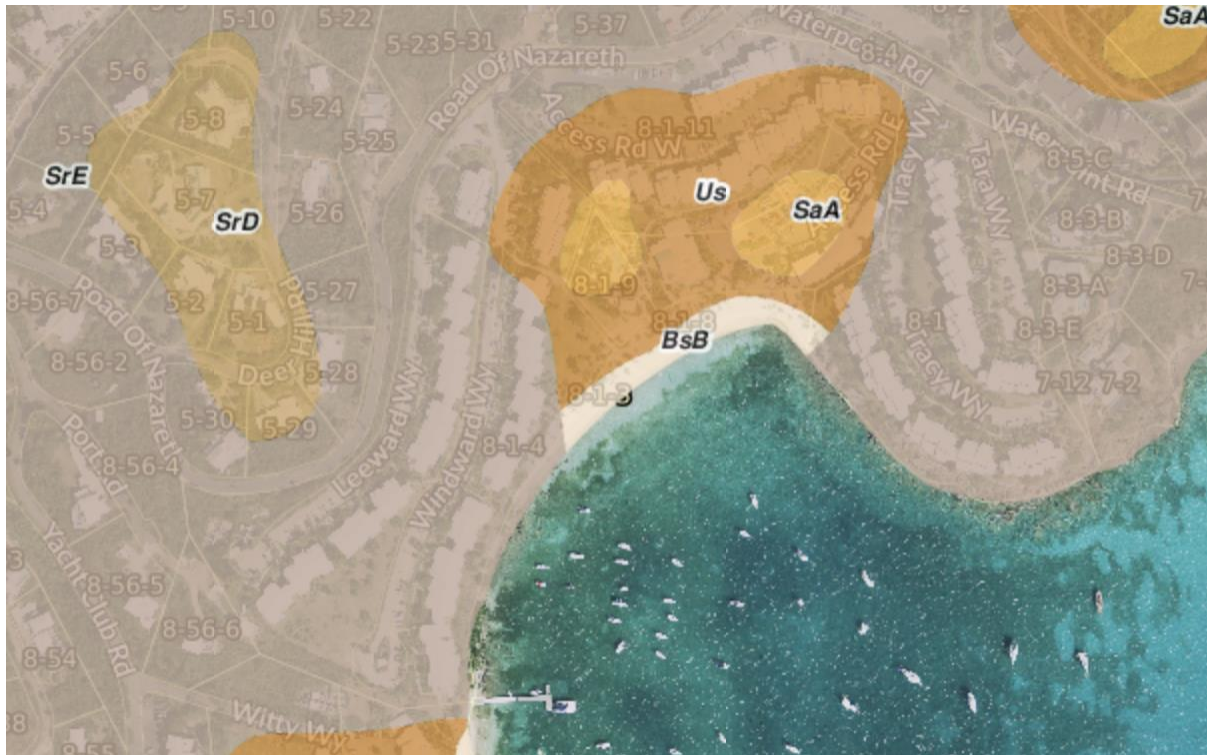
Figure 6.02.3 USDA-NRCS Soils Map

Two soil types are associated with Cowpet Bay West according to the Custom Soil Survey of the United States Virgin Islands. Southgate-Rock outcrop complex (SrE), 20 to 40 percent slope, these soils are found on hillslopes, mountain slopes, and ridges and often have as much as 40% exposed rock outcroppings. This is the soil found throughout most of the property. Only a very small portion at the northern corner is Ustrothends (Us), soils that have been highly reworked. In this case the filling of a pond.

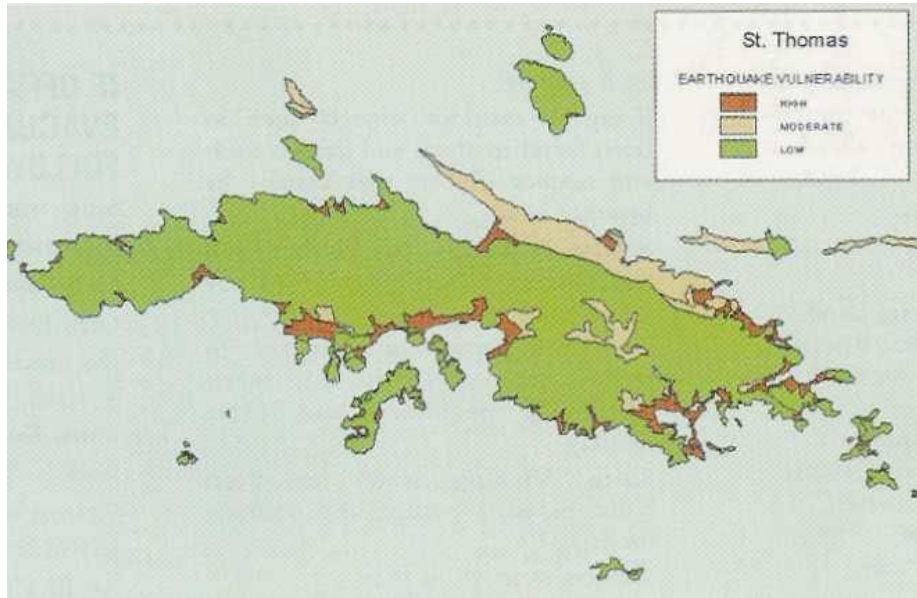
Figure 6.02.5 Earthquake Probability Map

The U.S. Virgin Islands lie in one of the most earthquake prone areas of the world, and are susceptible to ground shaking, earthquake-induced ground failures, surface fault ruptures and tsunamis (tidal waves) (Hays, 1984). The activity is mostly associated with large-scale tectonic activity or faulting, originating in the Anegada Trough to the northeast of the islands. The trough and its related scarp apparently were thrown up by block faulting during the late Pliocene or early Pleistocene. It is oriented generally northeast to southwest, separating St. Croix from Puerto Rico and the other Virgin Islands. Based on willow focus earthquakes, the Anegada Fault Trough is estimated to be more than 400 miles in length. There are indications that strike slip movement is occurring, with St. Croix shifting northeast relative to Puerto Rico (Puerto Rico Water Authority 1970). Since the 1867 quake, there has been continuous low intensity activity all below 6.0 Richter. Over the last several years, numerous minor

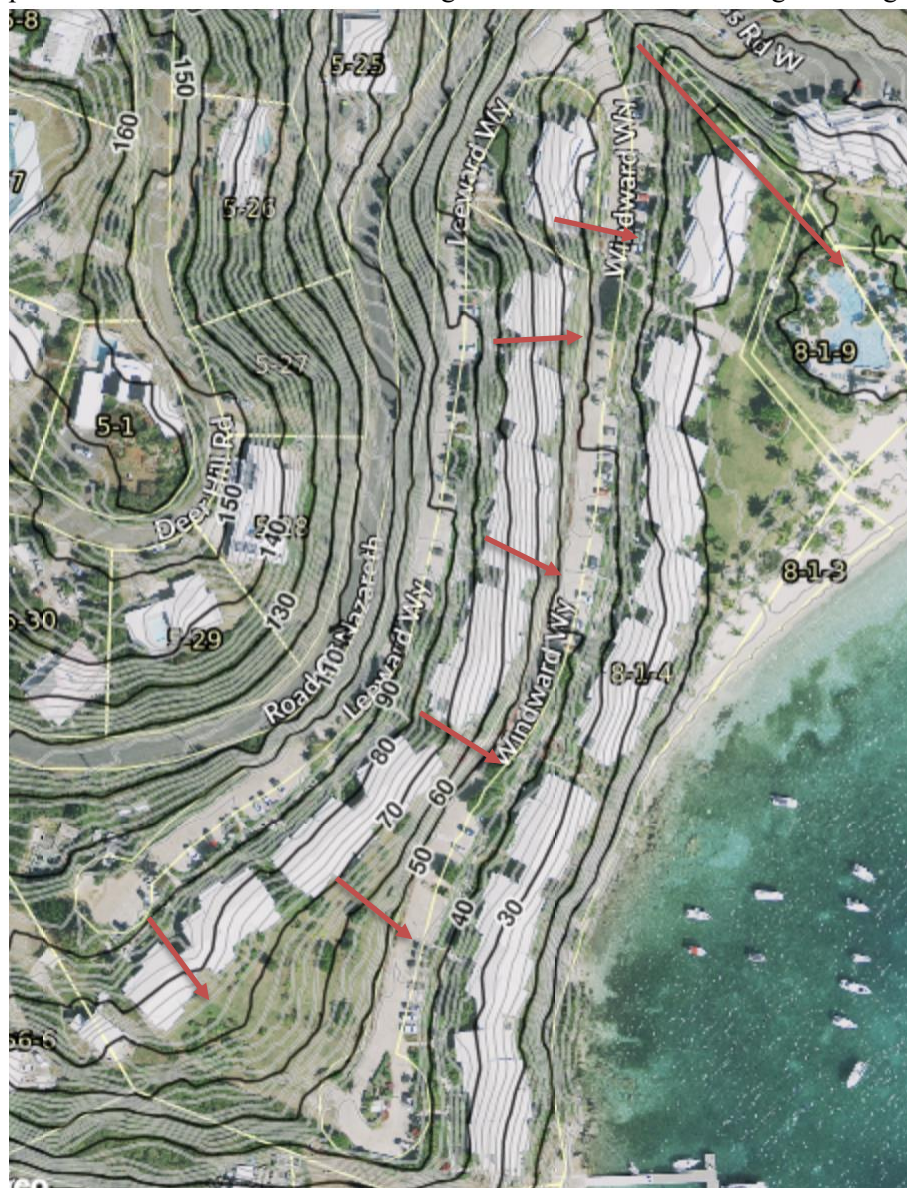
Figure 6.02.1

The site is relatively steep and water would sheet flow to the sea but is intercepted by the driveways and park and is directed into small drainages. The most define drainage is along the northeastern property line.

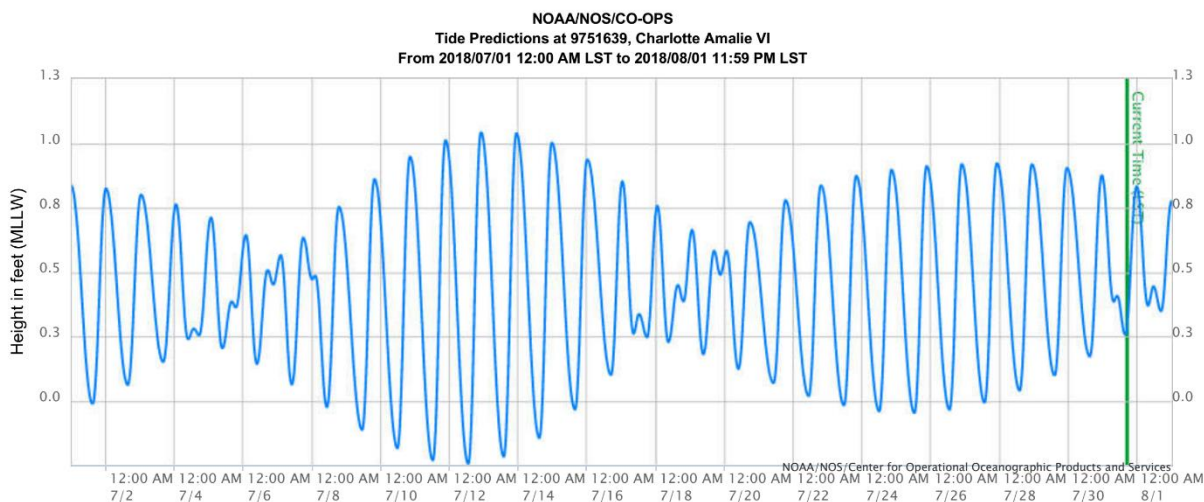
Figure 6.05.1 Tides in Charlotte Amalie, St. Thomas

The Virgin Islands coastal areas are not subject to significant tidal ranges or tidal currents. Due to the small size of the islands, the sea flows around the island causing an average tidal height of only a few inches and maximum change of only a little over a foot. Only very narrow intertidal zones are found because of this lack of tidal amplitude and the steepness of the island rising out of the sea. The tides offshore are primarily semi-diurnal in nature, with two cycles of high and two of low water every 24 hours. The mean tides range from 0.8 feet to 1.0 feet and the spring tidal ranges reach up to 1.3 feet (IRF 1977). There are not locally driven tidal currents off the resort property due to the openness of the embayment.

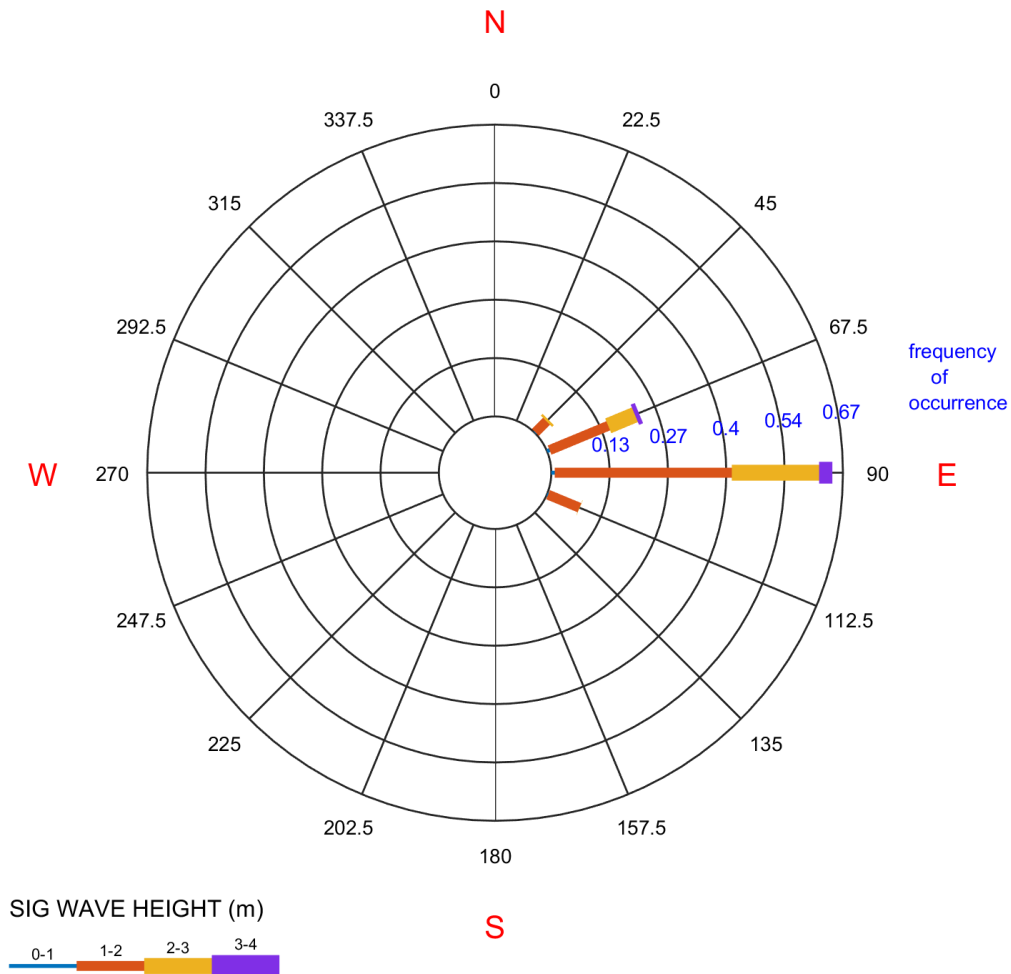
Atlantic WIS Station 61025
ANNUAL 2014
Long: -66° Lat: 17° Depth: 4687 m
Total Obs : 8756
WAVE ROSE
