**MAJOR WATER  
ENVIRONMENTAL ASSESSMENT REPORT  
FOR  
THE MOORING AND OPERATION OF  
A FLOATING RESTAURANT AND  
ASSOCIATED MOORINGS  
LINDBERGH BAY, U. S. VIRGIN ISLANDS**

**SUBMITTED TO  
THE OFFICE OF COASTAL ZONE MANAGEMENT  
DEPARTMENT OF PLANNING AND NATURAL RESOURCES  
GOVERNMENT OF THE VIRGIN ISLANDS**

**BIOIMPACT, INC.  
P.O. BOX 132 KINGSHILL  
ST. CROIX, U.S. VIRGIN ISLANDS 00851**

**APRIL 2021**

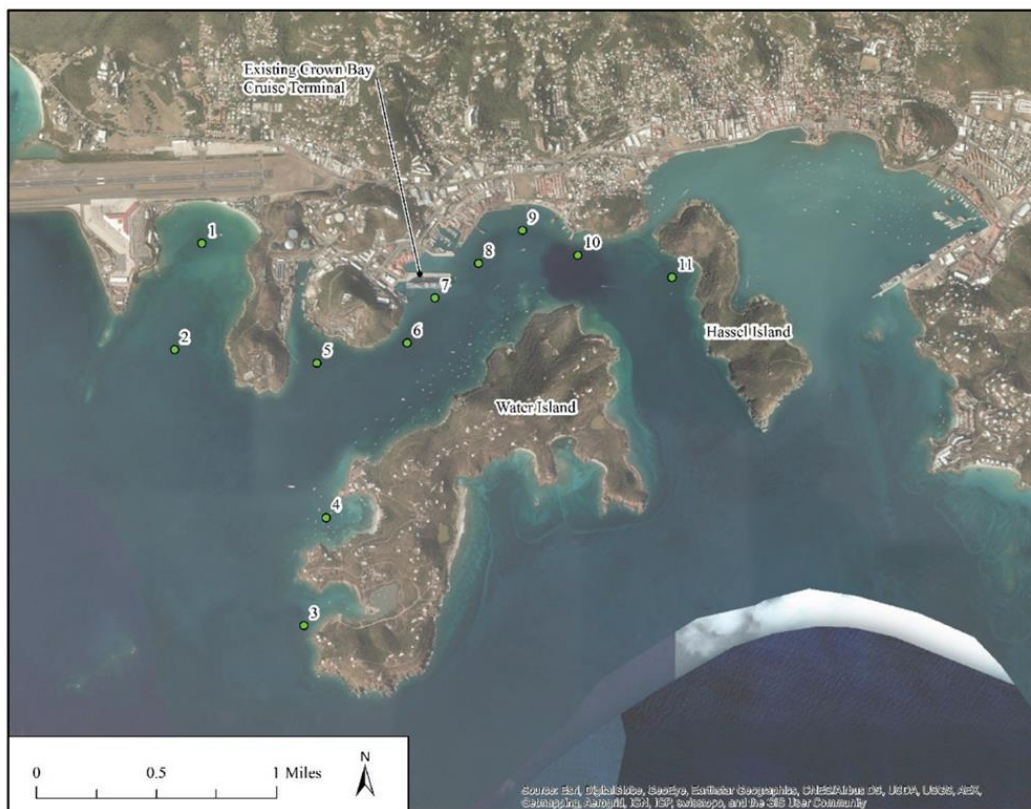
Figure 2-2: Observation Point Locations for Wave Conditions

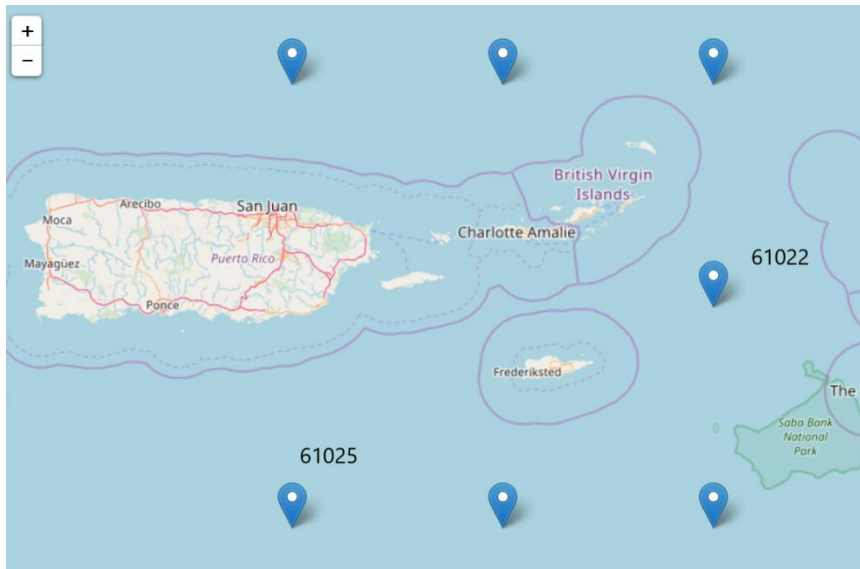
Figure 6.05.2 Wave Hindcast Stations USACE Wave Hindcast site, locations of 61022 and 61025 (<http://wis.usace.army.mil/hindcasts.html?dmn=atlantic>).

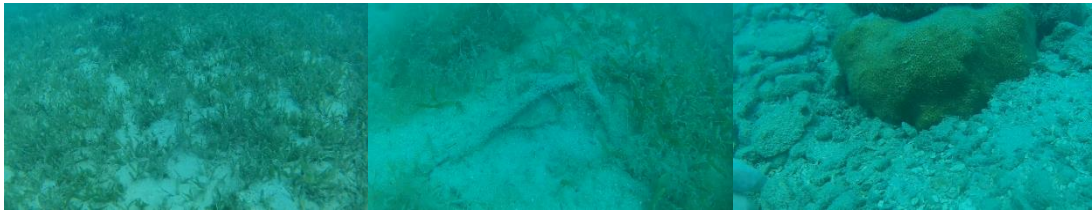
*Halophila stipulacea* has become the most abundant colonizer in the hole, and the bay. It is found in the hole down to 36ft. and even a few runners were found at 38ft. The algae is serving to improve water quality by stabilizing sediments.

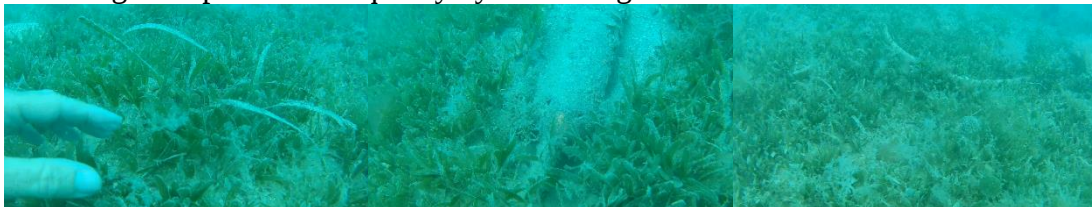
*Thalassia* is now found in very low abundances down to 26ft amid the *H. stipulacea*. An old cable with a repeater was found in the hole.

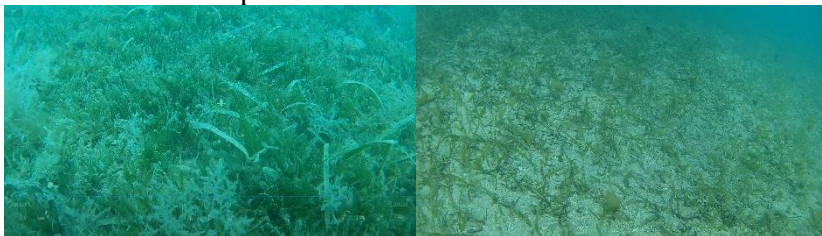
Seagrass represents approximately 5% of the total bottom coverage and as you reach the top of the hole there are small areas that are completely colonized by sparse *Thalassia* these have been avoided by the moorings and anchors.

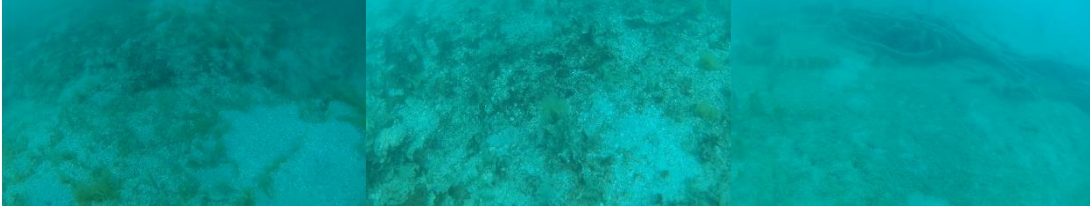
Between 36-38ft there is primarily algae colonization. There were a number of tree limbs and ropes.

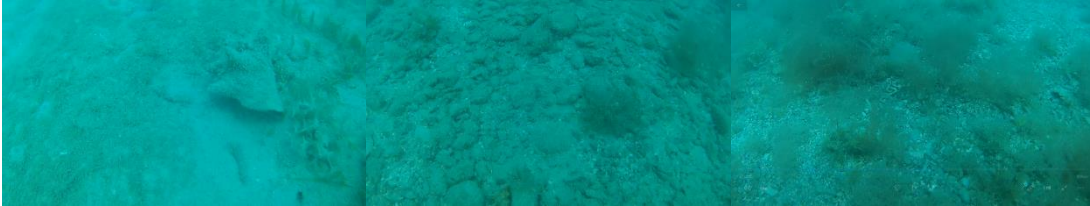
The deepest areas have some scattered cobbles and have drift algae, and very limited *Halimeda* colonization.

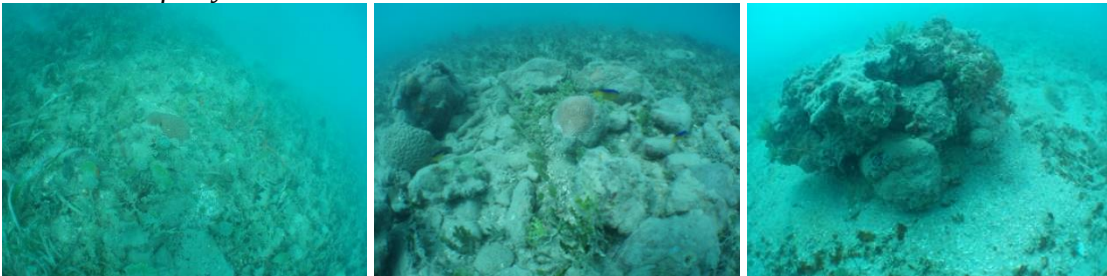
And at 23ft. a *Siderastrea siderea* appears amid the algae at the upper edge of the eastern side of the hole and a large boulder on the upper slope.

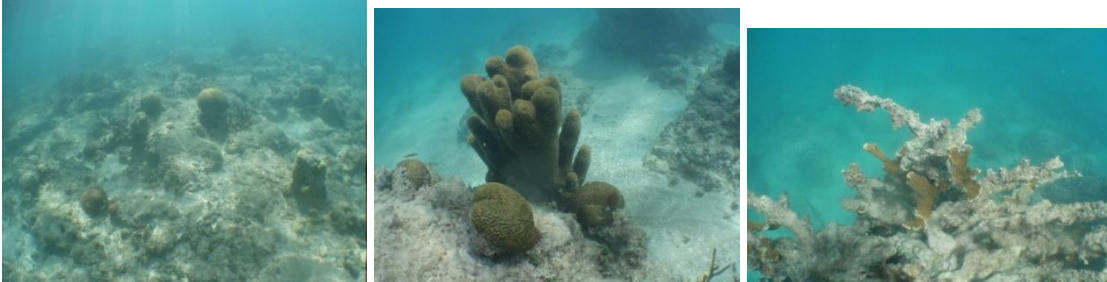
West of the hole below the Carib Beach Hotel there is a rock pavement which is colonized by corals including ESA listed *Orbicella*. On the rock point to the southwest there are *Orbicella*, *Dendrogya* and *Acropora palmata*.

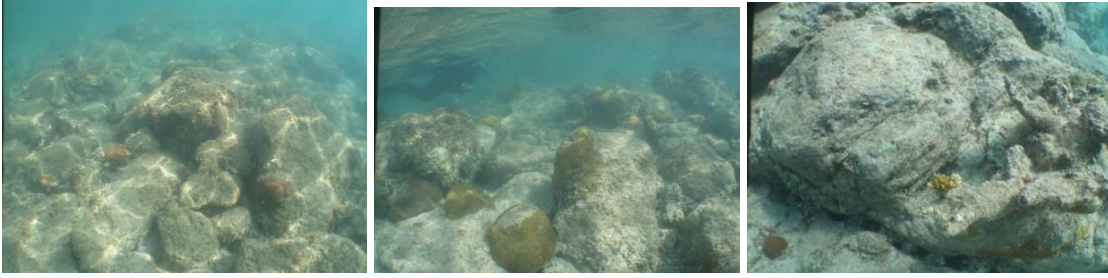
To the east there is a hard bottom along the shoreline that is coral colonized and *Orbicella* and *Dendrogyra* are present. A single *Acropora* recruit was found along the eastern hardbottom in 2009 but none were noted in 2018. As part of the monitoring for the construction of the LPG plant for WAPA quadrats were monitored in this area for more than a year. Corals showed no degradation during that time. Numerous *Nassua* groupers were noted in this area. No *Acropora palmata* were noted along the eastern shore in 2020 or 2021.

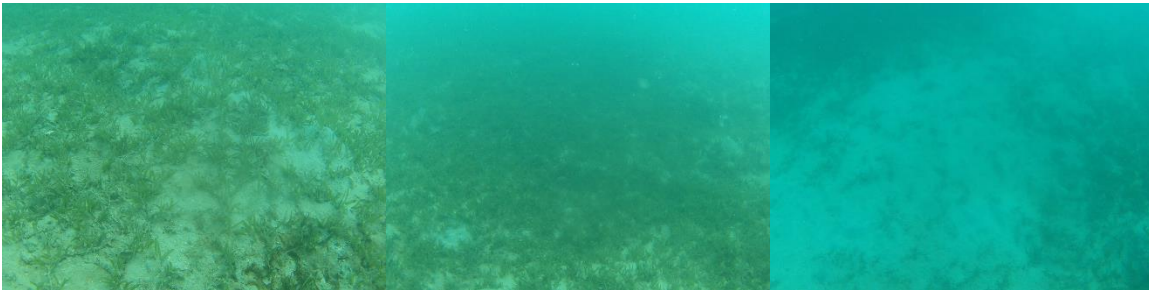
The project area is primarily colonized by *Halophila stipulacea* the invasive seagrass. Amid the *H. stipulacea* there are scattered areas of uncolonized sand.

Within the sand patches there are *Udotea flabellum*, *Penicillus capitatus*, *Halimeda opuntia* and *H. monile*. There are small widely scattered small patches of sparse *Thalassia testudinum* and *Syringodium filiforme* that are intermixed with *Penicillus capitatus*, *Udotea flabellum*, and *Halimeda* spp.

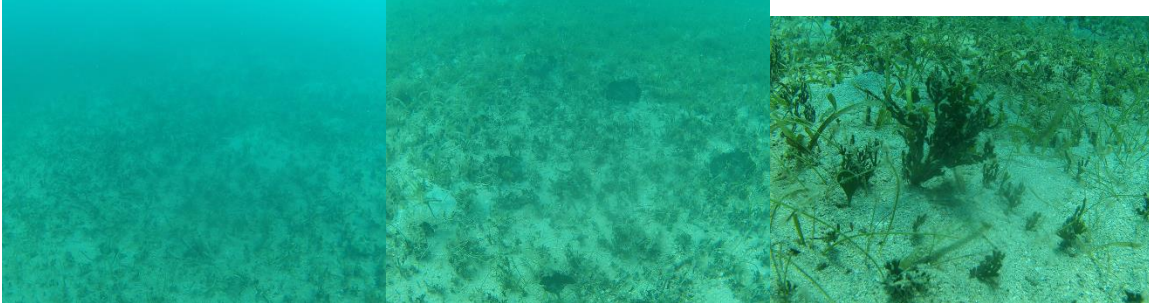
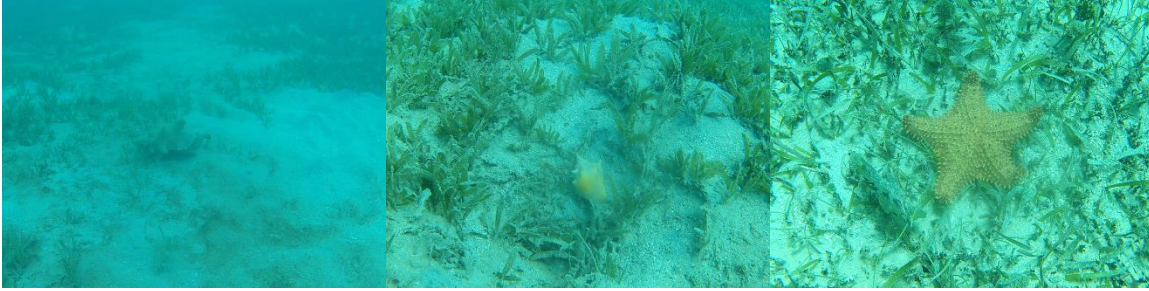
Queen conch (*Strombus gigas*), West Indian Fighting Conch (*Strombus pugilis*) and West Indian Sea Star (*Oreaster reticulatus*) were noted within the proposed mooring area.
