CZM PERMIT APPLICATION **MAJOR LAND & WATER**

MAGEN'S BAY, ST. THOMAS USVI TRANS-CARIBBEAN FIBER SYSTEM CABLE LANDING PROJECT

Submitted by:
TRANS AMERICAS FIBER US, LLC
175 Distant Island Dr.
Beaufort, South Carolina 29907

1. INTRODUCTION
2. APPLICATION FORMS
3. SUPPORTING DOCUMENTS
4. ENVIRONMENTAL ASSESSMENT REPORT
5. EGS & BENTHIC SURVEY REPORTS
6. ROUTE AND APPROACH MAPS
7. REQUIRED MAPS (ZONING, PARCEL, FIRM, ETC.)
8. QUALIFICATIONS & BACKGROUND

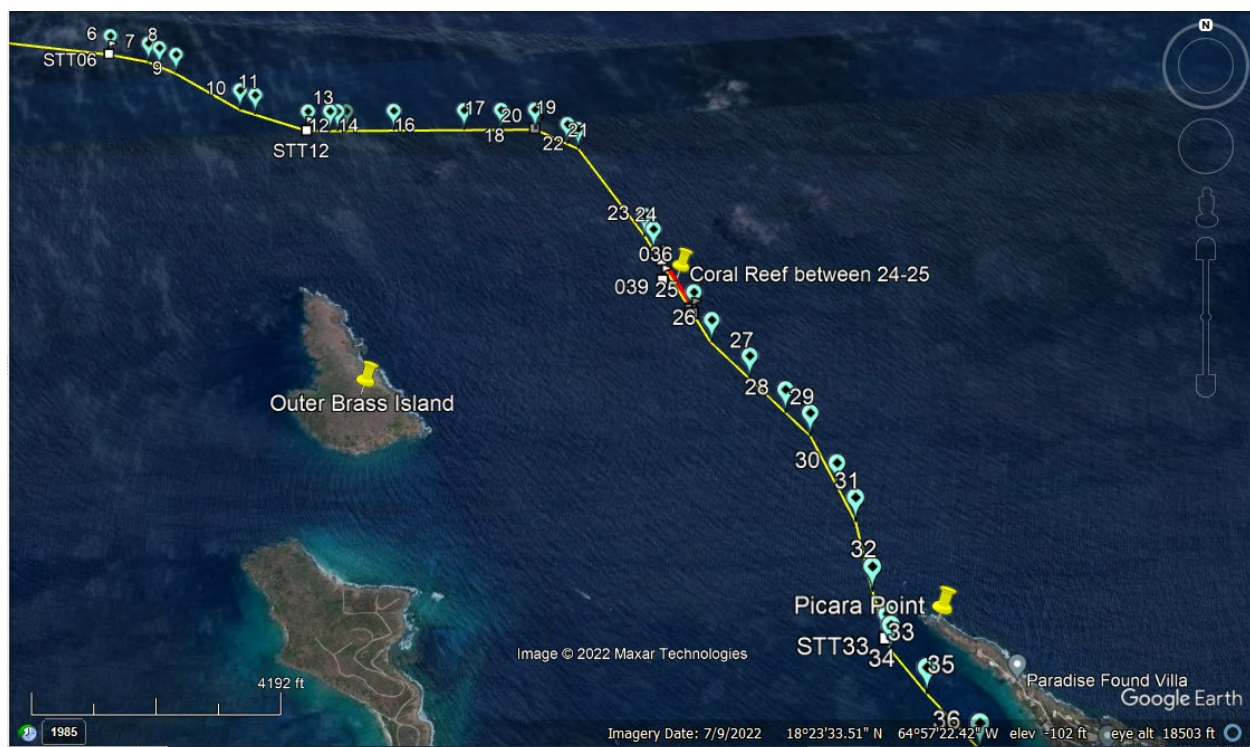
Figure 2: Location of reef between GPS Points 24 and 25 that is east of Outer Brass Island

Video and still photos were collected from a mid-point on the 70 foot deep reef discovered between GPS 24 and GPS 25 (Figure 2). Two 25 meter long transects, one running north and the other south, were laid from this center point via SCUBA with Nikon W300 and GoPro Hero 4 cameras. In the ROV video footage from the same area an existing cable is plainly visible with no observed disturbance of benthic habitats.

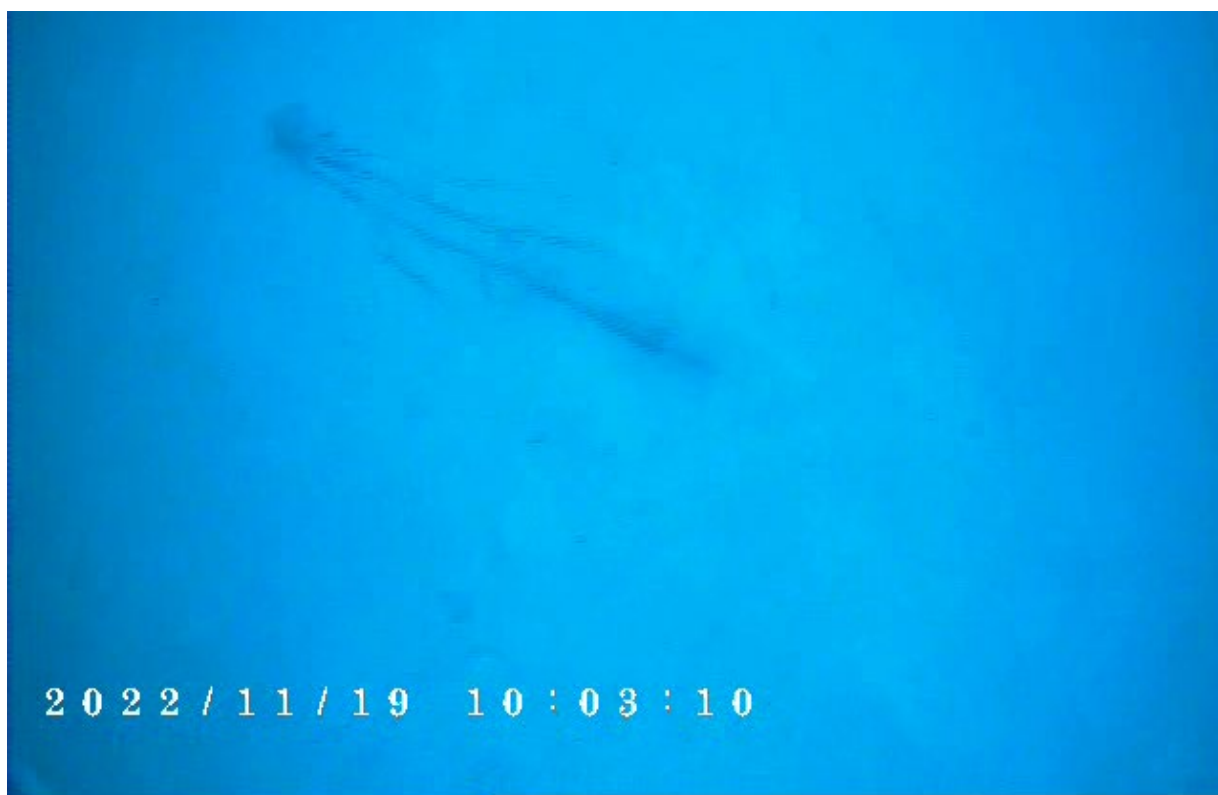
The most common benthic feature other than sand were a few gorgonian skeletons and approximately 20 were observed. Typical gorgonian skeleton in 170' deep water (frame grab from video camera).
