WATERSHED MANAGEMENT PLAN FOR THE DOROTHEA WATERSHED ST. THOMAS, USVI MARCH 2024

This watershed management plan (WMP) summarizes watershed-specific assessments and provides recommendations and design details to reduce flooding and improve water quality and resiliency for the Dorothea watershed. The three watersheds previously initially assessed on St. Thomas include Bolongo Bay, Cyril E. King Airport, and St. Thomas Harbor (Figure 1). The concurrent study on St. Croix includes the watersheds of Bethlehem, Diamond, Hovensa, Long Point Bay, and Salt River Bay. These plans are available through DPNR.

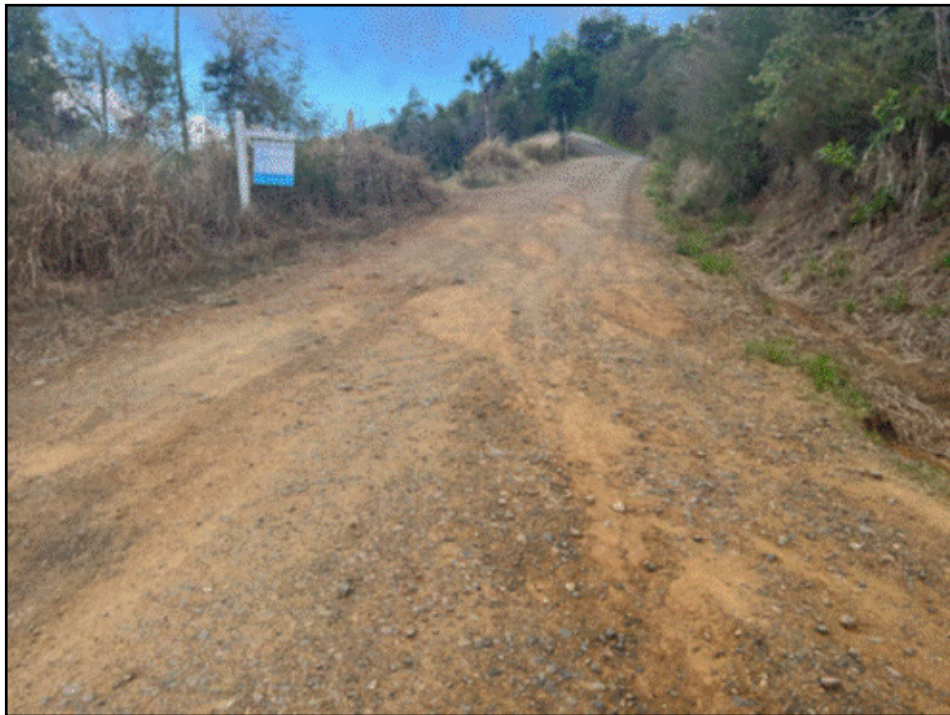
Figure 5. Runoff from impervious surfaces such as roads contributes to flooding and water quality problems.

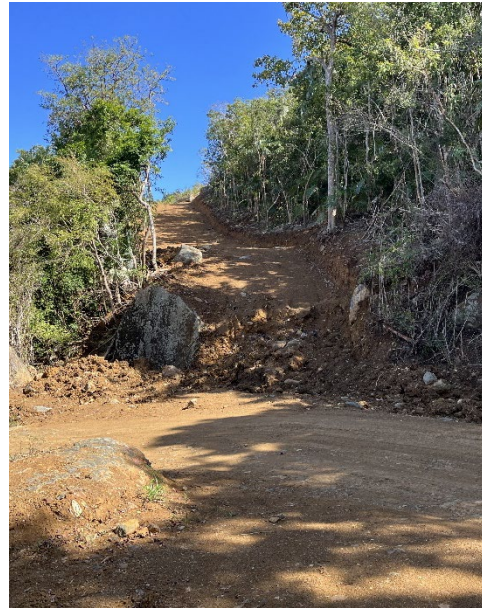
Figure 10. Photo of road erosion related to new development in the Dorothea watershed.

Often a relatively recent infrastructure development was cited as the source of erosion and sediment transport (Figure 10). This highlights the need for careful planning that considers stormwater management in any type of development.

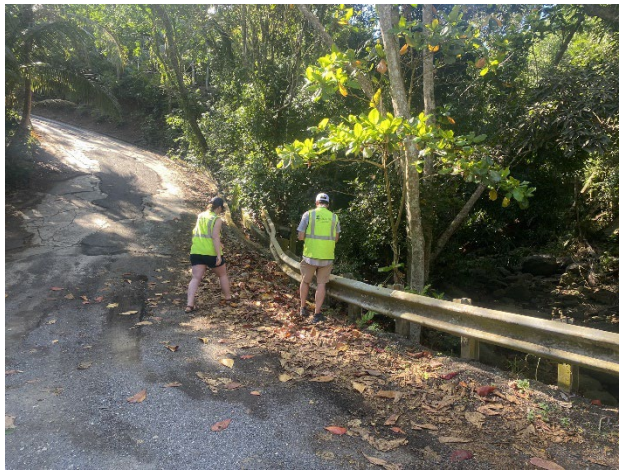
Figure 11. Field staff investigated potential water quality issues in the watershed.

Field staff assessed potential sources of water quality degradation, opportunities for management, and other issues such as contamination due to wastewater leaks (Figure 11) or solid waste management. These observations were documented for further assessment.

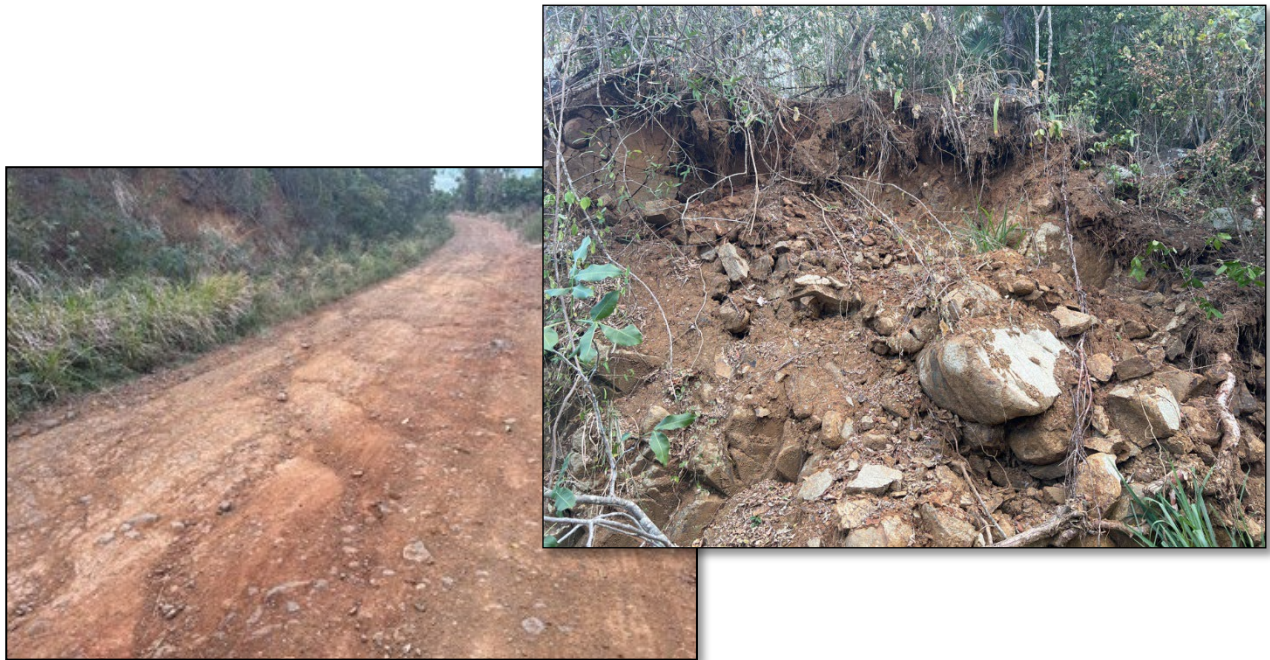
Figure 37. Road erosion (left) and undermined slope due to unmanaged stormwater (right).

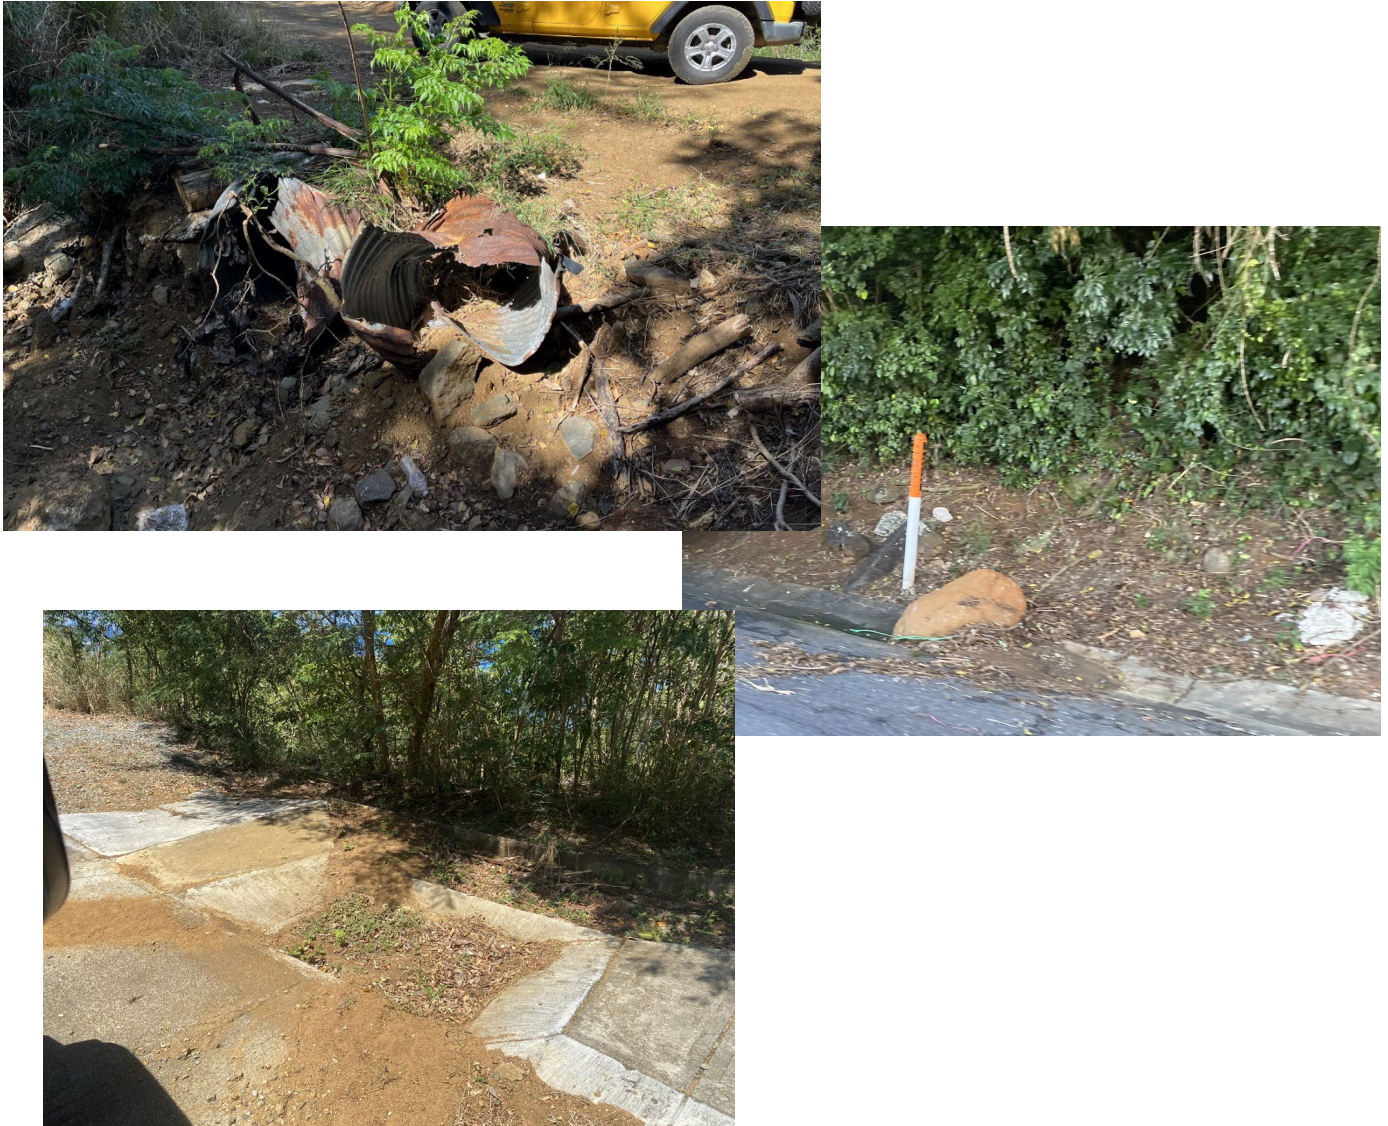
Figure 38. Roadway and drainage structures in need of maintenance were observed within the watershed.

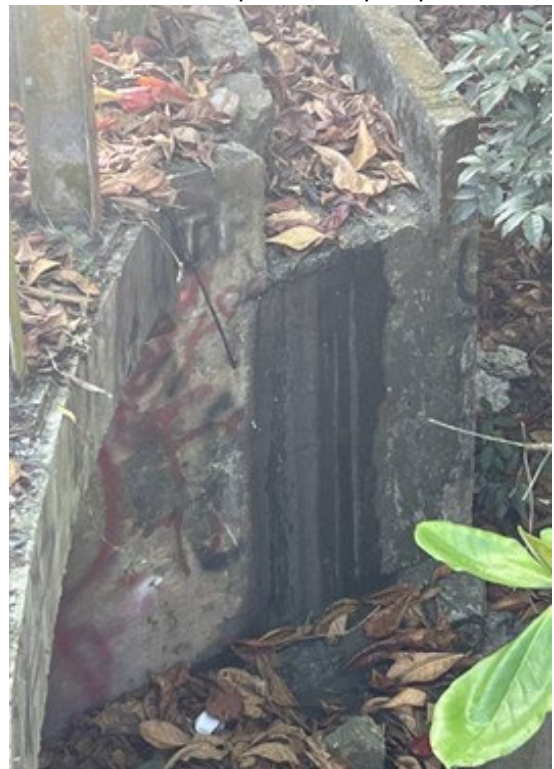
Figure 40. Suspected illicit discharge in gut.

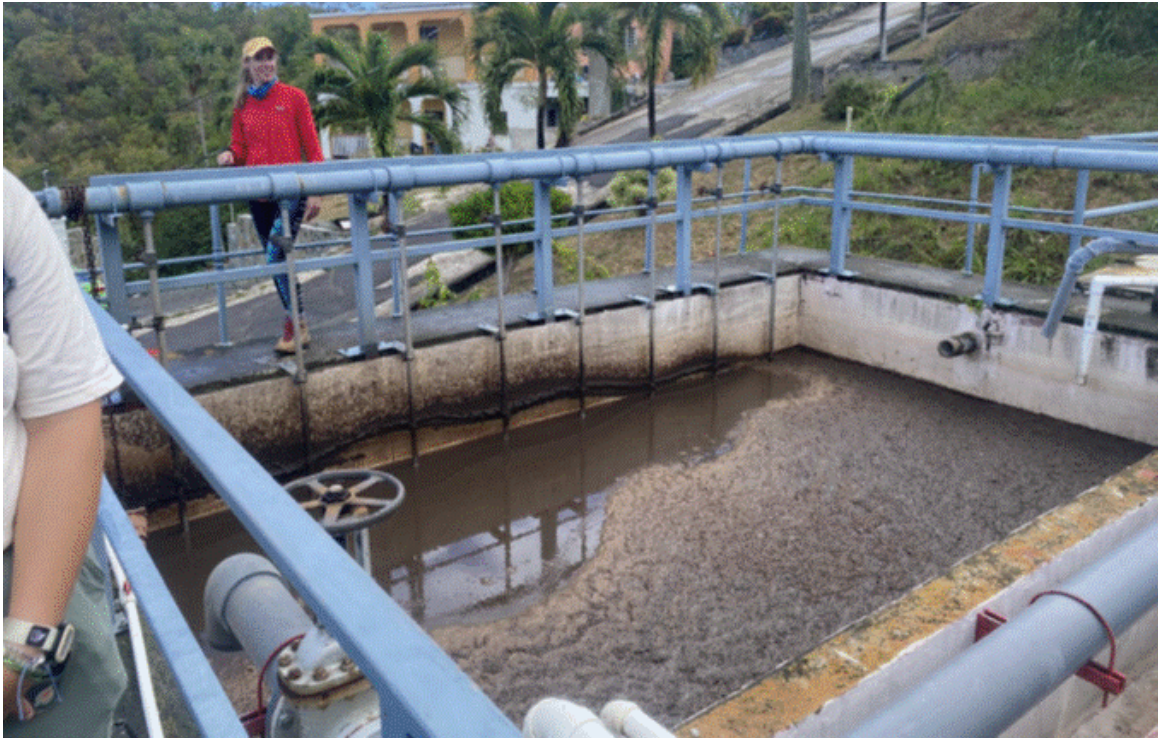
Figure 41. Brassview neighborhood wastewater treatment system within the Dorothea watershed.

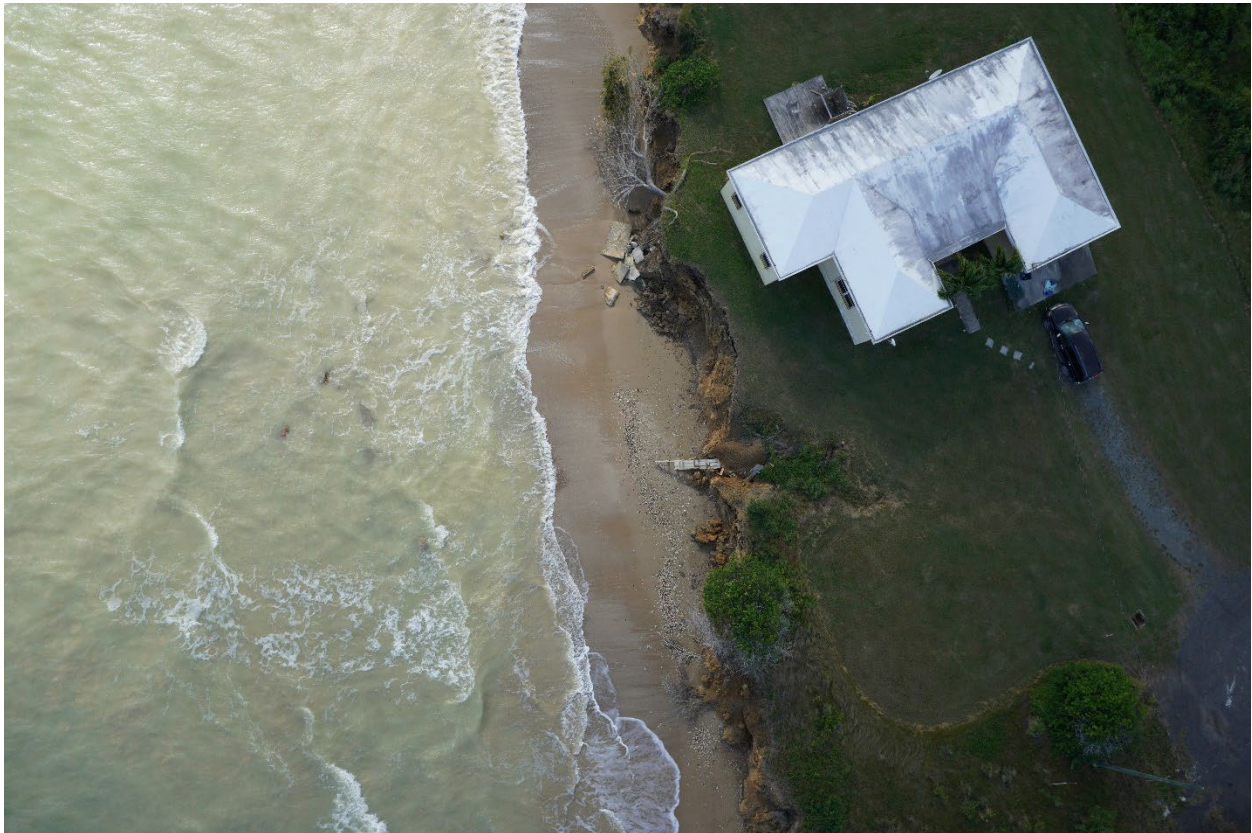
Figure 44. Coastal erosion due to sea level rise threatens stability of homes near the coast (note photo is from another area on St. Thomas and not within the Dorothea watershed).

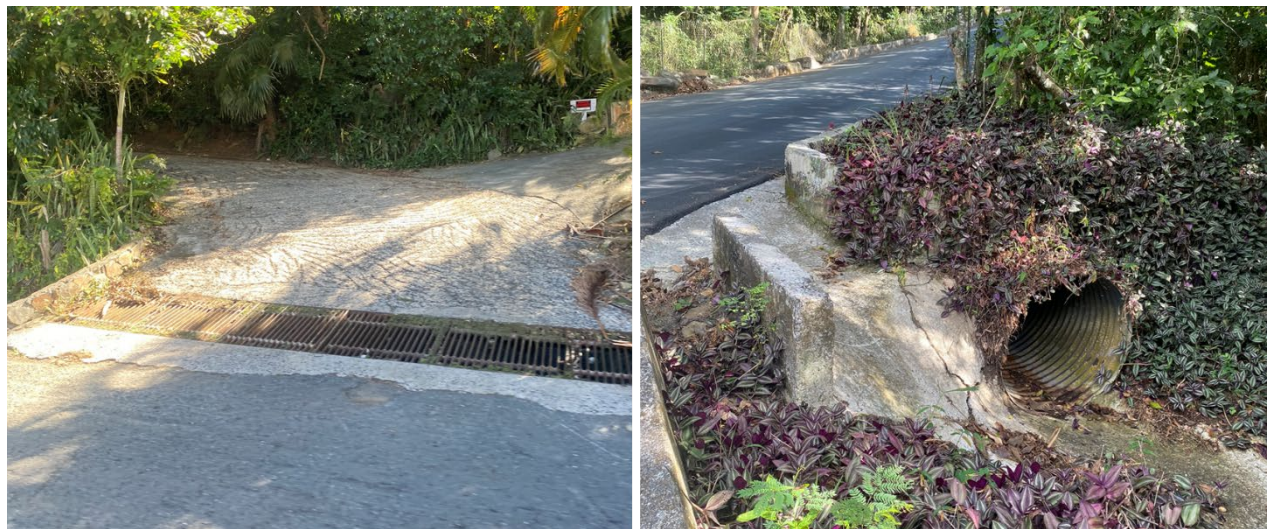
Figure 46. Examples of stormwater infrastructure. A trench drain (left) and a culvert (right).

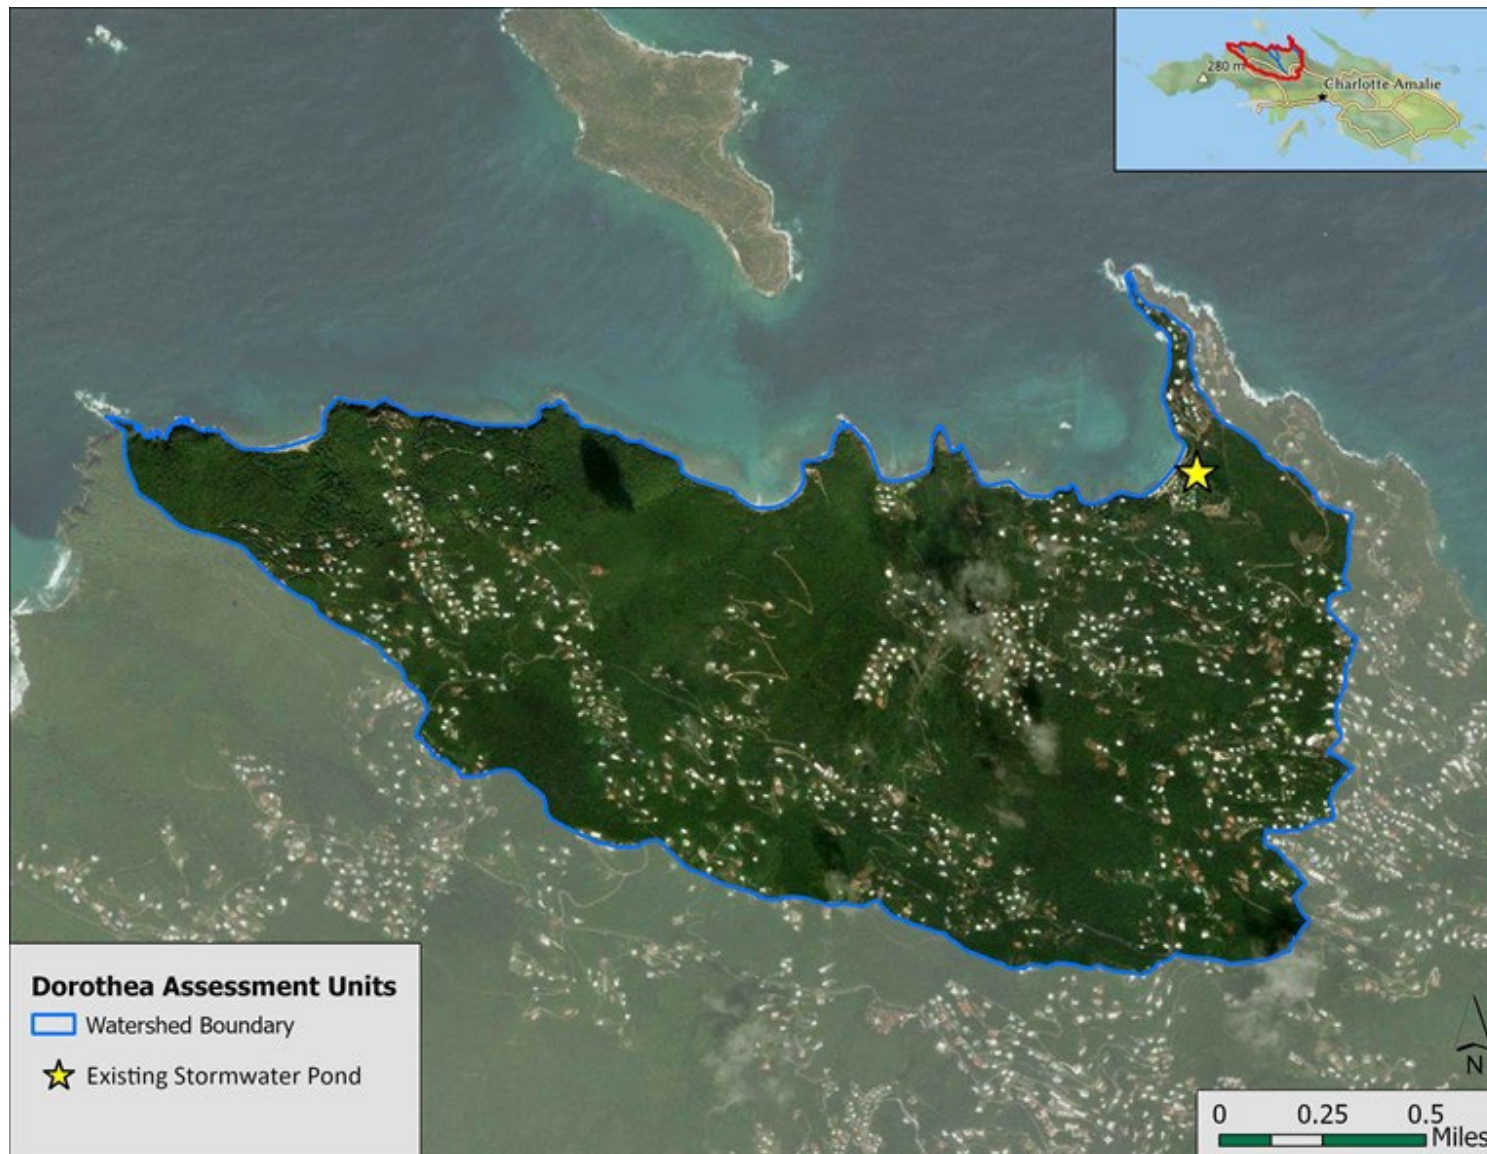
Figure 48. Existing stormwater BMP identified within the watershed.

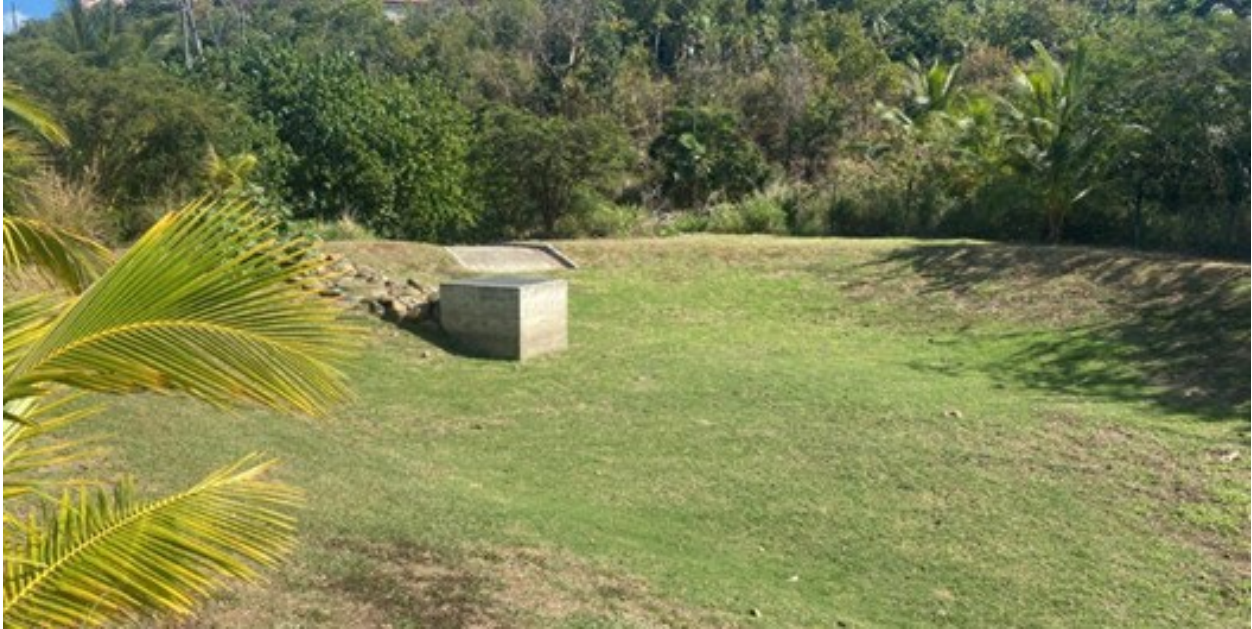
Figure 49. Existing stormwater basin in the Dorothea watershed.

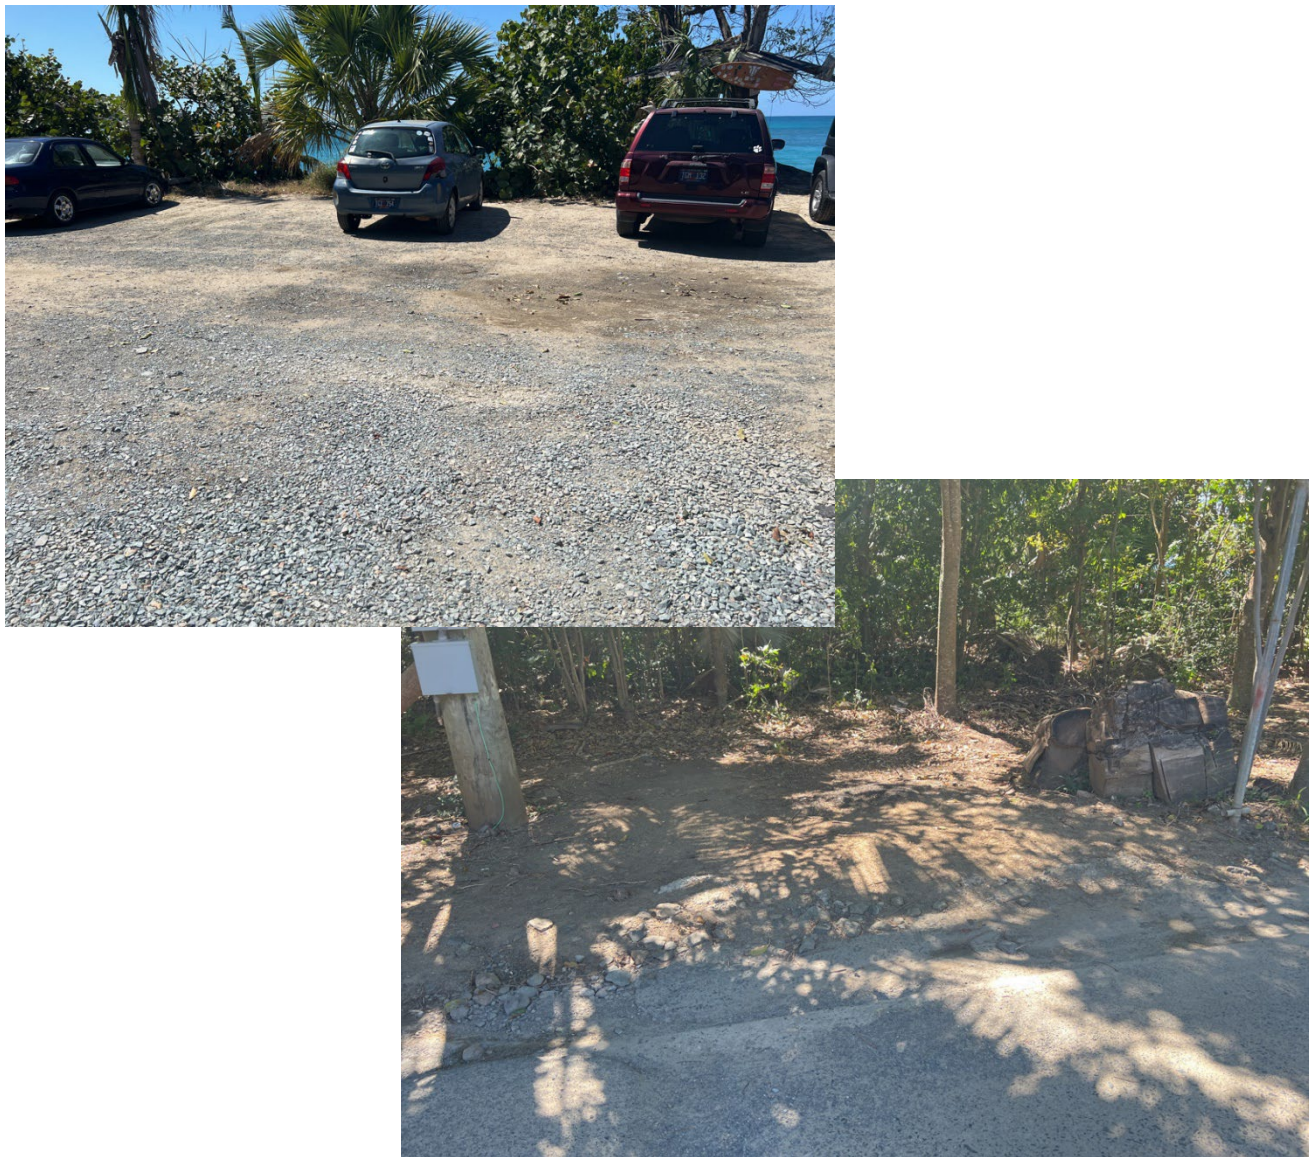
Figure 61. Stormwater improvements along the parking lot edge (above) access drive (below) to Hull Bay Beach are proposed.

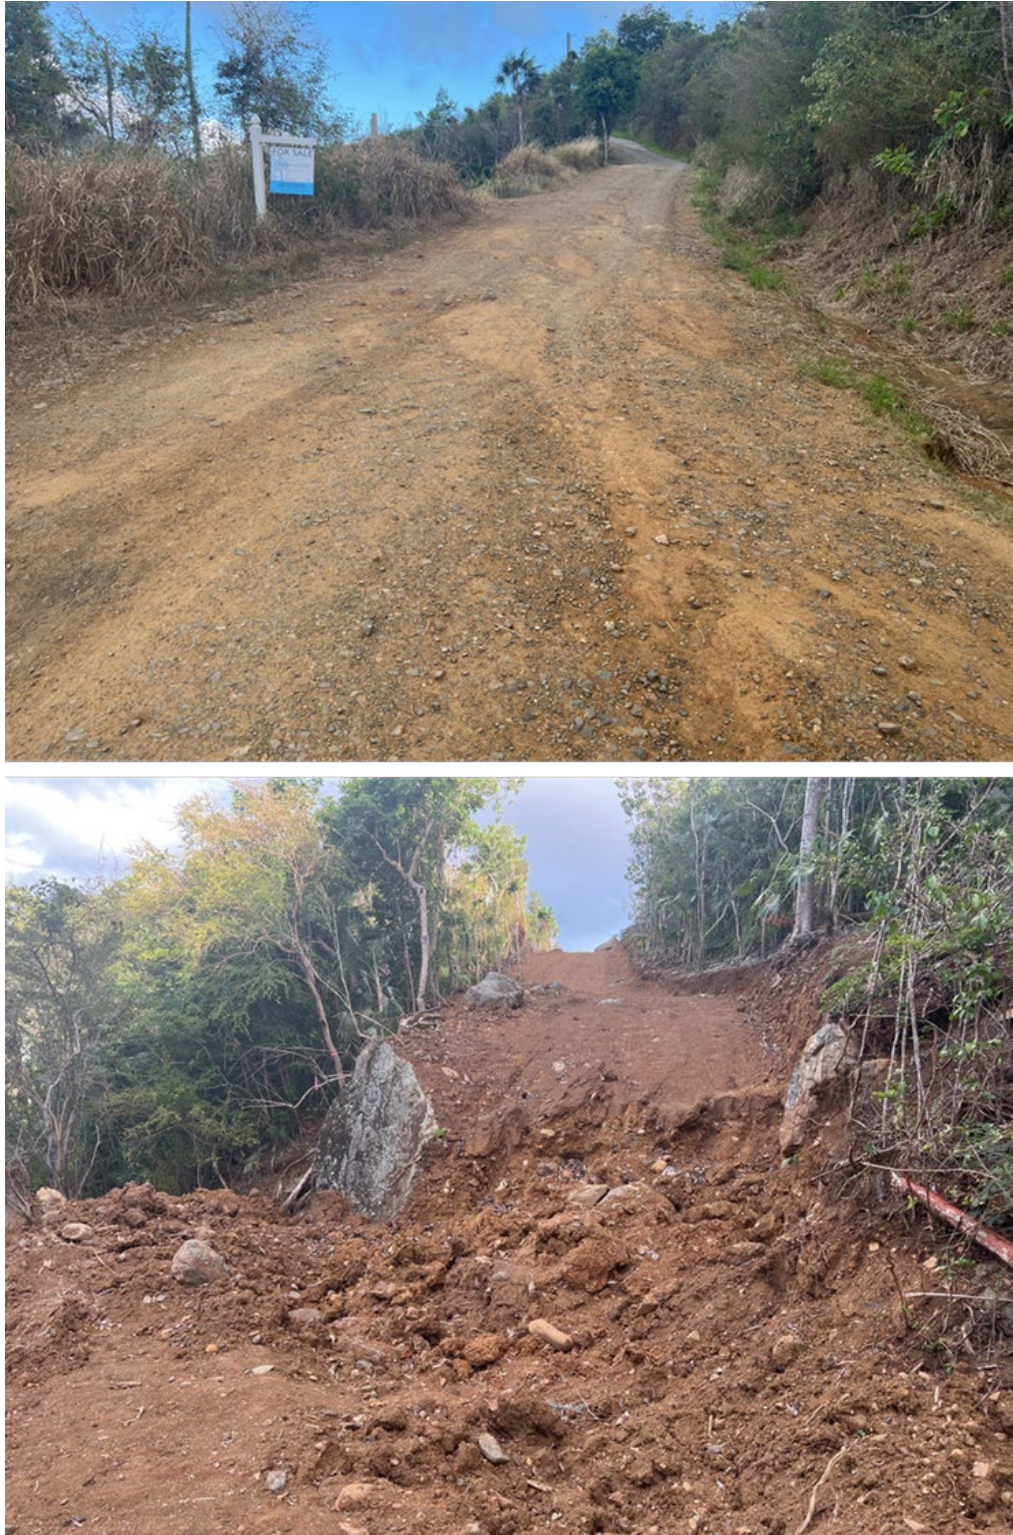
Figure 63. Stormwater runs down the road in many locations (upper) and new construction has not followed proper sediment and erosion control practices (lower).
