MAJOR WATER PERMIT APPLICATION

Environmental Assessment Report

Project: Butler Bay, St. Croix USVI Trans-Caribbean Fiber System Cable
Landing Project

Prepared by: Tysam Tech, LLC

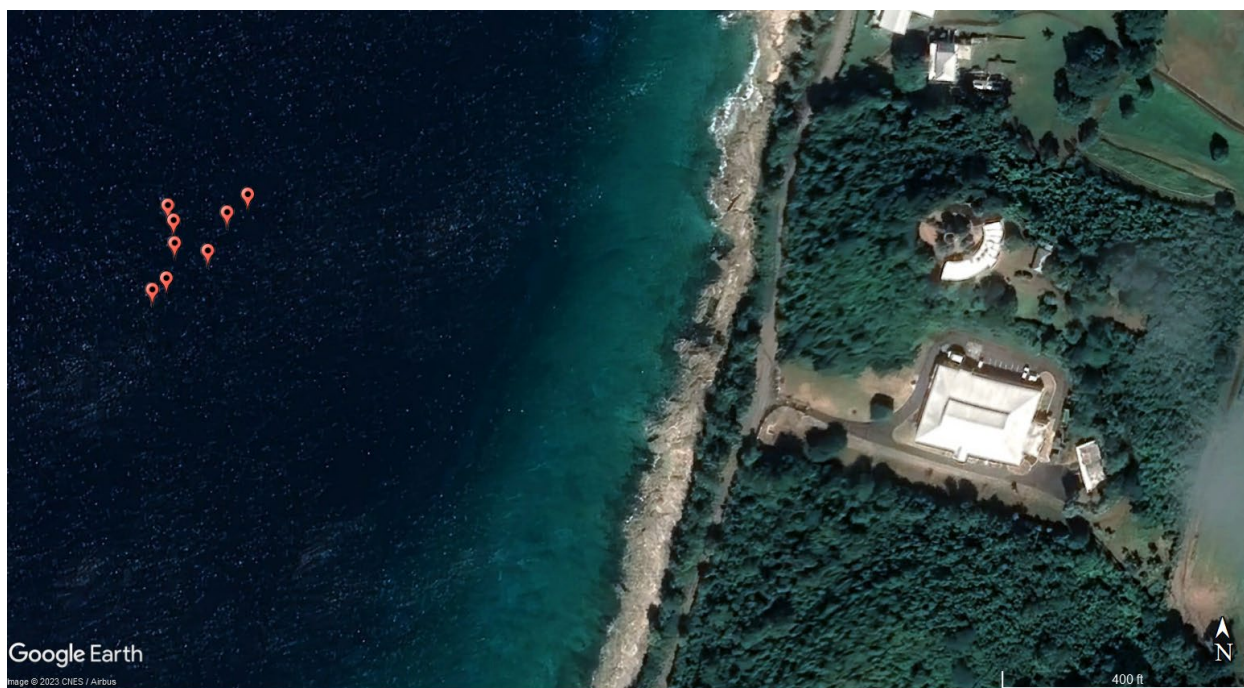
Figure 5.01.2 – St. Croix Bore Pipe Exits

Existing bores at the St. Croix landing will be used to avoid disruption of the shoreline and shallow water seafloor, as well as following seafloor contours that effectively function as a natural corridor for the cable route (e.g. optimizing use of flat seabed, avoiding slopes, side-slopes and hard bottom areas where possible). This will allow for a shorter installation timeline with less impact through minimally impacting installation methods. Shallow water laying will be aided by scuba divers while semi-deep and deepwater laying will be aided by remote operated vehicles.

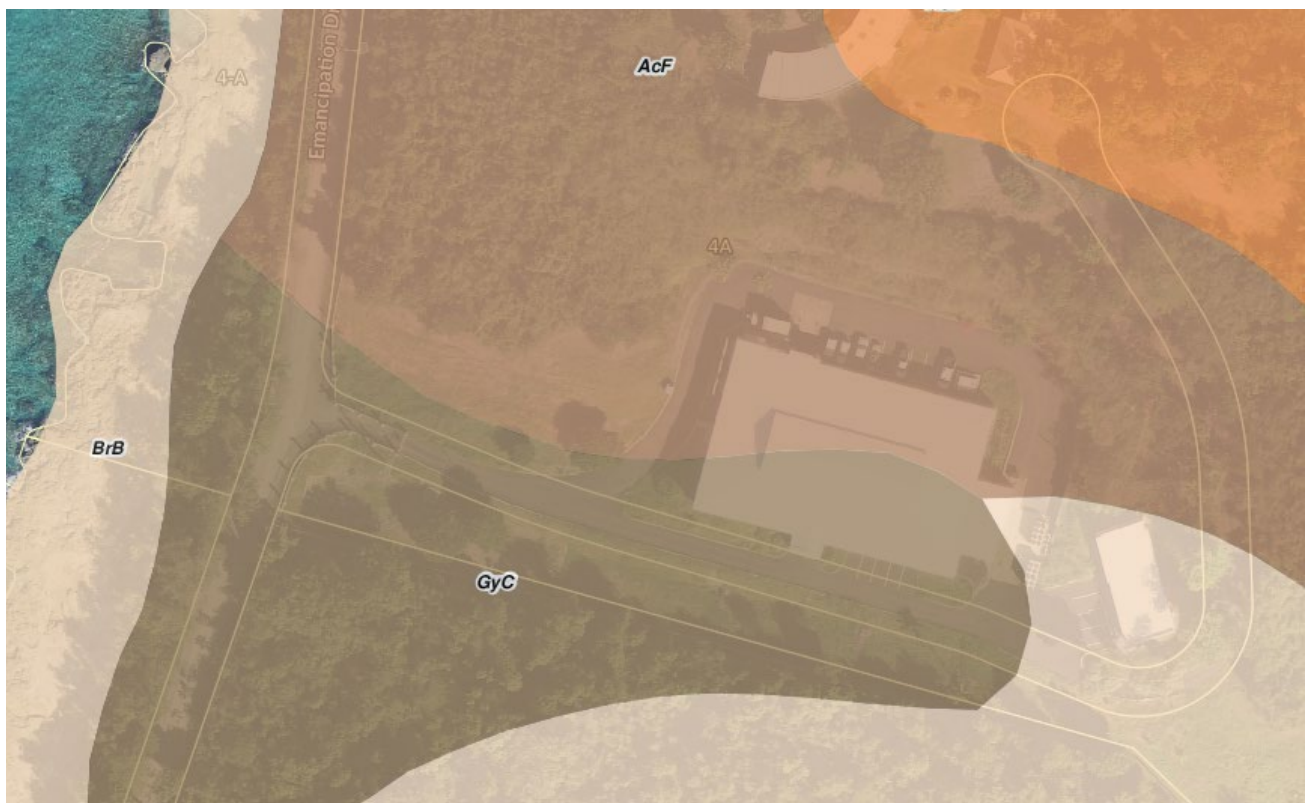
Figure 6.02.4 – Soil types in project vicinity (MapGeo)

Annaberg-Cramer complex are well drained and extremely stony soils that are not suitable for recreational uses, cultivated crops, or wildlife habitat. These soils are generally found on summits and side slopes of volcanic hills and mountains. AcF slopes vary from 40 to 60 percent.

Rock outcrop beaches consist of unvegetated areas of limestone rock adjacent to the sea. These areas are prone to flooding and subject to frequent ponding for long periods. Onsite investigation is recommended to determine suitability for any use. BrB slopes range from 0 to 5 percent. (USDA, 1994)

Elevation at the project site varies from 0 to 60 feet above sea level.

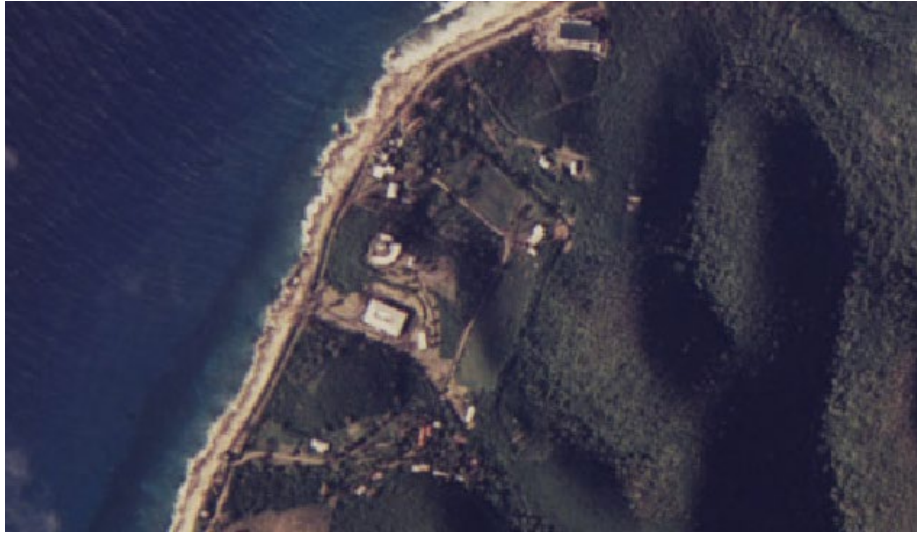
Figure 6.02.6 – 1999 Historical Photo, Butler Bay, Source: NOAA.

The land has been used as a communications hub for AT&T since the mid-nineties, when telecommunication cables were installed along with horizontal direction drilling of bores to house the cables.

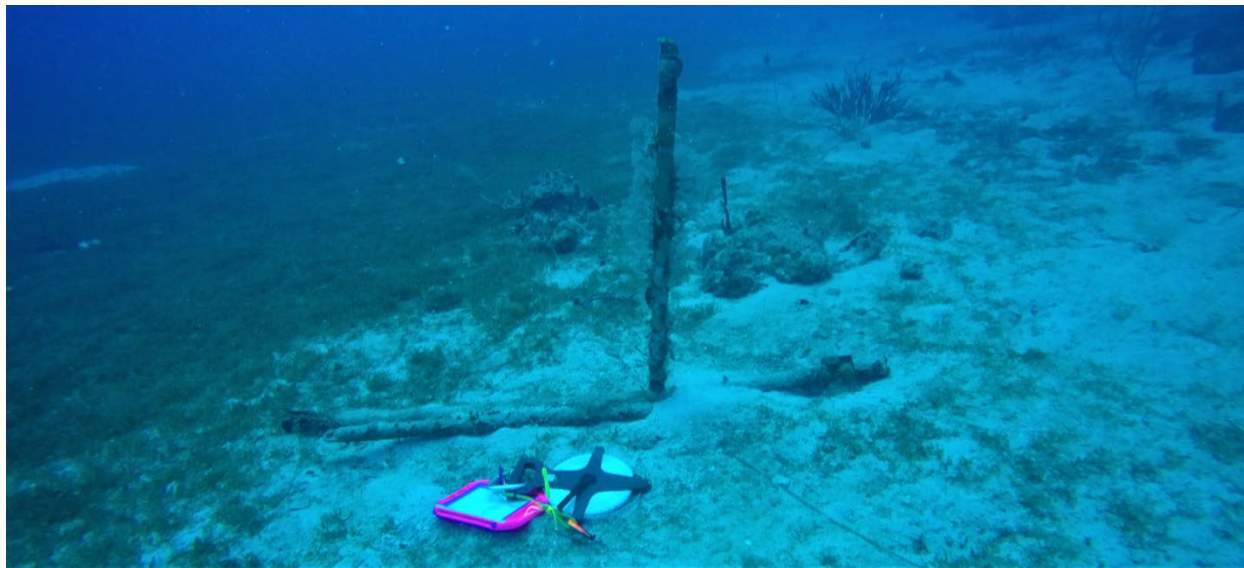
Figure 6.06.5 – Discarded vessel navigation light rack (vertical and horizontal pipes) in the sand halo area between the invasive seagrass and the top of the wall. Pink framed data slate and red 100 meter tape also shown.

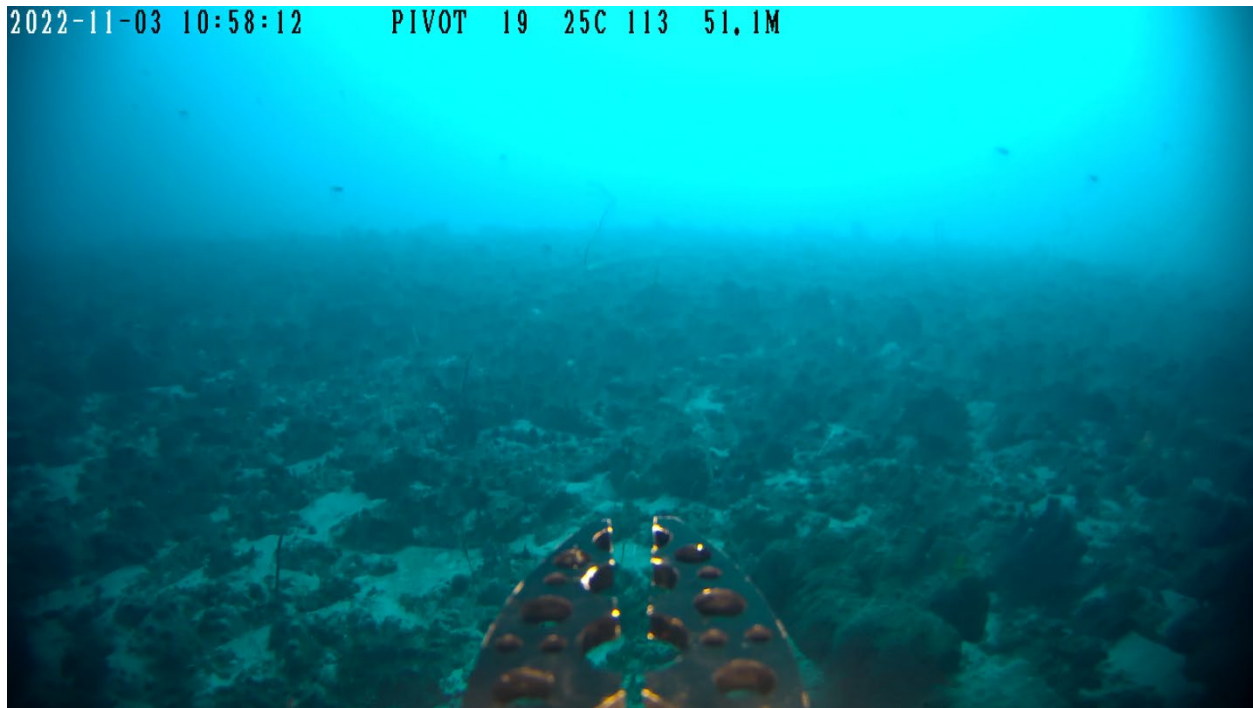
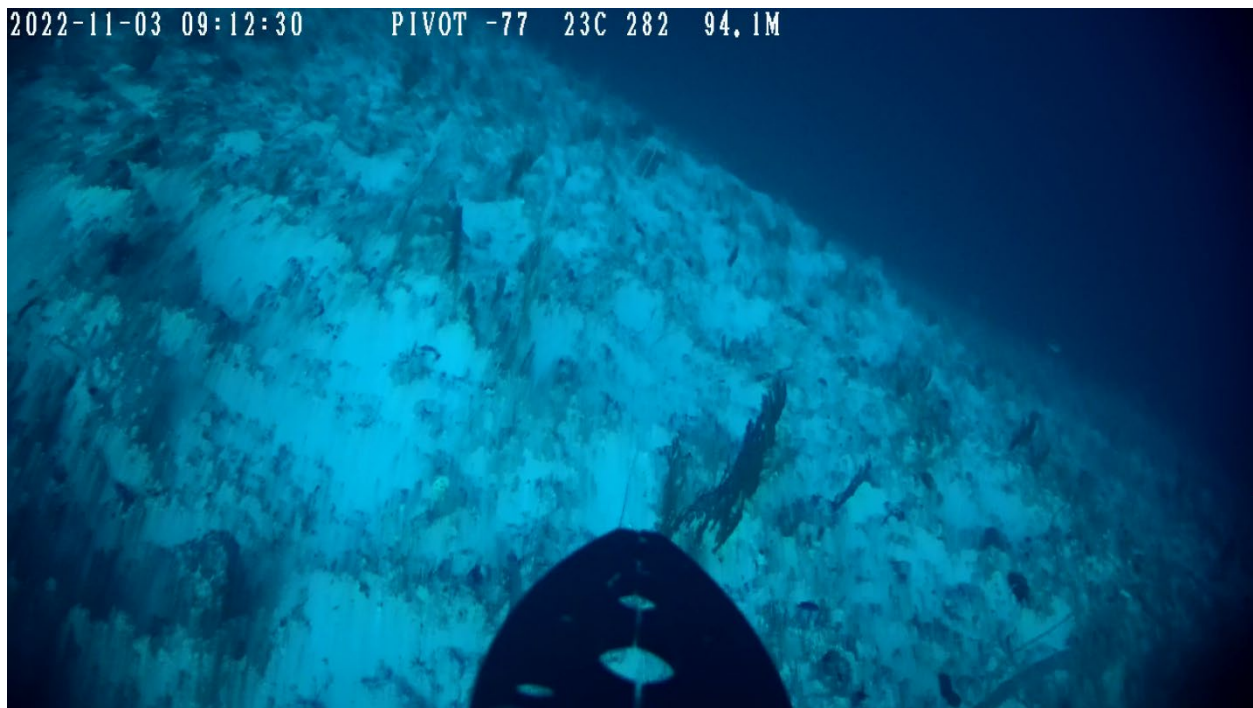
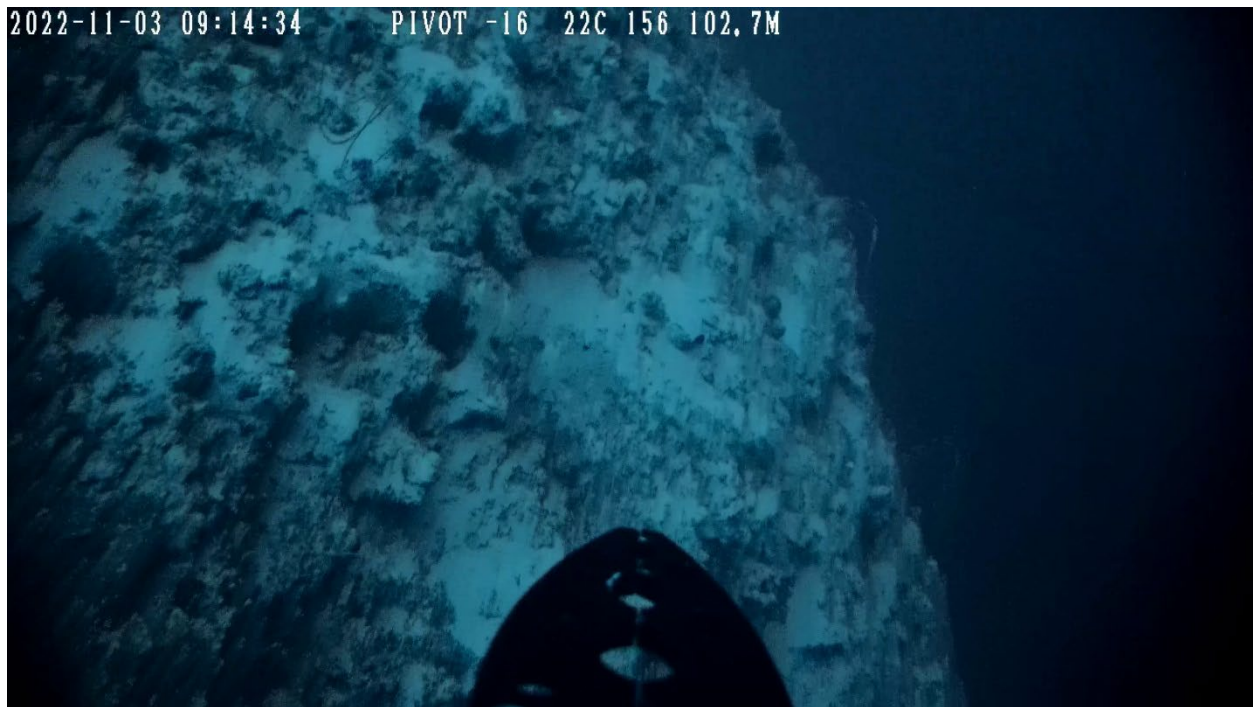
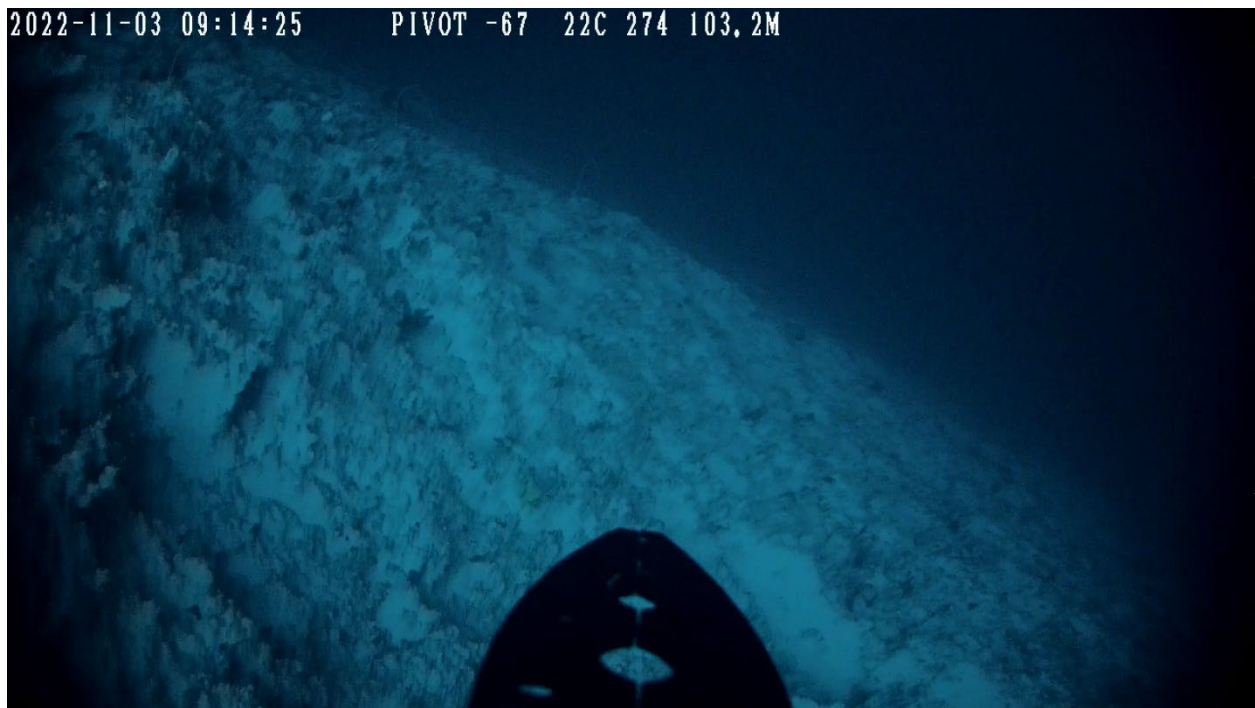
Figure 6.06.6 – ROV video frame grab at 51.1 meters deep looking up slope

Figure 6.06.7 – ROV video frame grab at 55.1 meters deep looking down slope

Figure 6.06.8 – ROV dive at 94.1 meters deep looking down slope

Figure 6.06.9 – ROV dive at 102.7 meters deep looking across slope

Figure 6.06.10 – ROV dive at 103.2 meters deep looking down slope

Figure 6.06.11 – ROV dive at 108.2 meters deep looking up slope

On November 3, 2022 the site was revisited via boat with the ROV. Five separate videos were recorded with the ROV. ROV dive #1 video begins at 13 meters deep then proceeds down to the sand halo area between the seagrass and the drop-off. Images of turtles and barracuda were recorded. After pausing at the subsurface buoy at 103' deep, the video records the proposed cable path down to 119 meters deep. The ROV then proceeds back up to 78.4 meters deep with 30 minutes of video recorded. ROV video #2 continues at the same location then proceeds along the bottom back up to the sand halo area with 9 ½ minutes of video footage. ROV video #3 begins again at the light rack location in the sand halo then proceeds down to the subsurface buoy site then on down to 42 meters deep. The current here was now too strong to continue on station so this ROV dive was aborted. ROV dive #4 began again at the abandoned light rack in the sand halo and proceeded along the proposed cable path area east to the abandoned fish trap area. It then goes on to the vicinity of the proposed cable path jog site. 9 minutes of video documents the bottom in this area. ROV video #5 records the area surrounding the cable path jog site then proceeds back to the sand halo area between the seagrass and the drop-off. A large male sea turtle is recorded close up in this location. The recording then proceeds down the wall to the subsurface buoy and beyond

down to 55 meters deep where again the current is too strong to maintain ROV position so the ROV returns back up the wall recording the proposed cable route back to the light rack in the sand halo with 20 minutes of proposed cable path video.
