**ENVIRONMENTAL ASSESSMENT REPORT FOR
ST. CROIX BOUTIQUE HOTEL
CHRISTIANSTED, ST. CROIX
U. S. VIRGIN ISLANDS**

Z PROPERTY VI LLC

BIOIMPACT, INC.

JUNE 2024

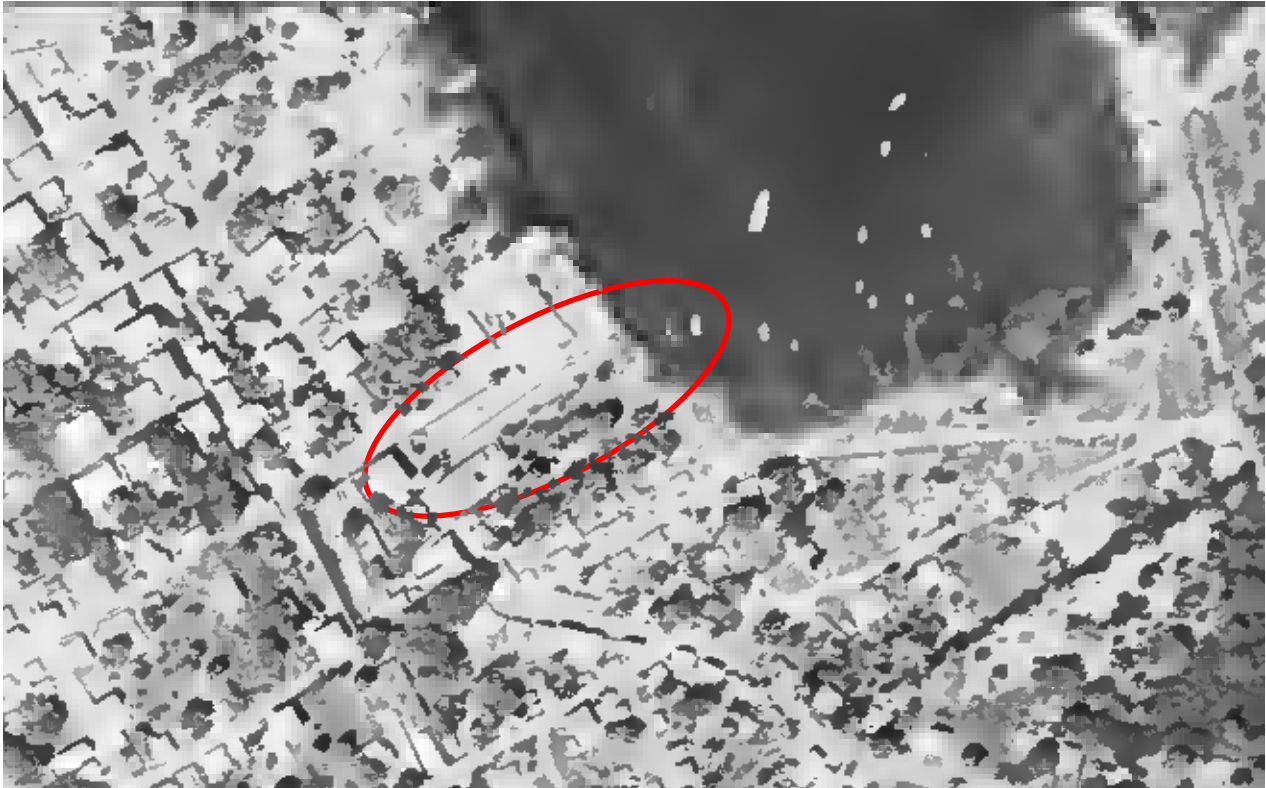
Figure 7. 1954 Aerial Service Map of the Project Area

The property has been developed since historic times. And the ruins of a historic building stand on Parcel 7-a to which the project will connect. In 1954 the building is still present and there are two piers extending from the property which had a rail system, the rails are still present today.

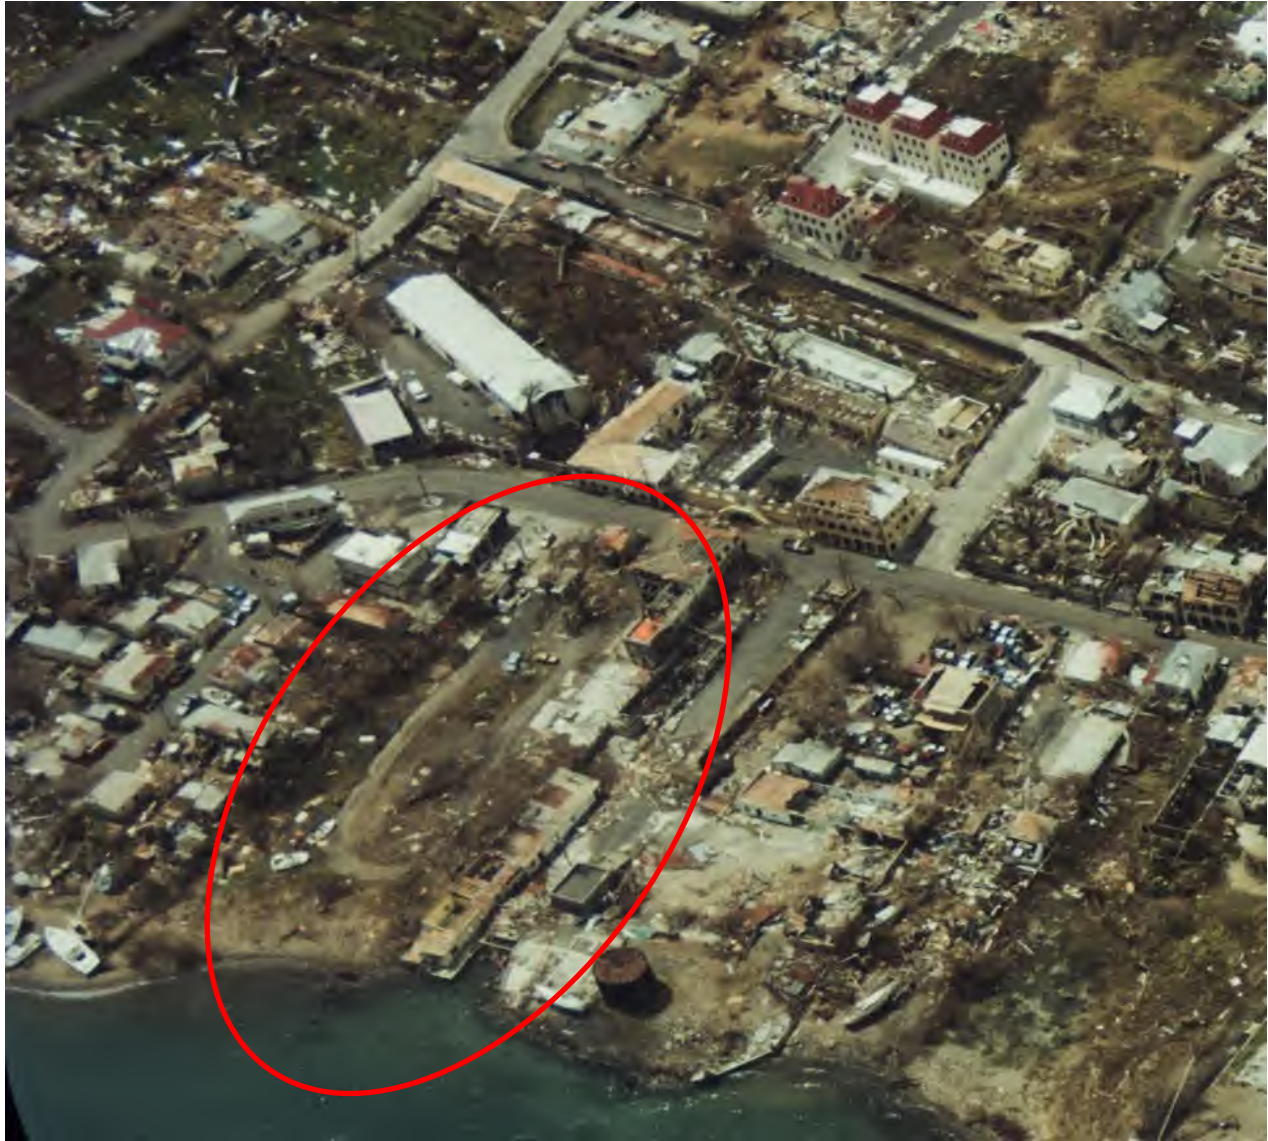
Figure 8. The site after Hurricane Hugo in 1989

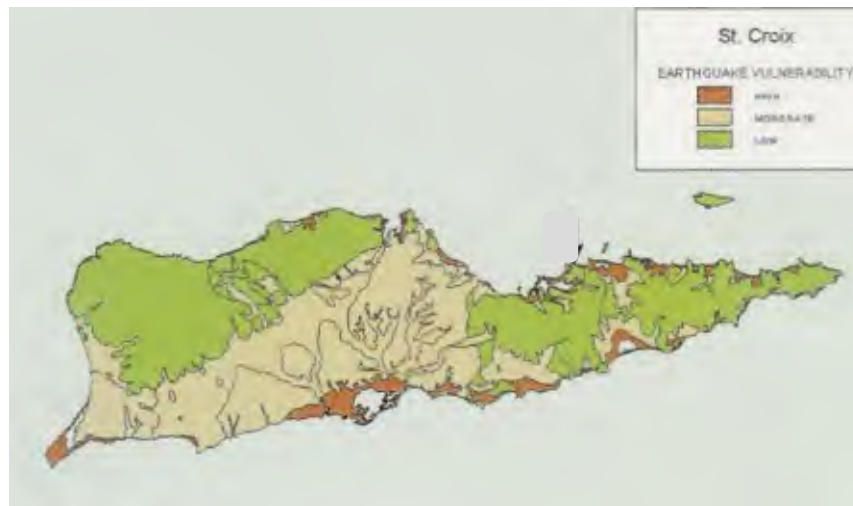
Figure 9. Earthquake probability map, UVI Conservation Data Center

The U.S. Virgin Islands lie in one of the most earthquake prone areas of the world, and are susceptible to ground shaking, earthquake-induced ground failures, surface fault ruptures and tsunamis (tidal waves) (Hays, 1984). The activity is mostly associated with large-scale tectonic activity or faulting, originating in the Anegada Trough to the northeast of the islands. The year 2024 marks the 157th anniversary of the last major earthquake in the islands. This quake, which occurred in 1867, had an identified intensity of VIII on the Modified Mercalli Scale. Earthquakes of this magnitude have generally been associated with epicentral ground accelerations of between 0.05 and 0.35 gravities. Over the last several years numerous minor tremors have been felt on the island. Many feel that this increased activity is associated with the volcanic eruptions that have been occurring to the southeast on the island of Montserrat. Below is the earthquake probability map for St. Croix produced by UVI Conservation Data Center. The hotel is in the high probability area for St. Croix.

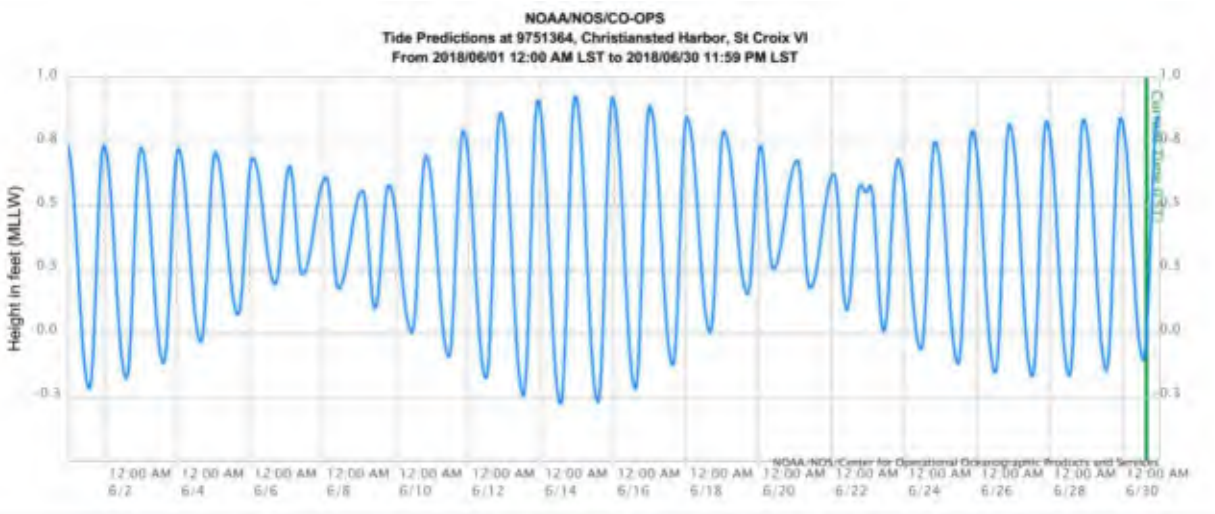
Figure 13. Tide Predictions Christiansted Harbor (<https://tidesandcurrents.noaa.gov/noaatidepredictions.html>)

The Virgin Islands coastal areas are not subject to significant tidal ranges or tidal currents. Due to the small size of the islands, the sea flows around the island causing an average tidal height of only a few inches and a maximum change of only a little over one foot. Only very narrow intertidal zones are found because of this lack of tidal amplitude and the steepness of the island rising out of the sea. Normal tidal ranges may be greatly exceeded during storm conditions, when a combination of lower barometric pressure at the ocean surface and storm winds amplifies the tidal crest. The tides on the north coast of St. Croix are primarily diurnal in nature. There is a slight secondary cycle (semi-diurnal), but this is almost indistinguishable and is reduced to very small ebbs and floods. The mean tides range from 0.8 feet to feet and the spring tidal ranges reach up to 1.3 feet. The tidal zone is visible on the rubble shoreline during periods of low tide.

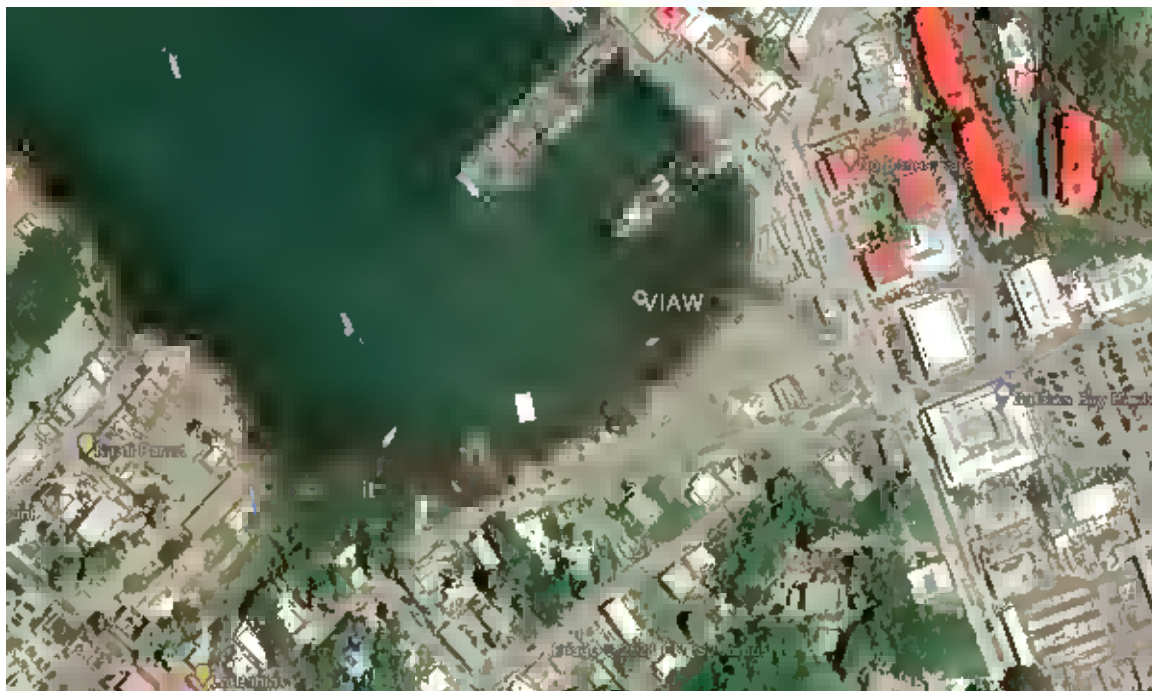
Figure 16. Location of property in relationship with VIAWQMP Station #42.

The VI Ambient Water Quality Monitoring Program (VIAWQMP) has an ambient monitoring station 390ft. to the east. The data for monitoring station 41 is summarized in Table 2. A map of the VIAWQMP water quality monitoring stations in Christiansted Harbor is provided (Figure 16) showing its relationship with the project site.

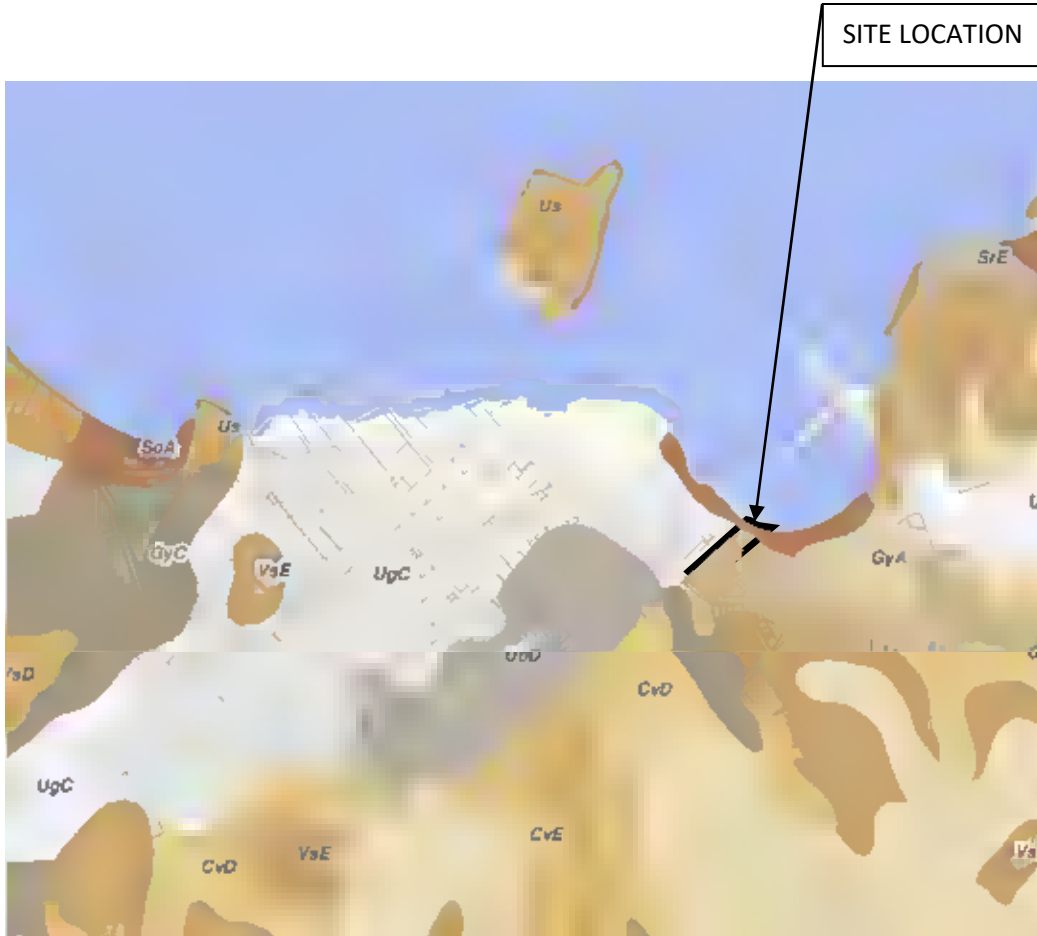
St. Croix Hydrologic Soils Classification (Source: <https://usvi.mapgeo.io>)

Based on the above, the Hydrologic Soils Classification for the Site is **Group A and Group B**. This soil classification type is synonymous with Group A and Group B in Table 3.6 below.
