BIOLOGICAL ASSESSMENT

U.S. VIRGIN ISLANDS

VETERANS DRIVE (ROUTE 30) IMPROVEMENTS

**IMPACT MINIMIZATION PLAN
FOR
PHASE II IMPROVMENTS TO VETERANS DRIVE
ST. THOMAS, U.S. VIRGIN ISLANDS**

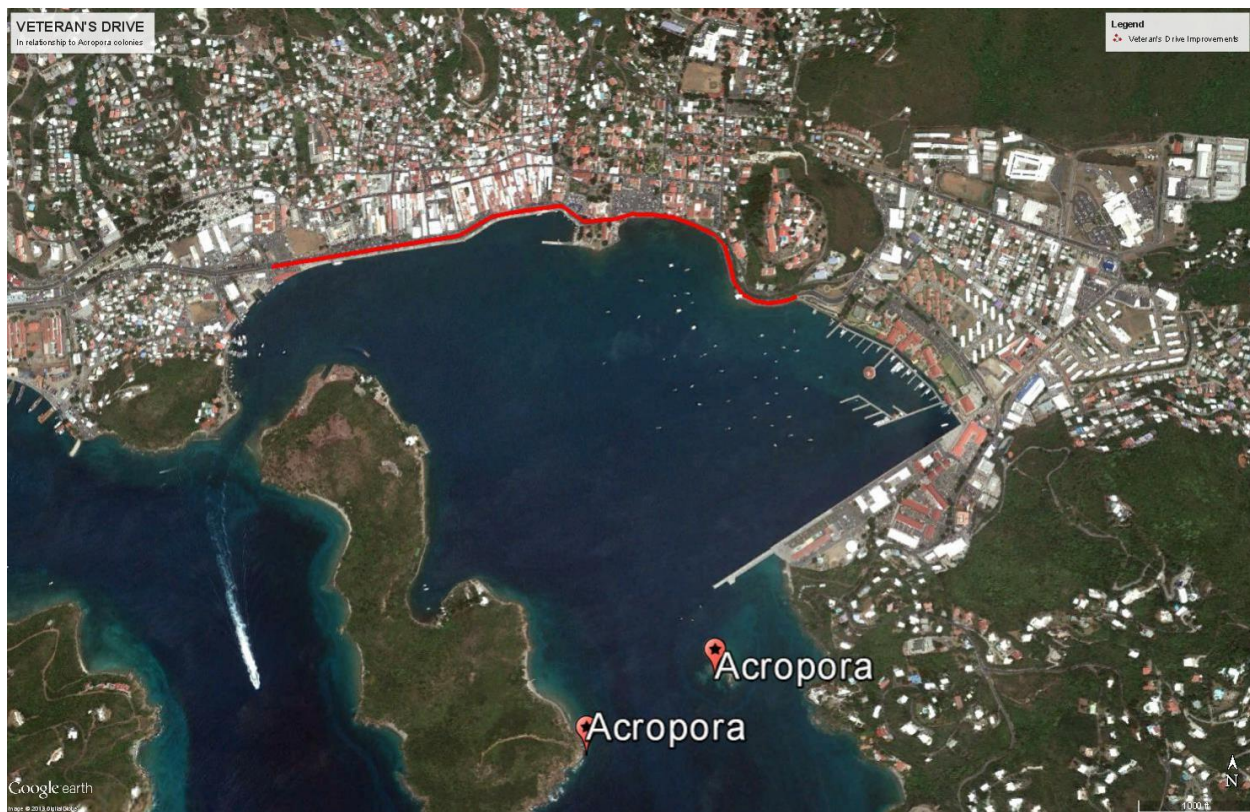
Figure 5. Location of *Acropora* in relationship to the project area.

The federally listed threatened species of coral, *Acropora palmata* occurs on Rupert's Rock which is located in Charlotte Amalie harbor about 0.69 miles to the south southeast of the project area, on the southern shore of Hassel Island further to the south, and around Muhlenfels Point.

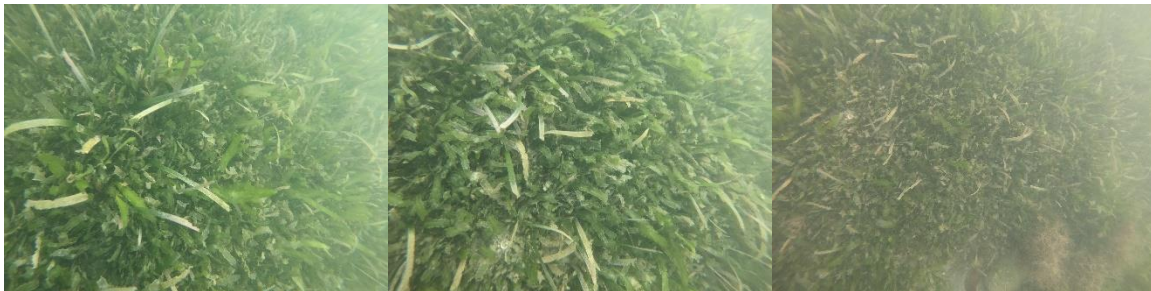
The new quay wall is completely colonized by *H. stipulacea*, *Caulerpa spp*, and *Padina sanctae-crucis*. The heavy colonization may be due to persistent sewer leaks in the area of the federal building.

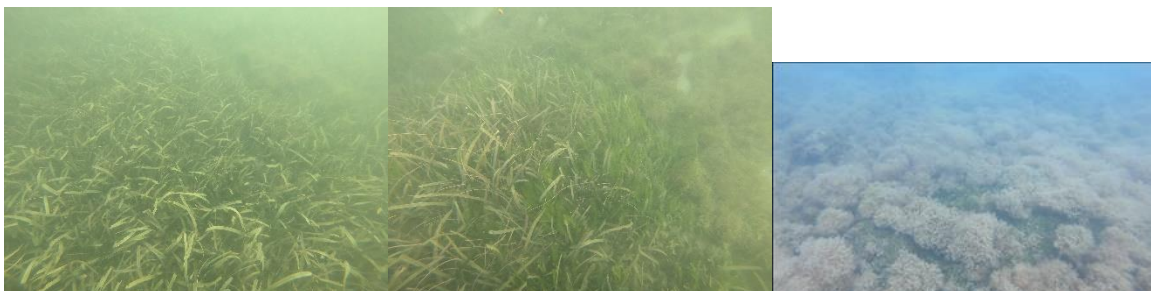
Sea grass is thriving south of the new section of Veterans Drive. Large areas are completely covered by drift algae.

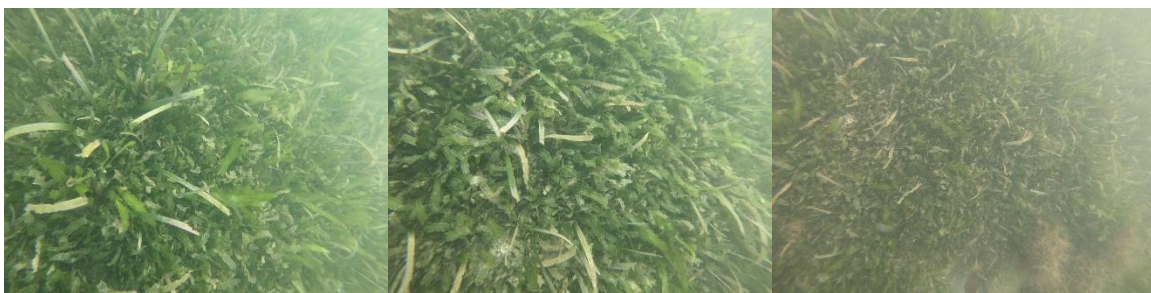
The new quay wall is completely colonized by, *Caulerpa* spp (*C. taxifolia*, *C. sertulorioides*, *C. mexicana*, *C. racemose*), *H. stipulacea*, and *Padina sanctae-crucis*. The heavy colonization may be due to persistent sewer leaks in the area of the federal building. (Blades from the offshore *Thalassia* are tangled in the algae.

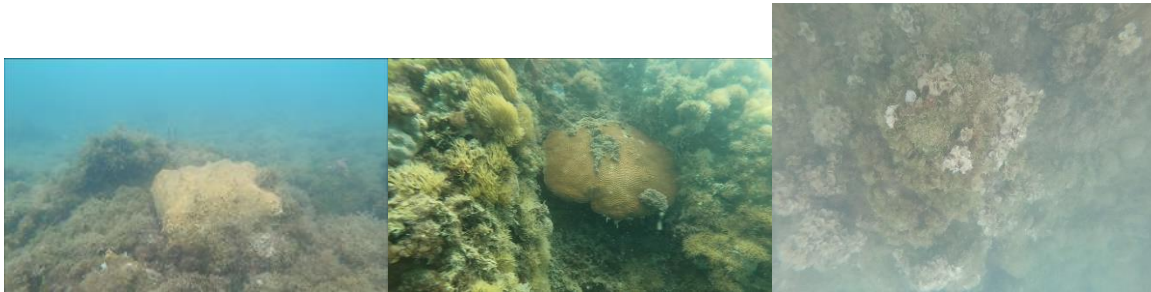
Outside of the roadway footprint, there are *Solenastrea bournoni*, and *Siderastrea siderea*. The rocks are completely algal covered and no longer have the characteristics of critical habitat.

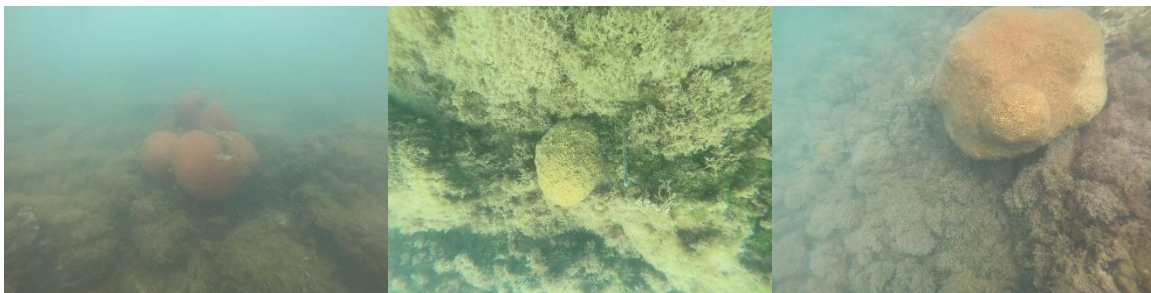
There are some larger heads at the edge of the project footprint.

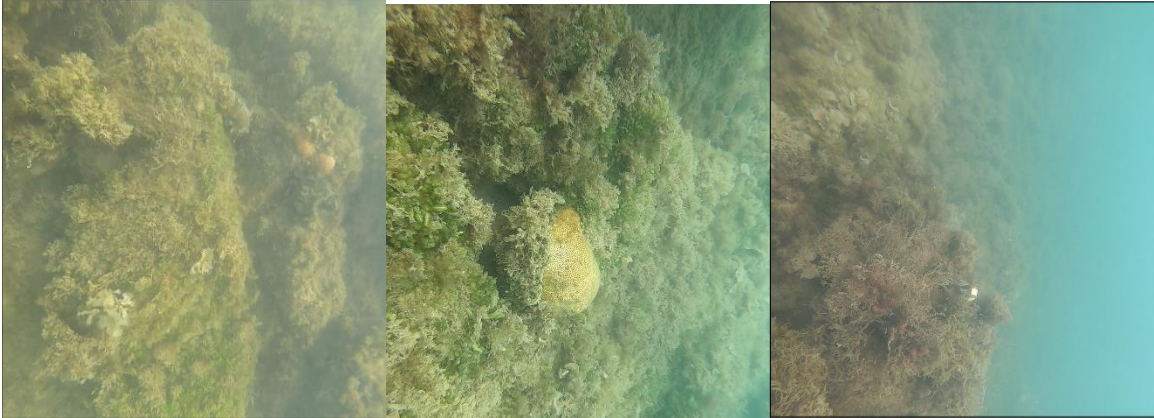
Two *Siderastrea siderea*, a loose *Solenastrea bournoni*, and a totally bleached *P. astreoides*. The *S. bournoni* is partially bleached (and had black band at the time of the original transplant, the dead area from black band is still notable) and the *P. astreoides* is completely bleached.

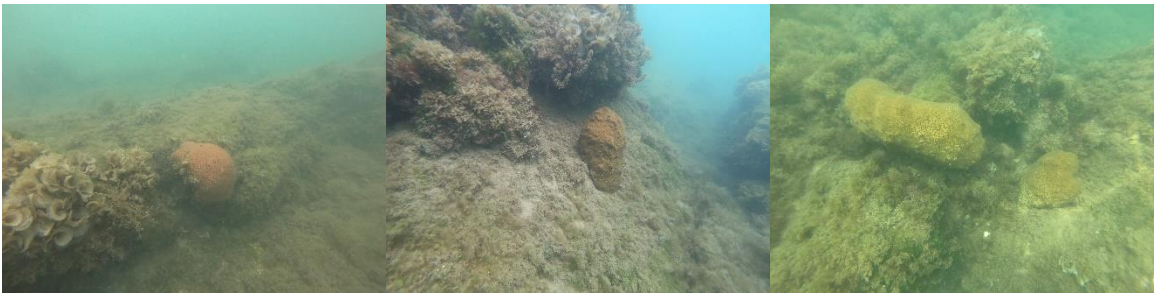
There are corals which have colonized since the transplant from the area. Including *S. siderea*, *S. bournoni* and *P. astreoides*.

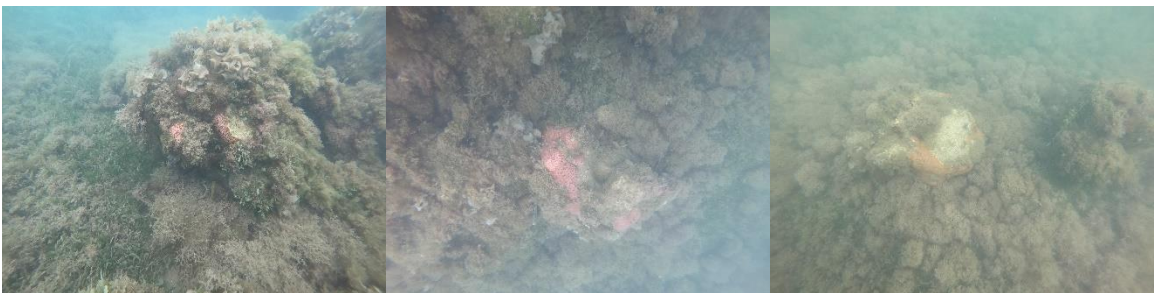
There are corals which no longer have black band disease and can now be transplanted.

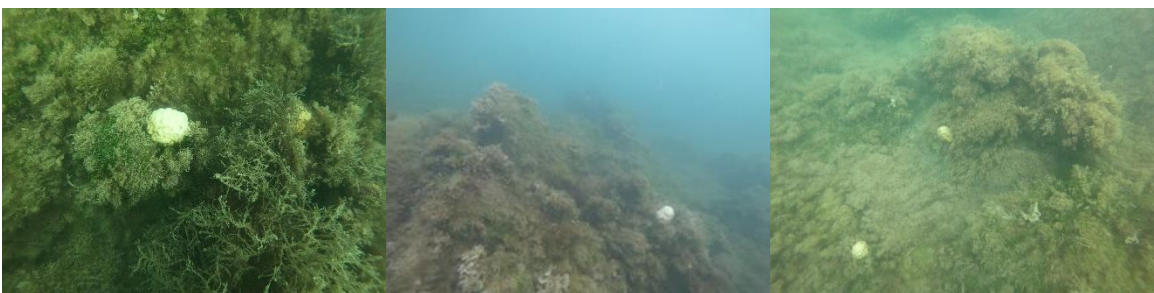
There are a number of *P. astreoides* on the hardbottom, almost all of which are bleached.

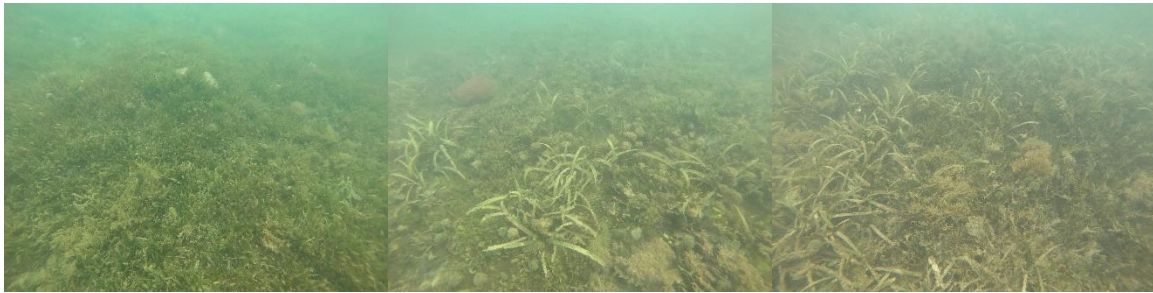
Mixed seagrass, algae and *H. stipulacea* west of Coast Guard Station.

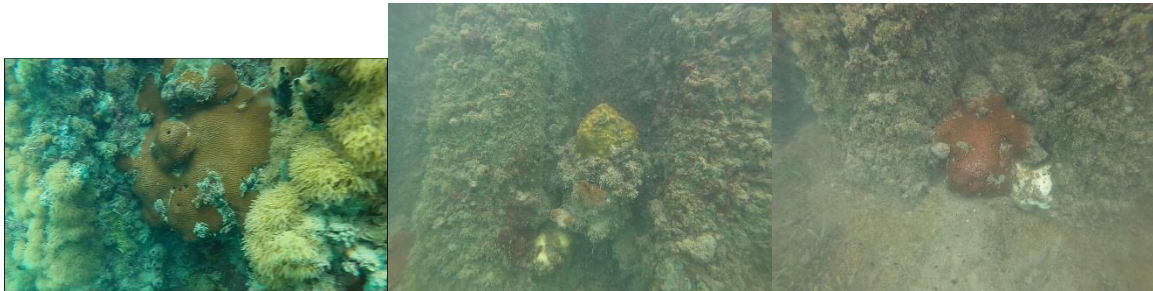
The sheet pile wall along the 2700ft of waterfront is heavily algae colonized, and there are scattered corals which have colonized since the last transplant or were diseased and not transplanted.

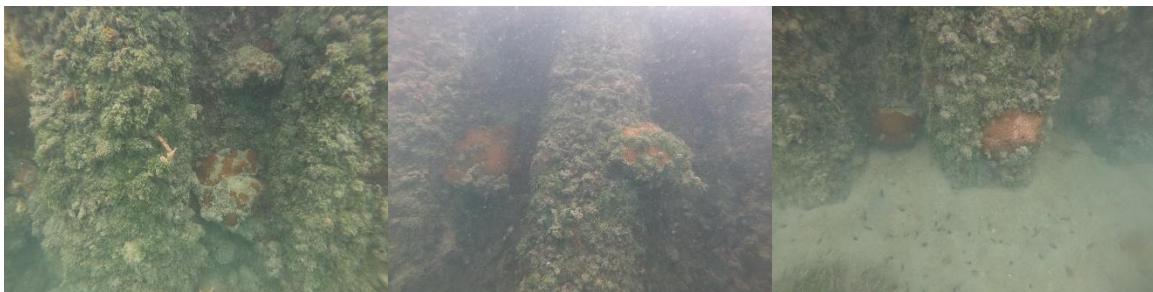
Some of the corals which were not transplanted before are up to 75% algal colonized.

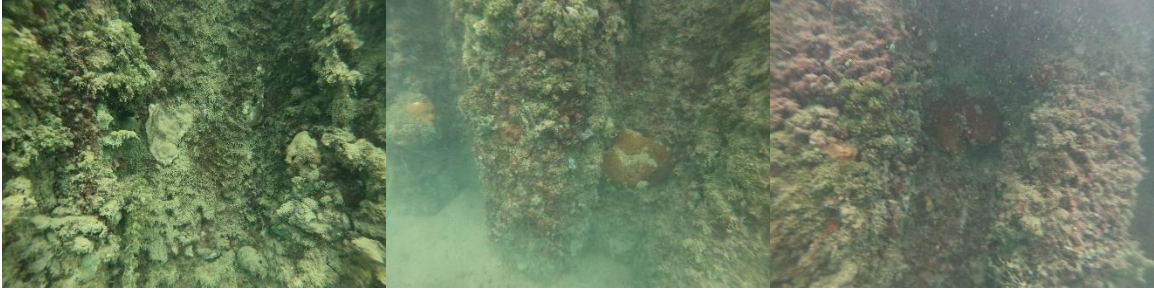
There are sponges as well as corals and where possible sponges will be removed and relocated.

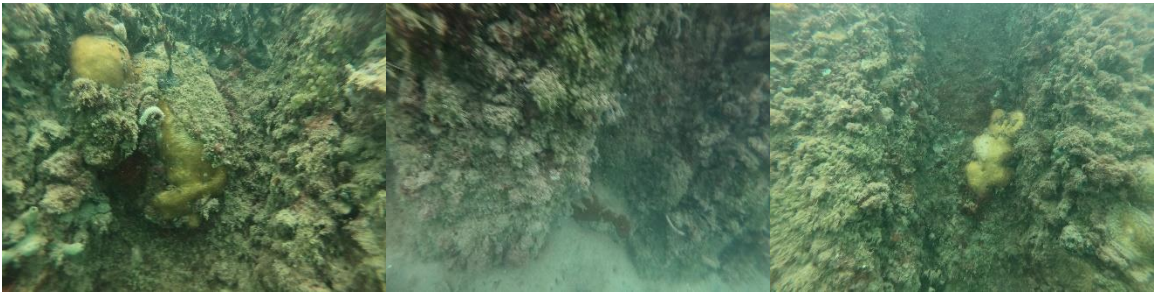
There is some bleaching on some of the corals on the sheet pile wall.

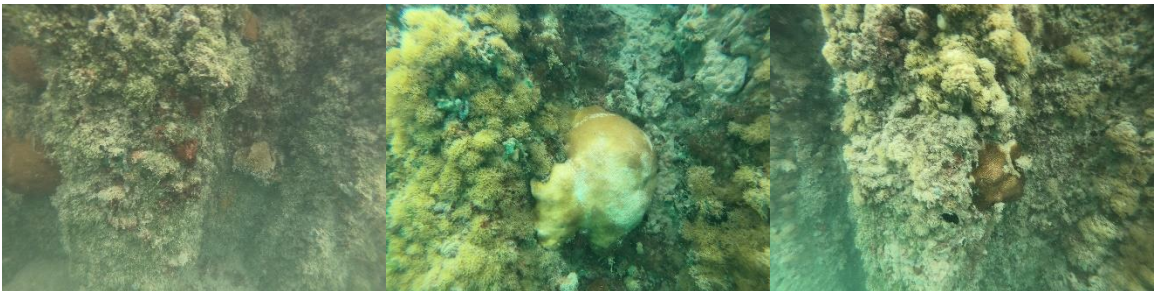
Most of the bleaching appears heat related by not all.

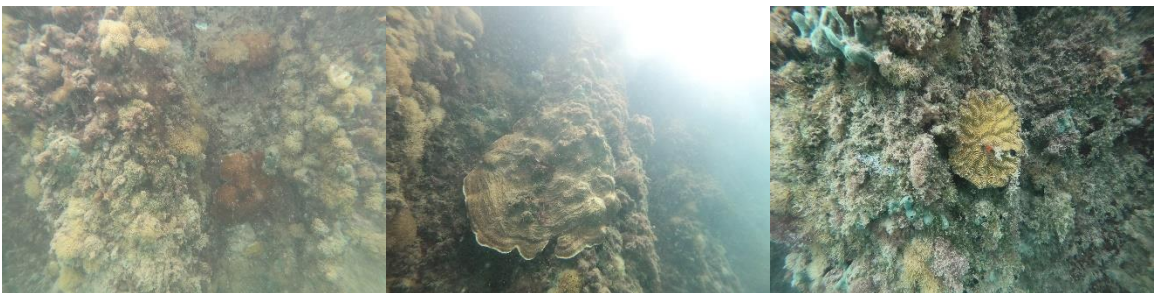
The corals are clustered primarily due to the previous clustering of diseased corals.

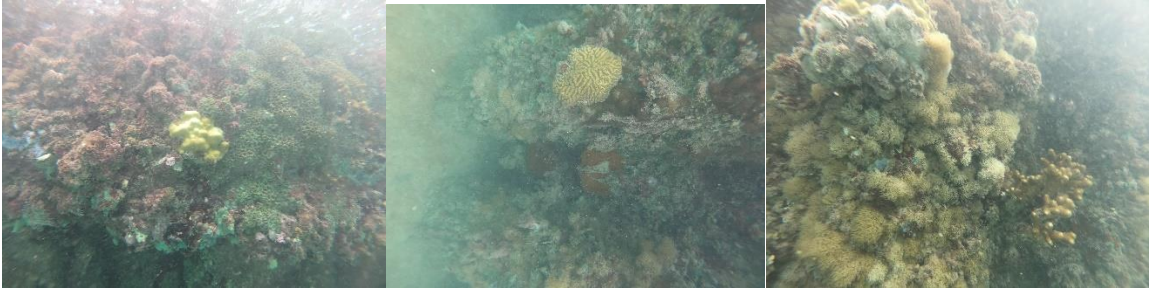
Most of the corals on the sheet pile are *S. siderea*, but there are a scattering of other species.

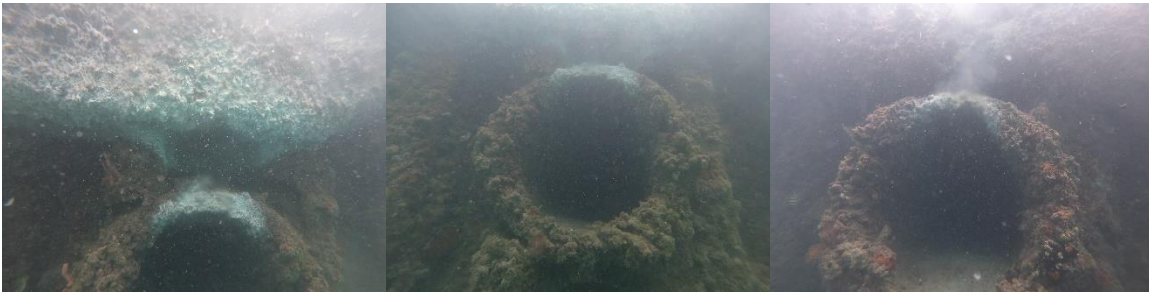
The seafloor colonization along the bulkhead is primarily *H. stipulacea* and scattered macro algae and a few areas have *Thalassia* intermixed with *H. stipulacea*. There is some scattered debris.

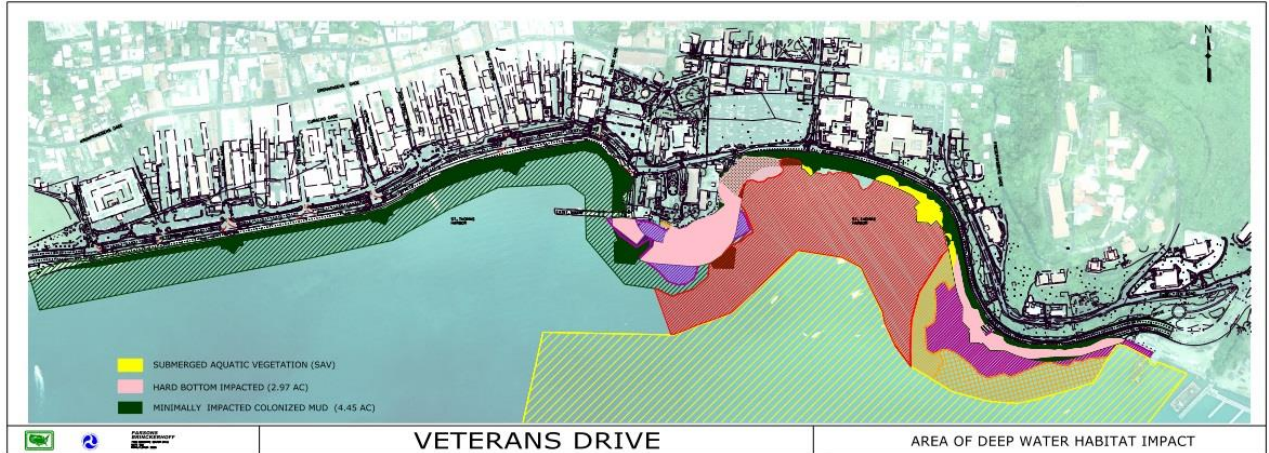
Figure 5. Direct Benthic Impact overall project

Area of Direct Impact, Total area of impact 8.57 acres, 1.15 acres of SAV impact, 2.97 acres of coral colonized hardbottom and 4.45 acres of minimally colonized mud bottom.

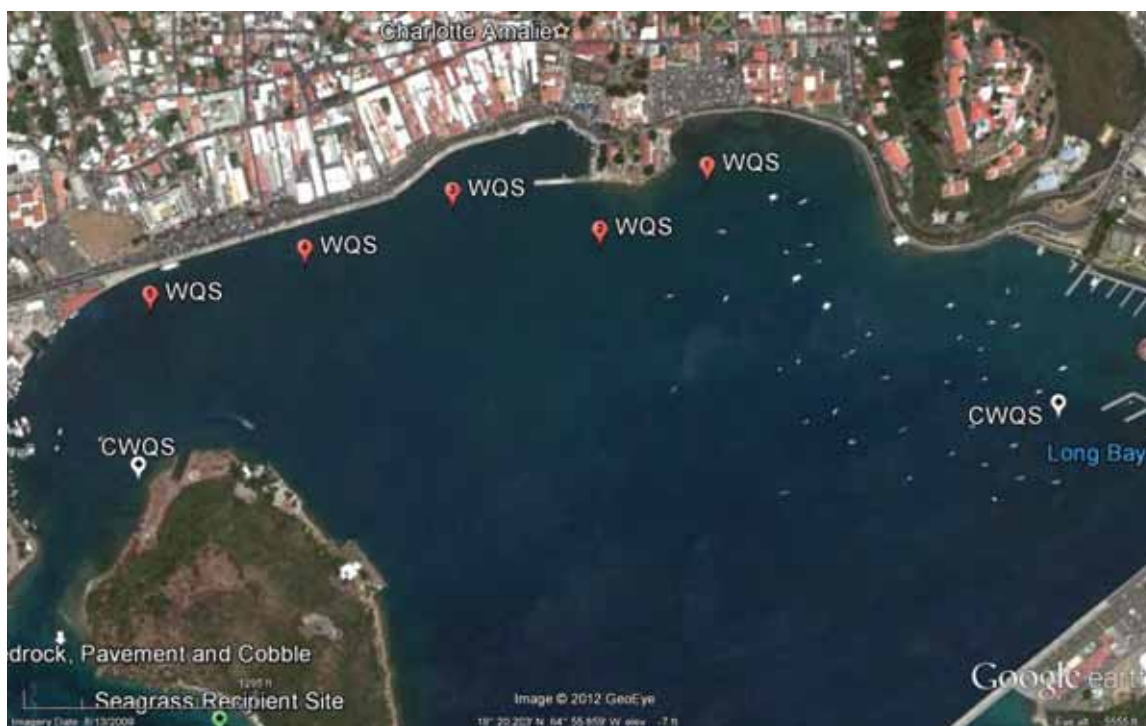
Figure 1 - Water Quality and Environmental Monitoring Locations for Phase II
WQS represents Water Quality Sampling Station, CWQS is a Control Water Quality Station.

The site locations are illustrated on Figures 1 and 2.

During in water construction, four (4) samples will be taken around the area of in-water work as shown in the above figure. In water work will include dredging, filling, and de-watering of dredge spoils and of the fill area. Samples will be taken one (1) meter below the surface and will be analyzed by a Hach Turbidity meter. Samples will be taken on a daily basis. During upland construction when in-water work is not occurring, water samples will be taken after rainfalls of $\frac{1}{4}$ and greater. A digital recording rain gauge will be placed at the site.

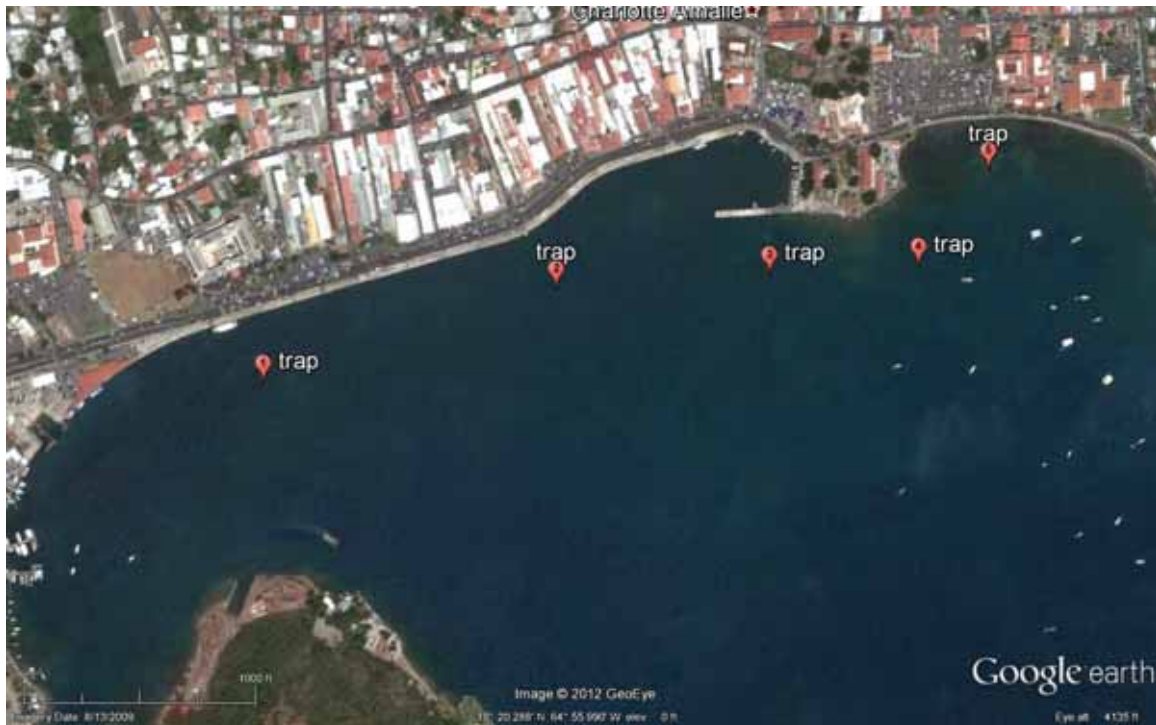
Figure 2 - Location of sediment traps for Phase II

Selected locations for Phase II of the project are illustrated on Figure 2. Traps have been concentrated near coral resources.
