# **ENVIRONMENTAL ASSESSMENT REPORT**

## **Application for the Renewal of a Major Land and Water Permit TotalEnergies St. Thomas Terminal United States Virgin Islands**

**ENVIRONMENTAL ASSESSMENT REPORT**

**Renewal of a Major Land and Water Permit  
TotalEnergies St. Thomas Terminal  
St. Thomas, United States Virgin Islands**

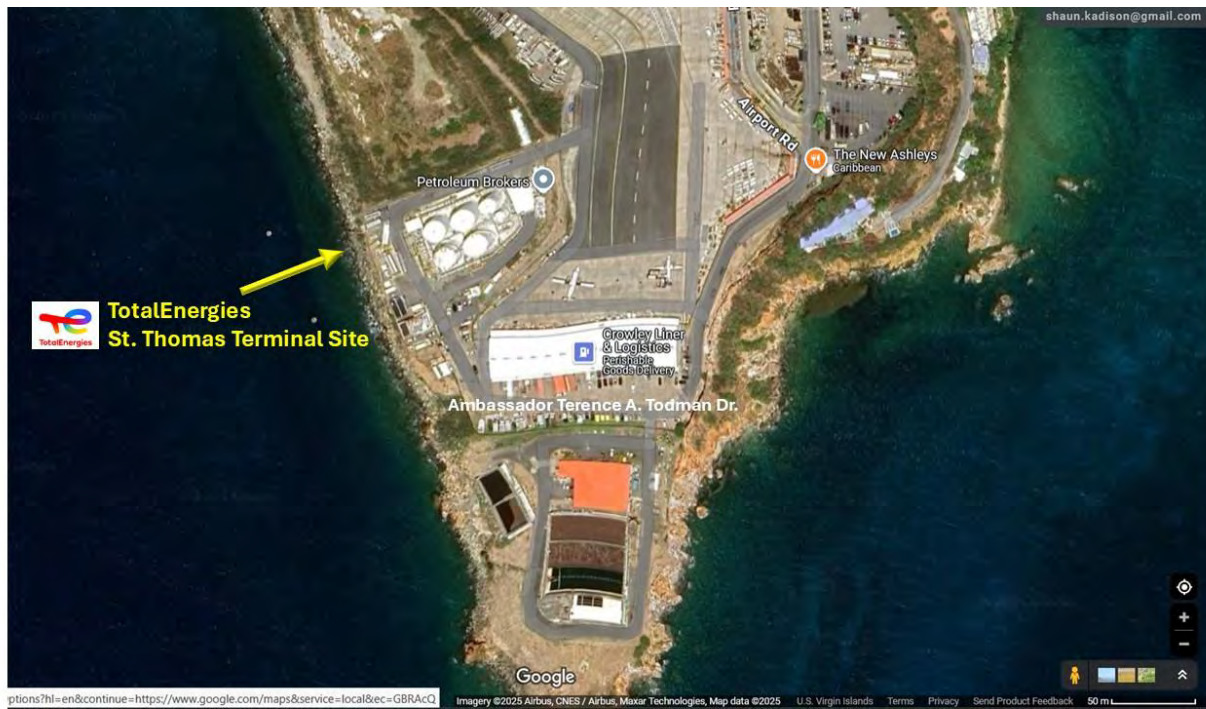
**Figure 5.02.02.01** Airport Road runs south along the Cyril E King airport and becomes the Ambassador Terence A. Todman Rd, which accesses the fuel depot site.

The property is accessed by the road at the southeastern corner where it is separated by a chain link fence that runs along the perimeter of the property (Figure 5.02.02.01 and Figure 5.02.02.02). The site is all concrete, asphalt and gravel. Directly north of the road is vacant land.

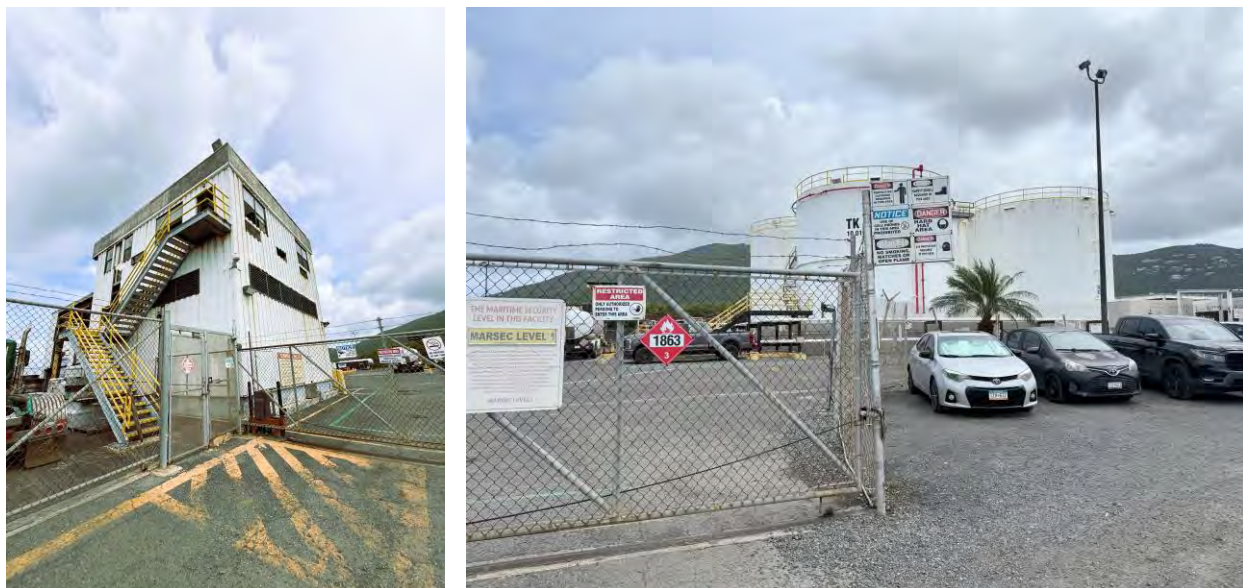
**Figure 5.02.02.2.** At the site the road is gated off and a chain link fence runs the periphery of the property.

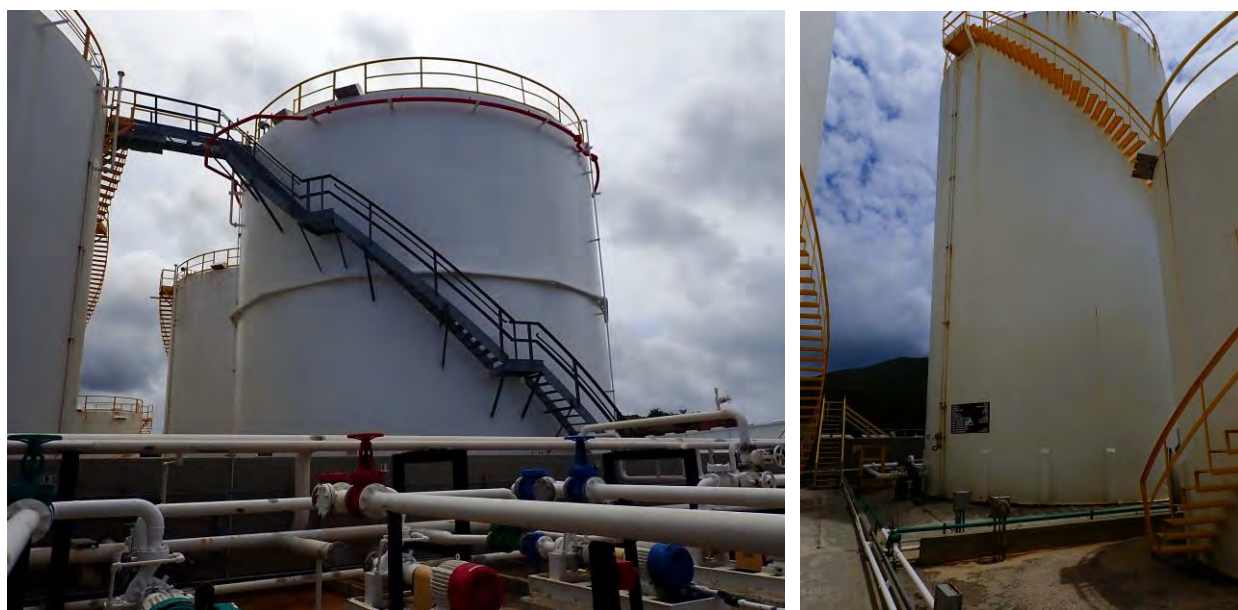
**Figure 5.02.03.01** Five large steel tanks occupy most of the property. Three hold Jet Fuel, one holds diesel oil and a fifth tank is not in use.

All tanks have fixed roofs and are inspected daily in the morning for inventory control. A tape measure is used manually to confirm the quantity of fuel in each tank. This is compared to the monitor gauges to ensure that no leaks are present, and the monitors are accurate. The tanks are surrounded by a 9' concrete retaining wall as required by 40 CFR Part 112 which stipulates that a secondary containment for bulk storage containers, such as a dike or a remote impoundment, must be present and must hold the full capacity of the container plus 10% for possible rainfall (Figure 5.02.03.02).

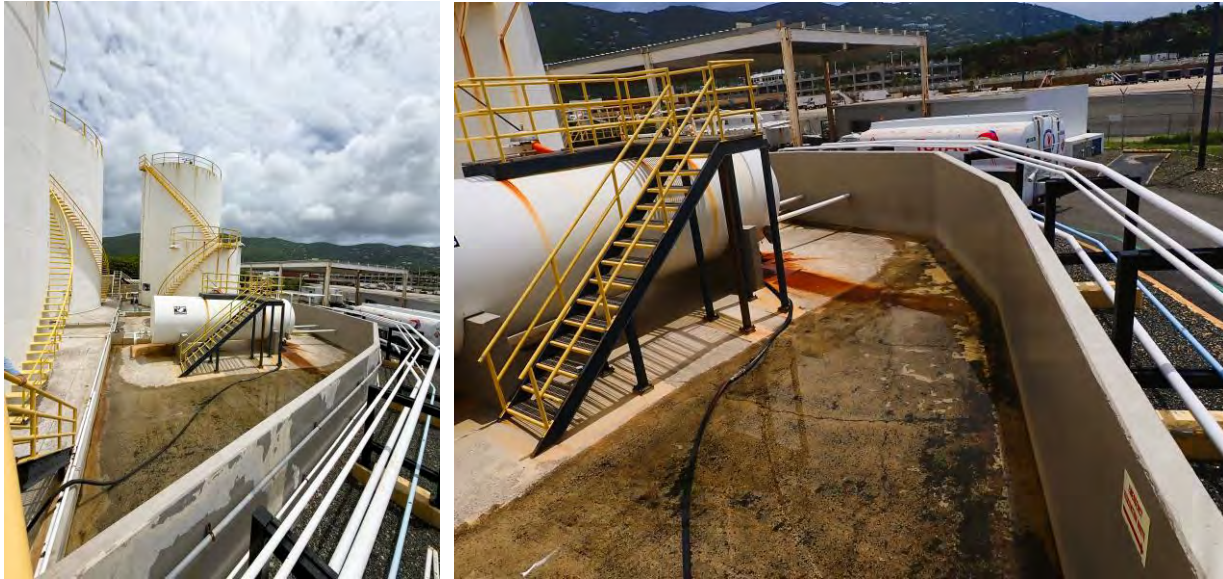
**Figure 5.02.03.02** The tanks are surrounded by a 9' concrete retaining wall as required by 40 CFR Part 112 which stipulates that a secondary containment for bulk storage containers must hold 110% of the container volume.

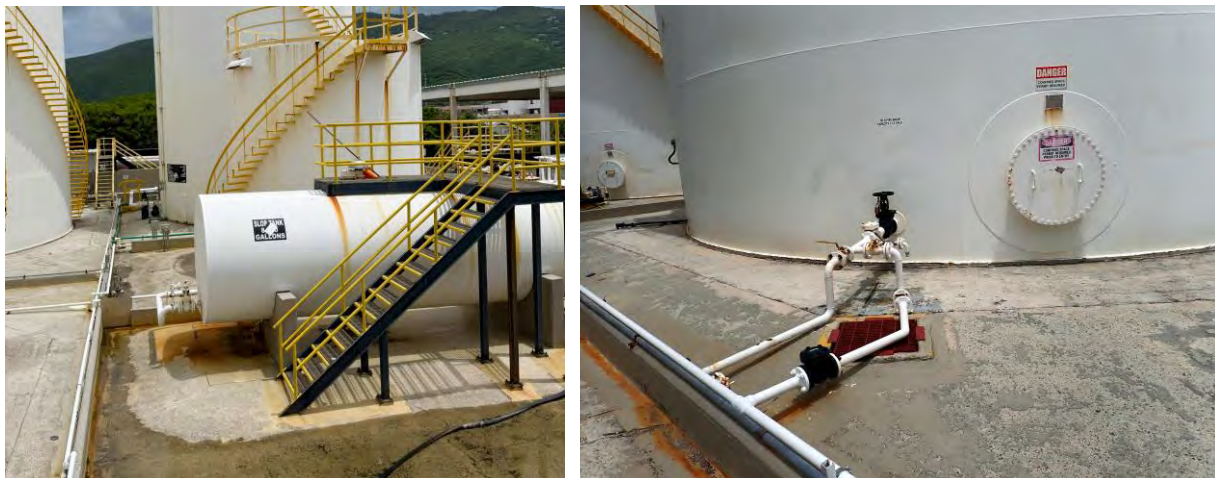
**Figure 5.02.03.03** Fuel is sampled daily from the bottom of the tanks for roof leakage or internal condensation; any water collected is piped to the slop tank where it is stored until removal by an outside contractor.

**Testing:** Tanks are sampled daily from drains at the bottom of the fuel tanks and any water collected is pumped into a “slop tank” (Figure 5.02.03.03), which is a horizontal tank that lies within the impoundment area. Separated pure fuel is returned to the storage tanks. The slop tank is emptied monthly or when needed by an outside contractor, and the processed water is taken off site for disposal.

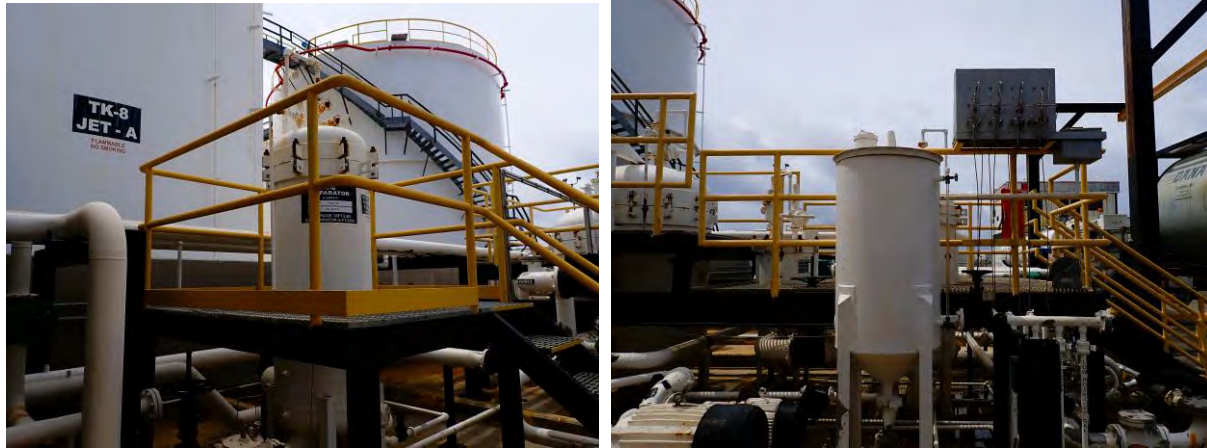
**Figure 5.02.03.04** A double filtration system is used inline when transferring Jet Fuel from storage tanks to the filling tank. This manifold/filtration area is on the west side of the storage tanks near the filling station.

**Jet Fuel Filtration:** The two tanks receiving Jet Fuel from offshore ships are transferred to the filling tank as needed after running through a filtration system. This manifold and filter system is located on the west side of the storage tanks near the filling areas. Two large filters, one mechanical to remove suspended solids and another micronic to remove water are in line between the Jet Fuel receiving tanks and filling tank (Figure 5.02.03.04). Diesel fuel is not filtered. Filters are cleaned and changed as needed; generally once annually. The tank manifold and filter system is surrounded by a 18” concrete barrier wall as required by 40 CFR Part 112.

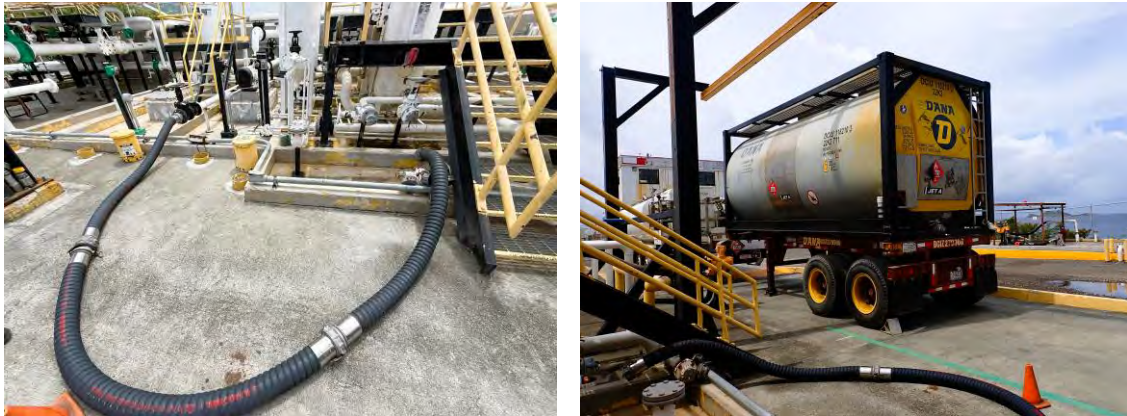
**Figure 5.02.3.05** The diesel truck filling area is adjacent to the manifold and filtration area

**Filling Areas:** Fuel truck filling areas are located west of the storage tanks, on concrete pads. The diesel filling area is located adjacent to the pipe filtration system (Figure 5.02.03.05) and the Jet Fuel filling area is across the road near the shoreline of the property (Figure 5.02.03.06). Both diesel and Jet Fuel are pumped into the tanker trucks using manually operated meters due to loss of the automated filling system in the 2017 storms (Figure 5.02.03.07). Improvements proposed by TotalEnergies include installing a new loading skid with an improved control system and covering the area with a steel canopy to help prevent rainwater from coming in contact with fuel processing equipment. This will further isolate hydrocarbons and prevent them from entering the environment.

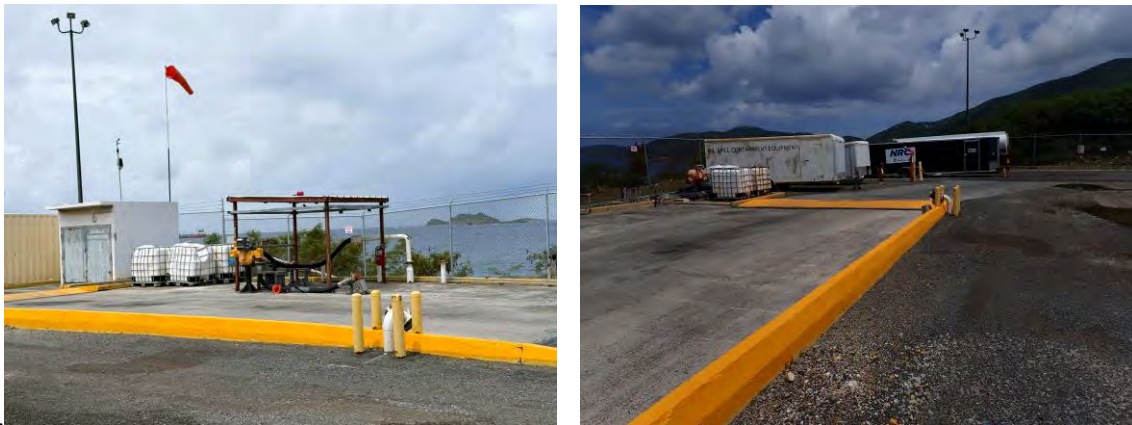
**Figure 5.02.03.06** The Jet Fuel filling area is located west, across the site, along the coastal area of the property. A containment wall surrounds all piping and filling areas.

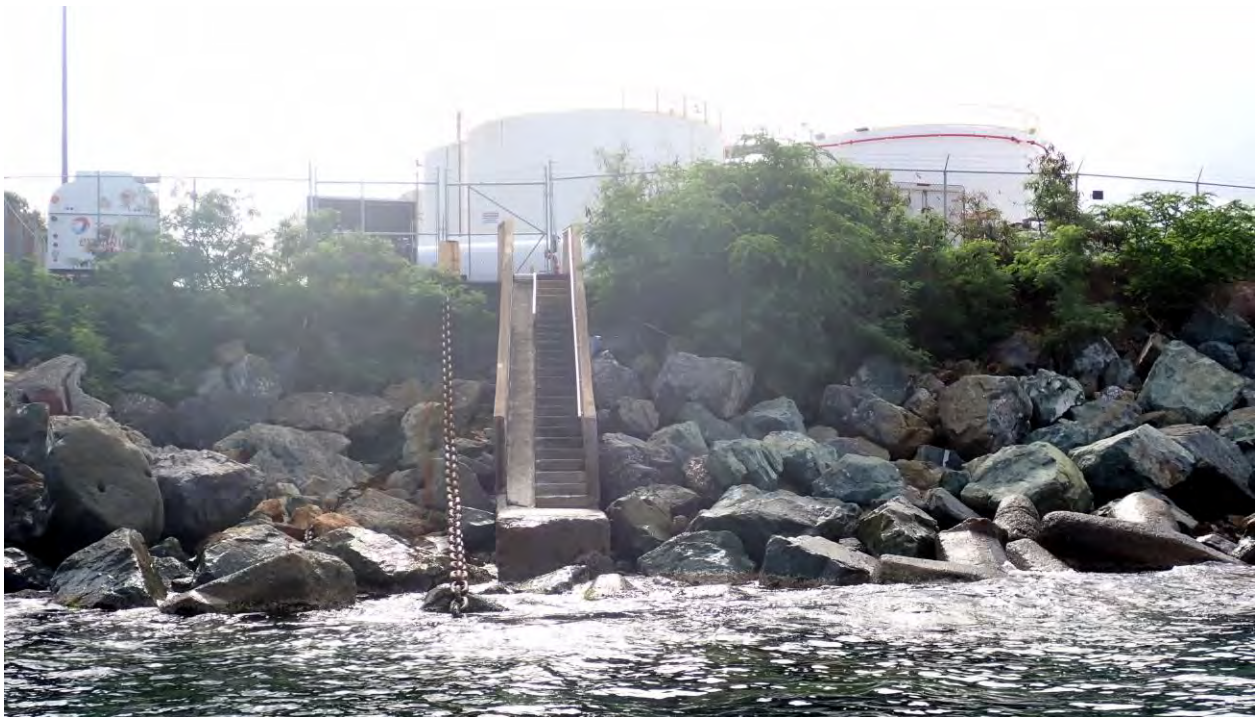
**Figure 5.02.03.08** The TotalEnergies Terminal steel pipeline is encased in concrete and descends down the shoreline covered in large boulders on the west side of the property to the sea floor.

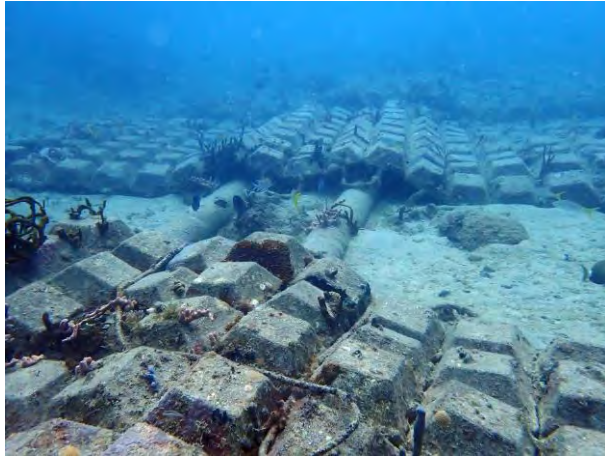
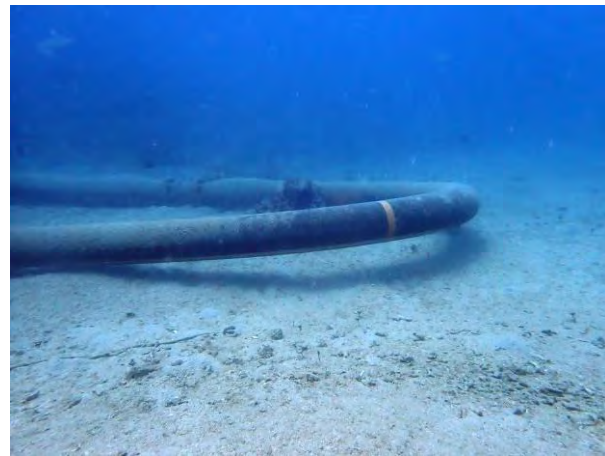
**Figure 5.02.03.09** The pipelines are held to the seafloor with SubMar concrete mats until the free terminal ends where they are free to be picked up by tankers and used to transfer fuel.

(Figure 5.02.03.09). Fuel tanker ships and barges, stationing themselves just offshore the depot on 4 permanent moorings (MBM), pick up the end of the operational fuel line via the large chain and connect it securely to the ship fuel tanks before TotalEnergies begins a transfer of refined Jet Fuel or diesel to the on-shore terminal.

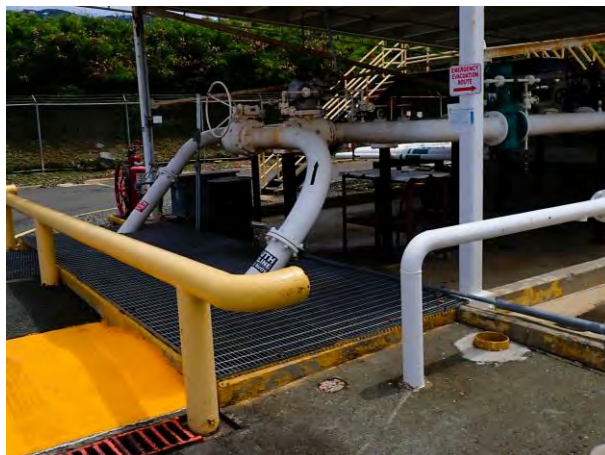
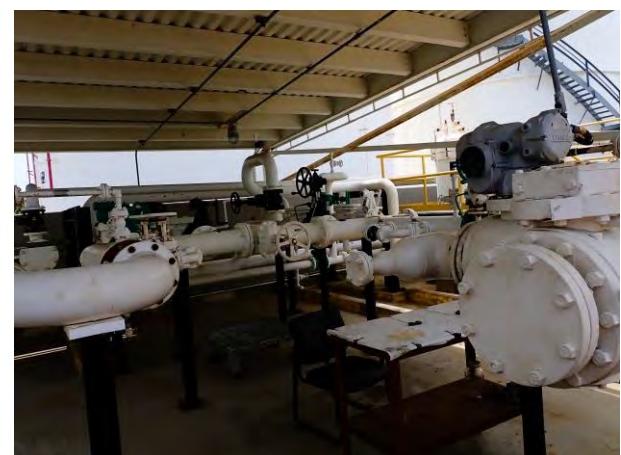
**Figure 5.02.03.10** Two pipelines emerge from beneath the concrete slab to fill the Jet Fuel and diesel tanks at the facility. Only one line is currently used. The second is for redundancy and a back-up in case something happens to the other.

Once the fuel reaches the transfer area on land via the underground pipe that emerges at the storage area, it is pumped to the appropriate tank via a large manifold system (5.02.03.10). This system is located between the fuel storage tanks and the filling areas. The same pipeline is used to transfer both Jet Fuel and diesel oil. Visual and density verifications are performed to control the purity of the product going into the tanks. When the pipeline is not in use it is filled with sea water. This is pumped into the slop tank before new fuel is pumped through the line.

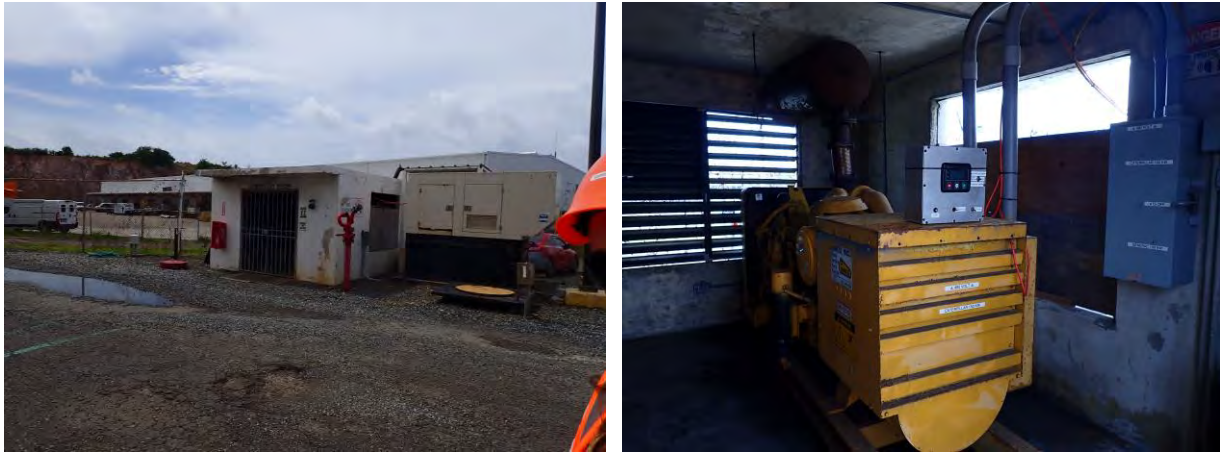
**Figure 5.02.03.11** A small concrete building housing a 150 KW generator sits on the southern edge of the property. An additional out of service 100 KW generator is located outside of the structure. Improvements included relocating generators and installing electrical cabinets for power distribution in the protected concrete building.

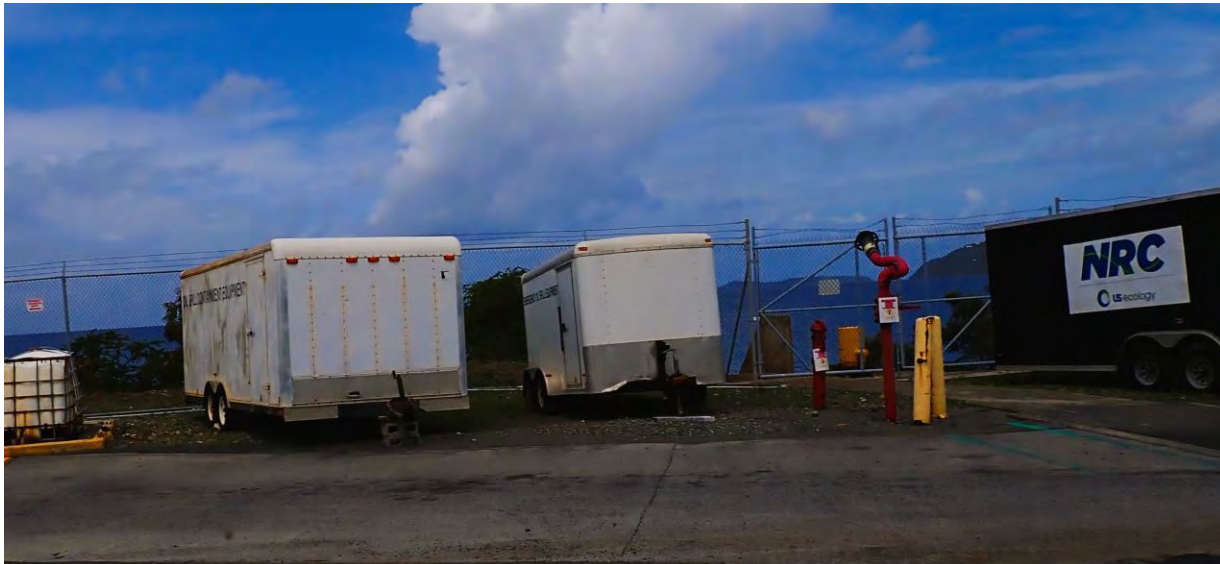
**Figure 5.02.03.12.** On the western edge of the property near the pipelines are trailers that hold oil spill equipment and supplies.

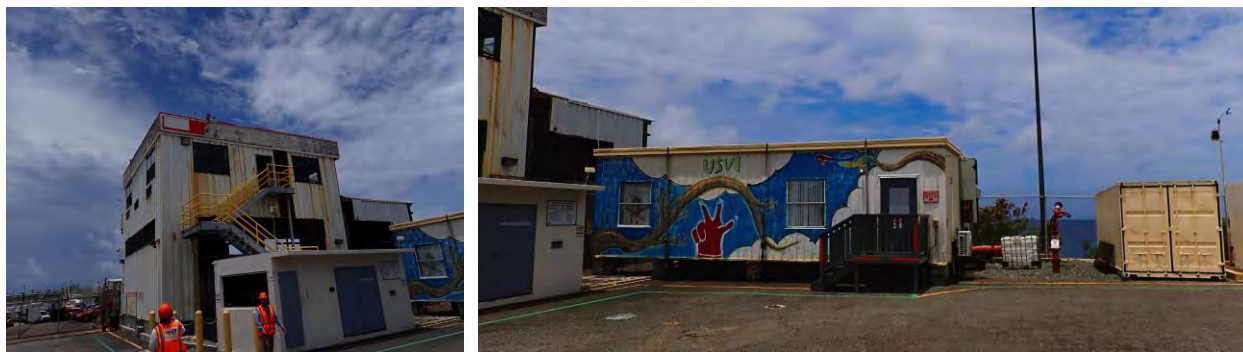
**Figure 5.02.01.10.** The old administration building was damaged in the storms of 2017 and now sits abandoned on the SW corner of the property. A trailer beside it currently serves as the administrative building. Next to it is a container with firefighting equipment which is not currently used. The depot now uses the Aircraft Rescue Fire Fighters (ARFF) based out of the adjacent Airport for emergency fire and explosion incidents. Improvements planned by TotalEnergies include reconstructing the administrative building and equipping the facility with a dedicated Firefighting system.

During the hurricanes of 2017 (Irma and Maria), the main administration building on the St. Thomas Terminal site was damaged, as well as other minor structures and fueling canopies. The fuel automation system was destroyed at the fuel depot site, as was the hydrocarbon detection mechanism in the water fuel separator system.

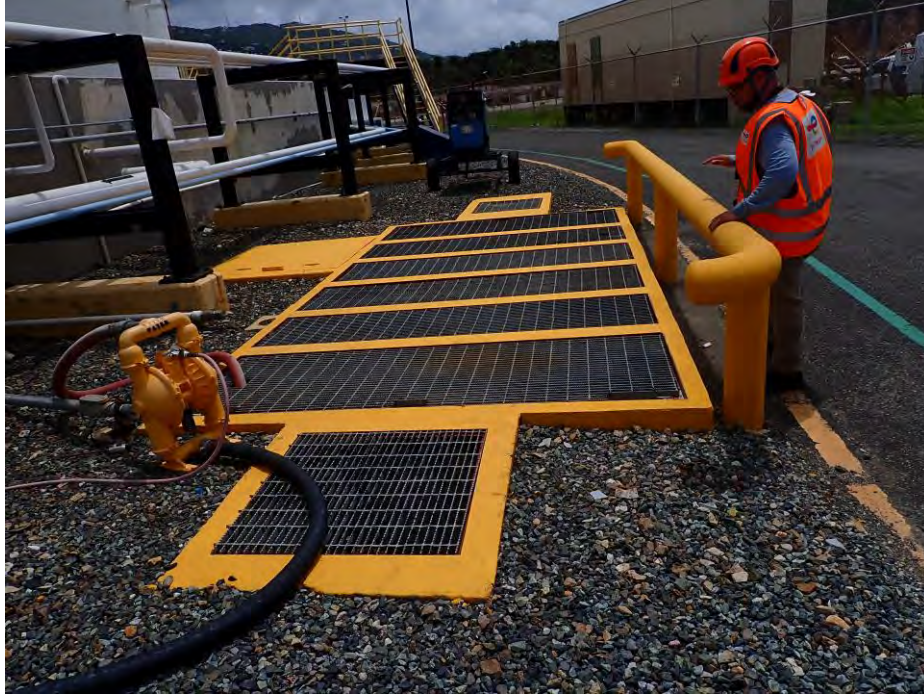
**Figure 5.02.06.01** The grated, underground three chambered storm water basin acts by separating clean water from fuel via density separation. Water that falls into containment areas is pumped into the water/fuel separator and only clean water is released.

The storm water separator is a concrete, grated underground basin with three chambers. These chambers are open at the bottom and act a density separator, allowing the denser clean water to flow from one to chamber to another. The hydrocarbons float on top of the first chamber. Prior to the release of any water, it is inspected visually to confirm there are traces of hydrocarbons. In the past there was a valve which closed automatically in case of hydrocarbon detection in the separator. This functionality was lost following damages to the main building in 2017, and TotalEnergies plans to recover it in the future. Contaminated water at the top of the water separator is pumped into the slop tank and disposed of by an external specialized company.

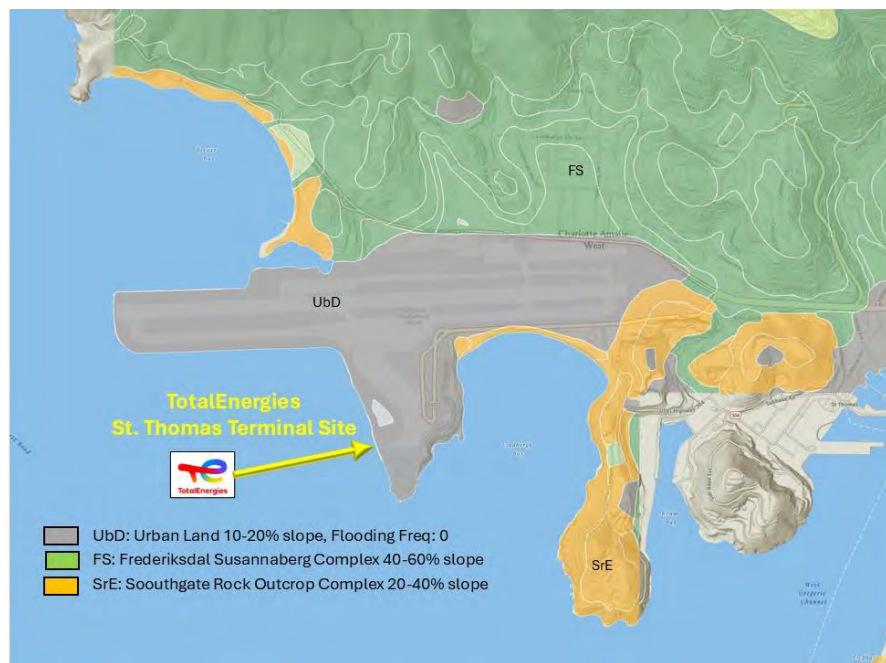
**Figure 6.02.03** Soils of Lindbergh Bay around TotalEnergies ST. Thomas Terminal identified in the 2020 USDA Soil Survey of the U.S. Virgin Islands.

Three soil types have been identified in the area around the TotalEnergies St. Thomas Terminal in the USGS Soil Surveys of the US Virgin Islands. These are shown on Figure 6.02.03 and listed below:

**Frederiksted Susannaberg FsF Complex:** The land above Lindbergh Bay and the airport is relatively steep and comprised of Frederiksted Susannaberg FsF Complex soils. These soils are well drained, non-saline, extremely rocky, on 40-60% slope. The water permeability is slow, organic matter high, and hazard of erosion high. The seasonal high water table is more than 6 feet deep and the chance of flooding none.

**Southgate Rock Outcrop SrE Complex:** The areas north and south of the airport along the sea are part of the Southgate Rock Outcrop SrE Complex. These soils on a 20-40% slope are brown gravelly loam over weathered igneous bedrock. Properties include well drained soil with moderate permeability, low water capacity, a severe hazard of erosion, a seasonal high water table more than 6 feet deep, and the chance of flooding none.

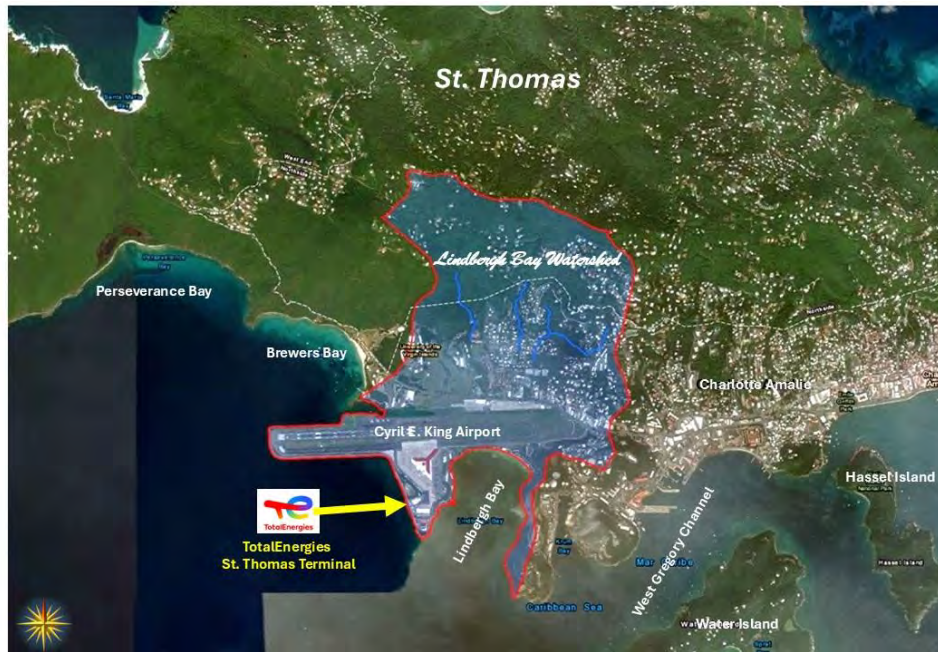
**Figure 6.03.01** Watersheds and guts in Lindbergh Bay around TotalEnergies St. Thomas Terminal.

Figures 6.03.01 show the watersheds and wetland area of Lindbergh Bay. Guts from the neighborhoods to the north flow south into Lindbergh Bay. The TotalEnergies property is unaffected by this water flow. Although originally a wetland existed where Lindbergh Bay is today (Mosquito Bay), this was filled and developed in the 1920's with the original airport development.

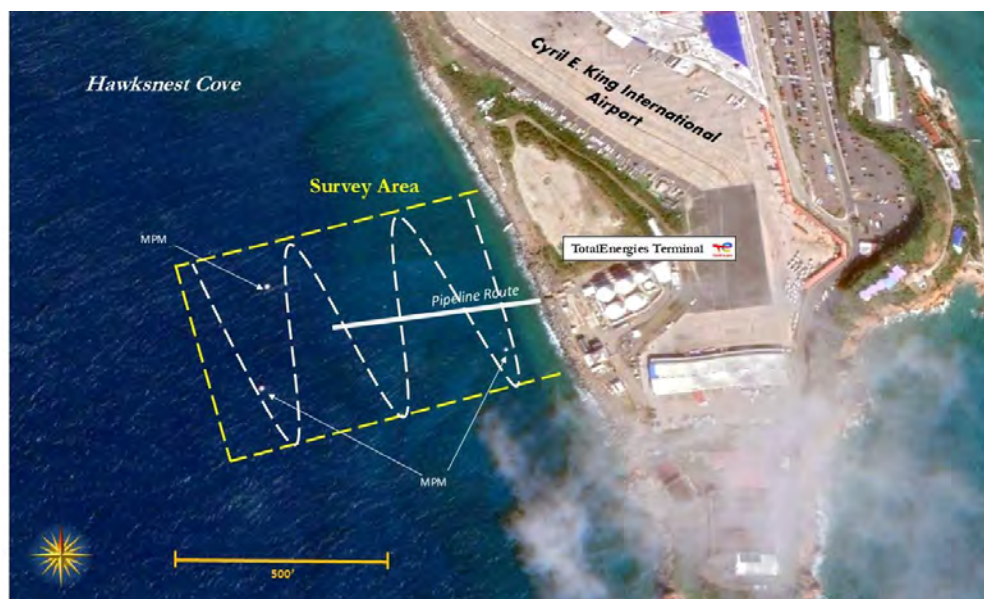
**Figure 6.06.01** Area surveyed on May 18, 2025, around the TotalEnergies submarine pipeline and mooring field.

species or species of special concern were documented. Additionally, the survey inspected the integrity of the MBMs, the fuel transfer pipes, and the SubMar concrete mats covering the pipelines, to assess any potential environmental damage due to defective underwater components present. The underwater survey was conducted over a three hour time period, habitat types were identified on Google Earth satellite images, and tables were generated with species occurrence and relative abundance. Any federally protected species encountered, either coral, invertebrate, fish or megafauna were photographed and documented.

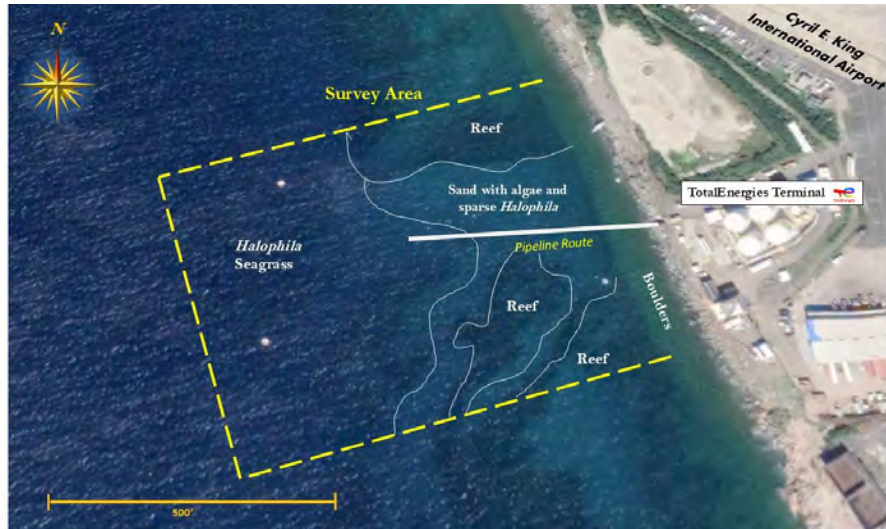
**Figure 6.06.02.** Site map with marine benthic survey area outlined and the benthic types delineated in the Google Earth aerial image taken in 2018 (Google Earth, 2018).

The survey site overall was a mix of large shoreline terrigenous rocks and concrete bolas, which transitioned to unconsolidated limestone rocks, rubble, and coarse grained sand at approximately 20 feet depth (Figure 6.06.02). The sandy region was colonized by turf and macroalgae, and sparse non-native *Halophila stipulacea* seagrass. This transitioned to a *Halophila* seagrass meadow which defined 50% of the survey area. A relic coral reef extended seaward from the shoreline on both northern and southern side of the survey area, and a third reef was found in the center of the site (Figure 6.06.02 and 6.06.03). These reefs ranged in depth from 25 feet to 55 feet, where they were met by sand and seagrass.

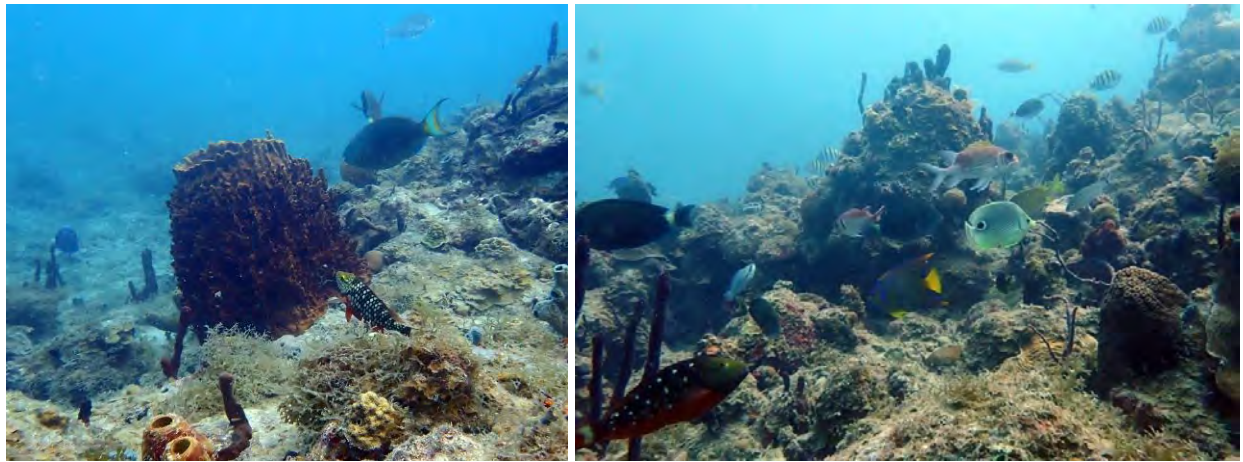
**Table 6.06.05** Fish diversity was high in the survey area around the TotalEnergies mooring field.

Fish diversity was also high across the pipeline, boulders, and relic reef areas (Figure 6.06.5). Over 80 species of fish were observed within the three hour survey. Many juveniles were recorded of the

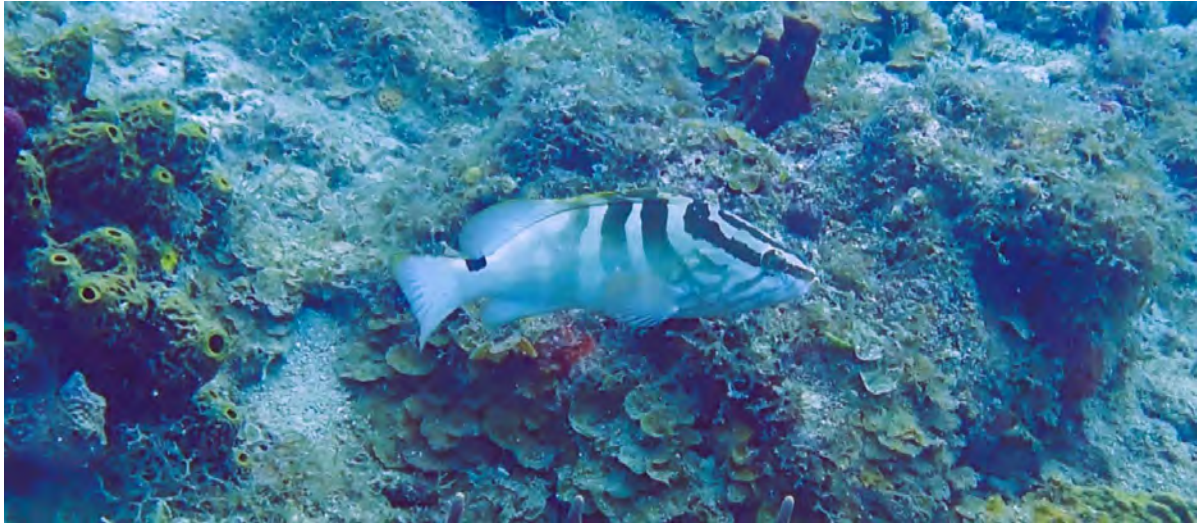
**Figure 6.09.02** Three Nassau grouper sea turtle were observed during the three hour benthic survey in the mooring field of the TotalEnergies St. Thomas Terminal.

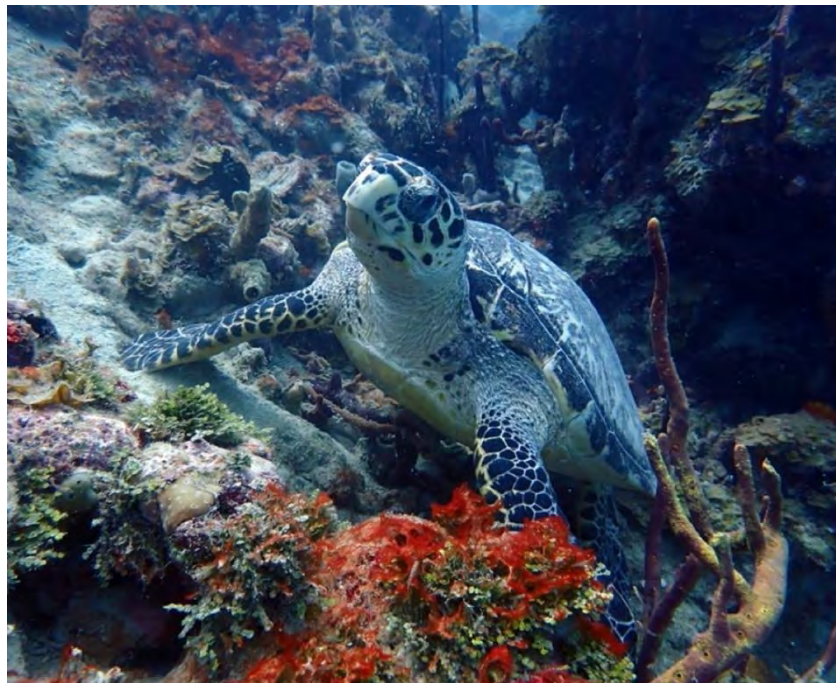
**Figure 6.09.03** One hawksbill was observed on the relic reef on the TotalEnergies St. Thomas Terminal

This survey area around the TotalEnergies Terminal mooring field and PMP supports a variety of protected corals, fish, and megafauna. Three species of coral present at the site are listed as ESA “Threatened” (*Orbicella annularis*, *Orbicella faveolata*, and *Orbicella franksi*). In addition, five species of coral present are listed as “Highly Susceptible Species” corals (*Meandrina meandrites*, *Eusmilia fastigiata*, *Diploria labyrinthiformis*, *Pseudodiploria strigosa*, and *Colpophyllia natans*; Figure 6.09.01) An additional ESA “Threatened” species observed during the survey was the Nassau grouper (*Epinephelus striatus*; Figure 6.09.02). Finally, the federally protected hawksbill turtle (*Eretmochelys imbricata*) observed during the survey and illustrates the importance of the near shore reef as critical habitat for juvenile and adult hawksbill turtles (Figure 6.09.03).
