# ENVIRONMENTAL ASSESSMENT REPORT FOR THE USVI SOCCER FEDERATIONS' ST. THOMAS SOCCER FACILITY

Estate Nazareth, St. Thomas U.S. Virgin Islands

**FEBRUARY 2026**

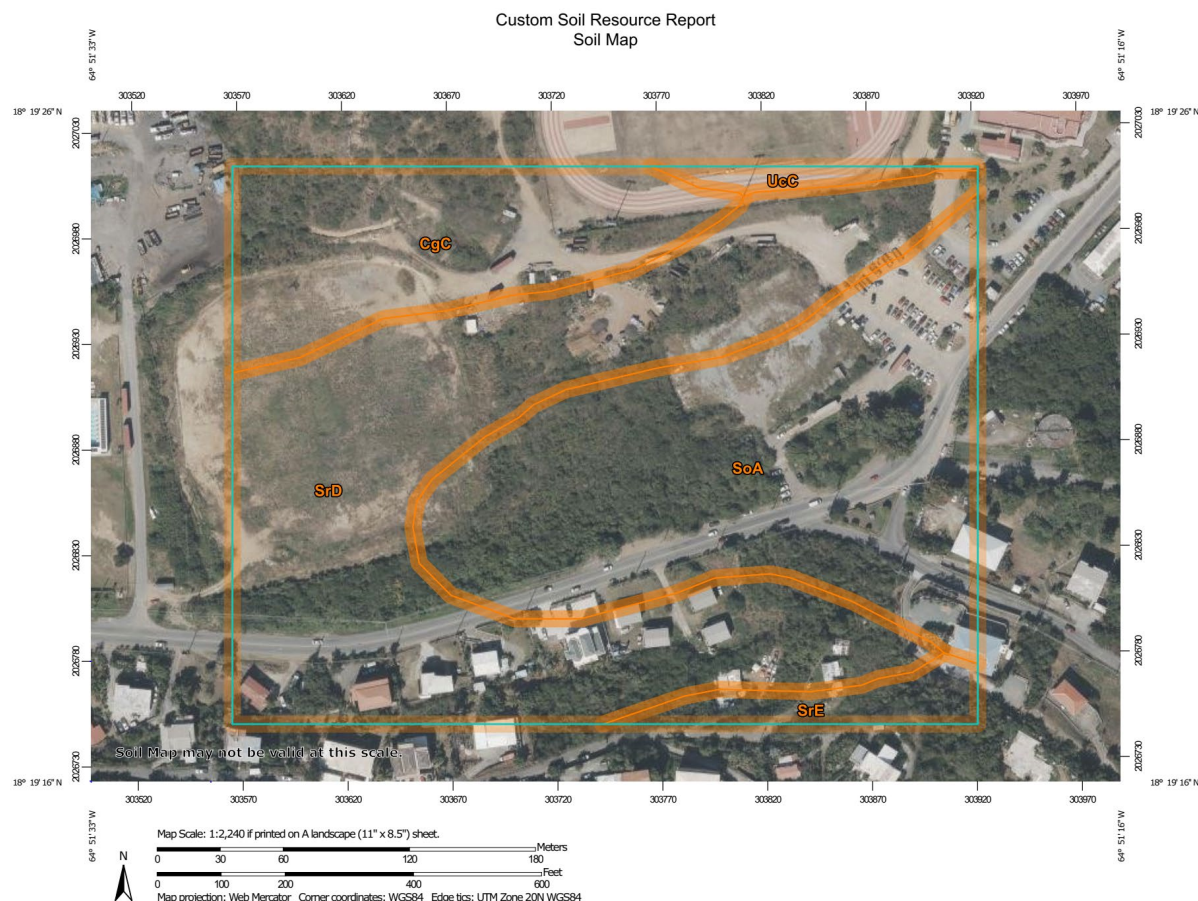
**Figure 10. USDA-NRCS Soils Map**

Two soil types are associated with Cowpet Bay West according to the Custom Soil Survey of the United States Virgin Islands. Southgate-Rock outcrop complex (SrD), 12 to 20 percent slope, these soils are found on hillslopes, mountain slopes, and ridges and often have as much as 40% exposed rock outcroppings. This is the soil found throughout the northern portion of the property. The southern portion of the site is Solitude gravelly fine sandy loam, 0 to 2 percent slopes, frequently flooded.
