**ENVIRONMENTAL ASSESSMENT REPORT  
FOR THE DEVELOPMENT OF  
HAIRON AVIATION SERVICES, INC  
FUEL FARM OPERATION AT  
CYRIL E. KING AIRPORT  
ST. THOMAS, US VIRGIN ISLANDS**

**ENVIRONMENTAL ASSESSMENT REPORT  
A MAJOR LAND PERMIT MODIFICATION**

EXECUTIVE FUEL TERMINAL  
TANKS FOUNDATION  
CYRIL E. KING AIRPORT  
CHARLOTTE AMALIE,  
ST. THOMAS, USVI 00801

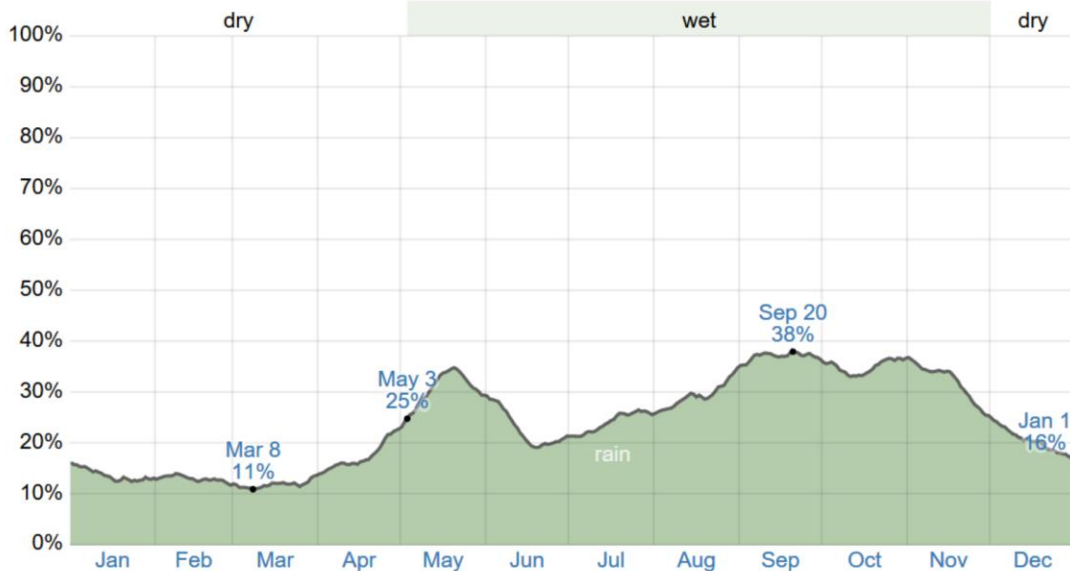
The percentage of days in which various types of precipitation are observed, excluding trace quantities: rain alone, snow alone, and mixed (both rain and snow fell in the same day).

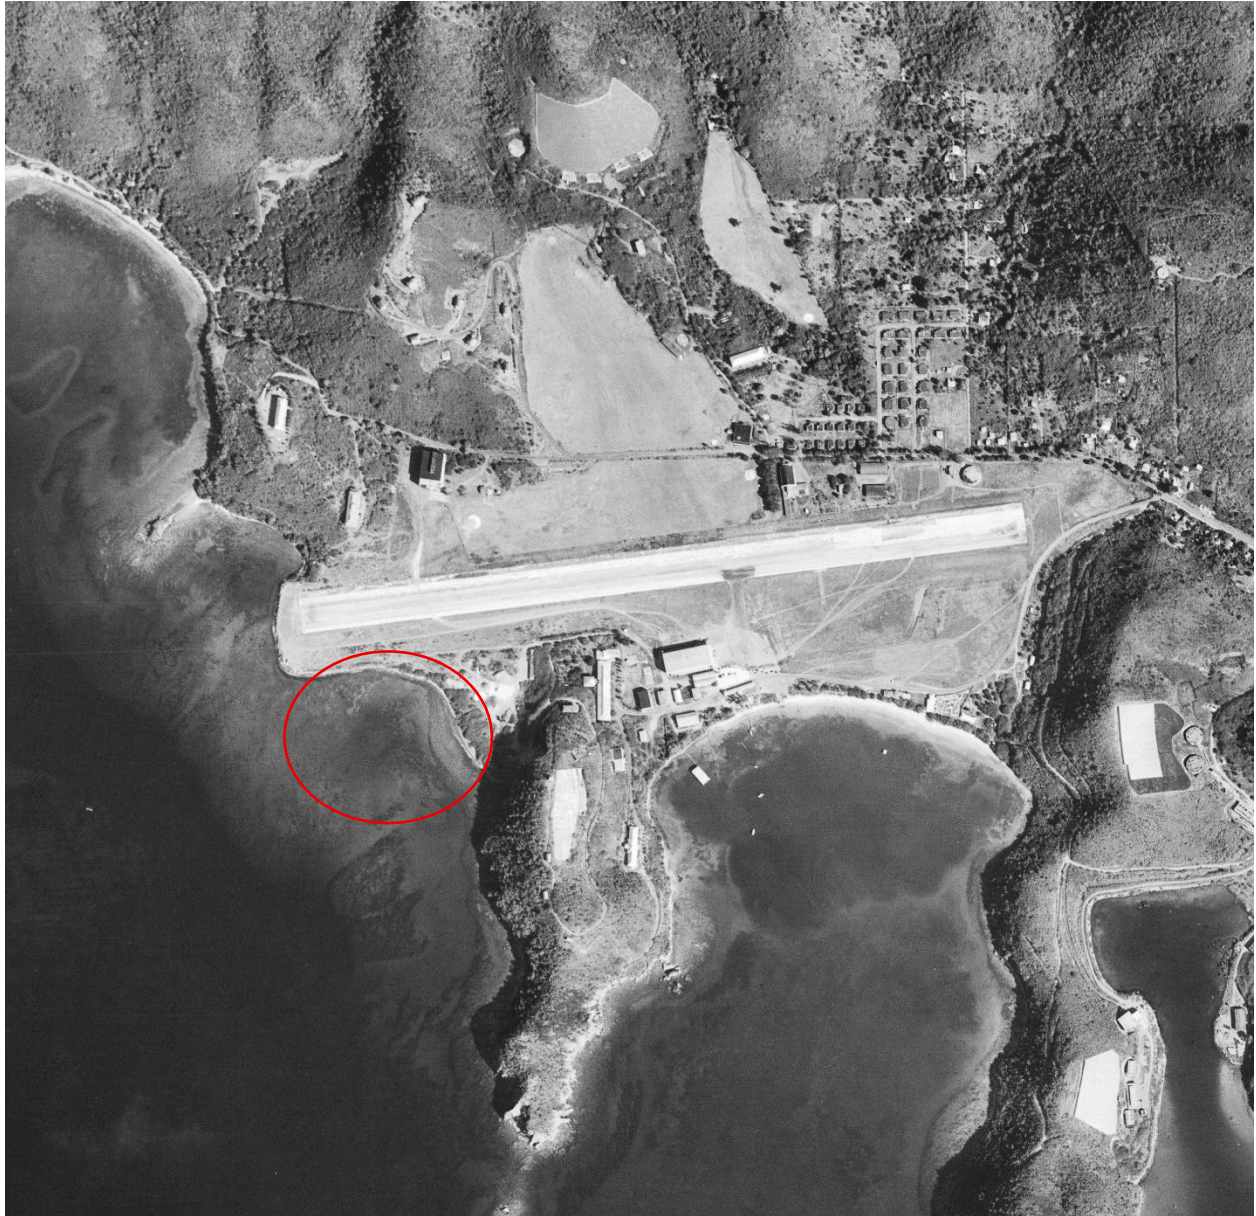
Airport 1954

A runway was constructed in the late 1960's created "College Cove" and impacted the area around Range Cay.

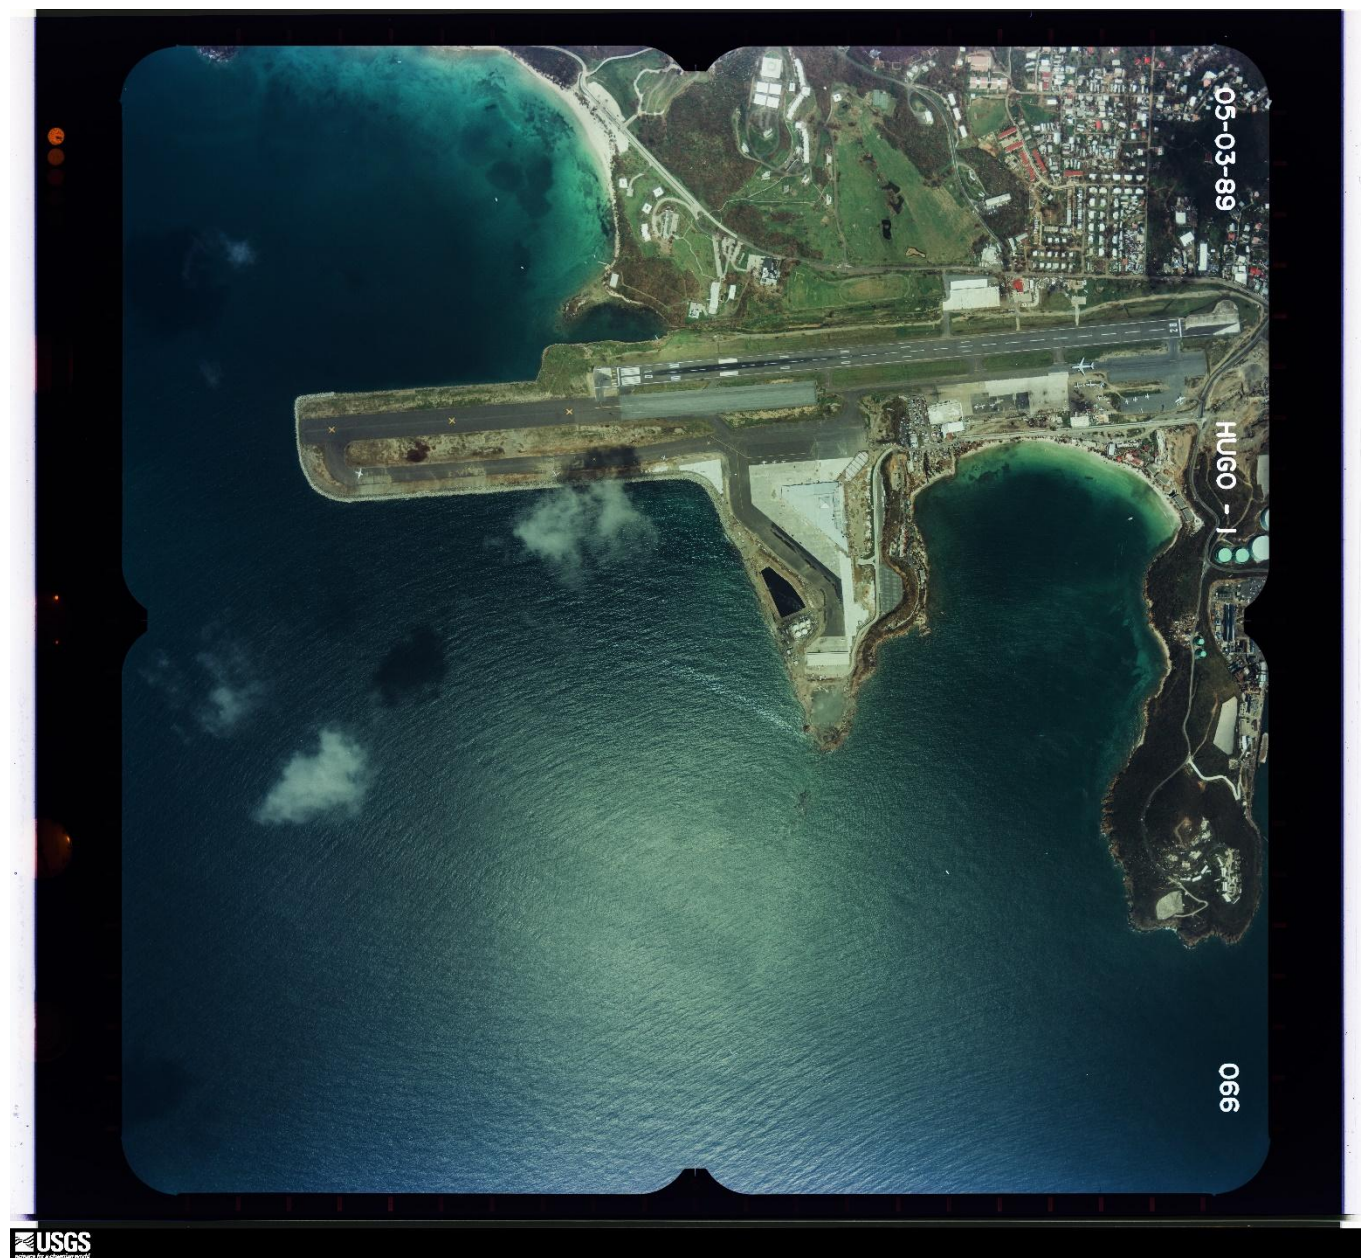
Airport in 1989, the new runway is not yet in operation. The project area is to the north of the large Wastewater Treatment Plant (WWTP) pond.

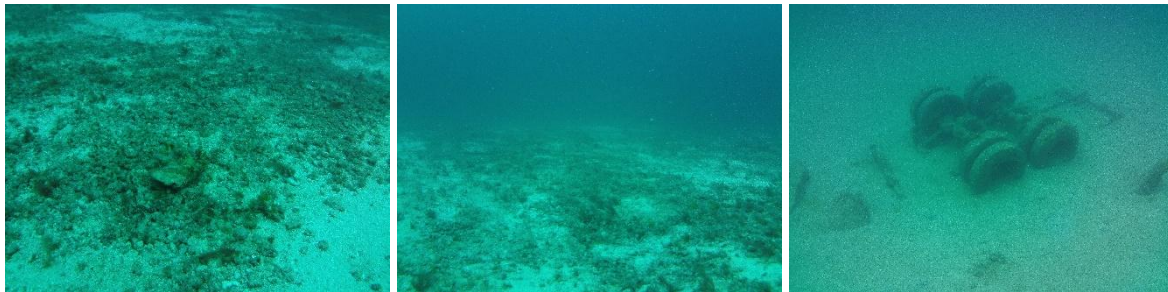
Along the edge of the revetment there are large areas of broken rock and there is a notable amount of debris.

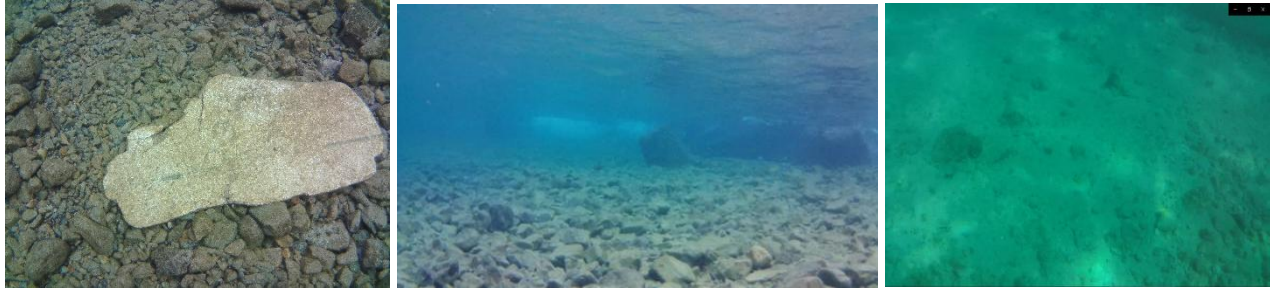
There is an area of rock revetment along the western shoreline. The rock revetment has less than 2% overall colonization. This may be due to movement of the stones during the hurricanes of 2017. *D. strigosa*, *P. astreoides* and *Millepora spp.* are the most abundant colonizers. The fuel depot fueling systems and buoy lie offshore. Total upgraded the fueling system and replaced the pipeline in 2019.

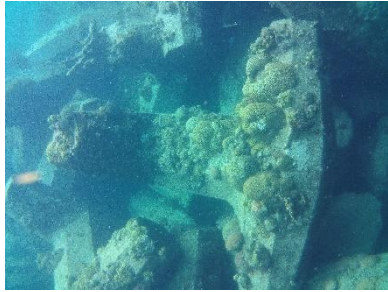
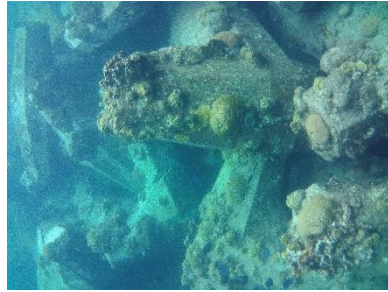
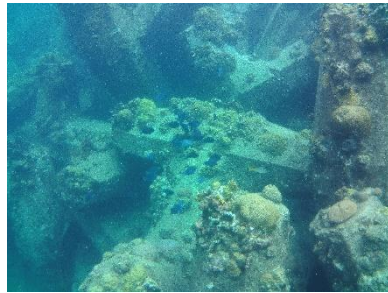
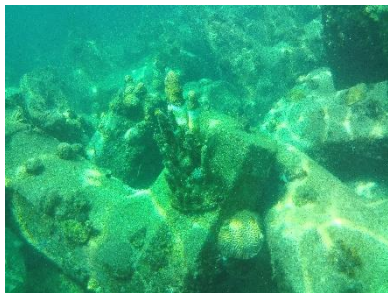
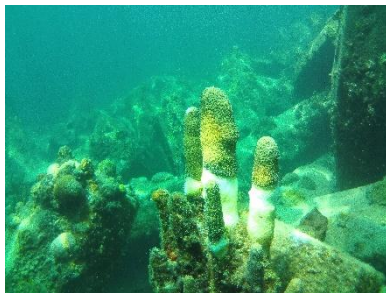
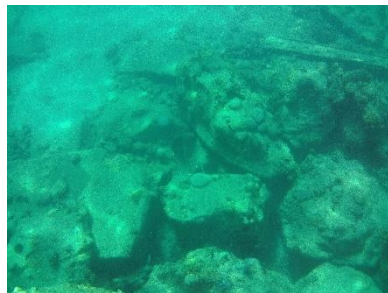
The dolos begin approximately 450ft from the base of the runway where it extends into the sea. The amount of coral colonization significantly increases on the dolos and colonization ranges from 10% to over 50% of the exposed surfaces. The dolos are colonized by *D. strigosa*, *S. siderea*, *Palythoa caribbaeorum*, *P. astreoides*, *P. porites*, *D. labyrinthiformis*, *Agaricia agaricites*, *A. fragilis*, *Stephanocoenia intersepta*, *Millepora alcicornis*, *M. complanata*, *Dichocoenia stokesii*, *Meandrina meandrites*, and ESA species *A. palmata*, *D. cylindrus*, and *O. faveolata*. Soft corals and gorgonians are also present though in much lower abundance than hard corals seen were *Briareum asbestinum*, *Gorgonia flabellum*, *G. ventalina*, *Pseudopterogorgia americana*, *P. bipinnata*, *Pterogorgia anceps*, *P. citrina*, *Eunicea spp.*, *Muriceopsis flavida*, *Plexaura flexuosa*, *Plexaurella nutans*, and *Pseudoplexaura spp.* Fish are abundant along the dolos. Some invertebrates were noted and lobsters (*Panularis argus*) were seen deep in the crevices. Stony Coral Tissue Loss Disease was seen on corals on the dolos. Damage from the 2017 hurricanes was evident on the branching corals which were noted to be recovering.
