Hazmat Assessment & Abatement/ Demolition for Swan Annex & Adjacent Buildings

Task 4: Manual for Bidders | APRIL 10, 2024

Materials Handling Performance Plan

Swan Annex Lots 104 - 109

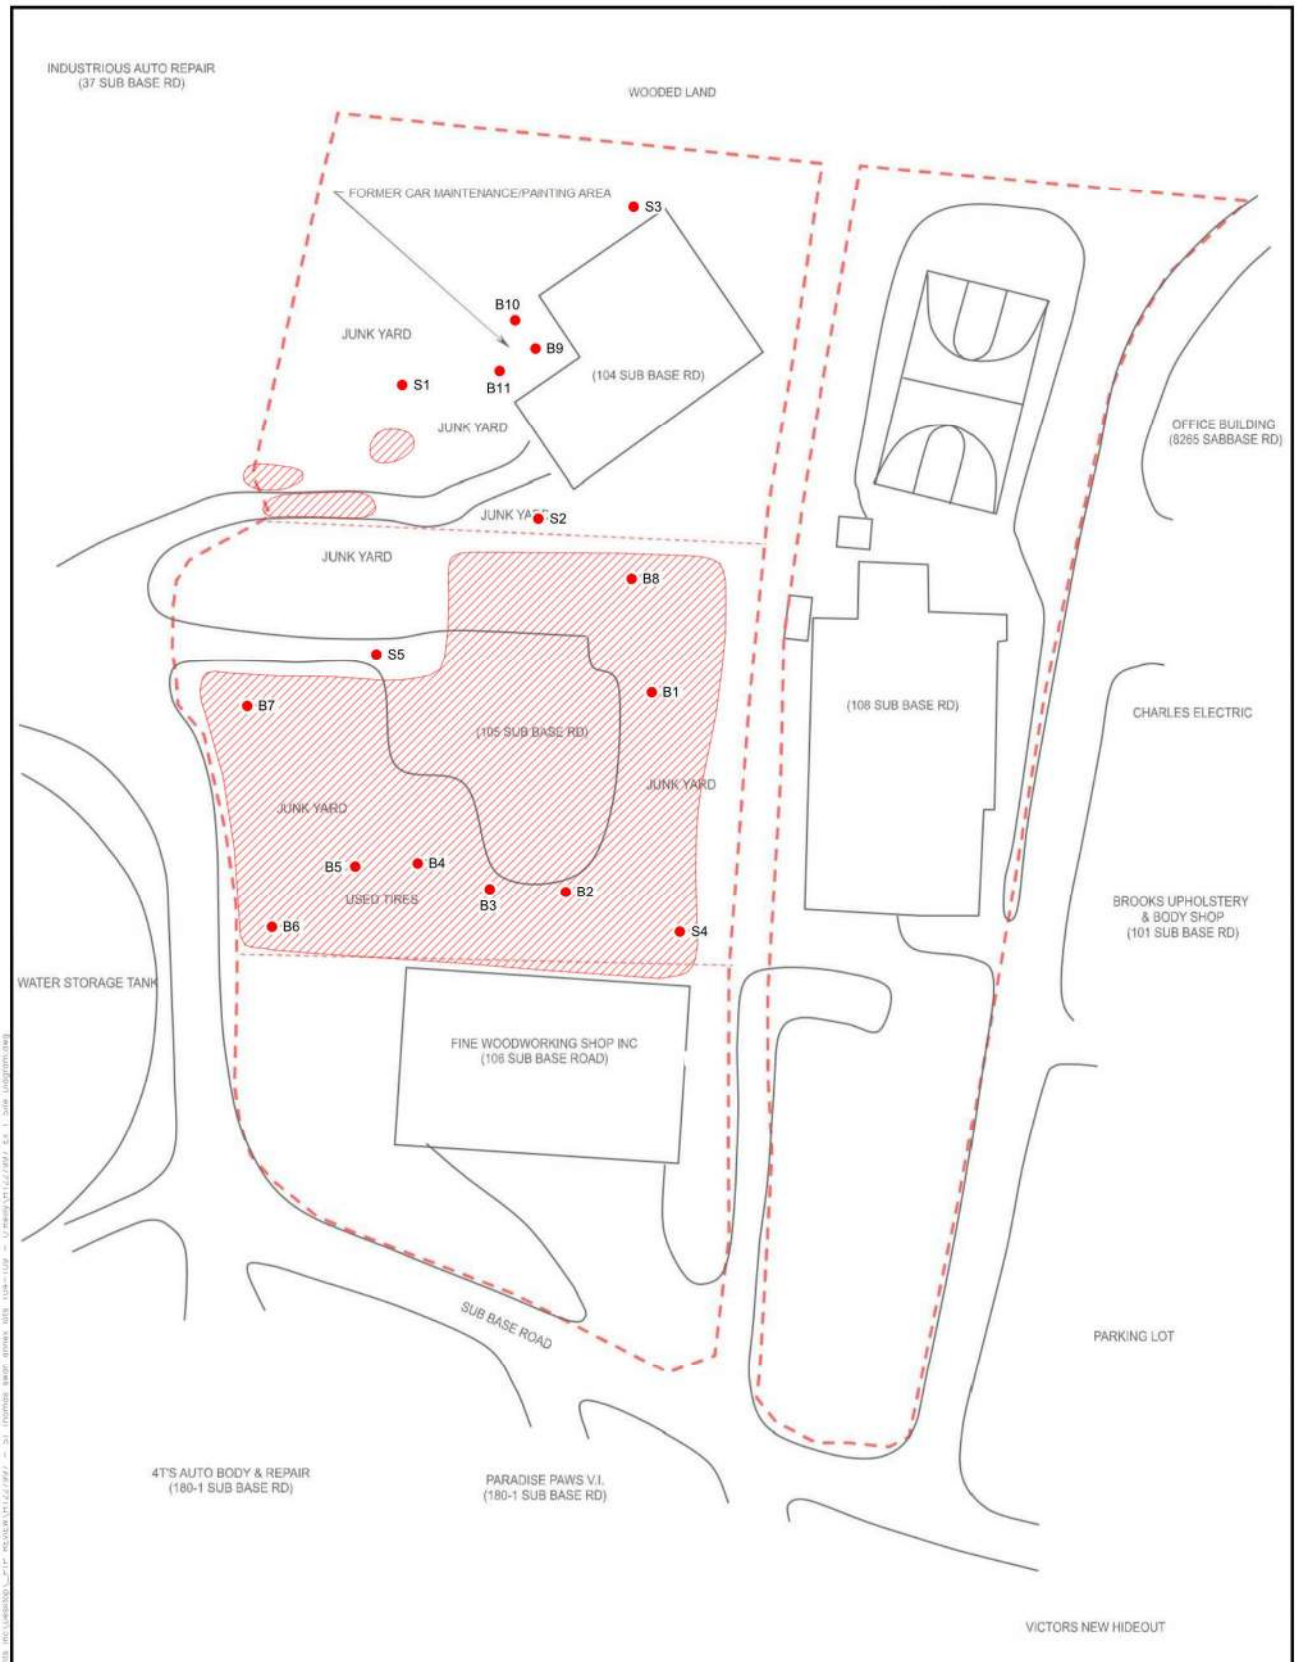
EXHIBIT 1

A site diagram in Exhibit 1 identifies the areas of petroleum-stained soil to be removed. Locations of stored chemical and other pertinent items are shown on the attached individual lot diagrams in Exhibits 2 through 5. Photographic documentation of observed site conditions is presented in Appendix A. The soil analytical laboratory reports are presented in Appendices B and C.

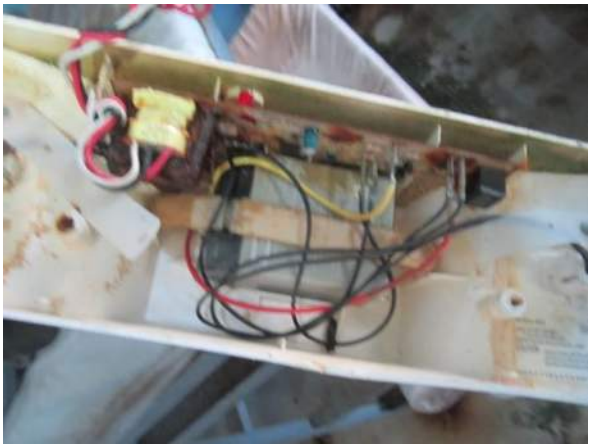
Photo #11 Emergency light battery in the Swan building.

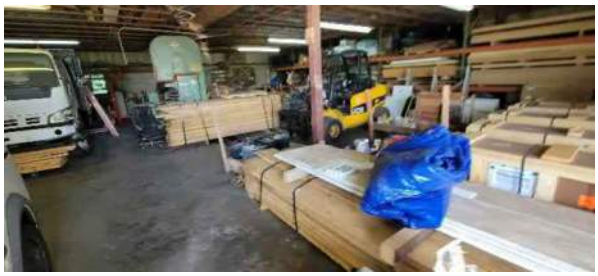
Photo 41 Building interior (Lot 106)

Photo 39 Air compressors (Lot 106)

Photo 40 Emergency generator and associated diesel fuel tank (Lot 106)

Photo 42 Chemicals storage (Lot 106)
