**MODIFICATION TO CZT-04-11(L) AND CZT-9-14(W)
ENVIRONMENTAL ASSESSMENT REPORT
SHORELINE ENHANCEMENT AND DOCK MODIFICATIONS
FRENCHMAN'S REEF & MORNING STAR RESORT
ST. THOMAS, US VIRGIN ISLANDS**

**ENVIRONMENTAL ASSESSMENT REPORT
A MAJOR PERMIT MODIFICATION
FRENCHMAN'S REEF**

CREF3 USVI Hotel Owner, Inc. (CREF3) is seeking to modify CZT-04-11(L) and CZT-9-14(W) to enhance the shoreline/beach area for guest use and to modify the permitted dock project to install a 65ft by 6ft wide dock with a 40ft by 6ft wide L-shaped extension. This 600ft² dock would replace the permitted 30ft extension to the northeast of the dock which was intended to house the seawater intake structures.

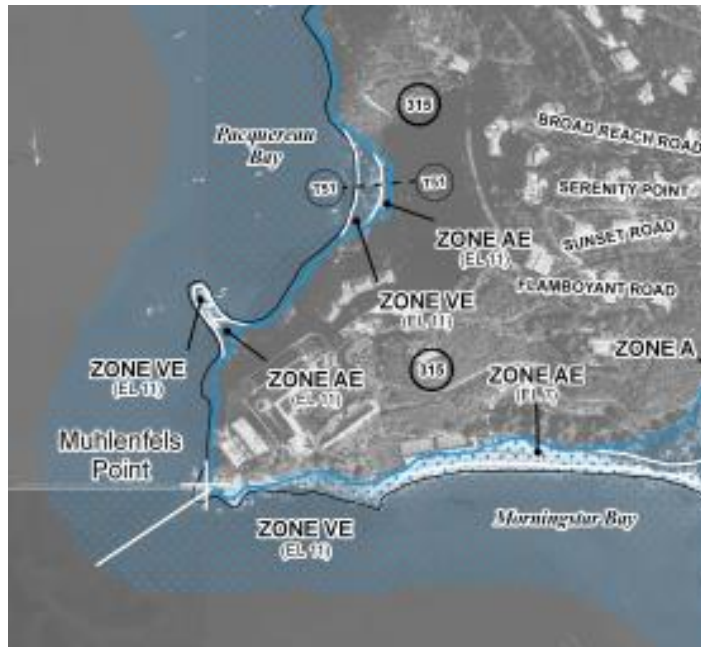
Figure 6.02.1 The FEMA FIRM Map dated April 16, 2007.

The typical wave and wave patterns affect Muhlenfels Point. The southern shoreline in front of Morningstar has some protection from the offshore reef, but Muhlenfels Point is exposed. The existing dock is somewhat protected from the southeasterly prevailing currents and wave climate by Muhlenfels Point. The dock is exposed to seas coming from the southwest and is impacted by waves which wrap around the point from the south. The shoreline areas are in Zone AE, areas of the 100-year coastal flooding in which base flood elevations have been determined to be 11 ft. The offshore area is Zone VE, areas of the coastal flood zone with velocity hazards (wave action) (Flood Insurance Rate Map, Panel 42 of 94, revised April 16, 2007).

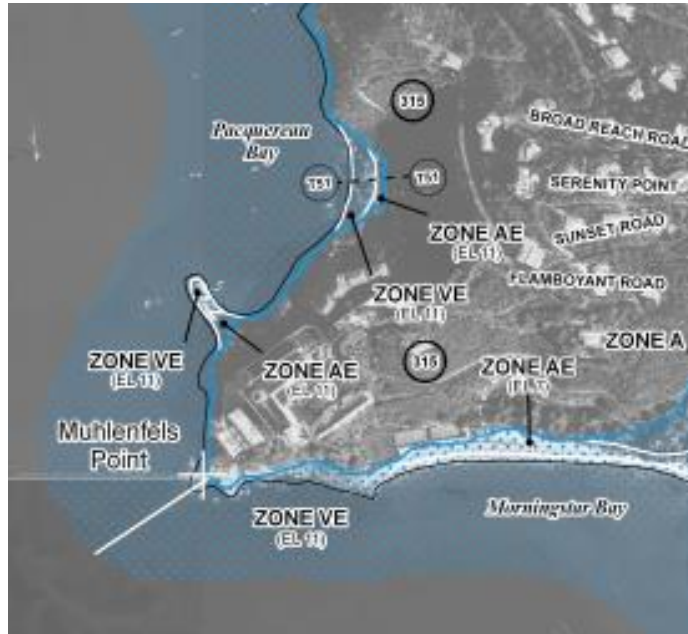
Figure 6.03.1 The FEMA FIRM Map dated April 16, 2007.

from the southeasterly prevailing currents and wave climate by Muhlenfels Point. The shoreline area is in Zone AE, areas of the 100-year coastal flooding in which base flood elevations have been determined to be 11 ft. The offshore area is Zone VE, areas of the coastal flood zone with velocity hazards (wave action) (Flood Insurance Rate Map, Panel 42 of 94, revised April 16, 2007).

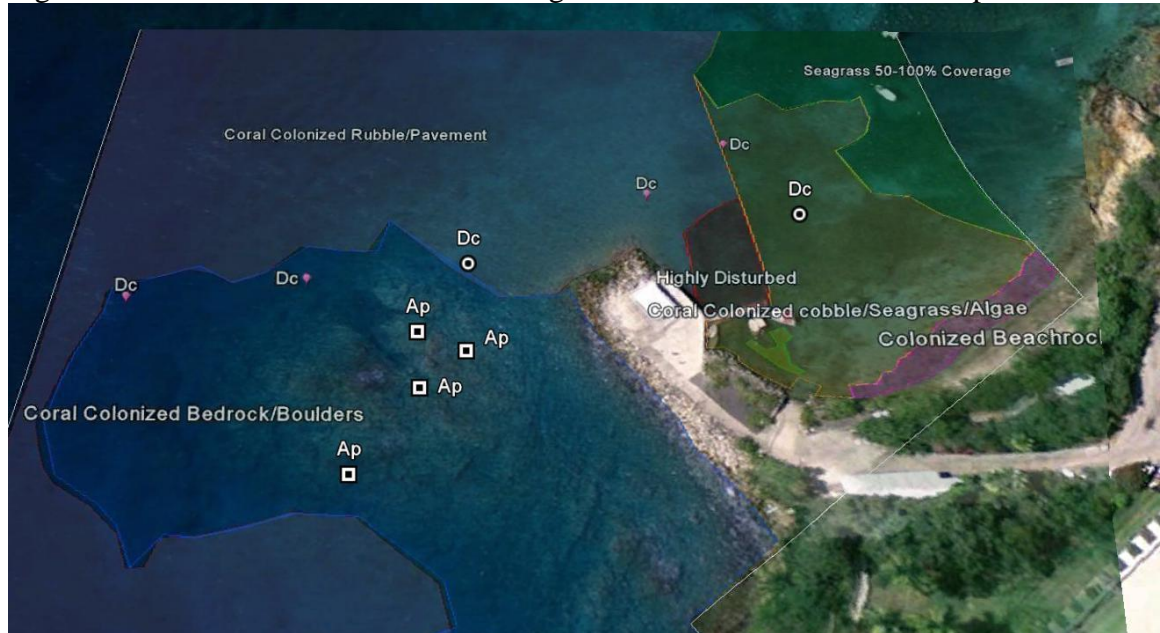
Figure 6.06.3 Benthic habitats around the dock. Dc indicates the approximate location of *Dendrogyra cylindrus* colonies, Ap *Acropora palmata* colonies prior to 2017 hurricanes.

Directly adjacent to the existing bulkhead is a shallow berm made of gravel at the top and slopes down into cobble and small boulder habitat. There is an area with large and small scattered boulders in an approximately 30 ft. by 60 ft. area near the middle of the survey site. This is where most of the corals occur within the survey site. There are a few corals found colonizing isolated boulders within the seagrass, and a few corals found on boulders located on the seagrass/hardbottom boundary. Seagrass colonization begins about 55ft north of the existing bulkhead in the northeastern portion of the study site and continues right up to the boulder habitat near the center of the survey site. There is seagrass colonization close to the shoreline in the southern portion of the survey site. Sand occurs in small patches within the larger seagrass area and in areas northwest of the outer seagrass boundary in the survey area. There is also a small sandy area with some small boulders and cobble between the hardbottom berm surrounding the existing bulkhead and the seagrass boundary in the southeastern portion of the survey site.

Forty-six coral colonies from five coral species were identified within the general proposed dock site at Muhlenfels Point, St. Thomas. *Siderastrea siderea* is the most abundant coral species located in the survey area, followed by *Porites astreoides*. Twenty-five *S. siderea* coral colonies and fifteen *P. astreoides* coral colonies are in the survey area. Two ESA-listed coral species occur in the survey area: *Dendrogyra cylindrus* and *Orbicella annularis*. There is one *D. cylindrus* colony and four *O. annularis* colonies, making up five of the 46 coral colonies found in the survey. The largest corals seen are two approximately 2-foot-long *S. siderea*. Most of the corals were small; 54.3% of corals were ≤ 1.0 feet in length.

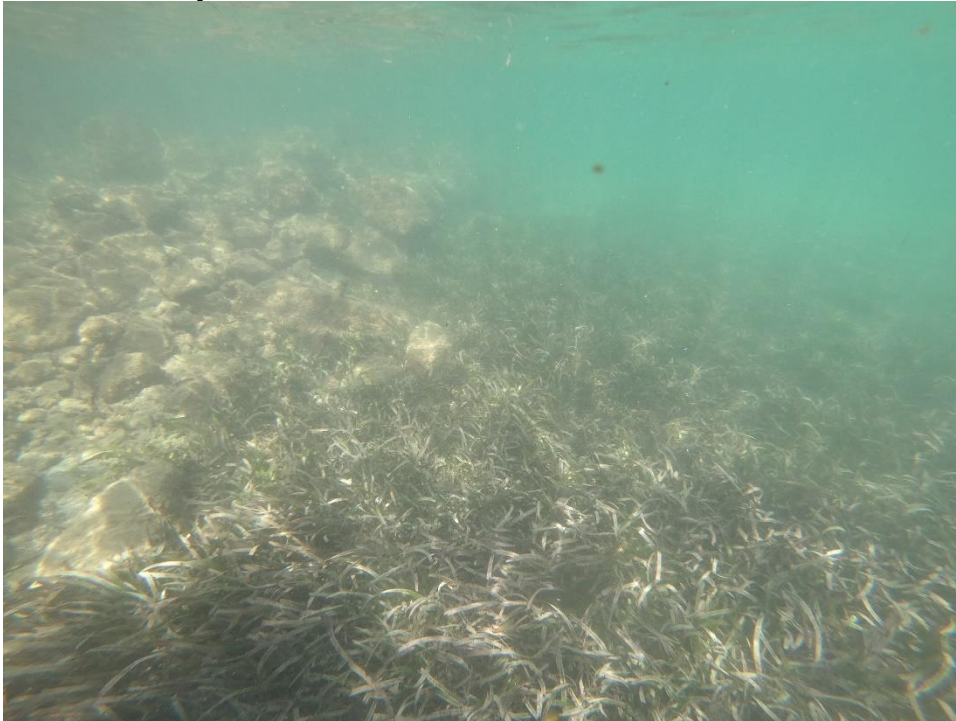
Seagrass extends almost to the shoreline in the southern portion of the survey site

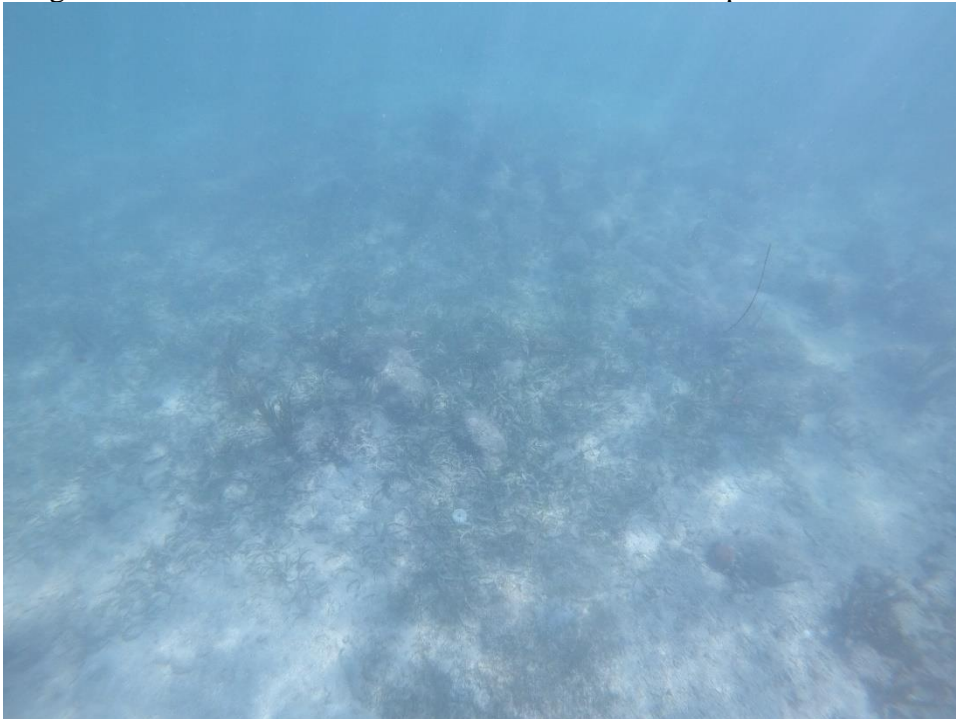
Unconsolidated hardbottom (loose boulders) and seagrass

This dock configuration will cover approximately 144 square feet of unconsolidated hardbottom, and another 96 square feet of sand with small boulders. The direct impact to the unconsolidated hardbottom would be the installation of two 12” diameter pilings, which would impact 6 ft² of unconsolidated hardbottom. Indirect impact includes shading impact to 144 ft² of unconsolidated hardbottom.

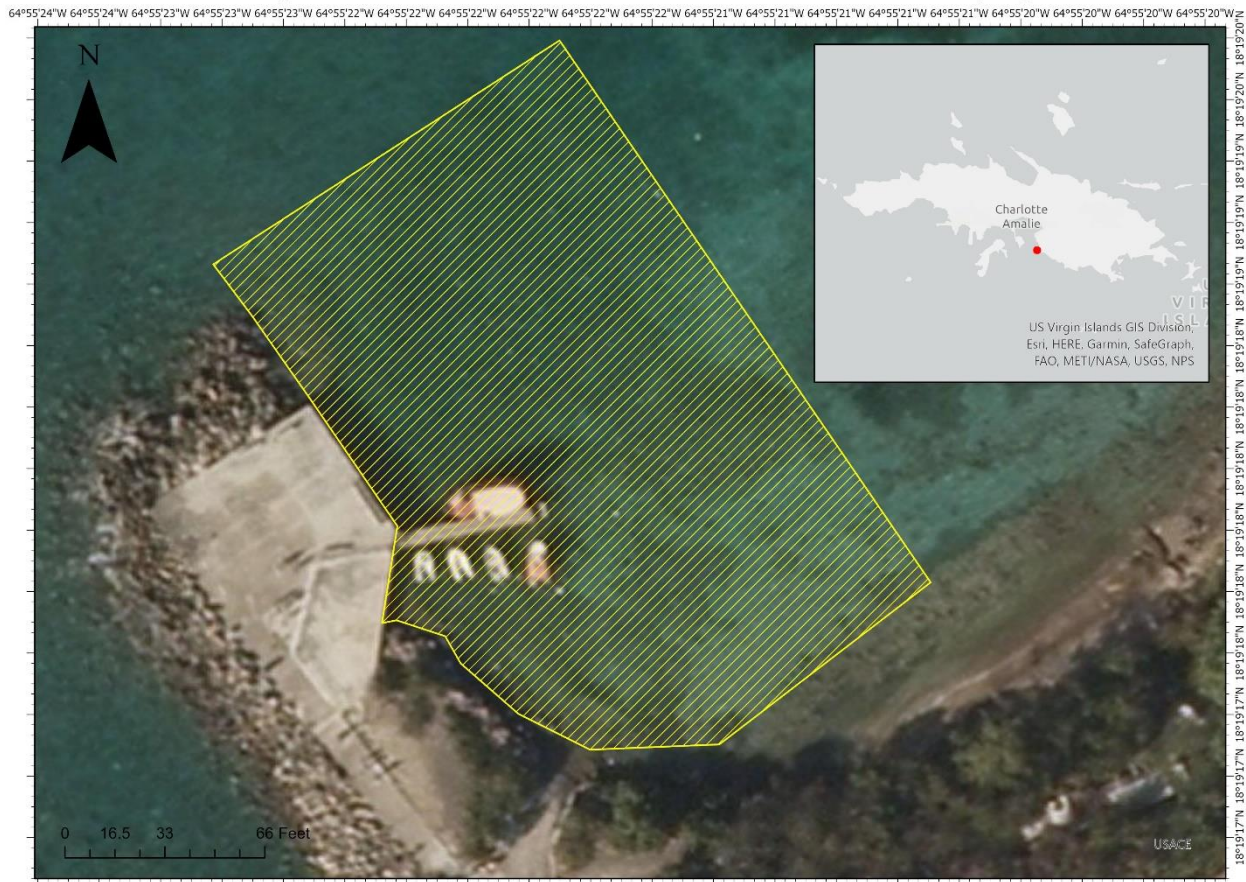
Survey Site: Bakker Estate 5A Frenchman's Bay QTR

Figure 6.04. Survey Site at Estate Bakker north of Muhlenfels Point

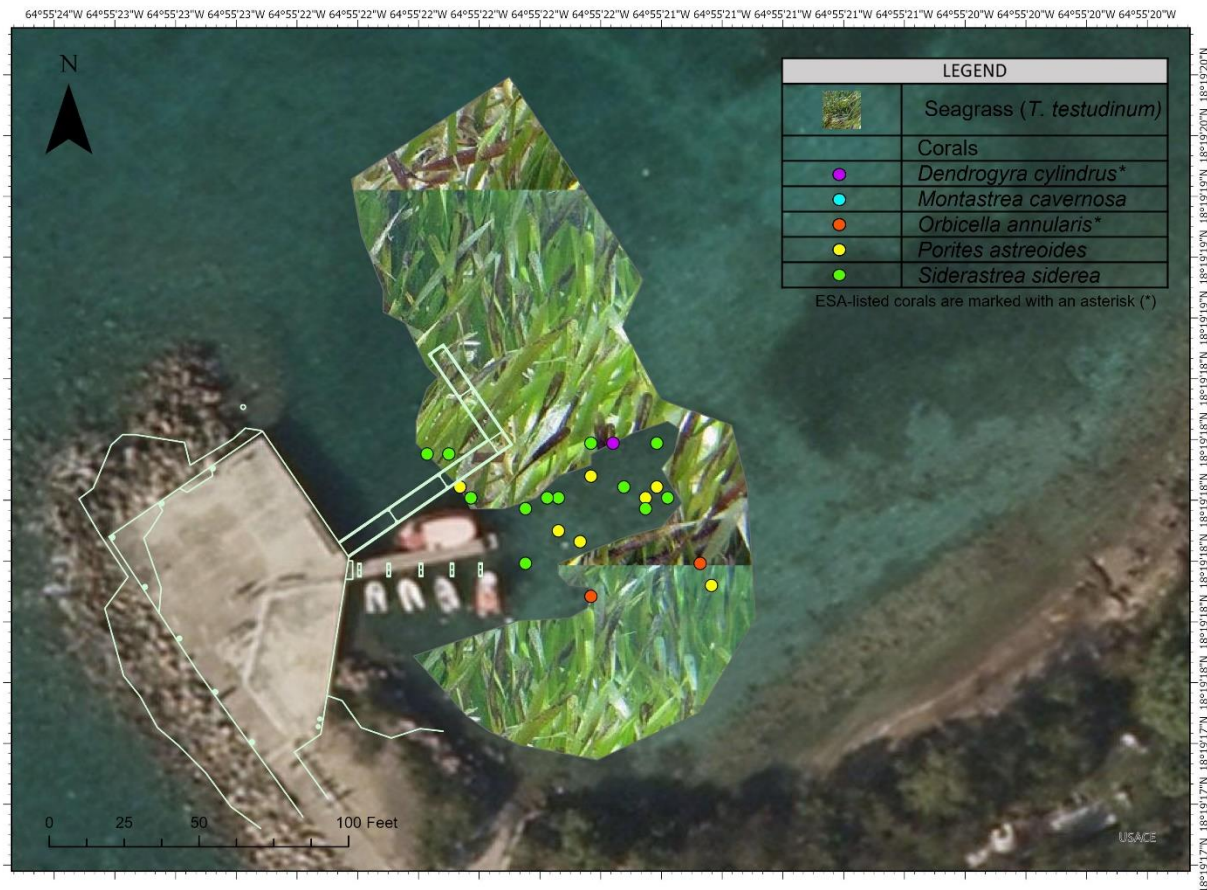
Corals and Seagrass

Figure 6.06. Distribution of corals and seagrass at survey site. The *Dendrogyra* is probably a broken fragment from the large colony well to the north.

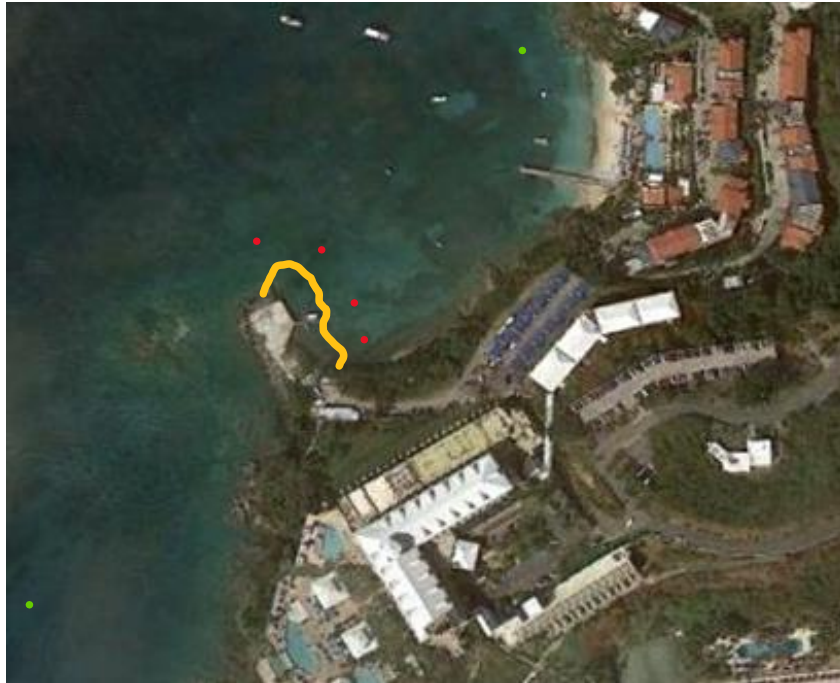
The site locations for the baseline study are illustrated on Figure 1 which follows.

Figure 1- Water Quality and Environmental Monitoring Locations Baseline -Green points represent the control sites and red monitoring sites.

Prior to the start of construction, a baseline of water quality conditions will be established. Location of the baseline sampling locations are shown below in Figure 1. During construction a total of four (4) sampling locations will be established within the potential impact footprint and two (2) control sites, one to the east and one to the west of the project area. The monitoring samples will be collected in the areas most likely to be impacted by the dredging and installation activities. The control sites will be located in areas which should be exposed by the same ambient conditions but should not be impacted by the construction project.

At each site the turbidity expressed as NTUs will be analyzed with a YSI meter or HACH meter and secchi disc readings will be taken. Samples will be taken at a depth of 1 meter. The meter will be calibrated daily before use. Samples will be taken on a weekly basis for two (2) months prior to the start of construction to establish a baseline. Baseline data will be used to compare with data collected during the construction to help assess whether readings are a result of the construction project or are due to ambient conditions.

During in water construction, four (4) samples will be taken immediately around the area of in-water work at the sample sites shown in Figure 1. Samples will be taken one (1) meter below the surface, and will be analyzed for turbidity expressed as NTU. Secchi disc readings will also be made. Samples will be taken no less than twice a day and at least 4 hours apart. Monitors will inform the contractors when they see issues with the turbidity control or see issues which may affect the surrounding environs.
