VIRGIN ISLANDS DEPARTMENT OF PUBLIC WORKS

COASTAL CONSISTENCY DETERMINATION REQUEST

NORTHSIDE ROAD (HIGHWAY 75) AND QUEEN STREET (HIGHWAY 75) IMPROVEMENTS AND FEEDER FROM CONTENTMENT ROAD TO NORTH OF CENTERLINE ROAD ST. CROIX, U.S. VIRGIN ISLANDS

DECEMBER 2022

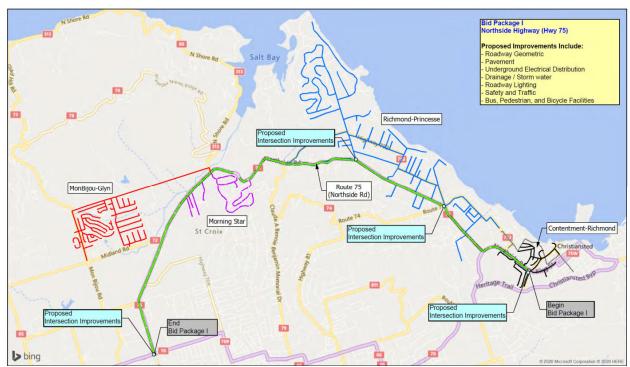
Figure 1. Location of the highway project on the island of St. Croix

The roadway project is located on the north shore of St. Croix west of the town of Christiansted. The project will extend from the intersection of Northside Highway and Contentment Road (Latitude 17.742091°N, Longitude -64.710496°W) and Northside Highway and Queen Mary Highway (Centerline Road, Highway 70)(Latitude 17.728515°N, Longitude -64.773790°W).

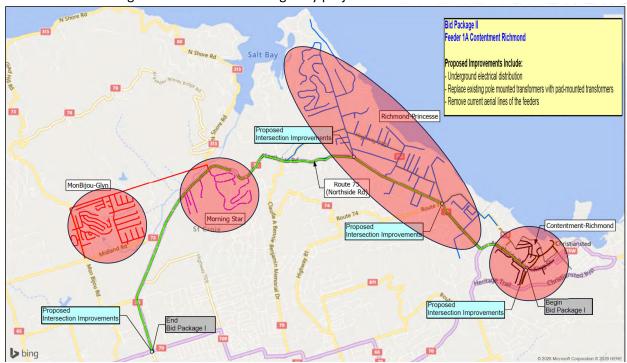
Figure 2. Location of underground electrical project on the island of St. Croix

The underground electrical project includes four adjacent neighborhoods west of the town of Christiansted, Contentment-Richmond (Latitude 17.745495°N, Longitude -64.711033°W), Richmond-Princesse spanning from Latitude 17.746743°N, Longitude -64.719283°W to Latitude 17.778360°N, Longitude -64.747830°W, Morning Star (Latitude 17.755142°N, Longitude -64.761988°W) and Mon Bijou- Glynn (Latitude 17.750309°N, Longitude -64.781413°W).

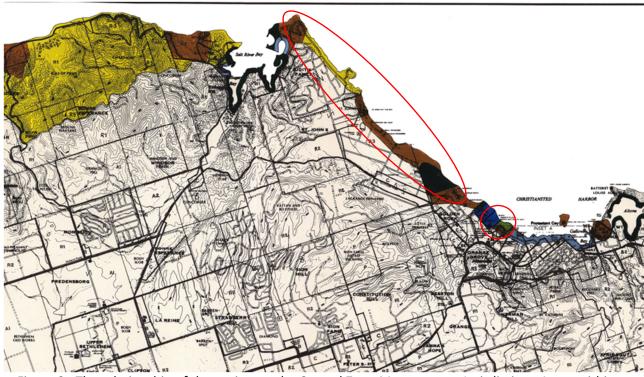
Figure 3. The relationship of the project to the Coastal Zone Management Jurisdiction. Areas within first tier jurisdiction are in color.

The roadway improvements are entirely outside the first-tier jurisdiction of Coastal Zone Management (CZM), some of the underground electrical distribution is within the CZM first tier jurisdiction.

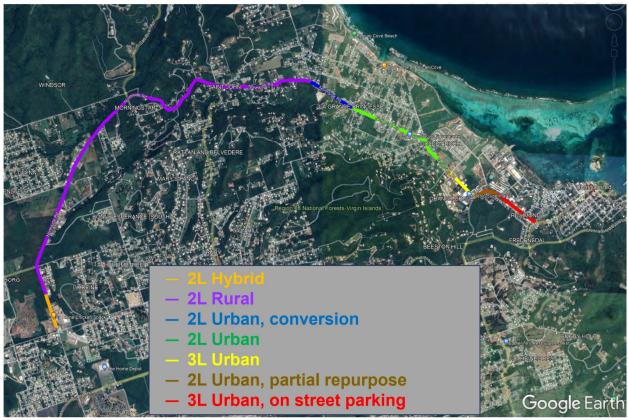
Figure 4. The Northside Roadway passes through areas that are Rural, Urban and a combination of both.

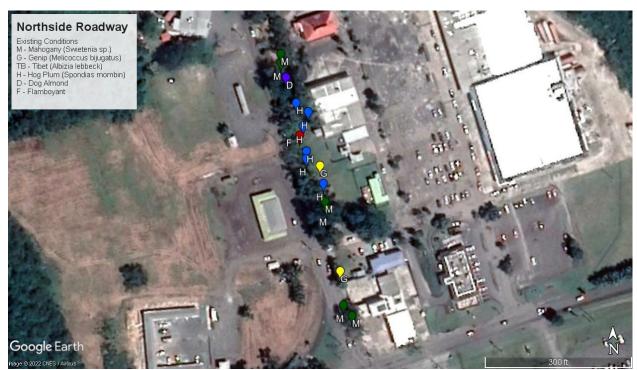
Figure 5. Map of trees in proximity of the roadway.

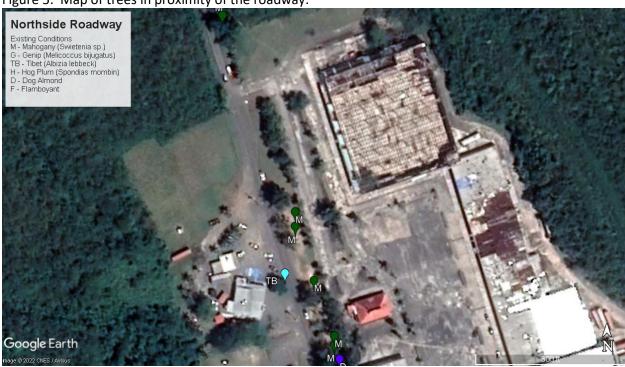
Figure 6. Map of trees in proximity of the roadway.

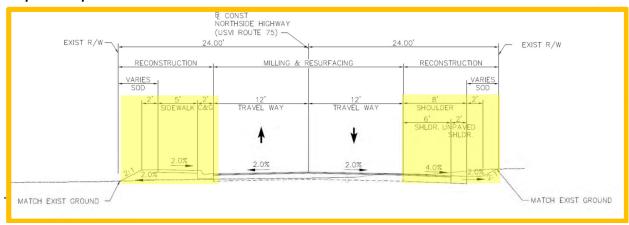
Note that the sideway is proposed on the west side of the roadway to avoid the Heritage trees

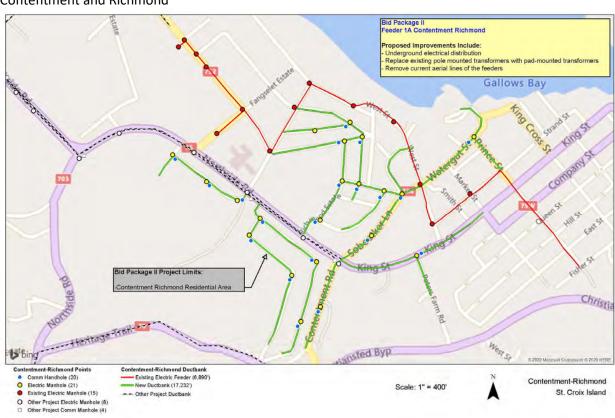
Contentment and Richmond

The installation of the electrical underground project in many areas will be working on very narrow streets and the project will be designed and constructed to minimize disruption to residents. Monitoring and inspections will be included in the design specifications to ensure that roadways are properly repaired once installation is complete.

Undergrounding the electrical service in the four neighborhoods includes placing electrical distribution underground, replacing pole mounted transformers, poles will be topped off where needed, and the existing overhead lines will be removed. This will make the area more resilient against future storms and provide more reliant power to these neighborhoods.

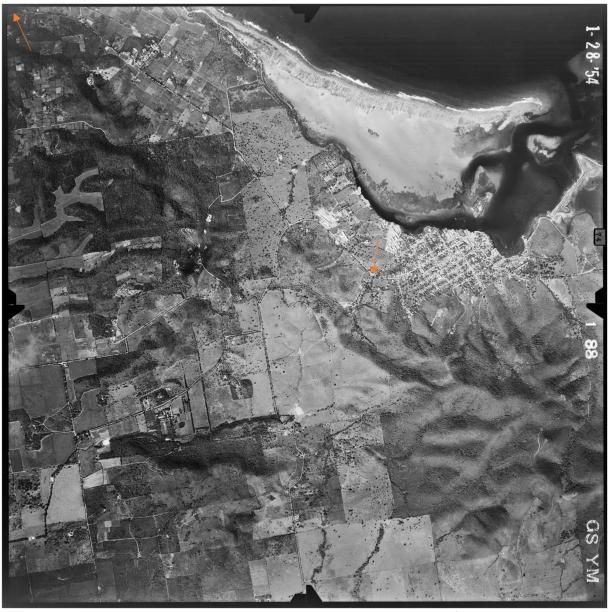
Figure 29. USGS 1954 Aerial – The orange arrow indicates the eastern end of the project area.

Highway 75 has been a main route of transportation since historic times. The roadway is shown on the 1954 USGS aerials.

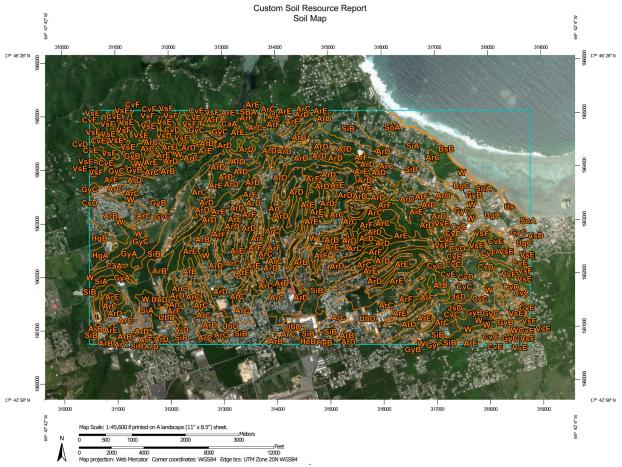
Figure 32. USGS Custom Soil Survey Map Northside Road

Northside Road passes through five soil types throughout its length, Arawak gravelly loam, 5 to 12percent slopes, very stony, Arawak gravelly loam, 12 to 20 percent slopes, very stony, Glynn gravelly loam, 2 to 5 percent slopes, Sion clay, 2 to 5 percent slopes and Urban land.

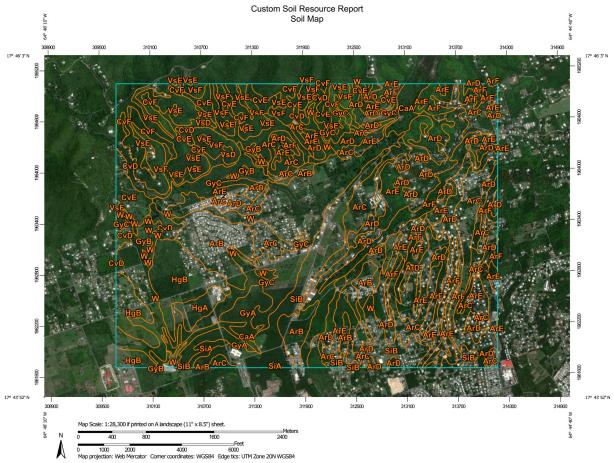
Figure 34. USGS Custom Soil Survey Map Underground Projects

The underground electrical project encompasses Arawak gravelly loam, 5 to 12 percent slopes, very stony, Cramer-Victory complex, 2 to 12 percent slopes, very stony, Cramer-Victory complex, 12 to 20 percent slopes, very stony, Cramer-Victory complex, 20 to 40 percent slopes, very stony, Glynn gravelly loam, 2 to 5 percent slopes, Solitude gravelly fine sandy loam, 0 to 2 percent slopes, frequently flooded, Urban land-Glynn complex, 0 to 12 percent slopes, Ustorthents, Victory-Southgate complex, 12 to 20 percent slopes, very stony

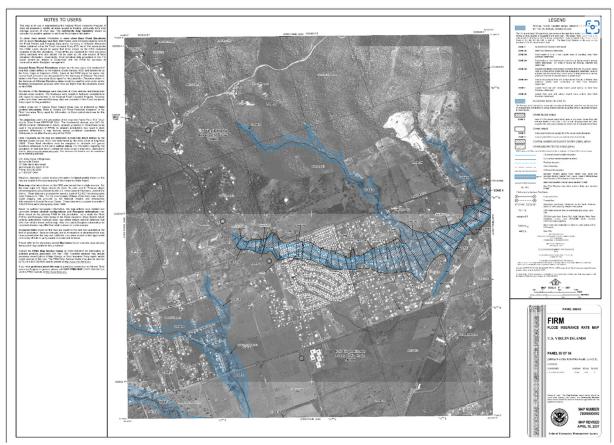
Figure 35. FEMA FIRM 69 of 94.

FEMA Flood Insurance Rate Map (FIRM) numbers 7800000069G, 7800000070G, 7800000071G, and 7800000080G show two SFHA designations along the proposed alignment, a Zone 'A' and Zone 'AE'.

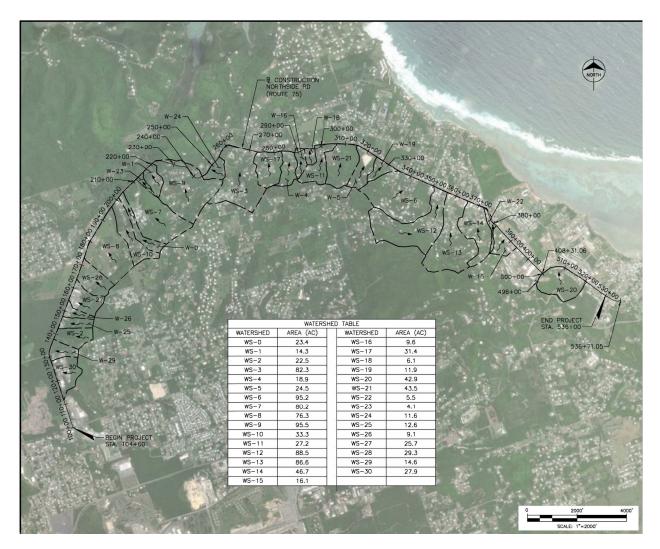
Figure 38. Drainage Map

- Cross culverts for offsite flows.
- Roadway curb opening inlet
- Closed storm drain systems in urban areas where curb and gutter are proposed

The project will not be altering any water flows and will be replacing and upsizing drainage features along the corridor to add resiliency and increase life expectancy of the roadway.

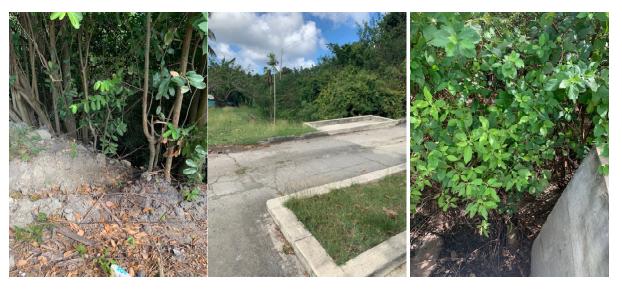
There is a large gut which is immediately off the roadside at Latitude 17.759288°N, Longitude - 64.749086W. There is a large box culvert crossing going into an apartment complex.

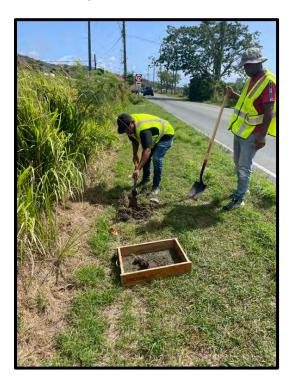
Figure 2: Photograph of the shovel testing activities along Northside Highway

CocoSol initially performed a vehicular and pedestrian reconnaissance of the approximately 53 miles of road alignments that will be affected by the project for the presence of artifacts or constructed features. We then proceeded to mark by measuring wheel the location of the tests at 30-meter intervals along the roads, followed by the excavation of shovel tests (where feasible). The shovel tests measured approximately 30 centimeters in diameter and were excavated to depths no longer considered to have the potential for containing non-random artifact bearing matrices. The excavated soil was screened through ½ inch hardware cloth to aid in artifact recovery.

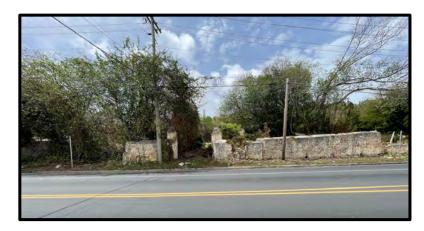
Figure 6: Photograph of entrance ruins to No. 1 Estate Orange Grove

At the intersection of Contentment Road and Northside Highway the duct bank alignment continues to the west for approximately 6 miles to its end at Centerline Road. Just east of the intersection of Northside Highway and Highway 70 are the remains of entrance monuments, walls, and possible building foundations in close proximity to the pavement, the building foundations are in fact almost adjacent to the pavement (Figures 6 and 7).

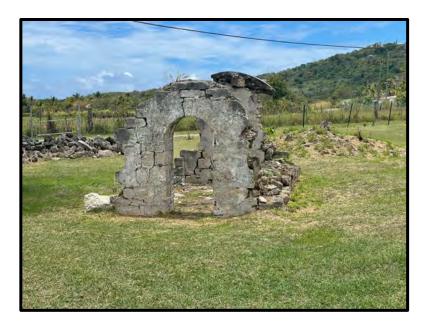
Figure 8: Photograph of watch house near the intersection of Northside and Midland Roads

Approximately 20 meters east of the intersection of Northside and Midland Road on the east side of oad are the remains of a watch house in poor state of preservation (Figure 8). This structure is behind a fence.

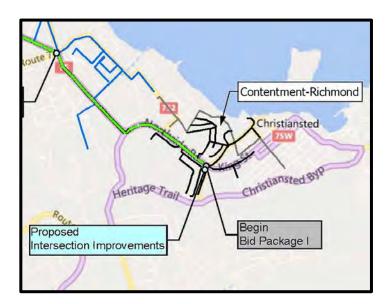
Figure 9: Section of Figure 1 depicting the Contentment-Richmond project component, lined in black

This section of the project (Figures 9 and 10) begins at Triangle Basin and enters Contentment Road proceeds to its intersection with King Street where it continues for approximately 250 meters to the east. At Peter's Farm Road the duct bank alignment turns and continues to the end of Peter's Farm Road. We note that the Christiansted Archaeological District boundary starts at Peter's Farm Road.

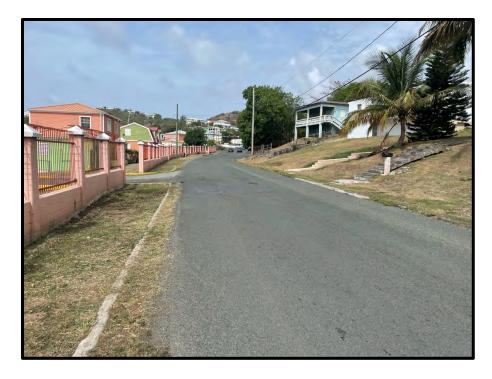
Figure 13: Photograph of Soboetker Lane depicting the cut slopes on its west side and the narrow grassy area on its east side that has been stripped of topsoil and compacted

From the Contentment Road and King Streets intersection, the duct bank alignment continues north along Soboetker Lane, Soboetker Lane is a road that was cut from slopes and extends to a residential community, tests along the fence line indicate that no topsoil is preserved and was very compacted (Figure 13).

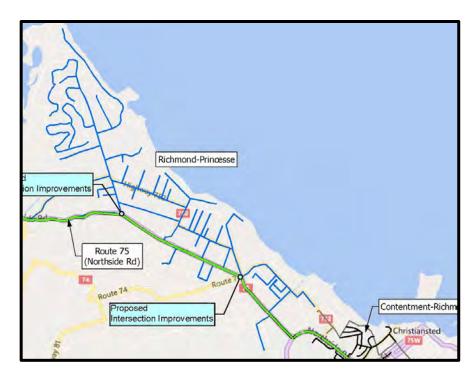
Figure 19. Segment of map shown in Figure 1 depicting the duct bank alignments for the Richmond-Princess sub project.

To the west of the Richmond Power Plant, the project alignments enter neighborhoods, hotel and condominium facilities, residential streets, and the Judith's Fancy subdivision on the north side of Northside Highway (Figure 19). Two duct bank alignments are proposed for the southside of Northside Highway. The shovel testing performed for Richmond-Princess project alignments resulted in the recovery of two sherds of undecorated hand-built coarse earthenware and a small fragment of olive-green glass fragment. Except for parts of the Princess Plantation Road, the Judith's Fancy subdivision and a small road to the St. Croix Condominiums which are at higher elevations, nearly all the Richmond-Princess duct banks are on low lying coastal flats (Figures 20 to 23).

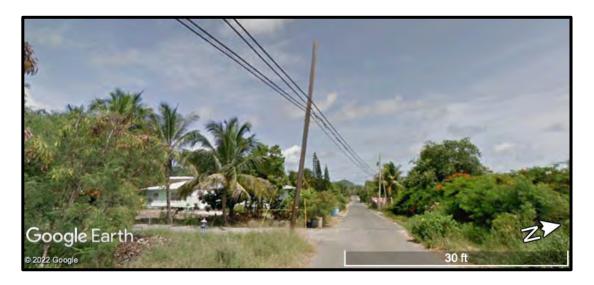
Figure 22: Google Earth image depicting neighborhood road

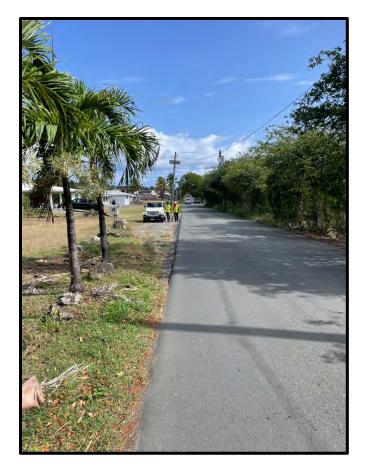
Figure 23: Photograph of part of Road 751, view to the north.

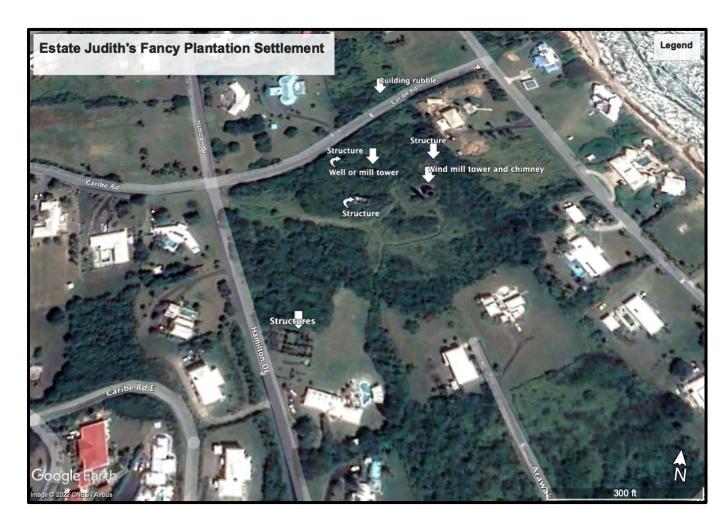
Figure 24: Google Earth image of readily visible structures for the Judith's Fancy Plantation settlement

The Judith's Fancy Plantation settlement is located in the central part of the subdivision and is bracketed by Hamilton Drive on the west, Caribe Road on the north, Jefferson Way on the east and houses on the south. The proposed duct banks would pass along Jefferson Way and Hamilton Drive, the latter is the closest to some of the plantation's ruins (Figures 24 to 26).

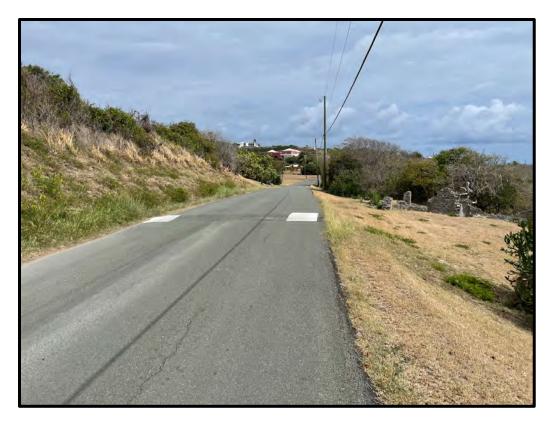
Figure 25: Photograph showing road cut along Hamilton Drive and historic building ruins on the center right of the photograph.

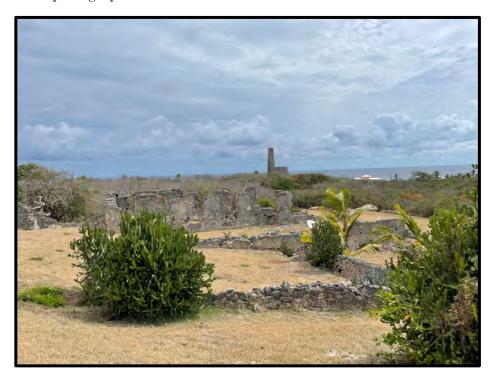
Figure 26: Photograph of ruins closest to Hamilton Drive, and chimney and windmill tower in background, view to the east.

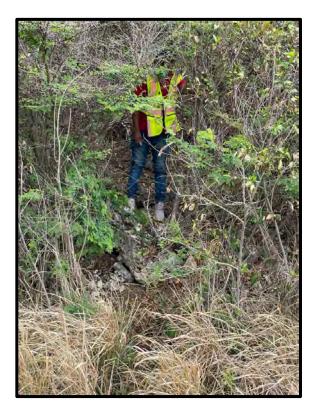
Figure 27: Photograph of individual standing on top of a disarticulated rubble wall.

On Caribe Road, we noted the presence of scatters of building rubble (Figures 27 and 28) to the north of the Caribe Road swale, indicating that road construction likely impacted constructed features. Also, at the intersection of Caribe Road and Jefferson Way and for approximately 50 meters to the south-southeast along Jefferson Way are landscaped features for residences that include what appear to be building

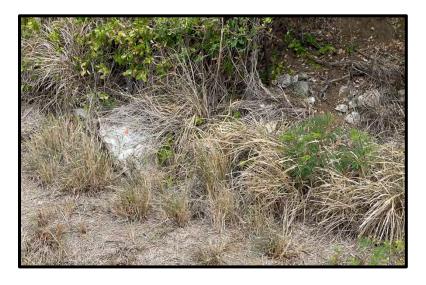
Figure 28: Photograph of a scatter of building rubble in swale

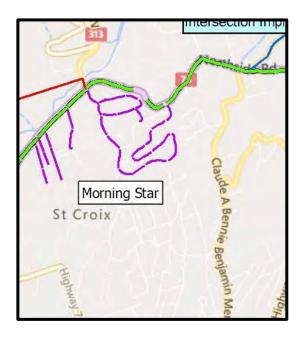
Figure 29: Segment of map shown in Figure 1 showing the duct bank alignments for the Morning Star-Glynn project component, lined in purple.

The Morning Star – Glynn Duct Bank is 15,549 feet in length and largely concentrated in the Morning Star subdivision, and four shorter duct banks perpendicular to Northside Highway (Figure 29). The Morning Star subdivision roads have been largely cut from slopes (Figures 30 to 32) and the roads practically end at property lines.

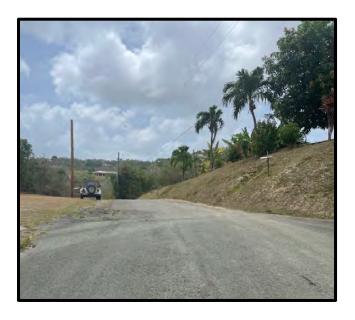
Figure 30: Photograph showing a characteristic road cut in the Morning Star subdivision

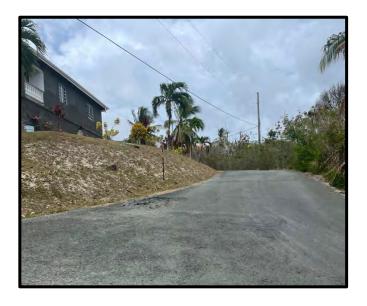
Figure 31: Photograph of another road cut in the Morning Star subdivision

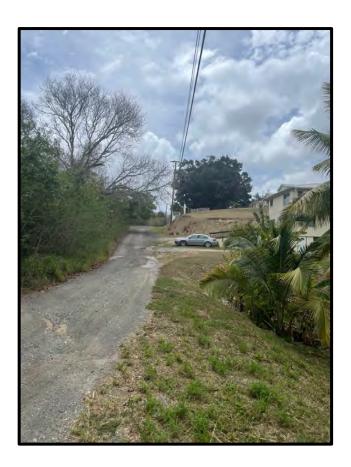
Figure 32: Photograph of section of the north side of Morning Star Circle

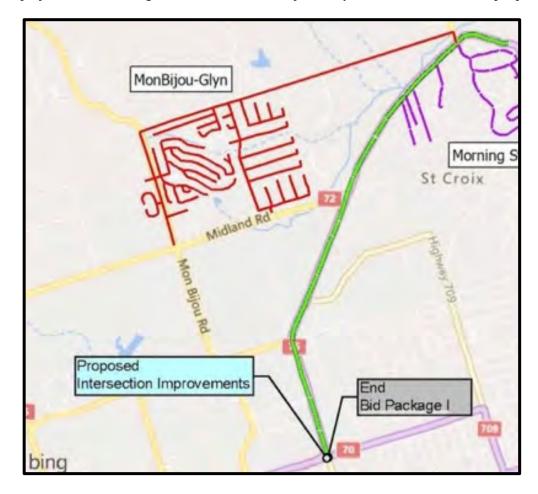
Figure 33: Section of the Figure 1 map depicting the MonBijou-Glynn project component, lined in red.

This duct bank is 47,916 feet long, it begins at the intersection of Northside Road and Windsor Road and continues west to MonBijou Road where it turns south and ends at Midland Road. As can be seen in Figure 34, the project' duct bank alignments enter the MonBijou – Glynn communities in multiple places.

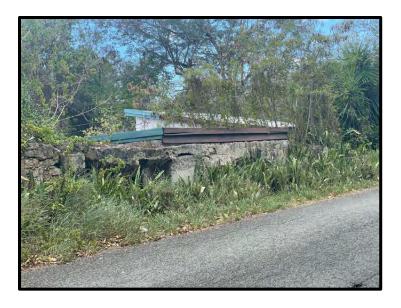
Figure 34: Photograph of adaptively reused Estate Concordia ruin along Windsor Road.

Approximately 350 meters west of the intersection of Northside and Windsor Roads are ruins associated with the Estate Concordia plantation settlement in close proximity to the edge of Windsor Road. (Figures 34 to 36)

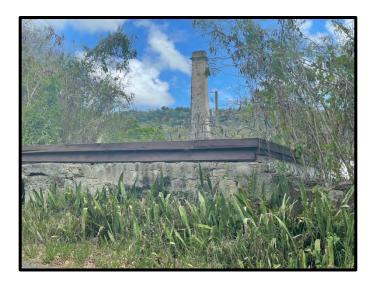
Figure 35: Photograph of same ruin as above, and the Estate Concordia chimney in the background.

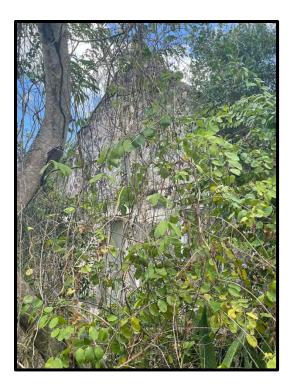
Figure 36: Photograph of an Estate Concordia plantation building, as seen from Windsor Road.

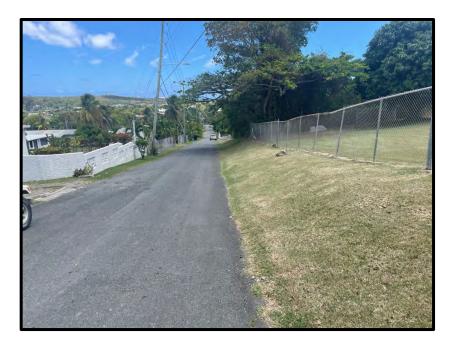
Figure 37: Photograph from near the entrance on Rama Lane, view to the south.

Three other archaeological sites are recorded within the MonBijou-Glynn sub project. At the intersection of Rama and South Lanes of the subdivision is the Old Friedensfeld Midlands Cemetery, the concentration of grave monuments is approximately 50 meters from the proposed duct bank for Rama Lane. The subdivision's roads have been both cut from side slopes or graded on relatively gently sloping terrain, for the most part, the compacted road shoulders extend to the property lines (Figures 37 and 38).

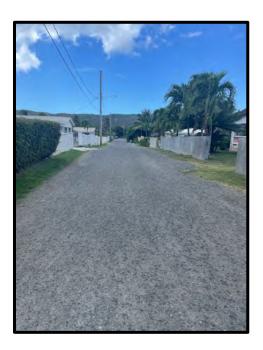
Figure 38: Photograph of a characteristic street at the MonBijou subdivision.

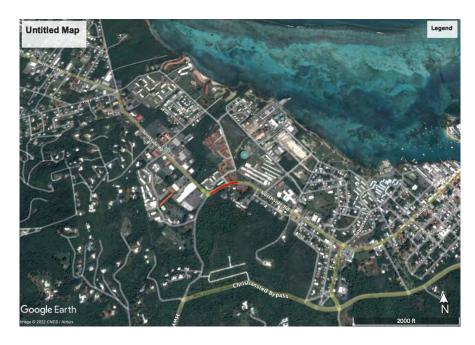
Figure 39: Google Earth image showing the recommended archaeological monitoring alignment for Estate Orange Grove, lined in red.

We recommend archaeological monitoring for two areas along the Northside Highway, one is the road fronting Orange Grove 1, historic ruins are in close proximity to the roadway including what appears to be the remains of building foundations adjacent to the pavement (Figure 39).

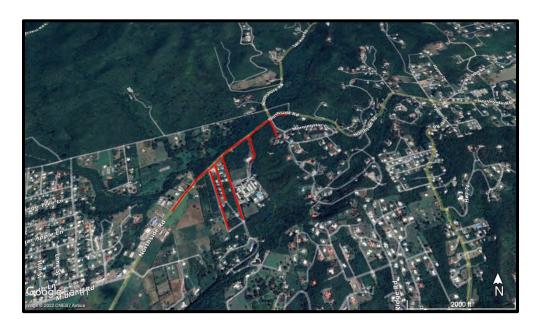
Figure 40: Google Earth image showing the duct bank alignment sections recommended for the Upper Salt River Archaeological District and duct bank alignments for the Morning Star-Glynn sub-project, lined in red

At the approximate intersection of Salt River Road and Northside Highway and for approximately 2 kilometers to the southwest (Figure 40) the duct bank alignments would pass in close proximity through a cluster of colonial and precolonial sites, including within the boundaries of the Upper Salt River Archaeological District.

No archaeological monitoring is considered warranted for this subproject except for four branch duct banks off Northside Highway which are partially contained within the Upper Salt River Archaeological District (Figure 40).

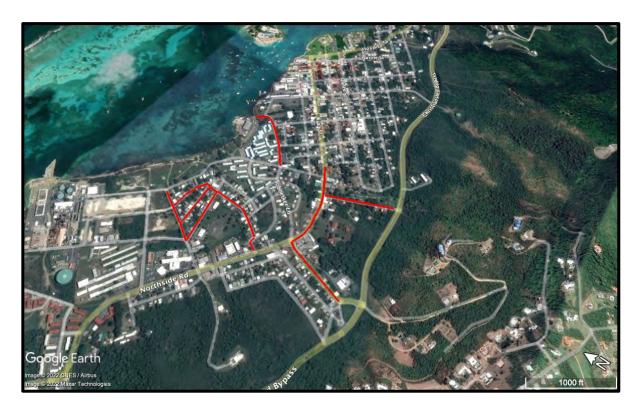
Figure 41: Google Earth image depicting the Contentment - Richmond recommended for archaeological monitoring, lined in red.

We recommend archaeological Monitoring for the following duct bank alignments for the Contentment-Richmond sub-project. The alignments are shown in Figure 41.

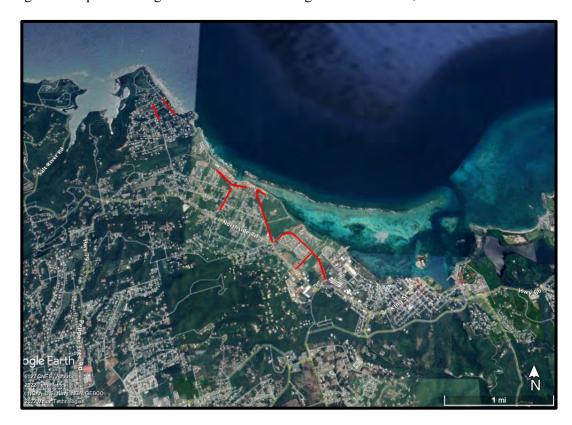
Figure 42: Google Earth image depicting the duct bank alignments recommended for archaeological monitoring for the Richmond-Princess sub project, lined in red.

In the case of the Judith's Fancy subdivision, we recommend that parts of Hamilton Drive and Jefferson Way that parallel the plantation's ruins complex be monitored by an archaeologist during earth change activities. Figure 42 depicts the alignments where monitoring is recommended, lined in red.

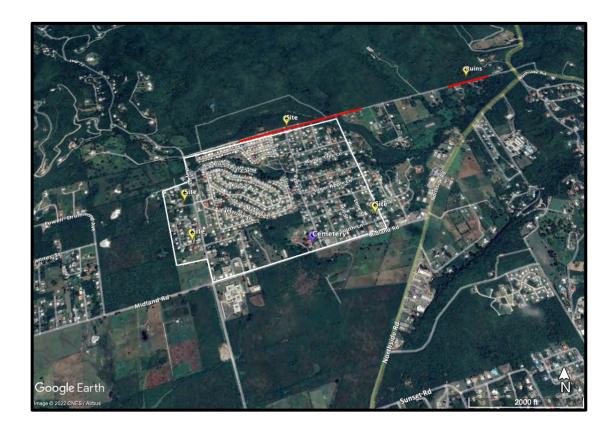
Figure 43: Google Earth image depicting the archaeological monitoring polygon (lined in white) and the monitoring sections along Windsor Road, lined in red.

As proposed, the MonBijou – Glynn duct bank alignments will pass adjacent to or near archaeological sites of record and a cemetery. Additionally, tributary streams to Salt River pass through the subdivision proper and are considered to have likely been attractive settlement locations to precolonial inhabitants. We recommend archaeological monitoring for the entirety of the subdivision. We also recommend archaeological monitoring be performed for an archaeological site along the edge of Windsor Road, and the Estate Concordia section along Windsor Road alignment be monitored by an archaeologist during earth change activities, Figure 43 depicts the locations of these two areas.

The Morning Star – Glynn general project area contains three historic plantation settlements on Estates Concordia, Morning Star and Windsor. Parts of the Concordia ruins are located immediately adjacent to the south edge of Windsor Road, our report (pp.32) recommends archaeological monitoring along those parts of the earth change activities that pass adjacent and near the Estate Concordia plantation settlement, the extent of the archaeological monitoring alignment for Concordia is shown in Figure 43 of our report.

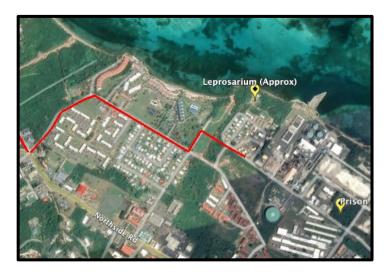
Figure 1: Google Earth image of the eastern parts of the Richmond – Princess sub-project depicting the location of the prison (lower right-hand corner)

• The former Richmond Prison is located approximately 150 meters from the closest proposed duct bank alignment and well outside of the APE. Figure 1 does show an alignment closer to the prison, but we note that this is an existing electrical feeder (Figure 1 and Attachment B).

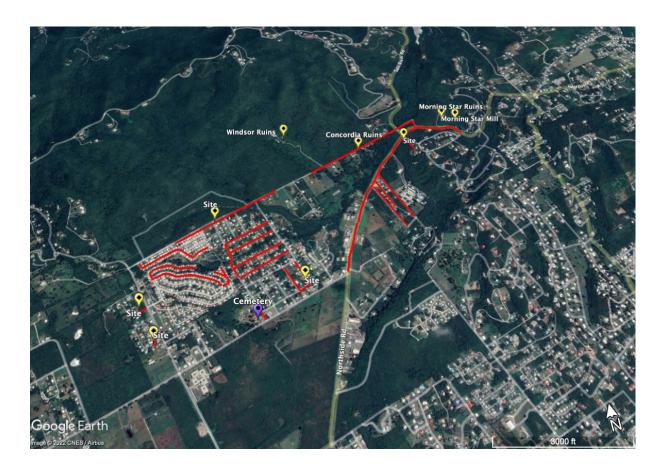
Figure 3: Google Earth image of the Morning Star-Glynn and Mon Bijou sub projects depicting the sections of the duct bank alignments (lined in red) recommended be monitored

Estate Windsor was not considered in our report because the plantation settlement is located approximately 300 meters distance from the proposed duct bank alignment on Windsor Road. Following the VISHPO's recommendation, we have extended the archaeological monitoring along Windsor Road to include the Estate Windsor plantation settlement road frontage. The Estate Morning Star plantation settlement was also not considered in our report because of its distance from the APE, approximately 60 meters to the plantation settlement and 90 meters to the windmill. Following the VISHPO's recommendation, we have extended the archaeological monitoring recommendation along Windsor and Northside Roads to include the Estate Morning Star plantation settlement road frontage (Figure 3).

monitoring. The revised recommendations now bracket the lands above the tributary stream to Salt River that crosses through parts of the existing subdivision (Figure 3). These lands are considered to potentially contain precolonial settlements.

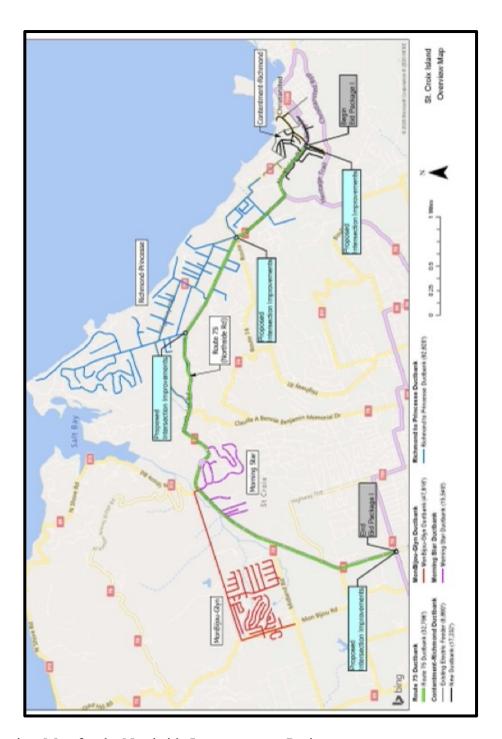
Figure 4: Overview Map for the Northside Improvements Project

With regards to the comment regarding the Mon Bijou duct bank alignments, we note the existing design does not include areas to the west of the Mon Bijou road. Upon further review of our original recommended archaeological monitoring alignment for the Mon Bijou sub project we have reduced the recommended monitoring segments to now only bracket the tributary stream to Salt River that passes through the subdivision to cover the banks and lands to the north and south of the stream. The monitoring segments to cover the sites of record and the cemetery have been adjusted to only the duct bank alignments closest to each site. The duct bank alignments that are recommended for monitoring during earth change activities are shown as red lines/paths on Figure 4 of this addendum.

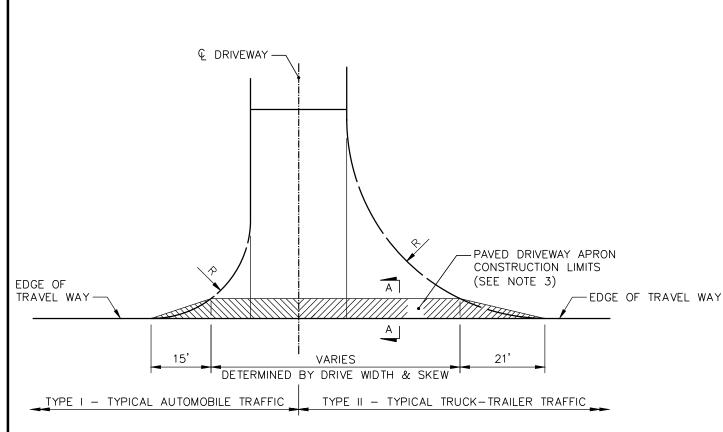
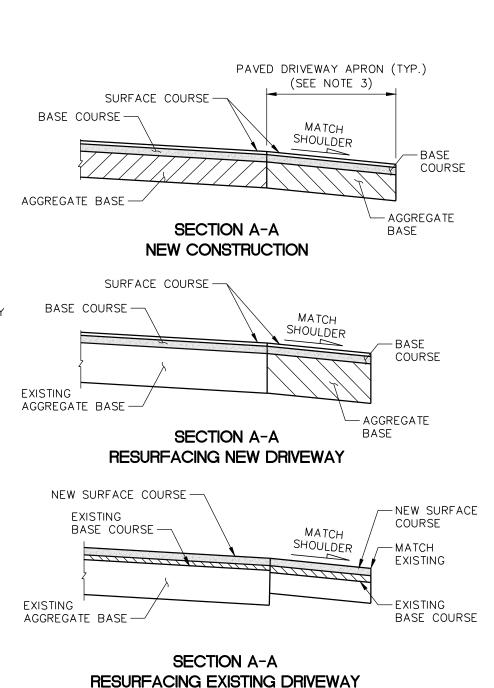
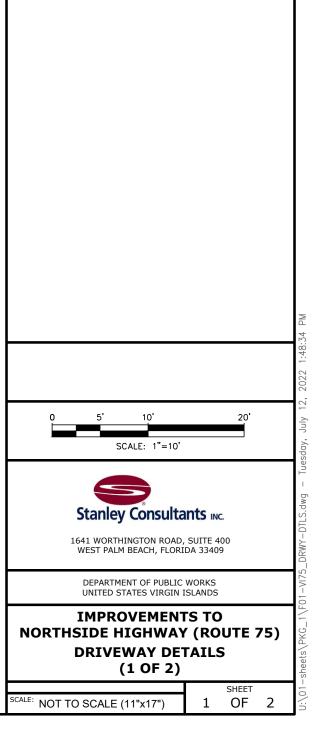
FLUSH SHOULDER DRIVEWAY TYPES

- 1. DRIVEWAYS ARE TO BE CONSTRUCTED OR RESURFACED FOR LOW VOLUME (SINGLE FAMILY, DUPLEX, FARM, ETC.) RESIDENTIAL CONNECTIONS AS DIRECTED BY THE CONTRACTING OFFICER OR AUTHORIZED REPRESENTATIVE (CO).
- 2. DRIVEWAYS CONSTRUCTION IS NOT REQUIRED FOR LOW VOLUME RESIDENTIAL CONNECTIONS WHERE ROADWAY SHOULDERS ARE PAVED.
- 3. MATCH EXISTING PAVED SHOULDER WIDTHS ≥ 4'. FOR ALL OTHER SHOULDERS CONDITIONS, CONSTRUCT AT 5' WIDE.
- 4. CONNECTIONS BEYOND THE SHOULDER WIDTH ARE TO BE CONSTRUCTED AS DIRECTED BY THE CO.
- 5. CONSTRUCT DRIVEWAY BASE USING SIMILAR PAVEMENT DESIGN AS THE MAINLINE.
- 6. PAYMENT FOR BASE COURSE AND SURFACE COURSE IS TO BE INCLUDED IN ROADWAY PAVEMENT PAY ITEM.
- 7. MATCH EXISTING RADIUS, R OR AS DIRECTED BY THE CO.

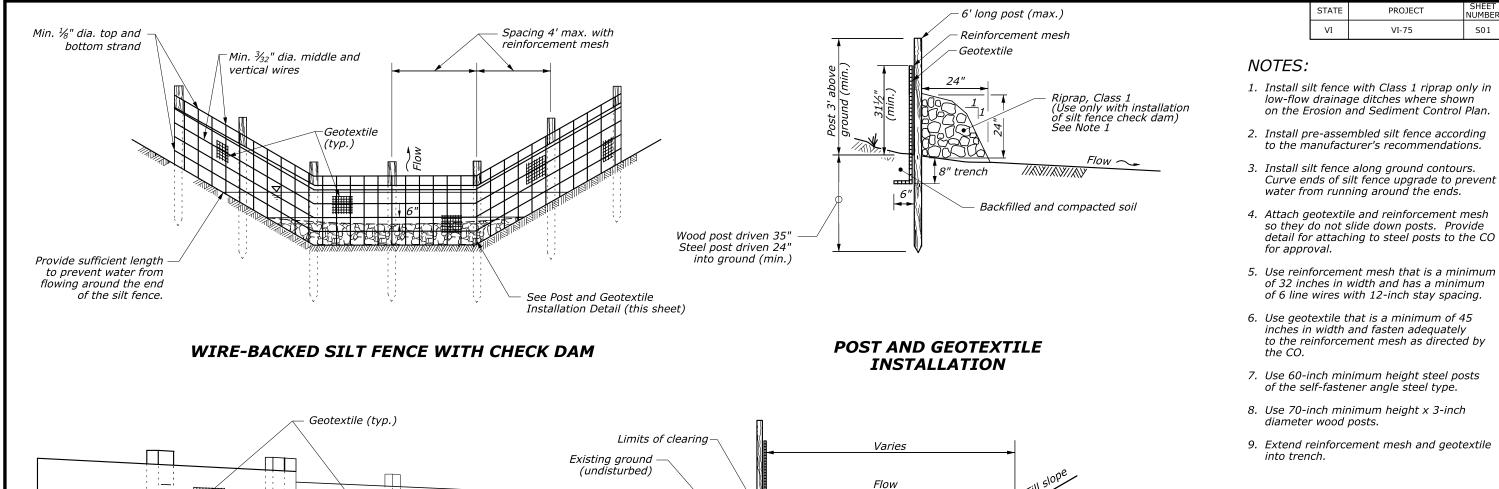
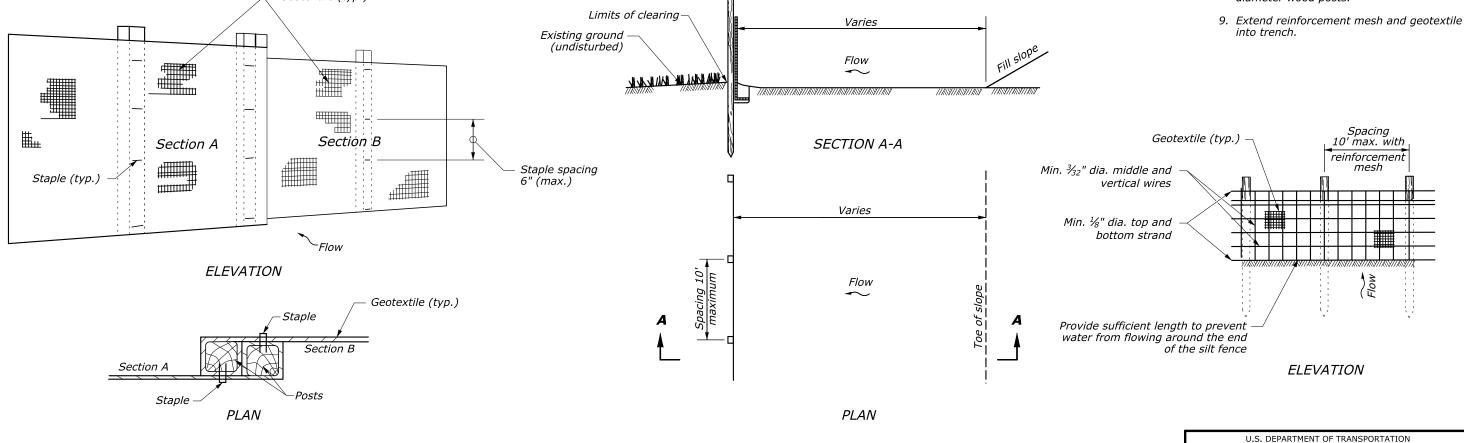
WIRE-BACKED SILT FENCE

INSTALLATION AT TOE OF FILL

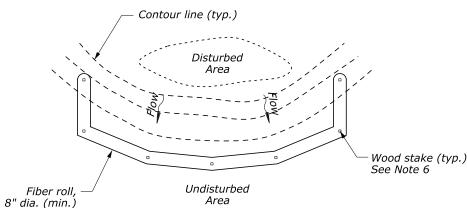
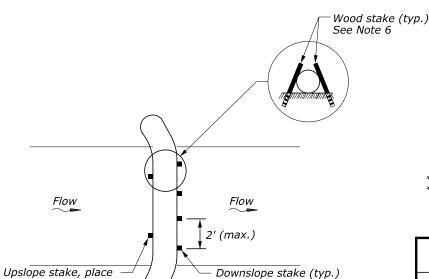
FIBER ROLL CHECK DAM PLAN VIEW

FIBER ROLL OVERLAP

PLAN VIEW

TRAPEZOIDAL DITCH

equidistant between downslope stakes

- Replace biodegradable fiber rolls 6 months after installation and photodegradable fiber rolls 12 months after installation.
- 10. When fiber rolls are required on paved surfaces, use gravel bags to support them as shown on the inlet protection detail.

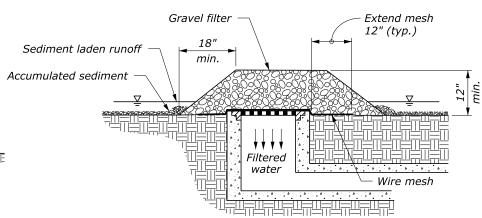
GRAVEL AND WIRE MESH DROP INLET PROTECTION (TYPE B)

Do not use where ponding around the structure might cause inconvenience or damage.

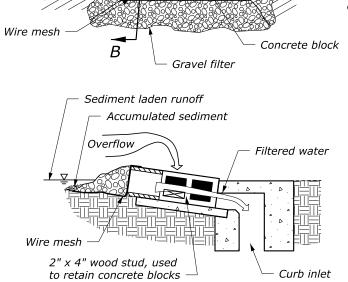
CURB INLET PROTECTION, BLOCK AND GRAVEL (TYPE D)

SECTION B-B

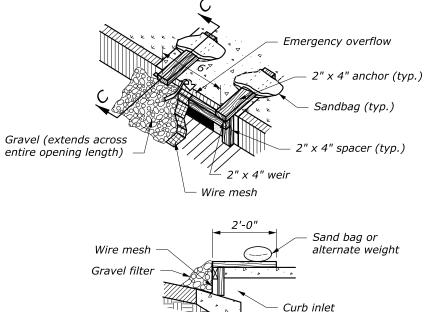
CURB INLET PROTECTION, WOODEN WEIR (TYPE E)

SECTION C-C

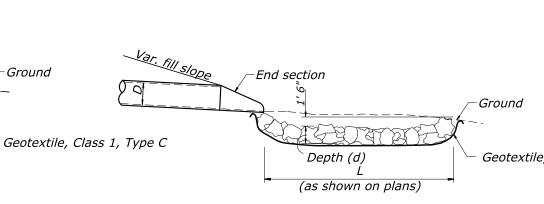
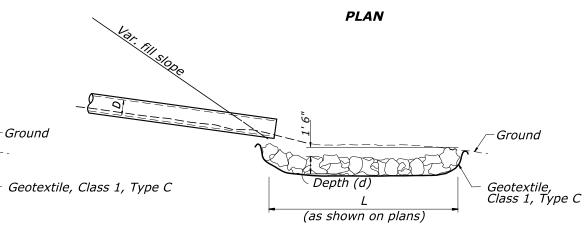
CULVERT WITH HEADWALL

RIPRAP DEPTH TABLE					
Riprap Class	Depth (d)				
2	18"				
3	24"				
4	30"

PLAN

ELEVATION

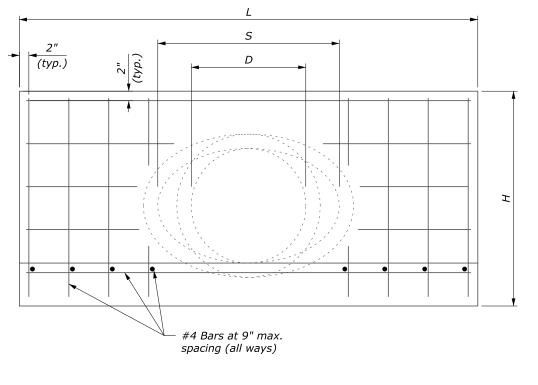
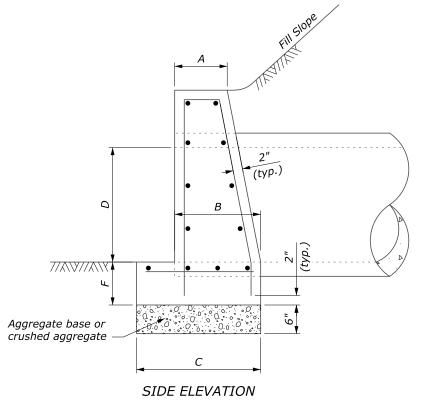
- 1. Orient all headwalls parallel to the roadway centerline unless otherwise indicated in the plans or by the CO.
- 2. When pipes are on a skew, adapt and lengthen headwalls as directed.
- 3. Chamfer all exposed corners not rounded to $\frac{3}{4}$ ".
- 4. Quantities shown are for one headwall with pipe at right angles.
- 5. Construct headwalls using dimensions shown under values for 1V:1.5H slope, unless otherwise designated by the CO.

HEADWALL FOR ELLIPTICAL PIPE									
			SIZ	ZE OF ELLIPTION	CAL PIPE CULV	ERT (SPAN x R	RISE)			
	23" x 14"	30" x 19"	34" x 22"	38" x 24"	42" x 27"	45" x 29"	49" x 32"	53" x 34"	60" x 38"	68" x 43"
Α	0'-8"	0'-9"	0'-10"	0'-10"	0'-11"	1'-0"	1'-0"	1'-0"	1'-0"	1'-0"
В	1'-2"	1'-5"	1'-6"	1'-8"	1'-9"	1'-10"	1'-11"	1'-11"	1'-11"	2'-0"
С	1'-8"	1'-11"	2'-1"	2'-4"	2'-5"	2'-7"	2'-8"	2'-9"	3'-3"	3'-6"
D	1'-2"	1'-7"	1'-10"	2'-0"	2'-3"	2'-5"	2'-8"	2'-10"	3'-2"	3'-7"
F	0'-8"	0'-8"	0'-9"	0'-9"	0'-9"	0'-9"	0'-9"	0'-9"	0'-9"	0'-9"
Н	2'-10"	3'-3"	3'-7"	3'-9"	4'-0"	4'-2"	4'-5"	4'-7"	4'-11"	5'-4"
L	5'-5"	7'-2"	8'-6"	9'-2"	10'-2"	10'-11"	12'-1"	12'-11"	13'-0"	13'-0"
S	1'-11"	2'-6"	2'-10"	3'-2"	3'-6"	3'-9"	4'-1"	4'-5"	5'-0"	5'-8"
	CUBIC YARDS OF CONCRETE									
Conc. Pipe	0.502	0.855	1.236	1.500	1.811	2.101	2.512	2.801	2.969	2.904

HEADWALL FOR CIRCULAR PIPE									
	DIAMETER OF PIPE CULVERT								
	6"	15"	18"	21" or 24"	27" or 30"	33" or 36"			
Α	0'-6"	0'-8"	0'-9"	0'-11"	1'-0"	1'-0"			
В	0'-9"	1'-1"	1'-3"	1'-6"	1'-9"	2'-0"			
С	1'-2"	1'-7"	1'-9"	2'-2"	2'-6"	2'-9"			
D	1'-0"	1'-3"	1'-6"	2'-0"	2'-6"	3'-0"			
F	0'-6"	0'-8"	0'-8"	0'-9"	0'-9"	0'-9"			
Н	2'-0"	2'-11"	3'-2"	3'-9"	4'-3"	4'-9"			
L	3'-8"	5'-0"	6'-0"	8'-0"	10'-0"	12'-0"			
CUBIC YARDS OF CONCRETE									
Conc. Pipe	0.241	0.492	0.697	1.319	2.067	2.947			
C.M. Pipe	0.257	0.521	0.739	1.398	2.198	3.145

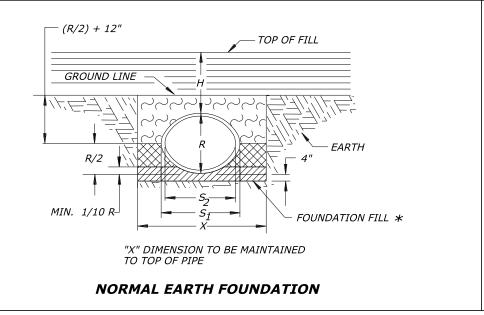
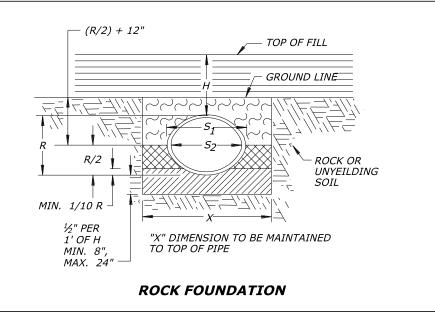
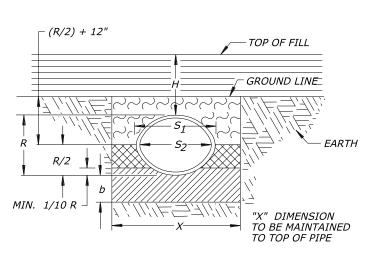
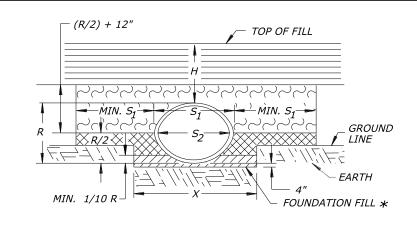
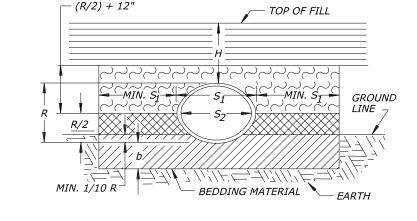
NO PROJECTION OF PIPE ABOVE GROUND LINE

FOUNDATION SOFT, YIELDING, OR OTHERWISE UNSUITABLE MATÉRIAL

PIPE PROJECTION ABOVE GROUND LINE

(R/2) + 12"TOP OF FILL \mathbb{R}^{2} GROUND LINE-ROCK OR UNYEILDING MIN. 1/10 R SOIL ½" PER 1' OF H MIN. 8", MAX. 24 **ROCK FOUNDATION**

CULVERTS LESS THAN S₁ = 36" $X = S_2 + 24''$

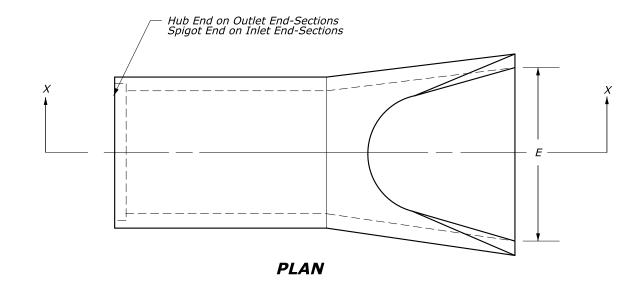
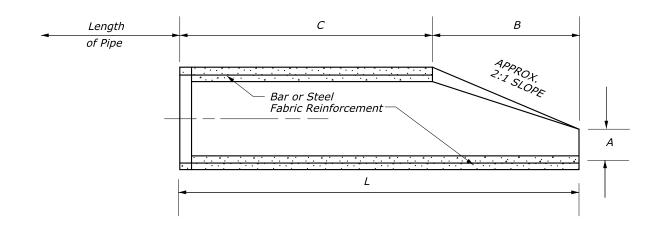
END SEC	TION DI	MENSION	IS	
SPAN X RISE	А	В	С	L	E
23" X 14"	6"	2'-3"	3'-10"	6'-1"	2'-8"
30" X 19"	9"	2'-11"	3'-2"	6'-1"	3'-6"
38" X 24"	10"	3'-8"	2'-6"	6'-2"	4'-0"
42" X 27"	12"	4'-8"	1'-8"	6'-2"	5'-0"
45" X 29"	13"	4'-11"	3'-3"	8'-2"	5'-6"
53" X 34"	15"	5'-3"	2'-11"	8'-2"	6'-0"

END VIEW

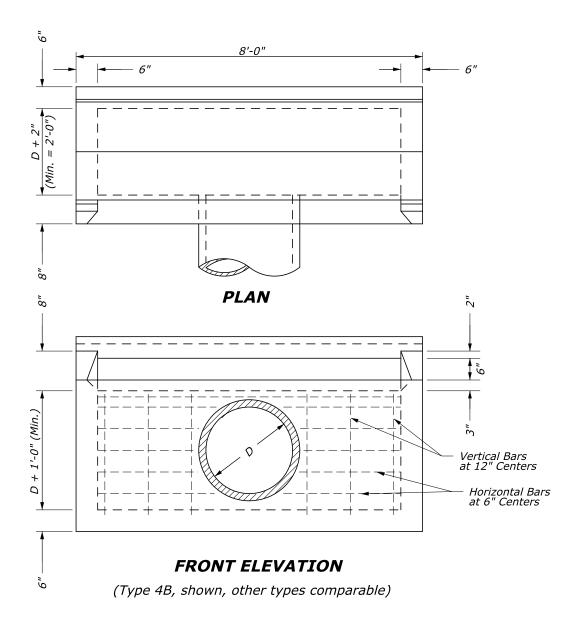
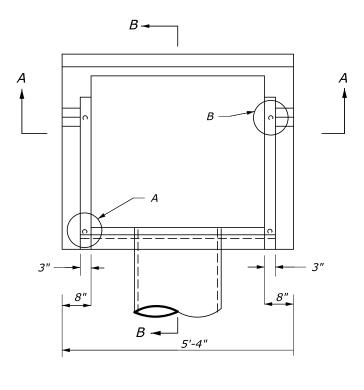
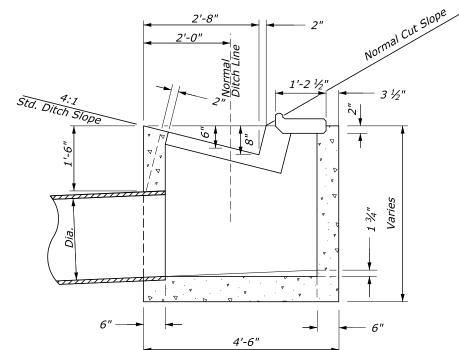
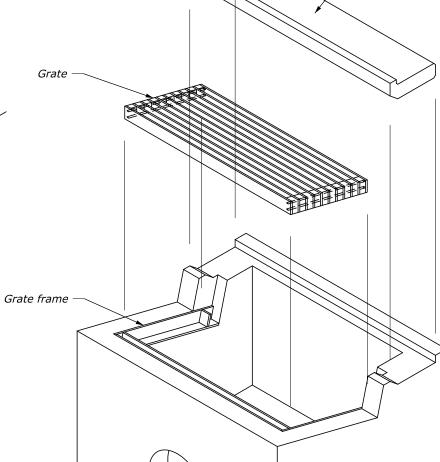
- 1. At the option of the Contractor, walls less than 4 feet deep may be of concrete or concrete block.
- 2. Inlets to be parallel to roadway centerline and grade. For pipes on skew, adjust inlets as directed.
- 3. Ditch or paved waterways to be warped and widened near inlets as directed by the CO, to facilitate drainage and to protect slopes at ends of inlets.
- 4. For payment purposes, one slab A plus one slab B or two slabs B constitute one concrete cover.

Cover

VIEW A

VIEW B

SECTION B-B

SECTION A-A

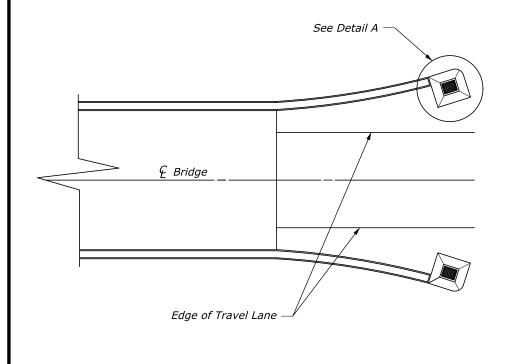
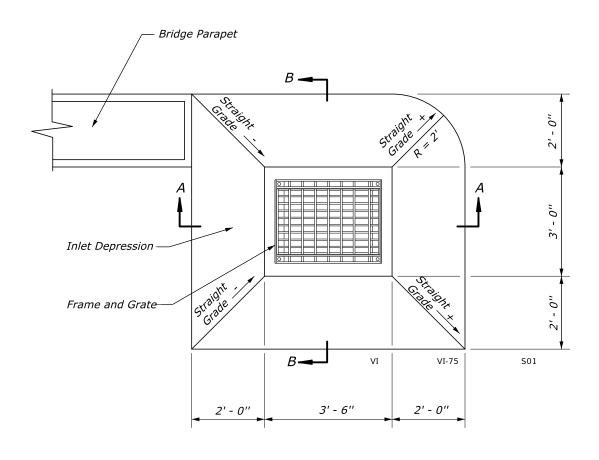
INLET, TYPE 5A MODIFIED

<u>PLAN</u>

1. See Standards 604-5 and 604-6 for drop inlet and frame and grate details.

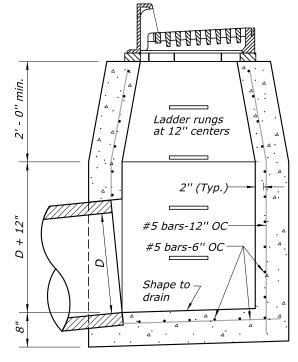
Ample Headroom **SECTION A-A**

INLET, TYPE 6A

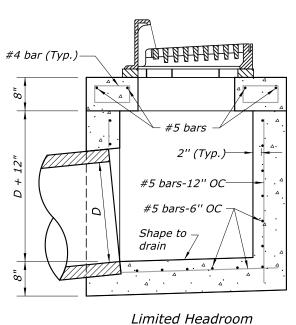
SECTION A-A

1. At the option of the Contractor, walls less than 4 feet may be of concrete or concrete block.

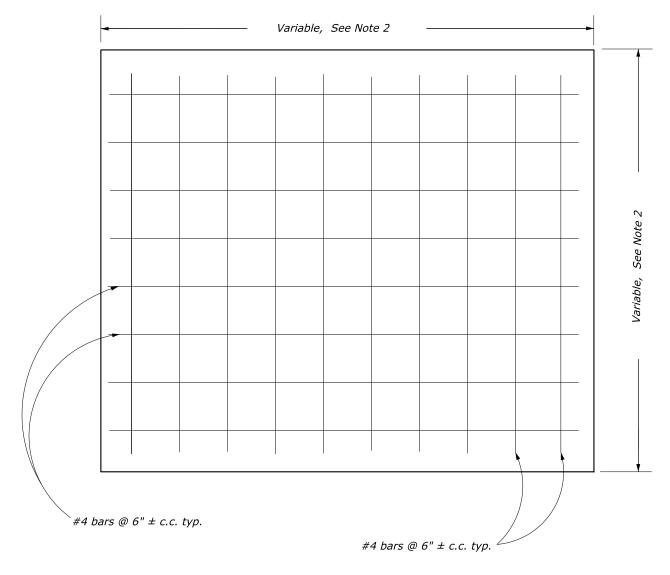
PLAN

- 6. Orient curved vanes toward direction of stormwater flow. In a sump condition, orient curved vanes in either direction. Ensure all grates are correctly oriented towards stormwater flow.

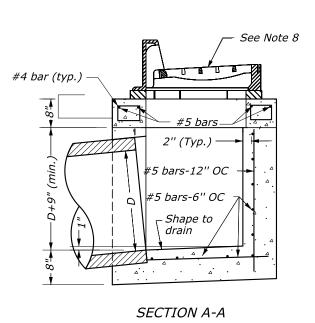
INLET, TYPE 6A-6 (For up to 24" pipes)

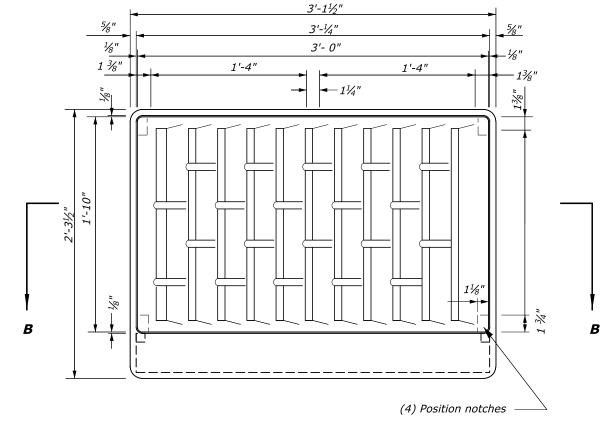
- 1. Minor variations in design and dimensions for frames and grating are permitted to allow manufacturer's standards. Ensure all grates are bicycle safe.
- 2. Orient curved vanes toward direction of stormwater flow. In a sump condition, orient curved vanes in either direction. Ensure all grates are correctly oriented towards stormwater flow.

FRONT ELEVATION GRATE TYPE 6A-6 MOUNTED (CURVED VANE GRATINGS)

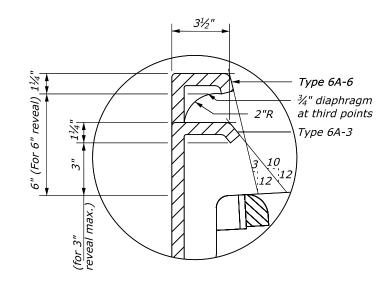
SIDE ELEVATION GRATE TYPE 6A-6 MODIFIED (CURVED VANE GRATINGS)

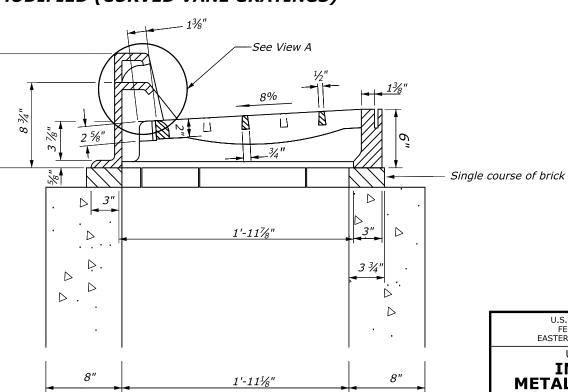
METAL FRAMES AND GRATING TYPE 6A-6 MODIFIED
