MAJOR LAND AND WATER ENVIRONMENTAL ASSESSMENT FOR THE LATITUDE 18 VESSUP BAY MARINA

ST. THOMAS, U.S. VIRGIN ISLANDS

JANUARY 2022

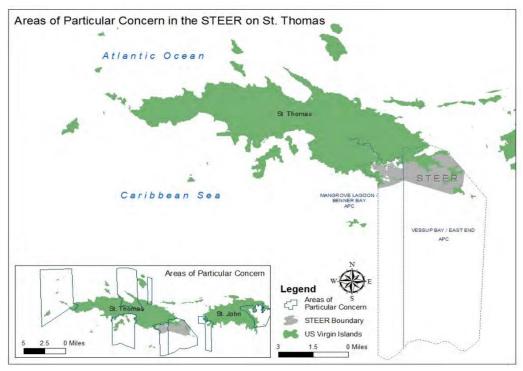
Figure 5.01.1 Areas of Particular Conern (STEER (2011) St. Thomas East End Reserve Management Plan. St. Thomas, USVI.

The subject parcels are within the Vessup Bay/ East End Red Hook Area of Particular Concern (APC) (Figure 5.01.1). The Vessup Bay/Red Hook APC is located on the eastern end of St. Thomas and includes Nazareth, Muller, Vessup, Red Hook, Great Bay, Cowpet Bay, Cabrita, Beck and Water Point, Great St. James, Little St, James, and Dog Island.

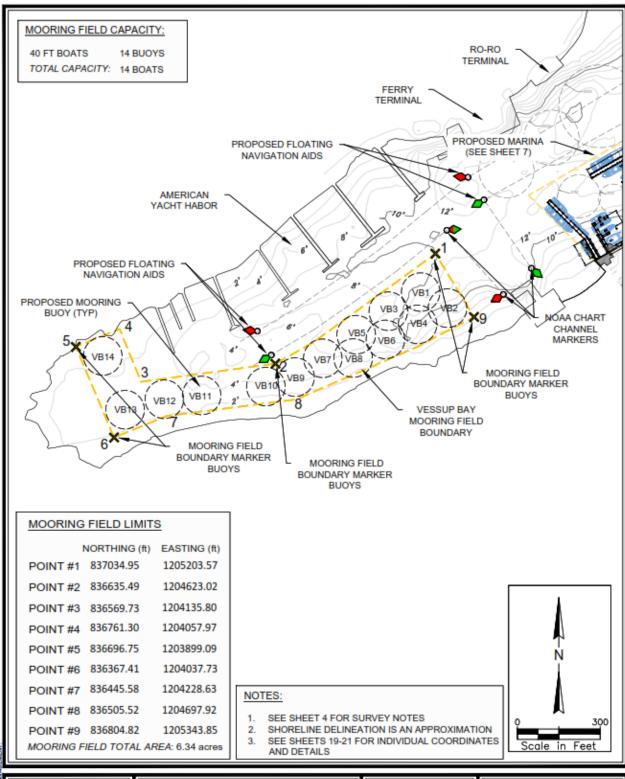
OVERALL PROPOSED PLAN VESSUP BAY MOORING FIELD

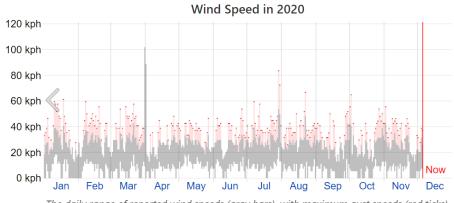
Figure 6.01.1 Wind speed and Gust reported at the Cyril E. King Airport, U.S. Virgin Islands in 2020 averages (https://weatherspark.com/y/28234/Average-Weather-inCharlotte-Amalie-U.S.-Virgin-Islands).

The daily range of reported wind speeds (gray bars), with maximum gust speeds (red ticks).

The Virgin Islands lie in the "Easterlies" or "Trade Winds" which traverse the southern part of the "Bermuda High" pressure area, thus the predominant winds are usually from the east-northeast and east (IRF, 1977). These trade winds vary seasonally (Figure 6.01.1) and are broadly divided into 4 seasonal modes: 1) December to February; 2) March to May; 3) June to August; and 4) September to November. Below are the characteristics of these modes as taken from Marine Environments of the Virgin Islands Technical Supplement No. 1 (IRF, 1977).

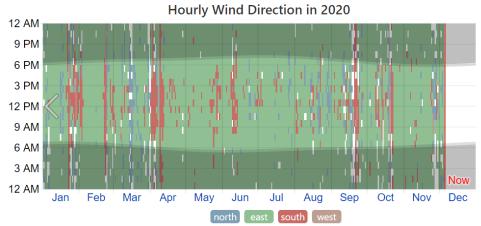
Figure 6.01.2 Hourly wind direction reported at the Cyril E. King Airport, U.S. Virgin Islands in 2020 (https://weatherspark.com/y/28234/Average-Weather-inCharlotte-Amalie-U.S.-Virgin-Islands).

The hourly reported wind direction, color coded by compass point. The shaded overlays indicate night and civil twilight.

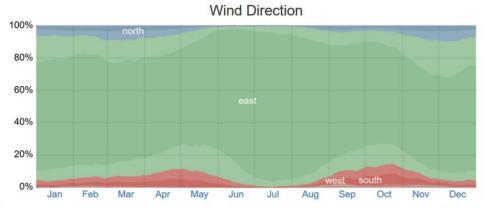
Figure 6.01.4 Wind averages (https://weatherspark.com/y/28234/Average-Weather-inCharlotte-Amalie-U.S.-Virgin-Islands)

The percentage of hours in which the mean wind direction is from each of the four cardinal wind directions (north, east, south, and west), excluding hours in which the mean wind speed is less than 1 mph. The lightly tinted areas at the boundaries are the percentage of hours spent in the implied intermediate directions (northeast, southeast, southwest, and northwest).

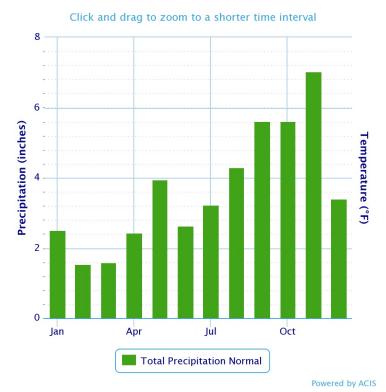
Figure 6.01.7 Rainfall Normals for Red Hook, St. Thomas. https://www.weather.gov/images/sju/Interactive_Map/RedHookBay.jpg

Monthly Climate Normals (1981–2010) – REDHOOK BAY ST THOMAS, VI

The Red Hook area gets between 36-45 inches of rainfall a year. Rainfall usually occurs in brief, intense showers of less than a few tenths of an inch and major rainfall events are associated with weather systems (USGS 1998). The Virgin Islands have no sharply defined wet season. The wettest period generally is from September to November, and the driest period is from January to June (USGS 1998). Rainfall data from 1981 to 2010 for the Red Hook Bay area is presented below.

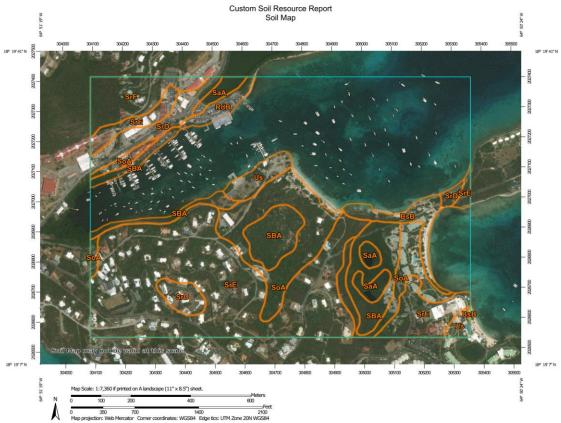
Figure 6.02.1 Custom Soils map of the project area (USGS Custom Soil Survey (https://websoilsurvey.sc.egov.usda.gov/App/WebSoilSurvey.aspx)

The Custom Soil Survey of the Unites State Virgin Islands has classified 3 soil types on the Cabrita Property. Salt flats ponded (SaA) consist of area of unvegetated saline flats, saline marshes and salt ponds. The soils are very deep and poorly drained, strongly saline and frequently ponded for very long periods. This soil type encompasses where the old salt pond used to be in the center of the property. Solitude gravelly fine sandy loan (SoA), is found in areas that are adjacent to saline marshes, flats and salt ponds and are a mixture of terrestrial and marine sediments. This soil type is found surrounding the area of the old salt pond and extends to the shoreline to the east. The final soil type is Ustorthents (Us), these soils are typically highly altered and have little vegetation and are excessively drained. These soils are found along the shoreline of the marina area and encompass a large portion of the property.

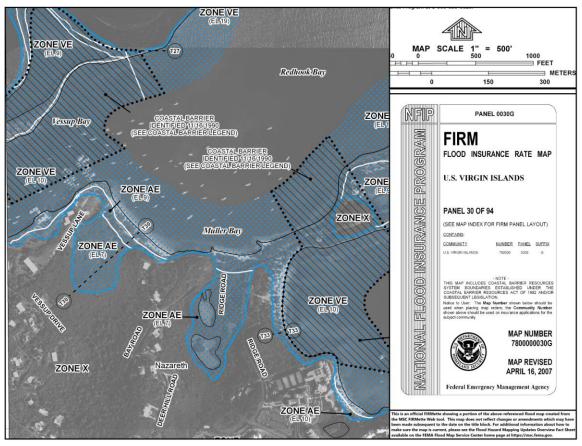
Figure 6.03.3 FEMA FIRM Map 30 of 94.

The offshore area where the dock is proposed, and the adjoining shoreline lie within area VE elevation 9ft where FEMA has determined that the 100-year flood elevation with velocity (wave action) will be 9ft as shown on FIRM map 30 of 94 and the immediate coastal area is in AE elevation 9ft where the 100-year coastal flood elevation has been determined to be 9ft. The old salt pond area is in AE elevation 7ft where the 100-year coastal flood has been determined to be 7ft. The rest of the property is in Zone X where coastal flooding is not expected.

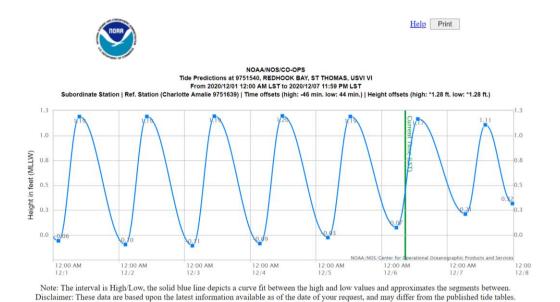
Figure 6.05.1. Tidal data from the Redhook Tidal Station (NOAA Buoys)

There is also a Tide Station in Redhook (Station ID: 9751540), the station is located at latitude 18° 19.6 N and longitude 64° 51.1 W and has a mean tidal range of 0.82ft and a diurnal range of 1.09ft.

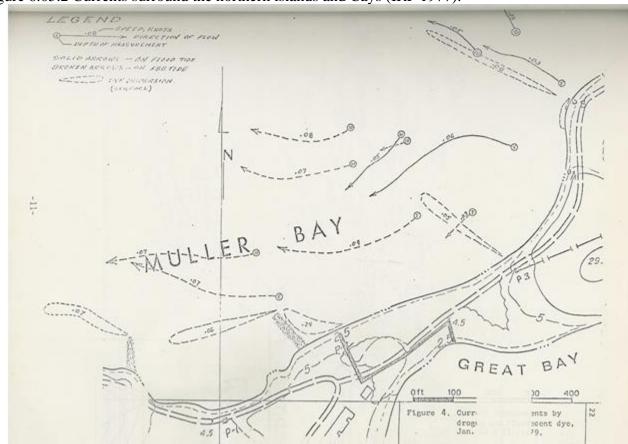
Figure 6.05.3 Currents in Muller Bay.

The measured data shows that there is no significant variation in the tidal signal between Muller Bay and the upper end of Vessup Bay, i.e. no damping or amplification.

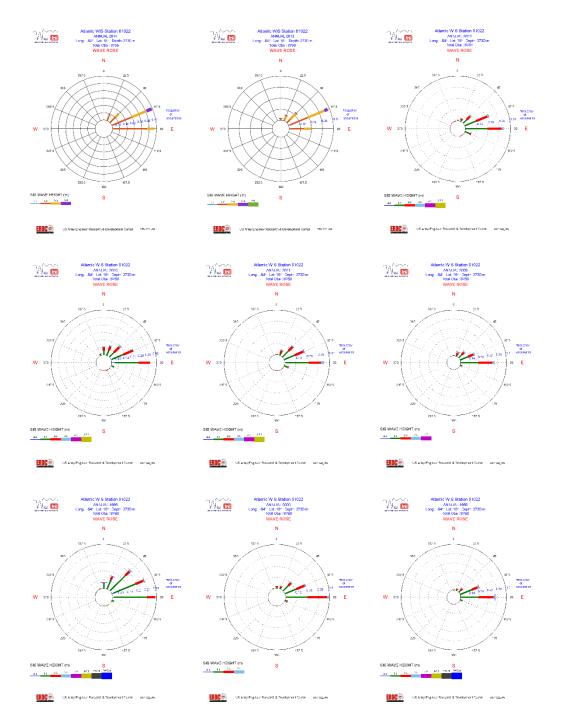
Figure 6.05.4. Wave Roses from the USACE Wave Information Studies for buoy 61022.

The deep-water waves off Red Hook Bay are primarily driven by the northeast trade winds that blow most of the year. Waves average from 1 to 3ft from the east, 42% of the time throughout the year (IRF, 1977). For 0.6% of the time easterly waves reach 12ft in height. The southeasterly swell with waves one to twelve feet high become significant in late summer and fall when the trade winds blow from the east or when tropical storms and hurricanes pass the islands at a distance to the south. During the winter months, long length, long period northern swells develop to a height of 1 to 5 feet. The USACE Hindcast Studies for buoy 61022 the two buoy whose waves patterns directly affect the project area, shows that a majority of the waves which occurred approach from easterly directions.

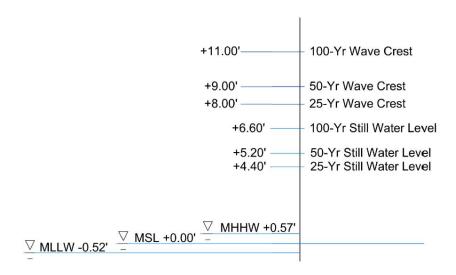
Figure 6.05.5: Summary Water Elevations. (*Wave crest values vary depending on project site's location.)

Based on the desktop review of tidal data, the wave studies and using the local mean sea level (MSL) as the vertical reference, the following still water levels and wave crest elevations are considered representative of conditions in the marina site:

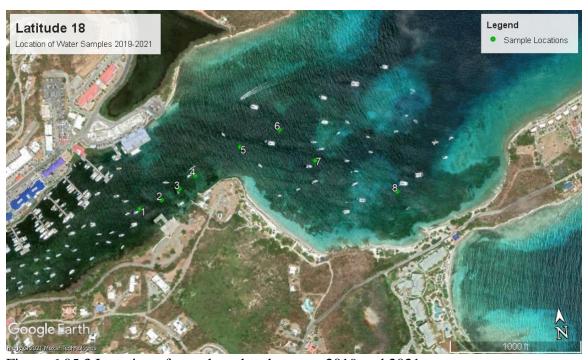
Water sampling has occurred on the site over the last several of years in order to establish a baseline of water quality conditions. Samples were taken with a calibrated YSI EXO multi-meter and were taken at a depth of 1 meter. The samples from 2019 and the beginning of 2020 were focused within the marina. As the idea of a managed mooring field was considered additional sampling locations were added (Table 6.05.3). Samples were also taken during the current study which are provided in Table 6.05.4.F The map below shows the location of the samples.

Figure 6.05.3 Location of samples taken between 2019 and 2021

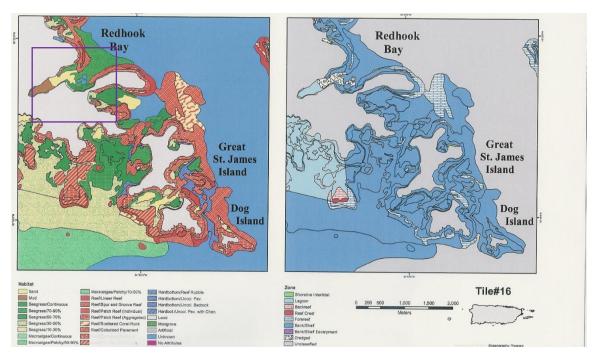
The NOAA NOS Benthic habitat map, depicts. This is an accurate description of the benthic habitats within the area. The NOAA NOS map is provided below followed by a benthic habitat map. Inner Vessup Bay is shown as mud with small areas of seagrass along the sides of the bay. The inner harbor is heavily algal colonized, and there is sparse seagrass along the edges. The area immediately off the marina site is shown as sand. This area is colonized by scattered algae and *H. stipulacea*. The NOS map shows seagrass 70-90% offshore, this area is more in the order of 30-40% and this area is highly impacted by *H. stipulacea*, anchors, ropes, and debris. The NOS map shows seagrass continuous along the eastern shoreline, again the seagrass is closer to 50%. The map shows an area of dredging in the bay which shows in the historic aerials shown in Section 6.02.

Figure 6.06.1. NOS Benthic Habitat Map Tile 16. Great Bay is shown within the blue box, and the project site is indicated by the red star.

Figure 6.06.1. NOS Benthic Habitat Map Tile 16. Great Bay is shown within the blue box, and the project site is indicated by the red star.

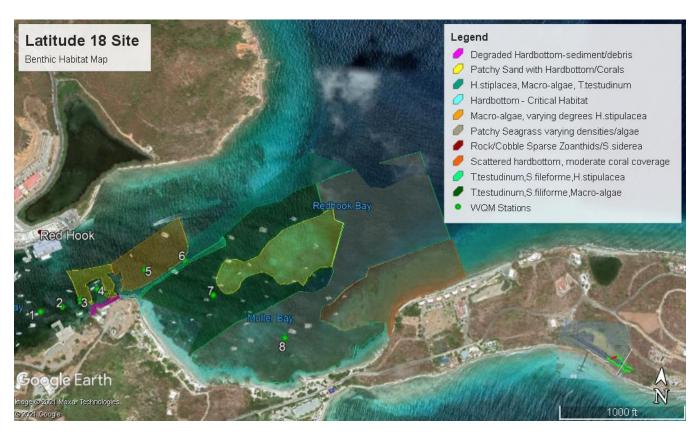
Figure 6.06.2 Benthic Habitat in the marina area

Figure 6.06.2 Benthic Habitat in the marina area

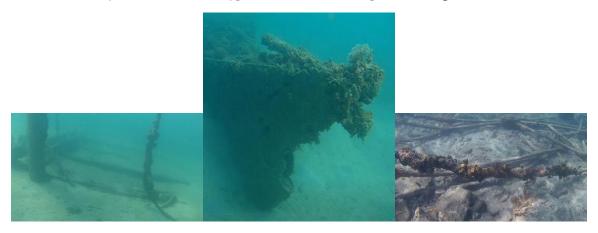
The seafloor is a mix of uncolonized sand, *Halophila stipulacea*, and scattered *Halimeda opuntia*, *Udotea flabellum* and *Penicillus capitatus*.

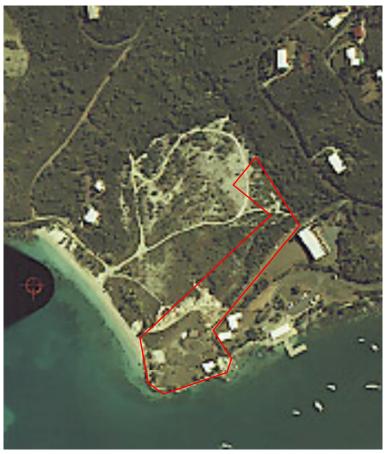
By 1974 there was more development in the subject parcel, the approximate disturbance lines for the Latitude 18 development are shown in red.

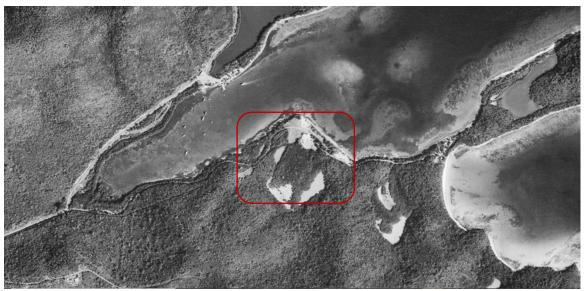
The area does contain an old filled saltpond/wetland system as shown in the 1954 aerial. These were filled like several wetlands systems in the late 1950s and through the 1960s. The area was filled with spoils pumped in from dredging the adjacent bay. To assess whether there were any remaining wetlands a delineation was conducted, and test augers were done throughout the site. No hydric soils were found within 36" of the surface and all subsoil material was sandy in nature. To confirm this assessment Jose Cedeno of the U.S. Army Corps of Engineers conducted a site visit and concurred with the findings.

Figure 6.08.1 There were wetlands throughout the site in 1954.

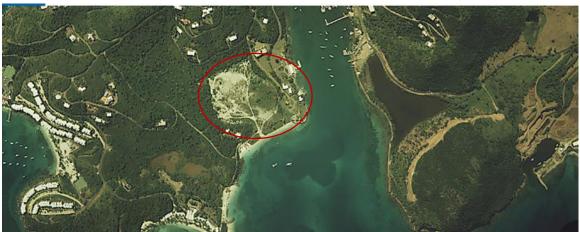
Figure 6.08.2 Comparing this 1972 aerial to the 1954 aerial you can clearly see the areas which were dredged.

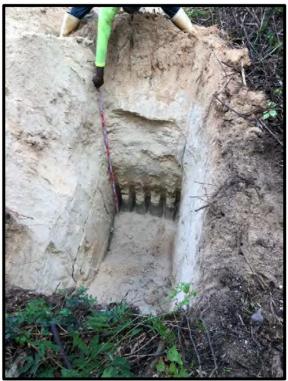
During the archeological survey a backhoe was utilized to excavate to try to find the depth of the fill on the site and that study found approximate 5ft of sand fill over what were hydric soils, the tape in the picture below is extended 2 meters.

From the archeological report, "The dredged spoil was found to extend from the surface to depths varying between approximately 2 to over 3 meters below the surface. The dredged materials consisted entirely of sand with surprisingly little coral or shell. We observed only a few juvenile conch shells and fewer mature specimens in the dredged spoil. Some seabed rock was also contained in the dredge deposits."

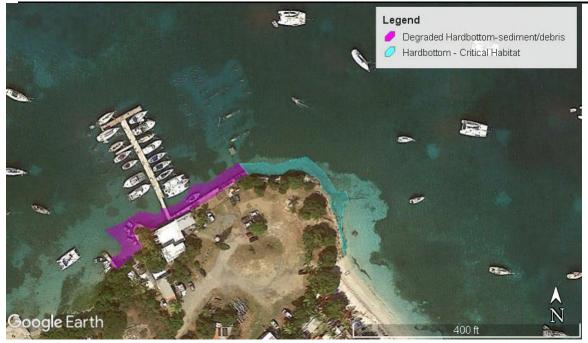
The hardbottom in the mooring field is critical habitat to listed coral species. Orbicella faveolata is found within the mooring.

Figure 6.09.1 Critical habitat near the marina.

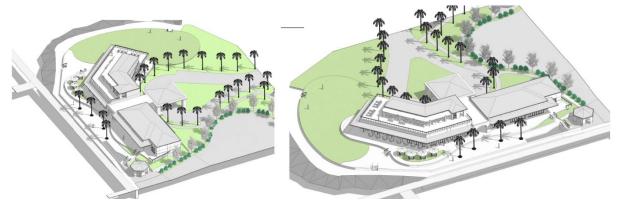
The proposed project will be a substantial improvement visually on the existing property. Presently, the Latitude 18 development consists of a wood framed ruin damaged from Hurricanes Irma and Maria in 2017. The existing marina layout has also been severely damaged over the past 25 years by the major hurricanes starting with Hurricane Marilyn in 1995 and culminating with Hurricanes Irma and Maria. The proposed wet slip Marina will for the most part be aligned with the layout of the original Latitude 18 Marina. The Restaurant & Marina Services Building is the cornerstone of the upland development. it is located on the Northeast Promontory of the site. This location forms the southern entry point to Red Hook Bay. The overall structure will be one and a half stories in height with a total square footage of approximately 10,000 SF. The Warehouse Building will be 10,000 SF in size. It will be a single-story structure that will contain storge of materials and supplies related to the operation of the Marina. The axonometric views shown below provide a visual representation of the project once complete.

Figure 7.02.1 The Restaurant and Marina Services Building

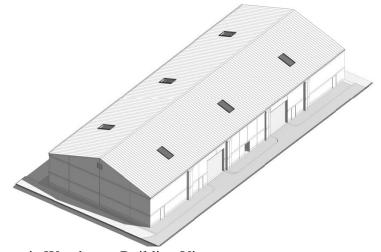
Figure 7.02.2 Axonometric Warehouse Building View

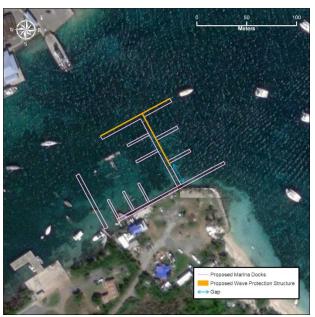
Alternative 2 – gap of 23 feet between the shoreline and the wave protection structure

Alternative 3 - gap of 46 feet between the shoreline and the wave protection structure

Figure 9.00.1: Proposed Marina Location and Wave Protection Structure (Design Condition) Initially, the design looked to extend the wave barrier perpendicular to the shoreline up to the shoreline in order to provide the maximum protection (Alternative 1). Initial flushing simulation results showed that this would significantly increase the overall flushing times within Vessup Bay. Two other alternatives were run. The first had a gap of 23 feet between the shoreline and the wave protection structure (Alternative 2). The second had a gap of 46 feet (Alternative 3). The runs with a gap of 70 feet was shown to have no negative impact on circulation.

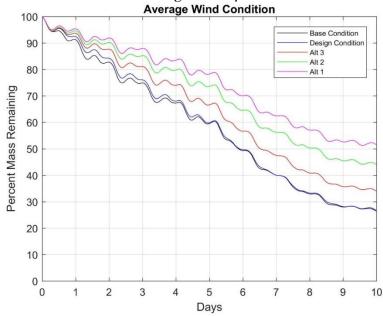
Figure 9.002: Comparison of the Percent Mass Remaining for the Alternatives, the Design Condition and the Baseline Condition under Average Wind Conditions

From the point of view of flushing Vessup Bay, the project achieved no negative impact by locating wave panels in a way that do not obstruct circulation, as demonstrated by the results of a calibrated flushing model.

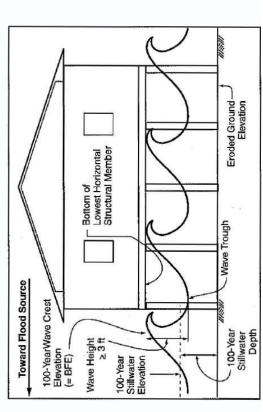
Figure: FEMA diagram showing waves riding on SWEL, and showing schematic freeboard of building lowest horizontal structural member above Maximum Wave

The maximum elevation of still water level plus wave height is known as the Maximum Wave Crest Elevation. This is the critical elevation to which wave crest heights can reach and serve as a basis for FEMA's Base Flood Elevations (BFE). BFE and wave heights are critical variables for coastal construction guidelines.

FEMA's WHAFIS model was used for the various scenarios and the output BFEs based on maximum wave crest elevations.

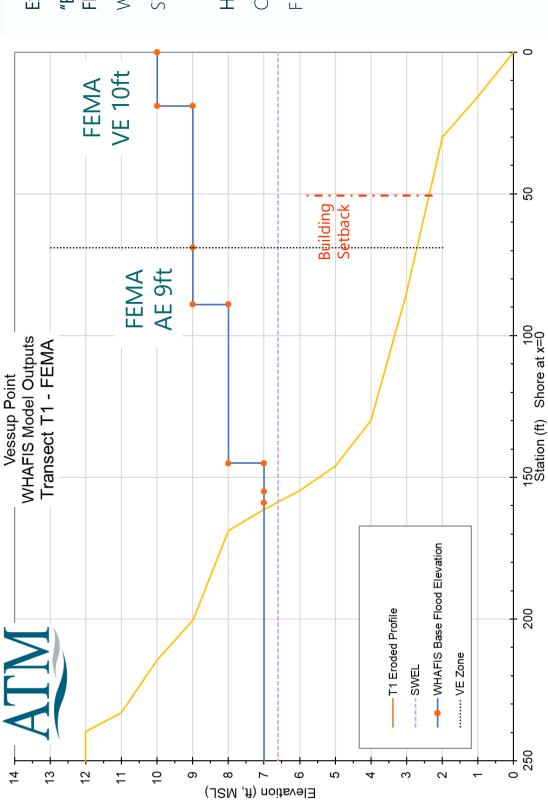
Transect 1 (FEMA): 100-year storm

Existing Site Conditions / Site Analysis "Eroded Profile" Model Run to reproduce FEMA Flood Map

Wave Condition 1% annual exceedance

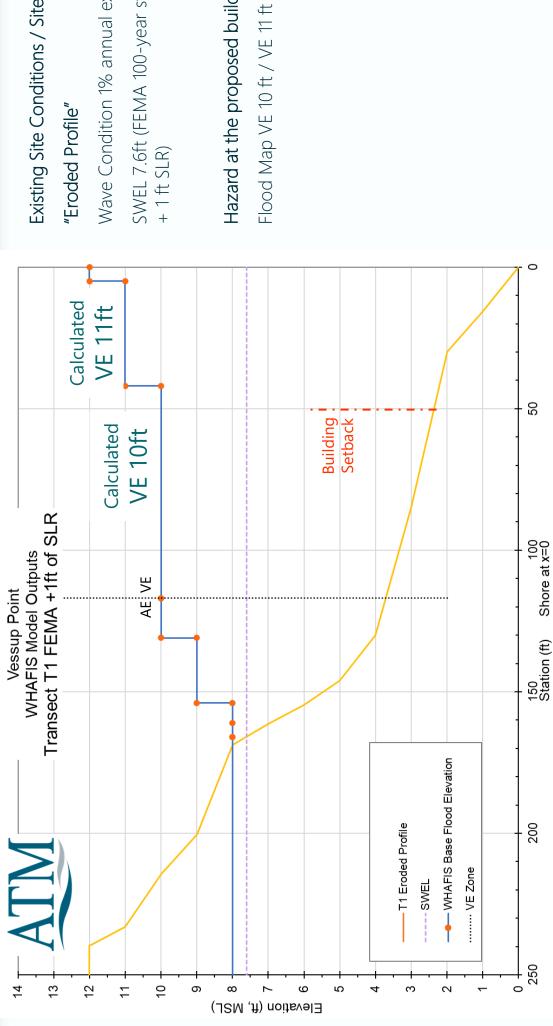
Fransect 1 (FEMA): 100-year storm + 1ft SLR

Existing Site Conditions / Site Analysis

"Eroded Profile"

Wave Condition 1% annual exceedance

Hazard at the proposed building setback:

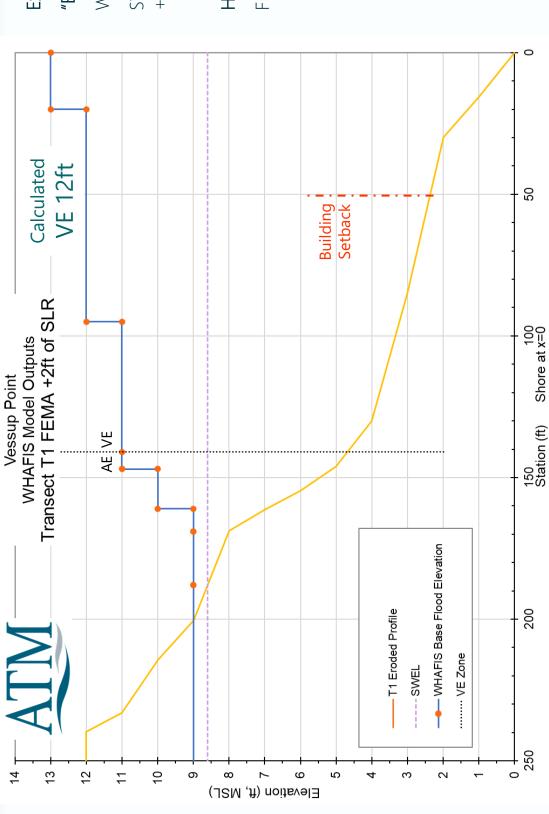
Fransect 1 (FEMA): 100-year storm + 2 ft SLR

Existing Site Conditions / Site Analysis

"Eroded Profile"

Wave Condition 1% annual exceedance

Hazard at the proposed building setback:

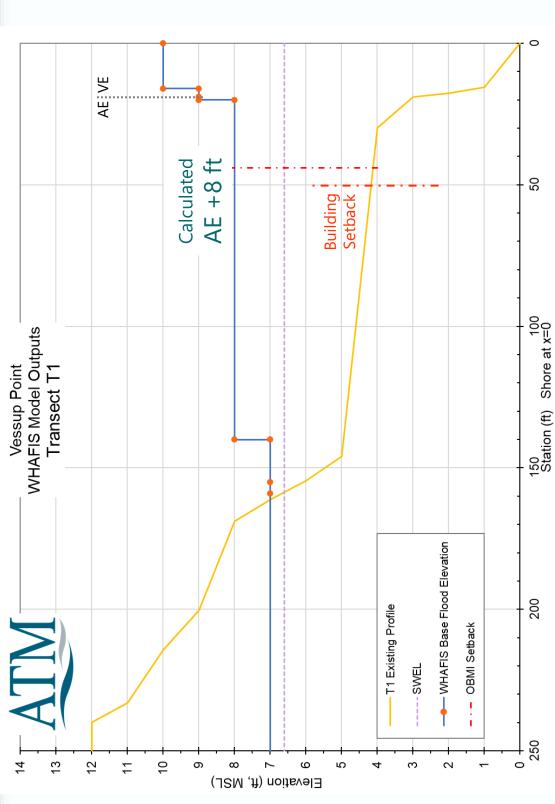
Transect 1: 100-year storm

Existing Site Conditions / Site Analysis

"Non-Eroded Profile"

Wave Condition 1% annual exceedance

Hazard at the proposed building setback:

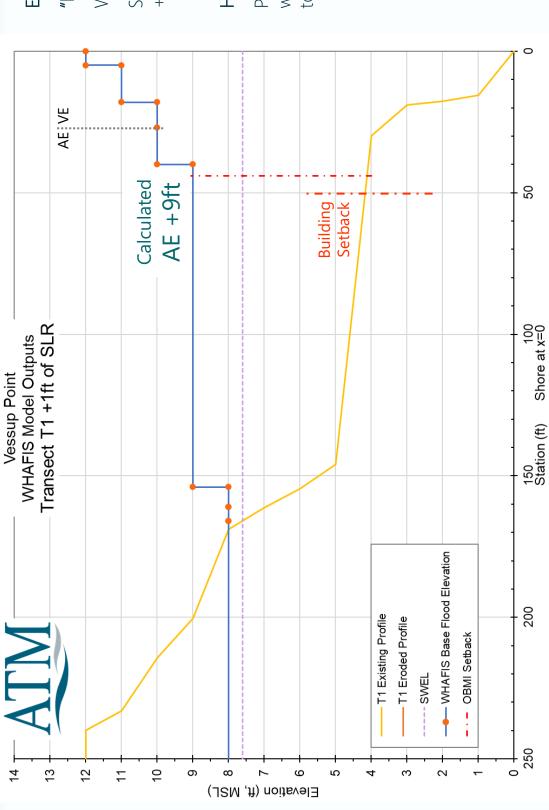
Fransect 1: 100-year storm + 1ft SLR

Existing Site Conditions / Site Analysis

"Non-Eroded Profile"

Wave Condition 1% annual exceedance

Hazard at the proposed building setback:

Proposed setback is in a calculated 'AE' zone with Base Flood Elevation (BFE) of +9 ft, adjacent to an AE +10 ft.

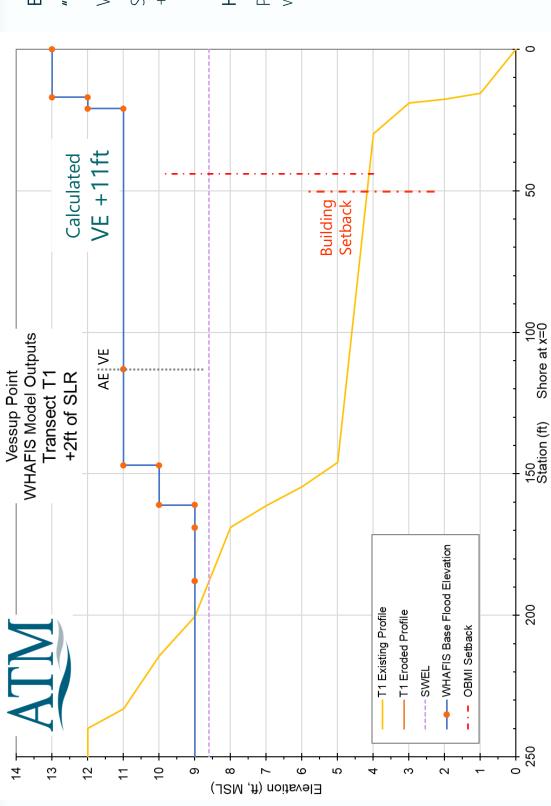
Fransect 1: 100-year storm + 2 ft SLR

Existing Site Conditions / Site Analysis

"Non-Eroded Profile"

Wave Condition 1% annual exceedance

Hazard at the proposed building setback:

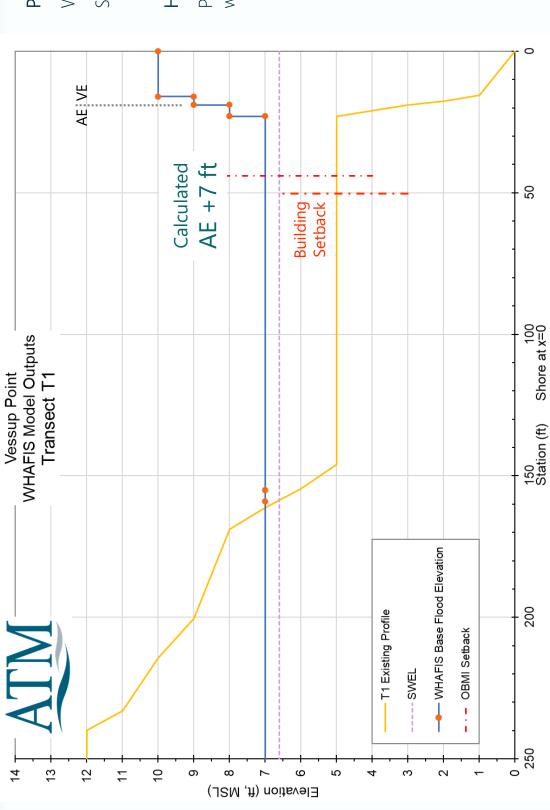
Transect 1 + Trip Wall 5') - 100-year storm

Proposed Trip Wall at +5ft Elevation
Wave Condition 1% annual exceedance
SWEL 6.6ft (FEMA 100-year still water elevation)

Hazard at the proposed building setback:

Proposed setback is in a calculated 'AE' zone with Base Flood Elevation (BFE) of 7 ft, MSL.

The proposed trip wall concept is a continuous structure, apart from openings for access to a planned walking path. The purpose of a trip wall is to break the incoming waves, to result in waves less than 3 ft prior to reaching the footprint of the building (the foundation or waterward-most structural projection) and, hence, result in an AE zone rating (versus VE zone).

The trip wall must be designed and constructed and certified to withstand FEMA 100-yr storm conditions. Although not required by FEMA, ATM recommends SLR allowances also be considered in design and structural loading calculations, unless adaptation measures can be implemented later to address those future conditions.

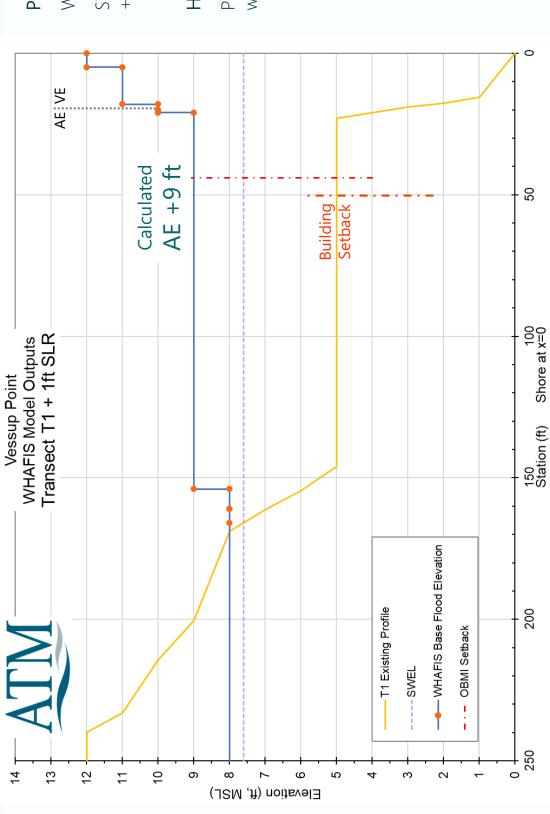
Transect 1 + Trip Wall (5') - 100-yr + 1ft SLR

Proposed Trip Wall at +5ft Elevation

Wave Condition 1% annual exceedance

Hazard at the proposed building setback:

Proposed setback is in a calculated 'AE' zone with Base Flood Elevation (BFE) of 9 ft, MSL.

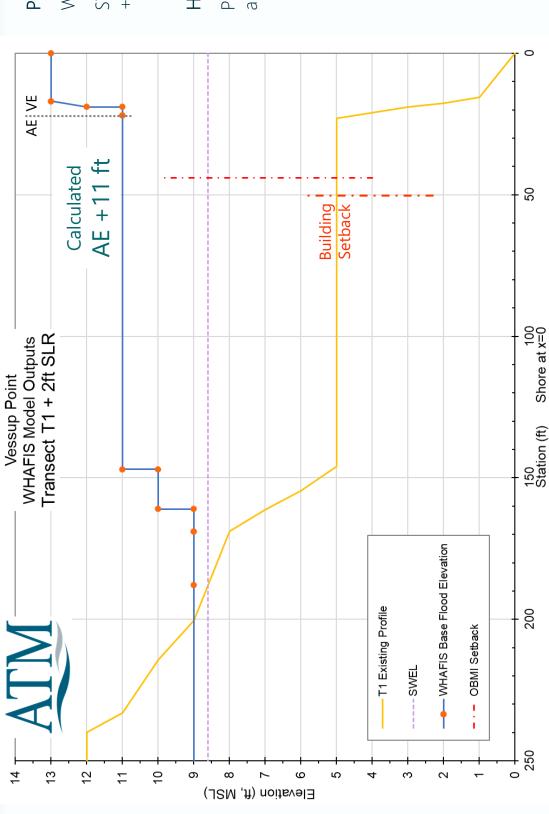
Transect 1 + Trip Wall (5') - 100-yr + 2ft SLR

Proposed Trip Wall at +5ft Elevation

Wave Condition 1% annual exceedance

Hazard at the proposed building setback:

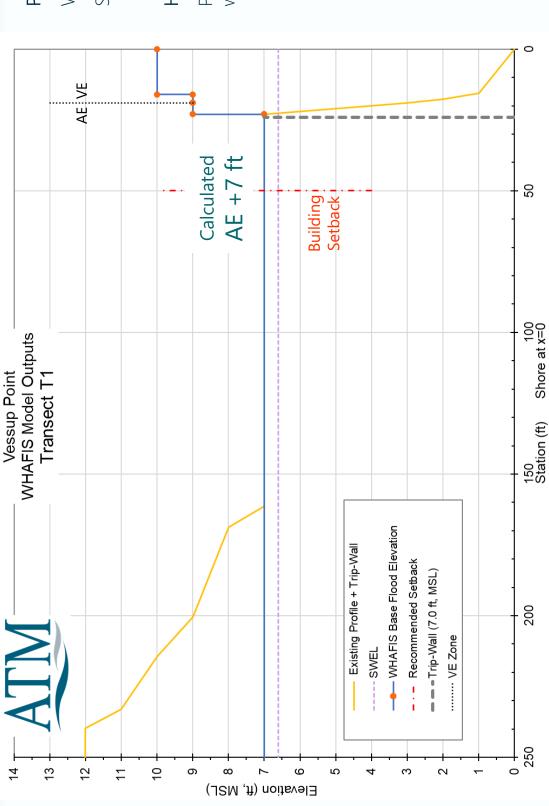
Transect 1 + Trip Wall (7') - 100-year storm

Proposed Trip Wall at +7ft Elevation
Wave Condition 1% annual exceedance
SWEL 6.6ft (FEMA 100-year still water elevation)

Hazard at the proposed building setback:

Proposed setback is in a calculated 'AE' zone with Base Flood Elevation (BFE) of 7 ft, MSL.

The proposed trip wall at +7ft elevation and development elevation of +11ft is recommended.

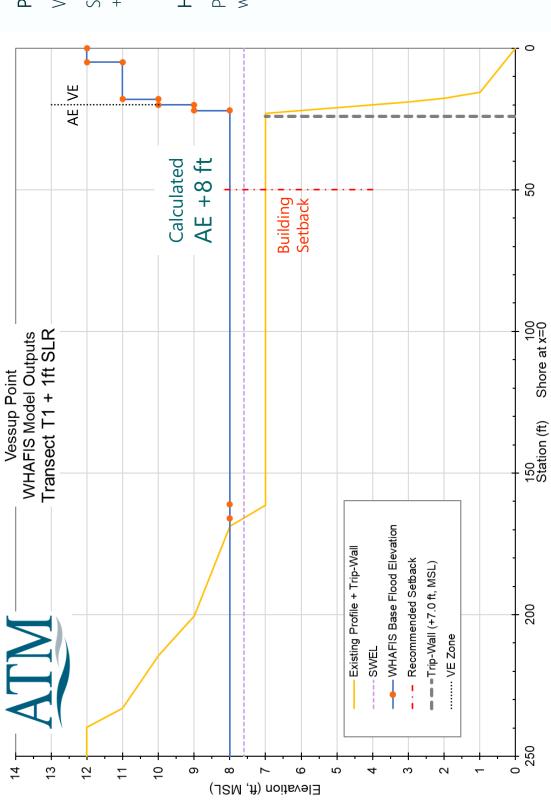
Transect 1 + Trip Wall (7') - 100-yr + 1ft SLR

Proposed Trip Wall at +7ft Elevation

Wave Condition 1% annual exceedance

Hazard at the proposed building setback:

Proposed setback is in a calculated 'AE' zone with Base Flood Elevation (BFE) of 8 ft, MSL.

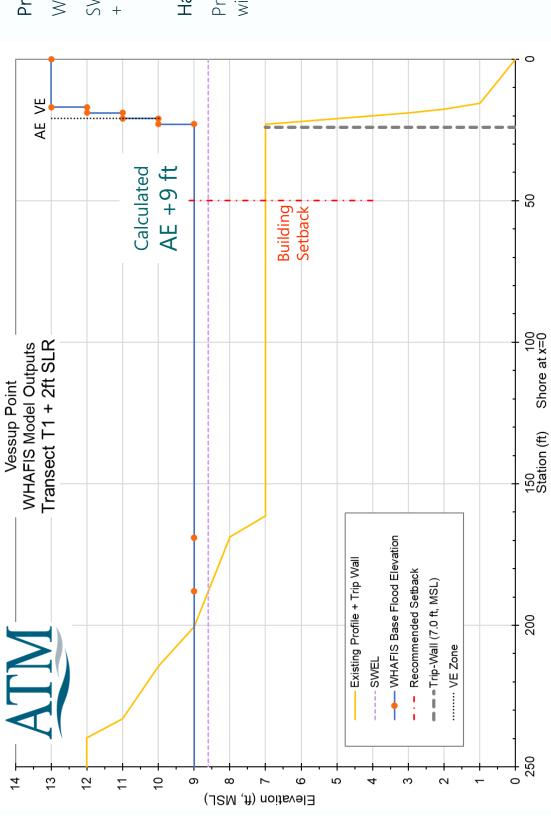
Transect 1 + Trip Wall (7') - 100-yr + 1ft SLR

Proposed Trip Wall at +7ft Elevation

Wave Condition 1% annual exceedance

Hazard at the proposed building setback:

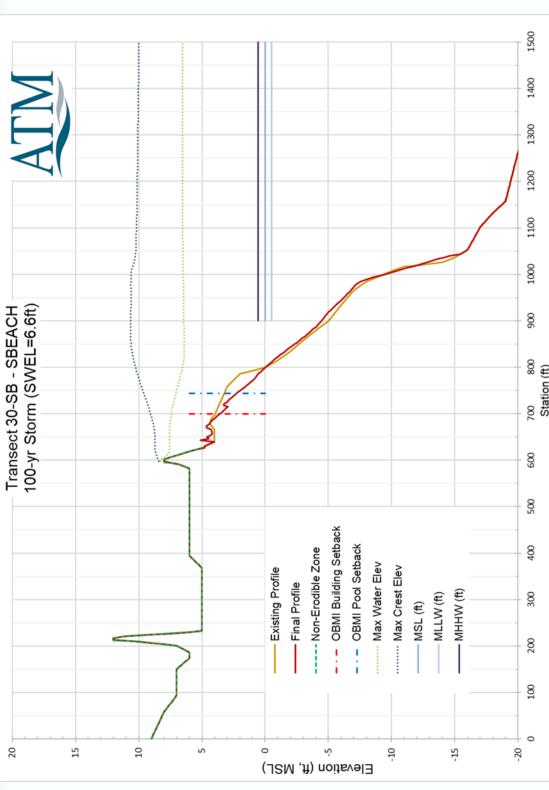
Transect 30: 100-year storm

Existing Site Conditions

Wave Condition 1% annual exceedance SWEL 6.6ft (FEMA 100-year still water elevation) Erosion and inundation occur landward of the originally proposed building footprint (STA 700). Additional setback is recommended.

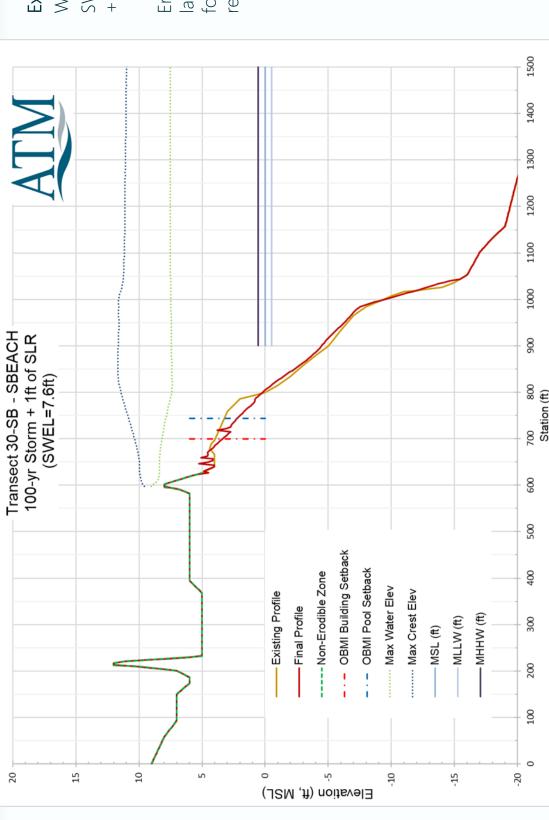
Transect 30: 100-year storm + 1ft SLR

Existing Site Conditions

Wave Condition 1% annual exceedance SWEL 7.6ft (FEMA 100-year still water elevation + 1ft SLR)

Erosion and inundation occur landward of landward of the originally proposed building footprint (STA 700). Additional setback is recommended.

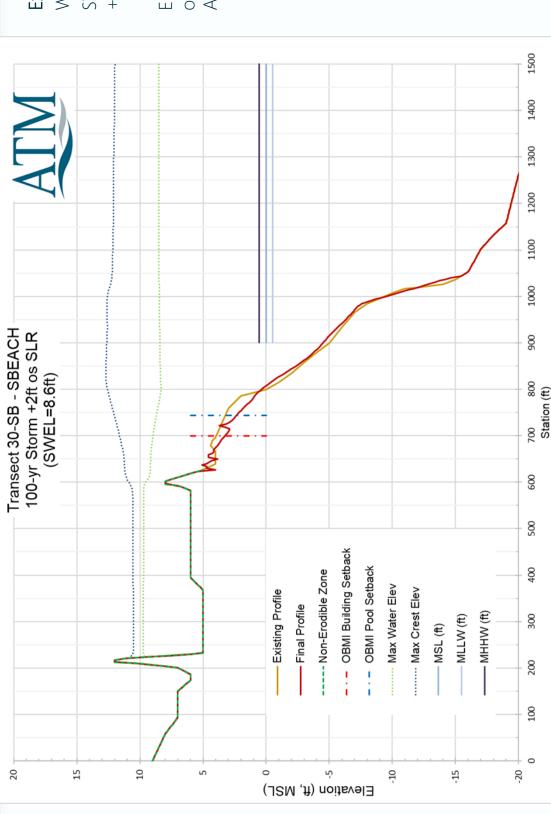
Transect 30: 100-year storm + 2 ft SLR

Existing Site Conditions

Wave Condition 1% annual exceedance SWEL 8.6ft (FEMA 100-year still water elevation + 2ft SLR) Erosion and inundation occur landward of the originally proposed building footprint (STA 700). Additional setback is recommended.

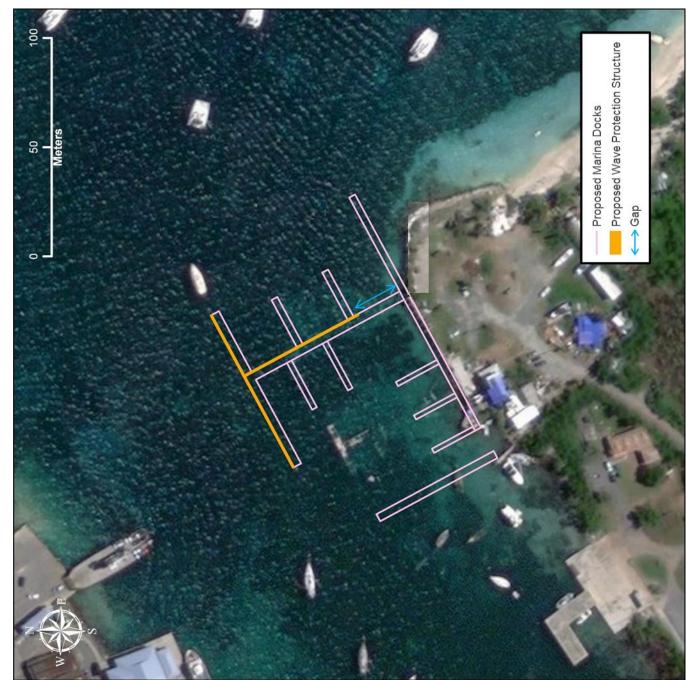
Figure 1-2. Vessup Point Plan View with Proposed Marina Location and Wave Protection Structure (Design Condition)

perpendicular to the shoreline, with a length of around 190 feet. A gap of approximately 70 feet Figure 1-2 presents a view of Vessup Bay with the proposed marina docks and the final design of the wave protection structure. Various alternative layouts of the wave protection structure were evaluated and are presented in this report. The final wave protection structure design will extend from the surface down to the bottom and will have two components. One component will sit will exist between the barrier and the shoreline to allow flow to pass through. This gap was identified through the alternative analyses presented later. The second component will run parallel to the shoreline at the end of the perpendicular barrier. This barrier is approximately 260

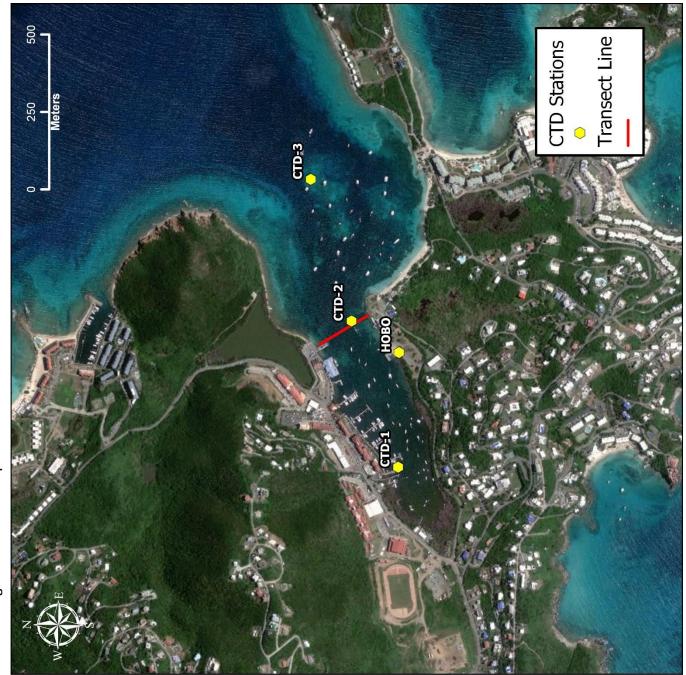
Figure 2-1. Locations of Data Collection for September 8 to 11, 2020 and October 7 to 8, 2020 Trips

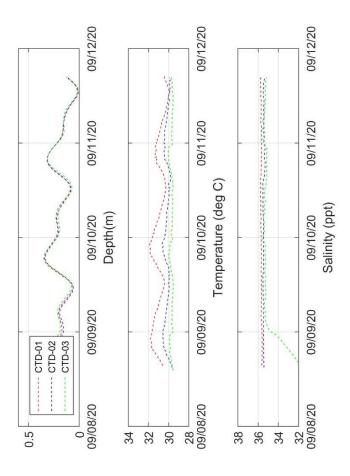
Figure 2-2. Measured Water Level, Temperature and Salinity for September 8 through 11, 2020 Trip

is very small with salinity levels near ocean conditions [35 parts per thousand (ppt)]. Salinities at Figure 2-2 presents plots of the data collected by the CTDs during the first trips. Figure 2-3 presents the CTD data from the second trip. The data show that there is no significant variation in the tidal The salinity data show that other than the first part of the measurements in September, where the salinities at the offshore station are low, the salinity gradient between the offshore and nearshore the interior station are slightly higher indicating little freshwater inflow and the potential for evaporation creating higher salinity levels. Temperatures fluctuate as expected with the response to the heating a cooling throughout the day more pronounced at the more interior stations signal from the offshore station to the upper end of Vessup Bay, i.e. no damping or amplification. reflective of the shallow stagnant nature of the waters.

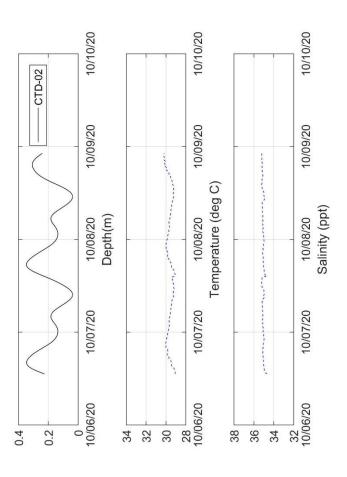
Figure 2-3. Measured Water Level, Temperature and Salinity for October 7 and 8, 2020 Trip

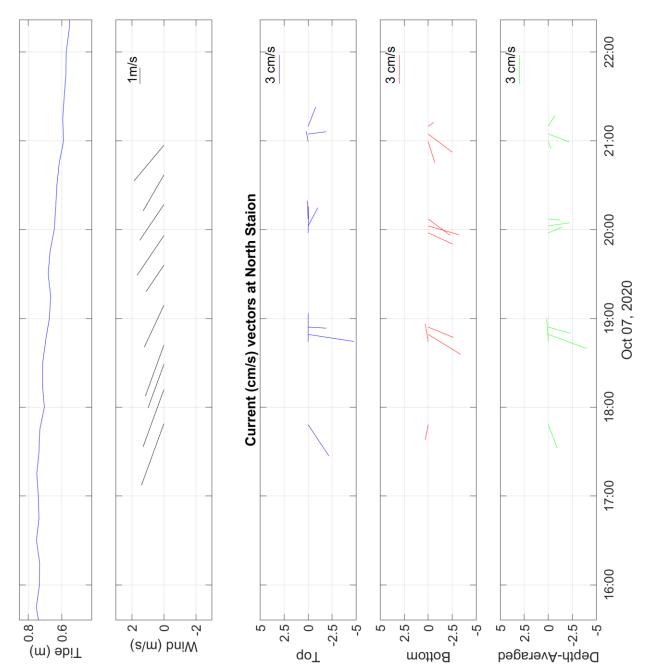
Figure 2-4a. Point Current Measurements at the North Station October 7, 2020

each of the three point stations respectively (North, Middle and South). Figure 2-7 presents the transects collected on October 8 plotted over one another. Hand-held wind measurements were Figures 2-4 a,b through 2-6 a,b present the point velocity measurements throughout the day for taken during the times of the point and transect measurements.

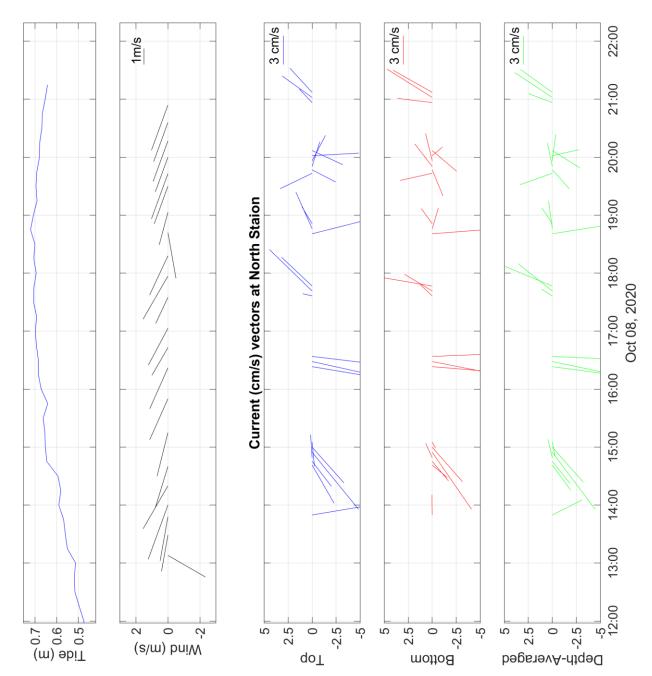
Figure 2-4b. Point Current Measurements at the North Station October 8, 2020

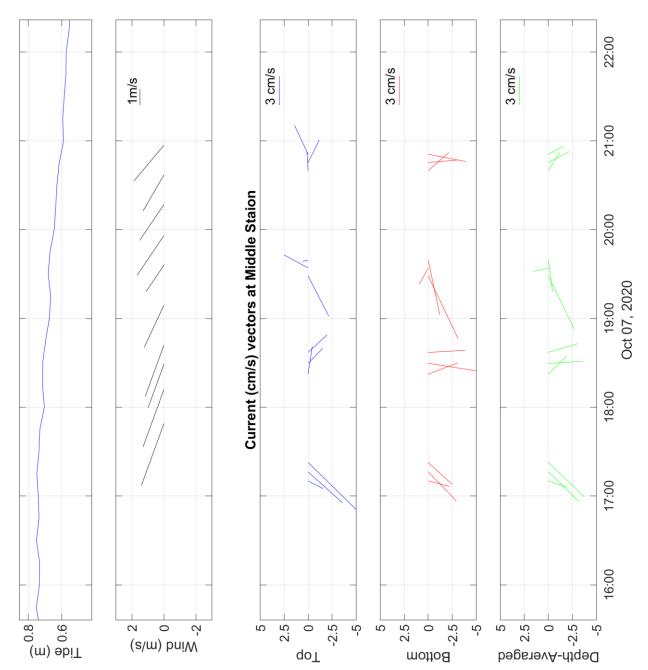
Figure 2-5a. Point Current Measurements at the Middle Station October 7, 2020

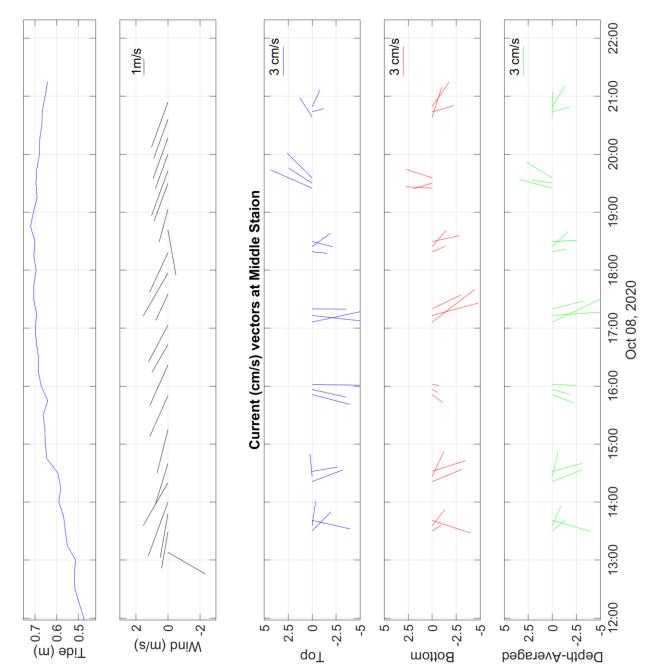
Figure 2-5b. Point Current Measurements at the Middle Station October 8, 2020

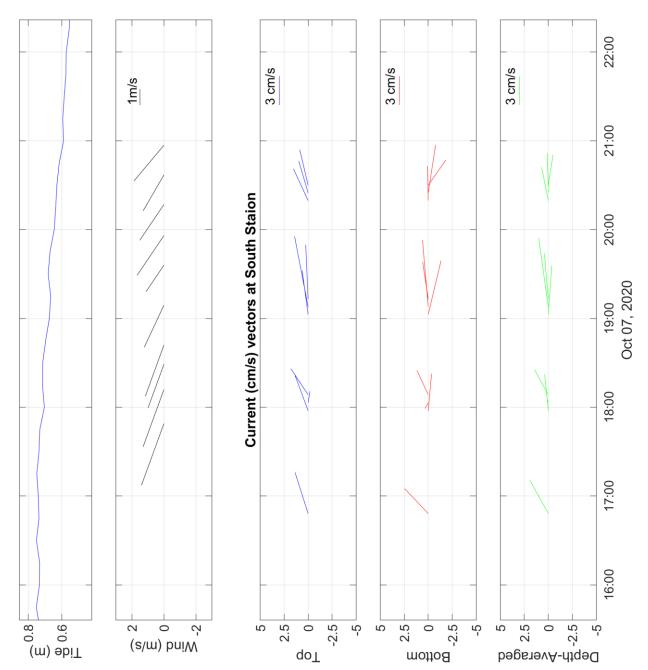
Figure 2-6a. Point Current Measurements at the South Station October 7, 2020

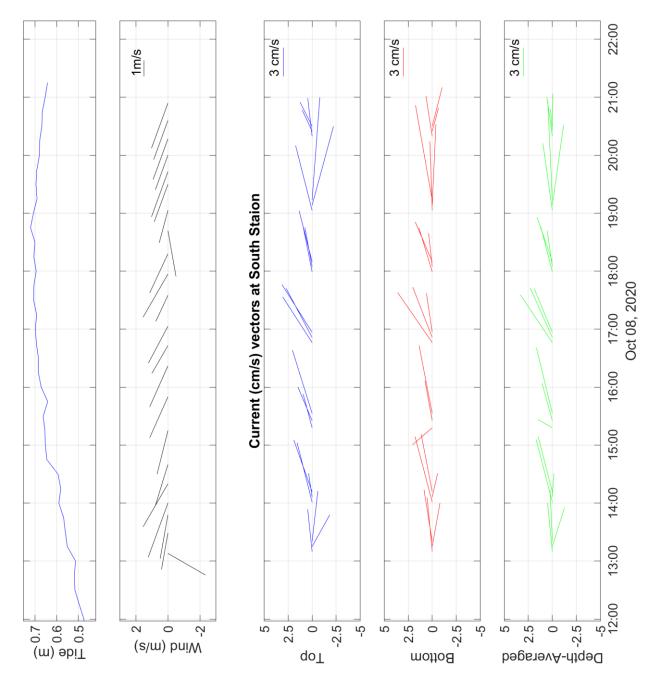
Figure 2-6b. Point Current Measurements at the South Station October 8, 2020

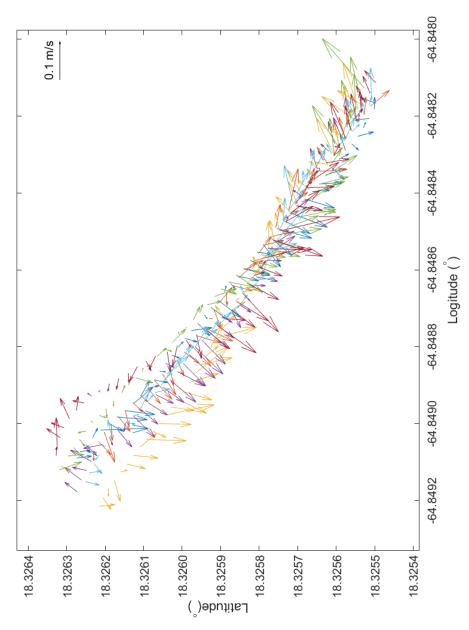
Figure 2-7. Velocity Transects October 8, 2020

Examination of the current measurements as a collective, illustrates the at or near 3 centimeters per second (cm/s). This is close to the measuring capability of the ADCP and setting up a gyre coming off Vessup Point. This creates currents that are generally pushing in on the north side, varied from pushing in to rotating southward in the middle, and then flowing out near the tip of Vessup Point. This can also be seen in the transect data presented in Figure 2the measurements. This pattern will be the primary aspect to represent in the results presented Examination of the measured currents shows that first the velocities are very low overall, generally development of a counterclockwise gyre forming at the entrance due to the winds coming out of the ESE. This make sense as the winds are blowing at an angle to the entrance from the south 7. While there is noise in the data and variation, this is the overall pattern that was seen during within the model validation section (3.4). current meter.

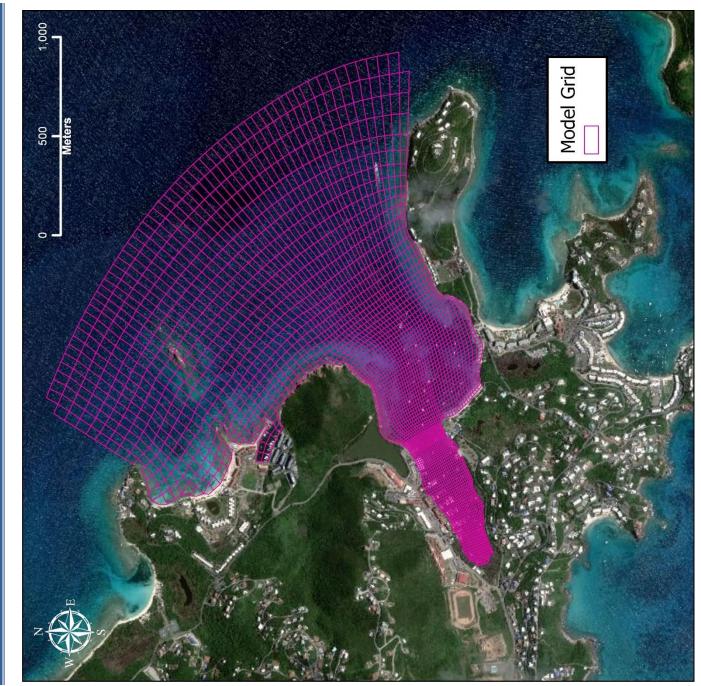
Figure 3-1. Overall Model Grid

ATM developed an overall model grid that covers a much larger region including Vessup Bay, Muller Bay, Redhook Bay, and portions of St. Johns Bay (Figure 3-1). The larger-scale domain allows currents to develop in hydrodynamic stability that force Vessup Bay and Redhook Bay

domains. The larger-scale domain also allows the transport and dispersion of conservative dye tracer into a region that is not influenced by boundary conditions. ATM discretized the domain with 3,689 horizontal grid cells and four vertical layers. The base grid is fit to the shoreline based upon aerial photography. The base grid represents present or existing conditions, prior to proposed construction. Figure 3-2 presents a zoomed-in view of the grid outlined. The only changes on the grid for the design condition and the alternatives is that barriers including Vessup Bay for the base conditions, with the proposed docks and the final design barrier are identified within the model domain blocking the grid faces that the barrier extends along. Bathymetry for the base modeling was taken from a combination of National Oceanic and of the project. The bathymetry in the vicinity of the proposed dock structures was not altered from Atmospheric Administration (NOAA) navigation charts and measured bathymetry in the vicinity the base bathymetry. Figure 3-3 shows the overall model bathymetry, and Figure 3-4 shows a zoomed-in view of the bathymetry for Vessup Bay. The datum for the bathymetry and the water levels was mean low water (MLW).
