MAJOR LAND AND WATER ENVIRONMENTAL ASSESSMENT FOR THE LATITUDE 18 VESSUP BAY MARINA

ST. THOMAS, U.S. VIRGIN ISLANDS

JANUARY 2022

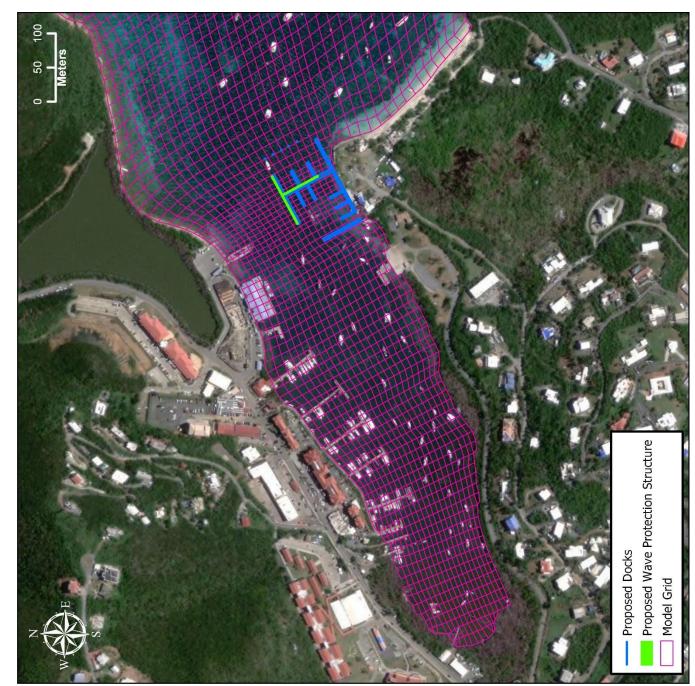
Figure 3-2. Model Grid within Vessup Bay

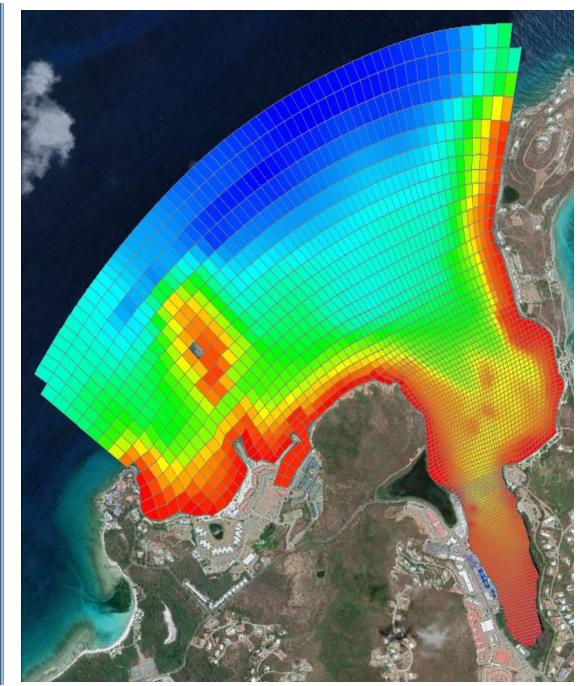
Figure 3-3. Overall Model Bathymetry

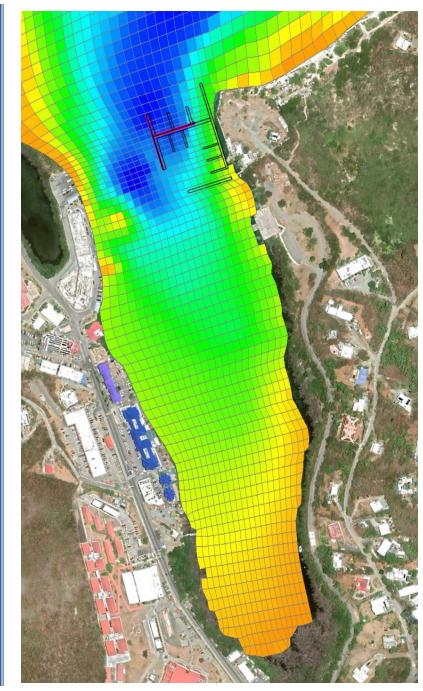
Figure 3-4. Model Bathymetry within Vessup Bay

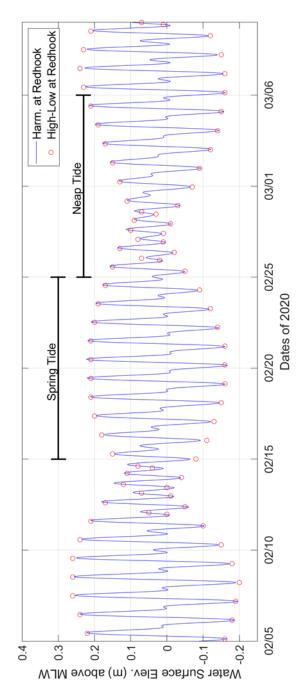
Figure 3-5. Predicted Tide (in blue solid line) Computed from NOAA High-Low tide Prediction (in red circle) at Redhook Bay

the field studies was of a relatively short duration and used primarily for the model validation To perform longer simulations, ATM performed a least-square analysis to compute tidal harmonics with the high-low tides provided from NOAA Tides & Currents at the high-low tides in red circles (Figure 3-5) for a period of time in February 2020. The range of the harmonic tides was 0.45 meters (m) from February 5 to March 10, 2020, with the dominance of Using this methodology, harmonic tide conditions were generated for the ATM forced the simulation with tides on the eastern open boundary of the domain. The data from Redhook Bay. The blue solid line presents the harmonic tide above MLW, which is calculated by periods of the simulations presented in Section 4. presented in Section 3.4. lunar diurnal (K1).

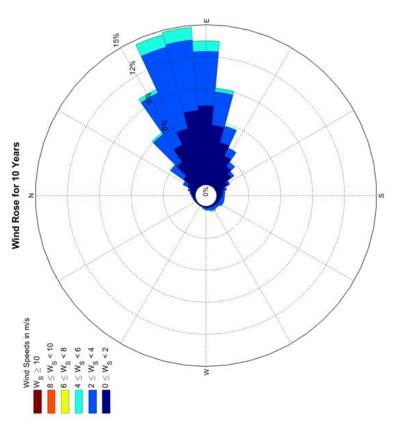
Figure 3-6. Wind Rose from January 2007 to September 2017

to September 2017, since the wind data were not recorded from June 2011 to January 2012. The wind rose (Figure 3-6) presents the distribution of wind speed and direction. Wind direction is expressed at a point from which the wind blows, for example, a northerly wind direction blows the 10-year average wind speed was 1.95 meters per second (m/s). The data were analyzed to define the average monthly wind (Figure 3-7), which was averaged by month for 10 years. This The most dominant direction, with 15 percent of the total, was 80° clockwise from the north, and ATM performed a statistical analysis for approximately 10 years of wind data from January 2007 from the north. The frequency of wind direction over a time period is described by a polar coordinate system (the circle in Figure 3-6), with color band showing the range of wind speed. Most of the wind directions were oriented from the east, which indicate the wind blew onshore. plot shows that winds are stronger in the summer and weaker in the winter.

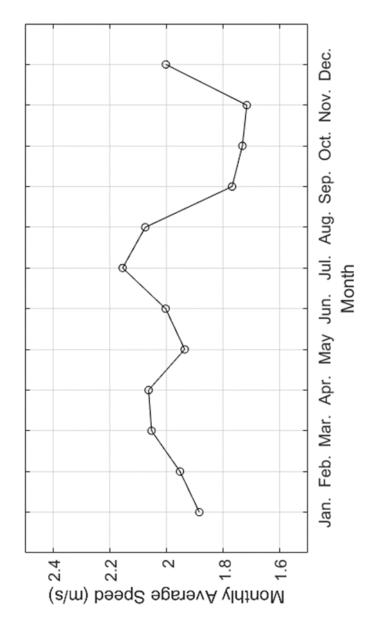
Figure 3-7. Monthly Average Wind Speed (m/s) for 10 Years

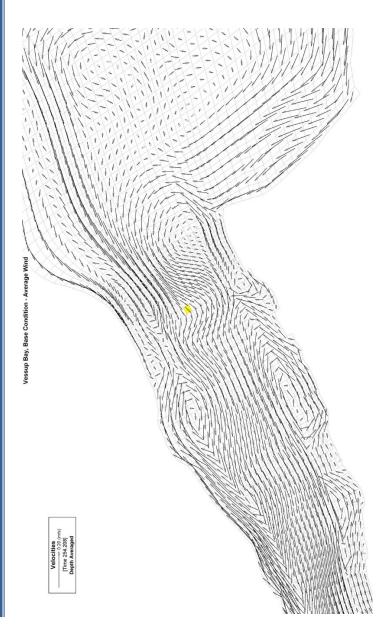
Figure 3-8a. Velocity Vectors in Mouth of Vessup Bay (Time 254.208)

Figures 3-8a and 3-8b present vector plots showing shapshots of the simulated velocity vectors. The plots show the gyre with the flows out along the edges with the flows moving into the bay in the middle. The gyre, based on the winds out of the southeast, exists model to reproduce this condition, wind shading was applied to the more nearshore areas. This at the mouth with velocity magnitudes similar to those measured in the field. In order to get the The model was run for the conditions which existed at the time of the successful velocity allowed the pattern found in the measurements to be simulated as shown in the figures. provides qualitative and somewhat quantitative validation of the model simulations. measurements in October.

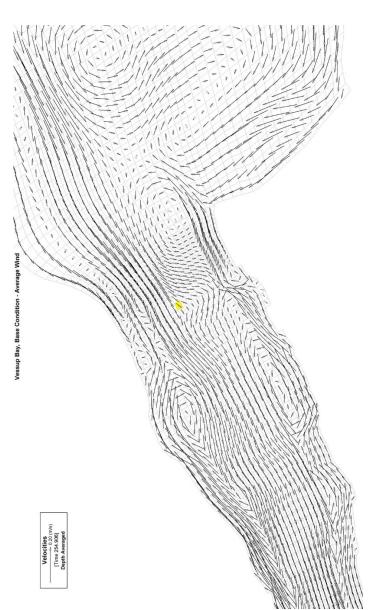
Figure 3-8b. Velocity Vectors in Mouth of Vessup Bay (Time 254.208)

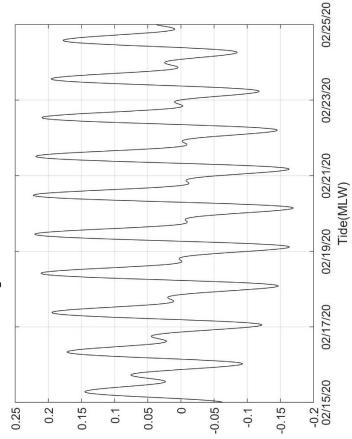
Figure 4-1. Tide Conditions for Flushing Simulations

4-1 presents the tides for the 10-day simulations presented below. The simulations start at neap tide conditions. As the tidal influence is low, and the goal is to provide a relative comparison of the flushing between the base, design and alternative conditions, rather than an absolute ATM simulated concentration of a conservative tracer forced by harmonic tide and winds. The average and high winds as defined in Section 3.3.2 along with the design conditions and alternatives. The tide conditions cycle through a spring/neap condition for the simulations. Figure model configurations in Table 4-1 describes the wind conditions for each scenario as the low, assessment of the flushing times, these conditions are reasonable for the analyses.

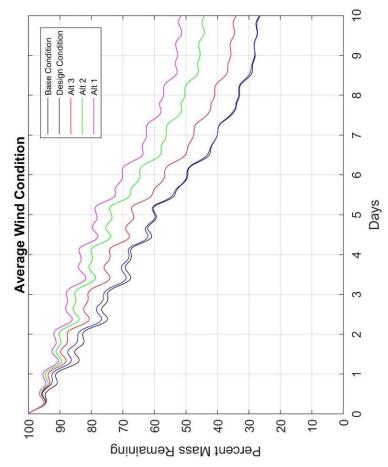
Figure 4-2a. Comparison of the Percent Mass Remaining for the Alternatives, the Design Condition and the Baseline Condition under Average Wind Conditions

Examination of the figures shows that a gap of 70 feet (Design condition) is required between the shore perpendicular wave protection structure and the shoreline in order to not significantly impact the flushing in Vessup Bay. Section 4.3 presents a more detailed presentation of the design Figures 4-2a through 4-2c present graphs of the percent mass remaining for the average wind, high wind, and low wind conditions for each alternative compared to the baseline condition. results

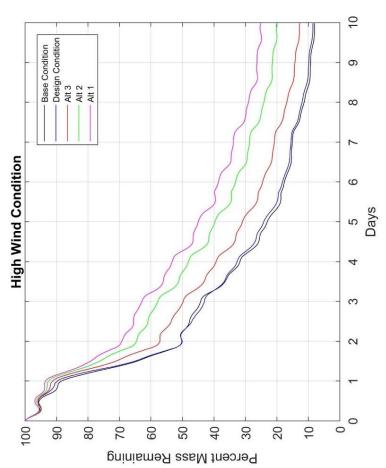
Figure 4-2b. Comparison of the Percent Mass Remaining for the Alternatives, the Design Condition and the Baseline Condition under High Wind Conditions

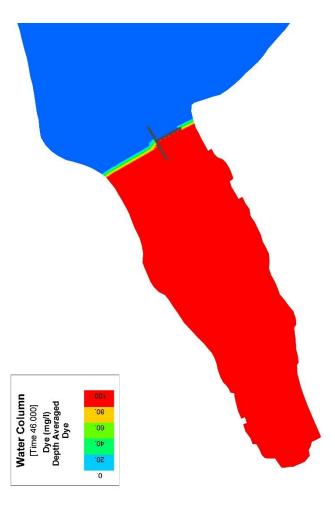
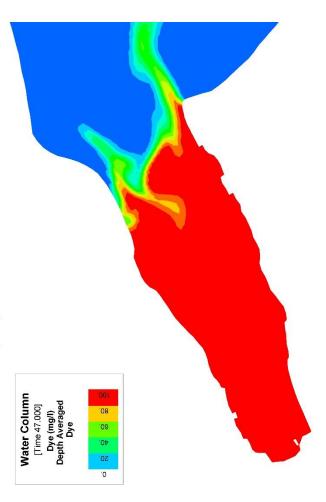
Figure 4-3a. Base and Design Vertically Averaged Dye Concentrations for Low Wind Simulation (Day 0)

Vessup Bay, Design Condition - Low Wind

dye exchanging into and out of the system reflect the findings from the field observations with the general pattern of movement into the bay through the middle and out of the bay along the edges. This is also the case with the design wave protection structure in place. Second, the degree of flushing in the system is a function of the wind conditions, with the highest level of flushing occurring during the higher wind conditions and the overall level of flushing decreasing as the Examination of the plots shows a number of aspects. First, the patterns of the movement of the lower winds are used in the simulations.

flushing of the bay. While the snapshot plots show some trapping that occurs in the area of the structure and its influence is clearly seen in the local dye patterns in the immediate vicinity, the overall levels of exchange are not altered in a significant way. The time series plots for all the wind conditions show only minor differences, with the overall percent mass remaining at the end under the proposed design condition with the 70-foot gap, does not significantly impact the overall The most significant finding from the results is that the inclusion of the wave protection structure, of the 10-day periods nearly identical for all wind conditions.

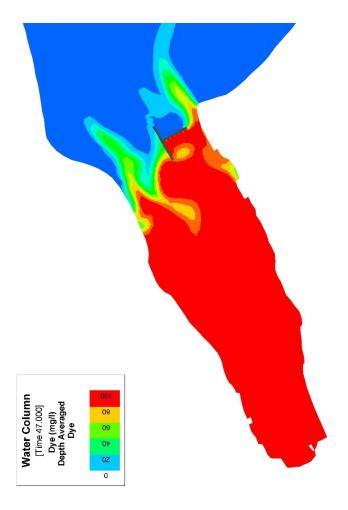
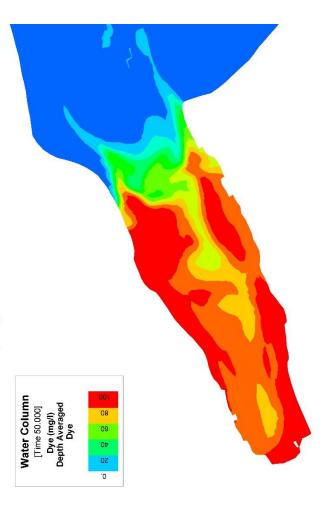
Figure 4-3b. Base and Design Vertically Averaged Dye Concentrations for Low Wind Simulation (Day 1)

Vessup Bay, Design Condition - Low Wind

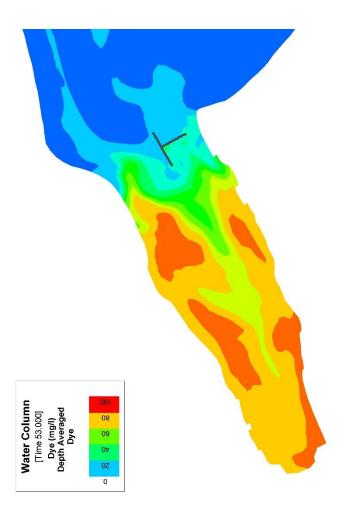
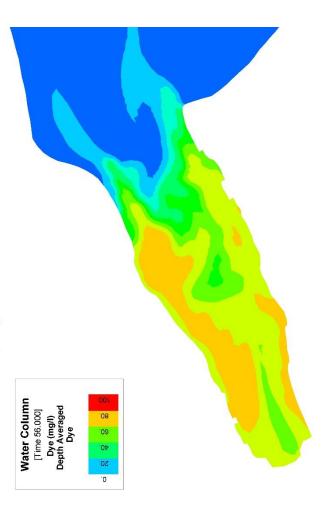
Figure 4-3d. Base and Design Vertically Averaged Dye Concentrations for Low Wind Simulation (Day 7)

Vessup Bay, Design Condition - Low Wind

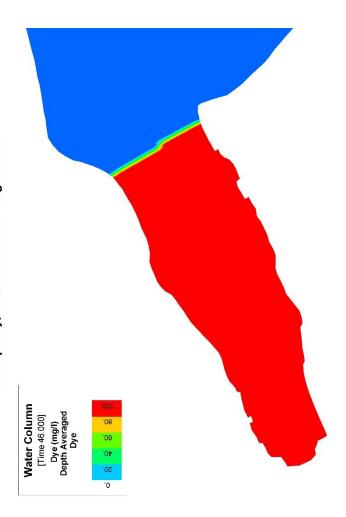
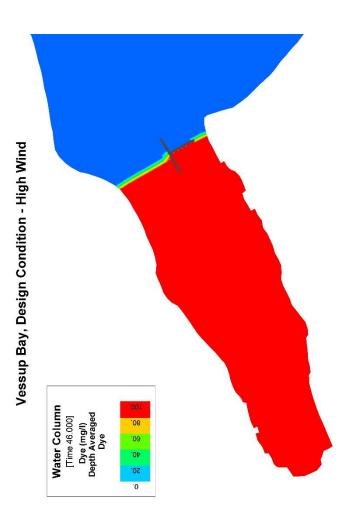
Figure 4-5a. Base and Design Vertically Averaged Dye Concentrations for High Wind Simulation (Day 0)

Vessup Bay, Base Condition - High Wind

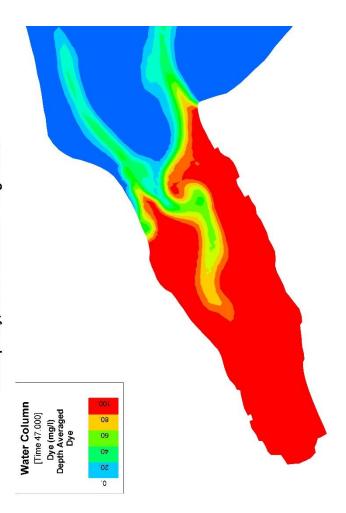
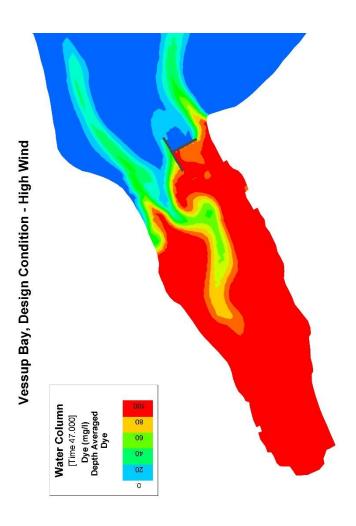
Figure 4-5b. Base and Design Vertically Averaged Dye Concentrations for High Wind Simulation (Day 1)

Vessup Bay, Base Condition - High Wind

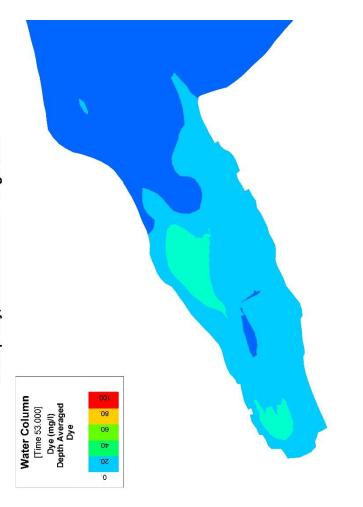
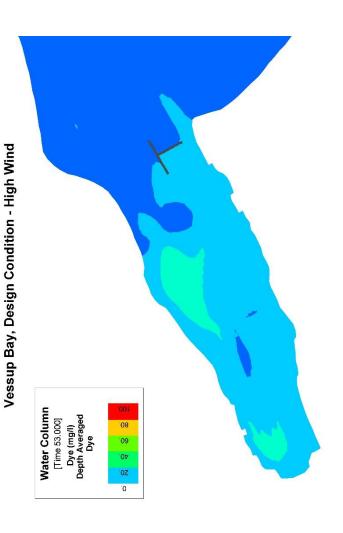
Figure 4-5d. Base and Design Vertically Averaged Dye Concentrations for High Wind Simulation (Day 7)

Vessup Bay, Base Condition - High Wind

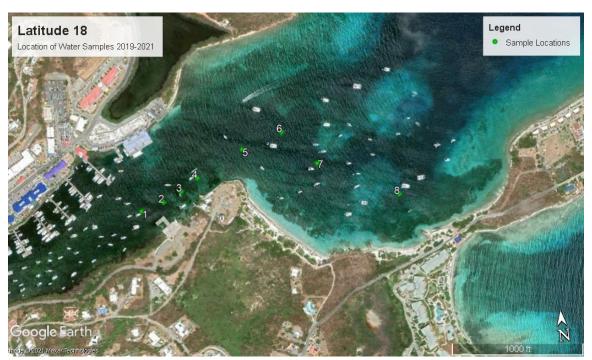
Water sampling has occurred on the site over the last several of years in order to establish a baseline of water quality conditions. Samples were taken with a calibrated YSI EXO multi-meter and were taken at a depth of 1 meter. The samples from 2019 and the beginning of 2020 were focused within the marina. As the idea of a managed mooring field was considered additional sampling locations were added (Table 1). Samples were also taken during the current study which are provided in Table 2. The map below shows the location of the samples.

Figure 3 Location of samples taken between 2019 and 2021

Water quality samples will be taken 5m outside the turbidity barriers immediately offshore of where the current work is ongoing. Three sites will be taken approximately 10m apart with the central point immediately off of the area of work. The monitor will also take samples in any plume that is noted coming through the turbidity barriers. The monitoring samples will be placed in the areas most likely to be impacted by the project. Control sites will be established in areas which should be exposed by the same ambient conditions but should not be impacted by the project's activities. Two control sites will be established one to the east and one to the west. These will be taken at Stations 1 and 8 shown in Figure 3.

A baseline of water quality conditions has been established of water quality conditions at the site prior to any work, eight samples were taken evenly spread along the length to the project area (Figure 3). This data will be used to compare with construction water quality.

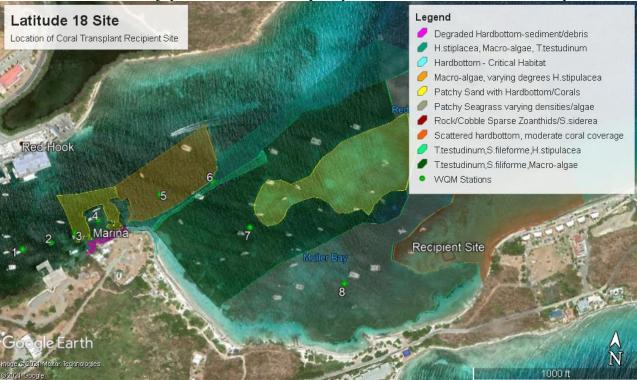
Figure 1. Location of transplant recipient site.

The recipient site is south of the proposed managed mooring field and is an area of broken pavement which enjoys excellent water quality. The corals will be planted at a similar depth from that they were taken from. The area has scattered *Pseudodiploria* and *Siderastrea*.

The intent is to transplant the 12 corals within the marina footprint to east to the large area of hardbottom. The area enjoys much better water quality than where the corals are currently located.

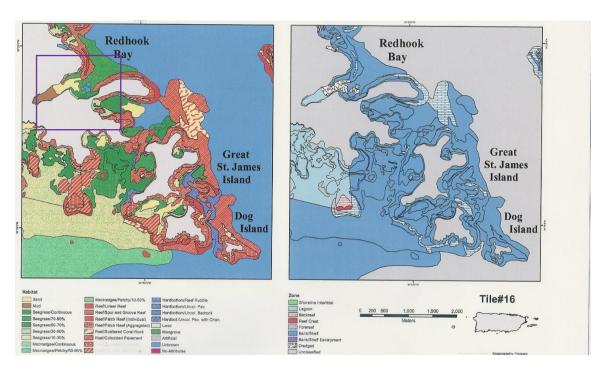
The NOAA NOS Benthic habitat map, depicts. This is an accurate description of the benthic habitats within the area. The NOAA NOS map is provided below followed by a benthic habitat map. Inner Vessup Bay is shown as mud with small areas of seagrass along the sides of the bay. The inner harbor is heavily algal colonized, and there is sparse seagrass along the edges. The area immediately off the marina site is shown as sand. This area is colonized by scattered algae and *H. stipulacea*. The NOS map shows seagrass 70-90% offshore, this area is more in the order of 30-40% and this area is highly impacted by *H. stipulacea*, anchors, ropes, and debris. The NOS map shows seagrass continuous along the eastern shoreline, again the seagrass is closer to 50%. The map shows an area of dredging in the bay which shows in the historic aerials shown in Section 6.02.

Figure 6.06.1. NOS Benthic Habitat Map Tile 16. Great Bay is shown within the blue box, and the project site is indicated by the red star.

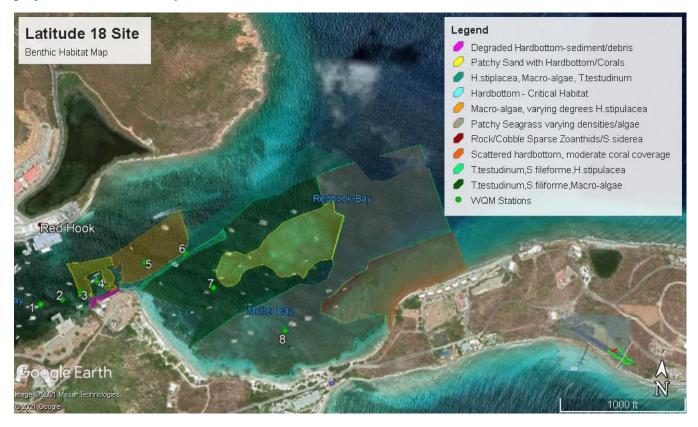
Figure 6.06.2 Benthic Habitat in the marina area
