2014 Department of Planning & Natural Resources Division of Environmental Protection Water Quality Management Program ing & Assessment Repor **USVI Integrated Water Qualit**

The 2014 USVI Integrated Water Quality Monitoring & Assessment Report intends to satisfy the USVI requirements of the Federal Clean Water Act Sections 305(b) and 303(d).

Department of Planning &Natural Resources
Division of Environmental Protection

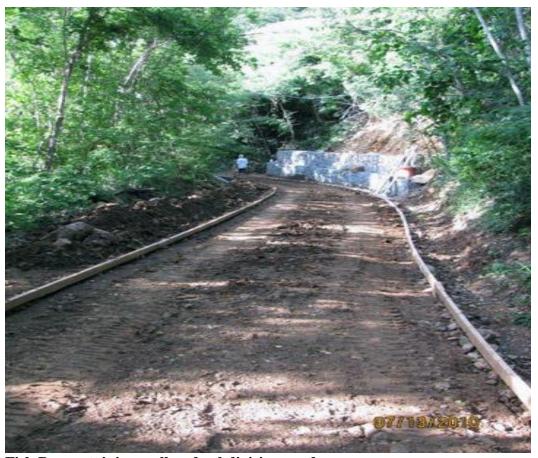
Fish Bay: retaining wall and subdivision road.

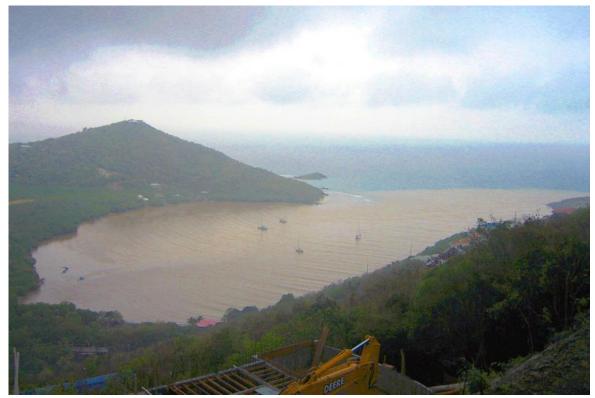
Coral Bay: sediment damage from http://www.usvircd.org/NOAA-ARRA_Grant.htm

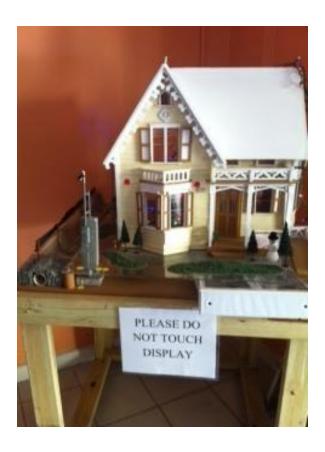
Fig.4 Model house depicting the use of gabion baskets and erosion control straw matting as a

best management practice (BMP's)

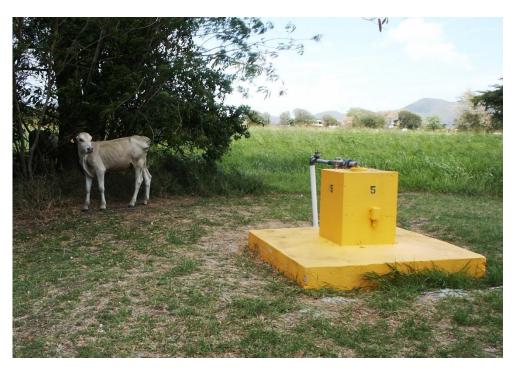
Figure IV.C.10. WAPA well with typical platform and riser.

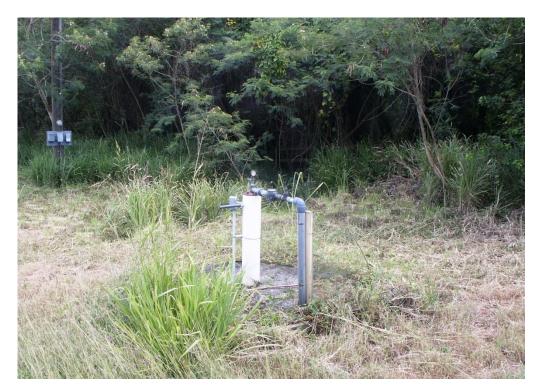
Figure IV.C.11. Untypical WAPA well.

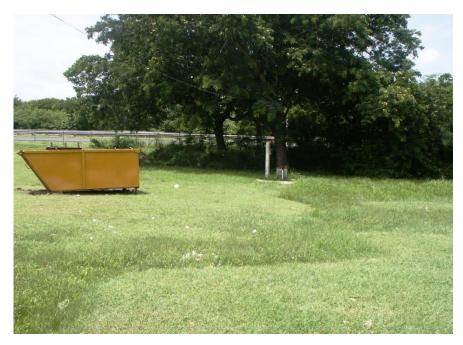
Figure IV.C.14. Well with possible surface sources of contamination; note ditch from cistern/wastewater overflow and dumpster.

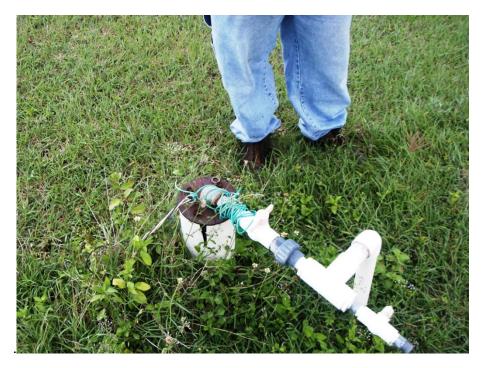
Figure IV.C.15. Wellhead with compromised sanitary seal and cut in casing.

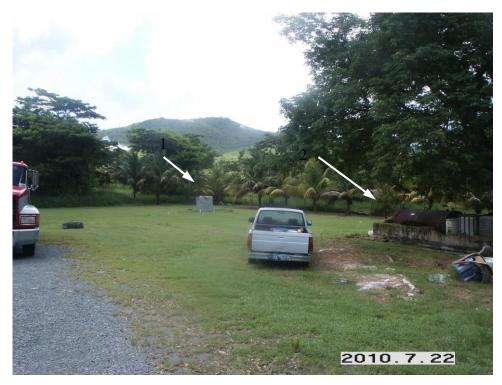
Figure IV.C.17. Francis Water Site; 1 is well house, 2 is oil tank and ditch.

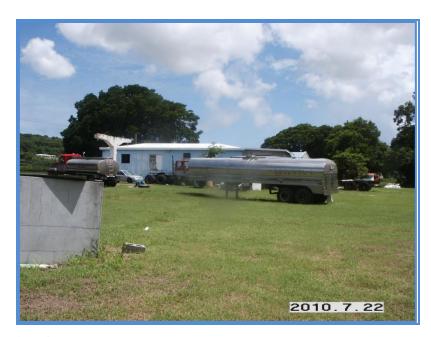
Figure IV.C.18. View from North, near well house. Note slope towards well.

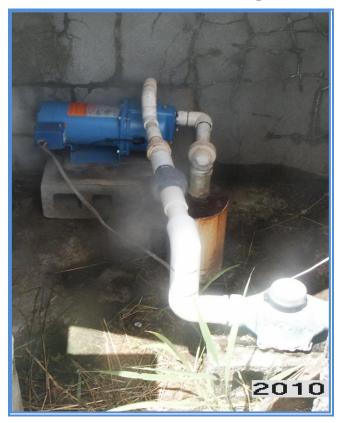
Figure IV.C.19. Well head and pump, shallow Francis Water Delivery well.

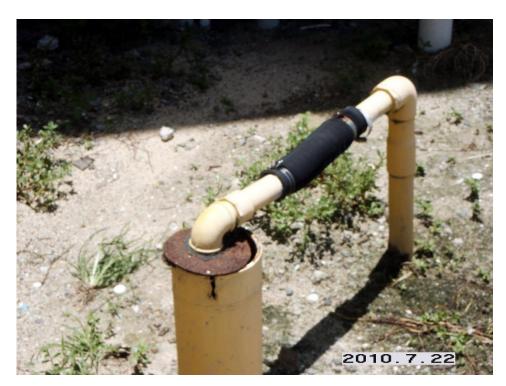
Figure IV.C.20. Laundromat well without effective seal.

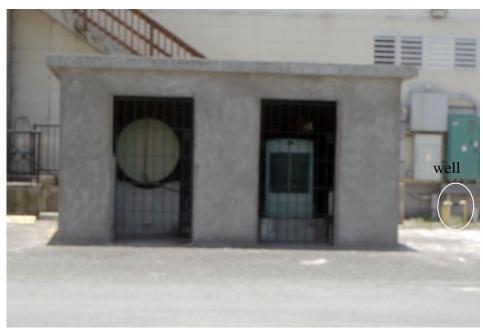
Figure IV.C.21. Diesel tank without containment adjacent to well.

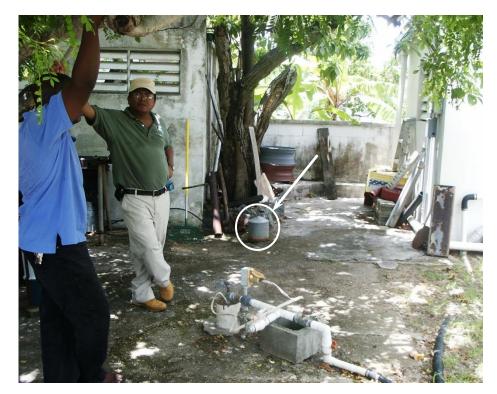
Figure IV.C.22. Production well for vendor; note the galvanized cover.

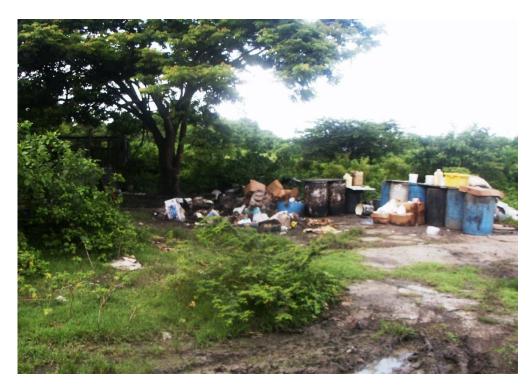
Figure IV.C.24. Trash near Bethlehem Ghut and wells.

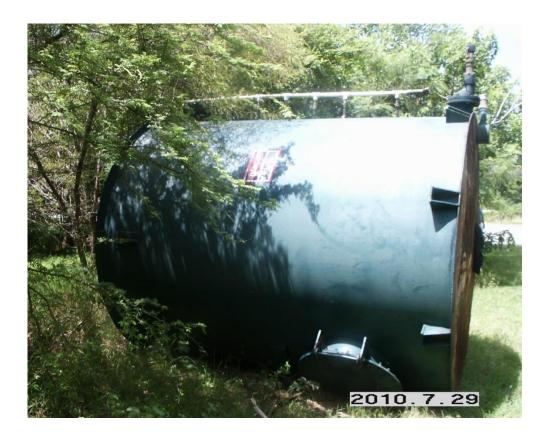
Figure IV.C.25. Abandoned Caustic tank near Bethlehem Ghut and wells.

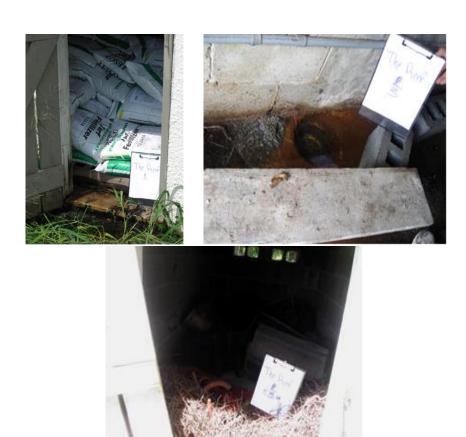
The follow-up compliance inspection a meter was place.

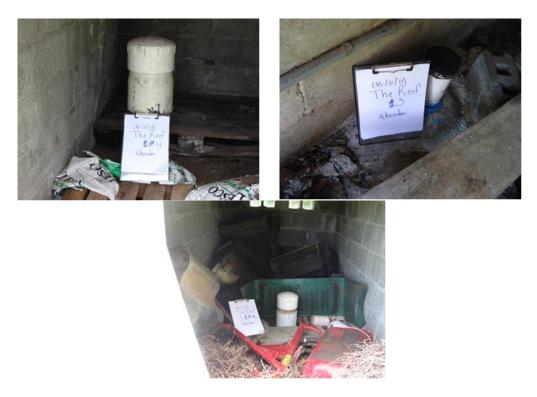
The initial inspection show inactive wells that not were seal and abandon properly.

The follow-up compliance inspection all the wells were seal and abandon properly. 2014 USVI Integrated Report Page **214** of **268**

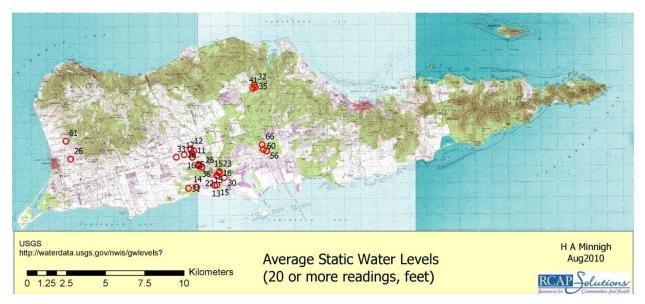
Figure IV.C.27. Average Static Water levels in wells on St. Croix.

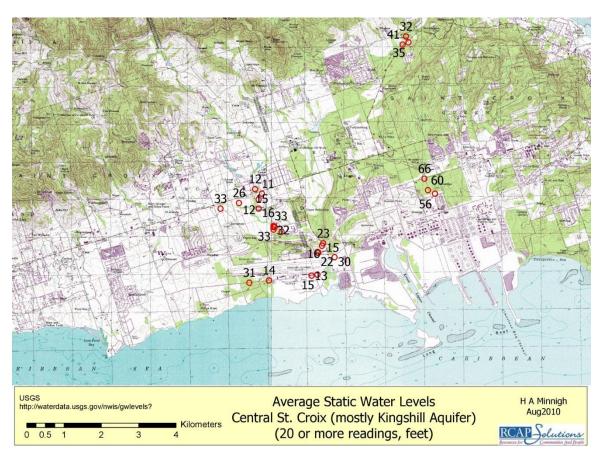
Figure IV.C.28. Static water levels, central St. Croix.

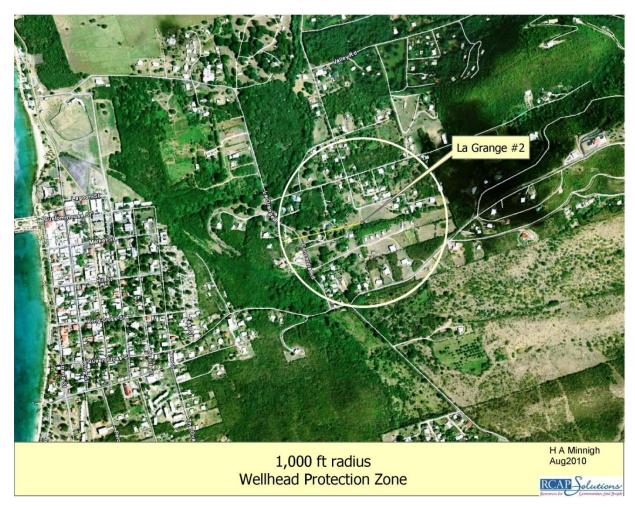
Figure IV.C.30. Wellhead Protection Zone, La Grange
