# The 2006 Integrated Water Quality Monitoring and Assessment Report for the United States Virgin Islands September 21, 2006

**Submitted by the Division of Environmental Protection, Department of Planning  
and Natural Resources, Government of the Virgin Islands of the United States**

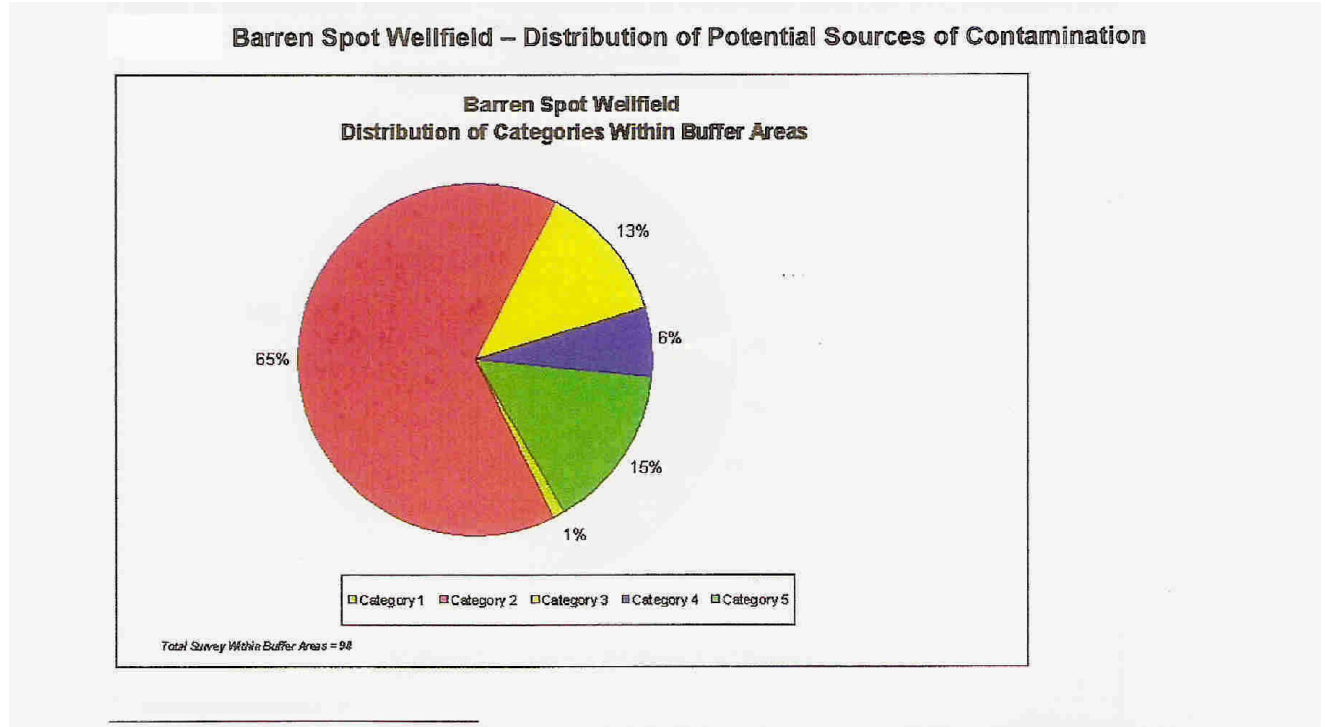
**Figure IV.C.3 Typical distribution of potential sources of contamination within a WHPA**
