**CZM PERMIT MODIFICATION - MAJOR LAND NO. CZX-11-18(L)**

RANDALL "DOC" JAMES RACETRACK RECONSTRUCTION

Environmental Assessment Report

RANDALL "DOC" JAMES RACETRACK  
RECONSTRUCTION  
AIRPORT ROAD, ST. CROIX, U.S.V.I.  
**Modification to Existing Permit No. CZX-11-18(L)**

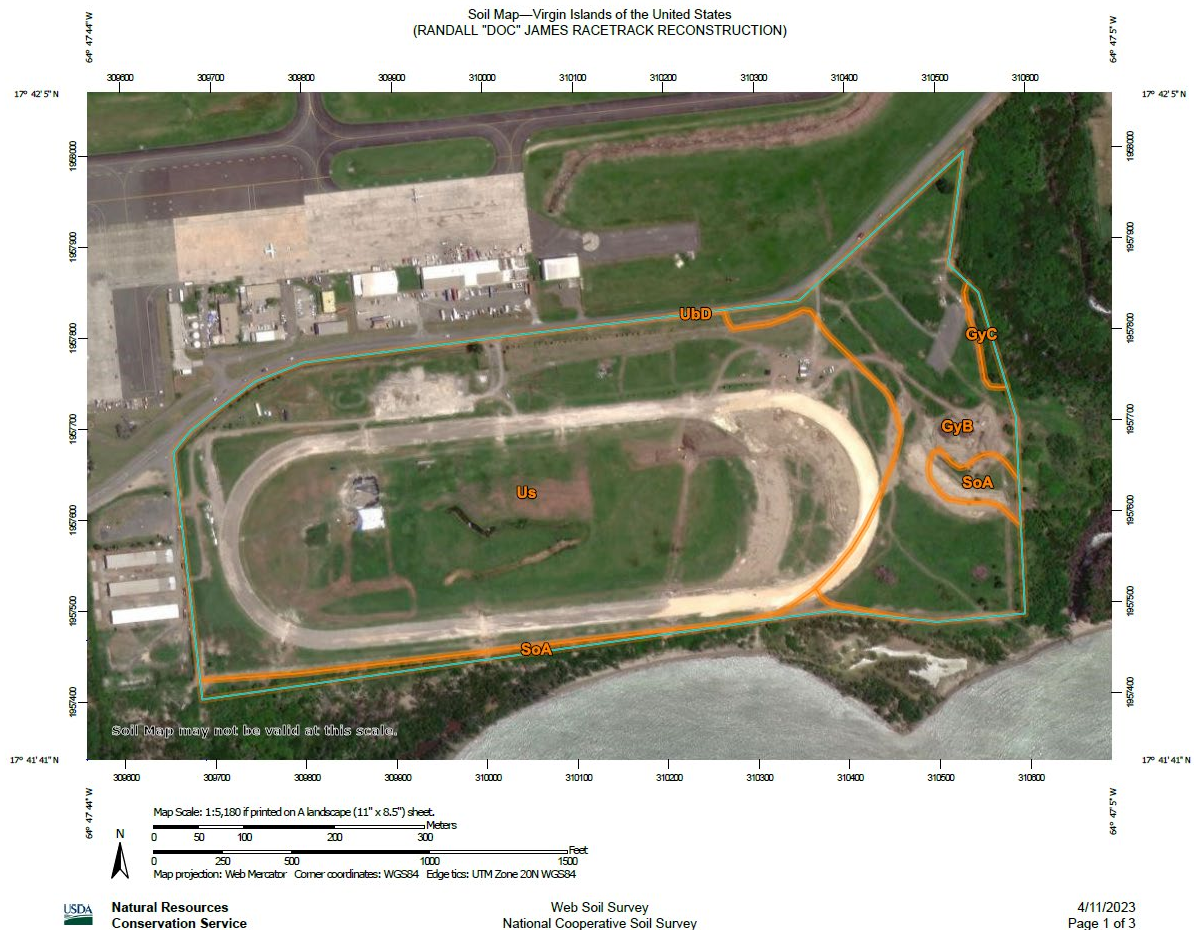
Figure 6.02.4 – Natural Resource Conservation Service Soil Type Map

The project site is located at 17°41'51.2"N 64°47'26.9"W in the South Shore due South of the Henry E. Rohlsen Airport. The Custom Soil Survey by the National Resource Conservation Service (NRCS) identifies the soil types for the project area as Ustorthents (Us) with Glynn gravelly loam (GyB) to the east of the main parcel.

It is not prone to flooding or ponding, and this area has very little slope (<2%) in its current state. Elevation at the project site ranges between 5-20 feet above sea level.
