# FIFA Soccer Field Hydrology Report

Prepared for USVI Soccer Federation

# Hydrology Study Report

Pre-development versus post-development analysis for the 5-acre site located at N-1 Estate Nazareth, St. Thomas, VI.

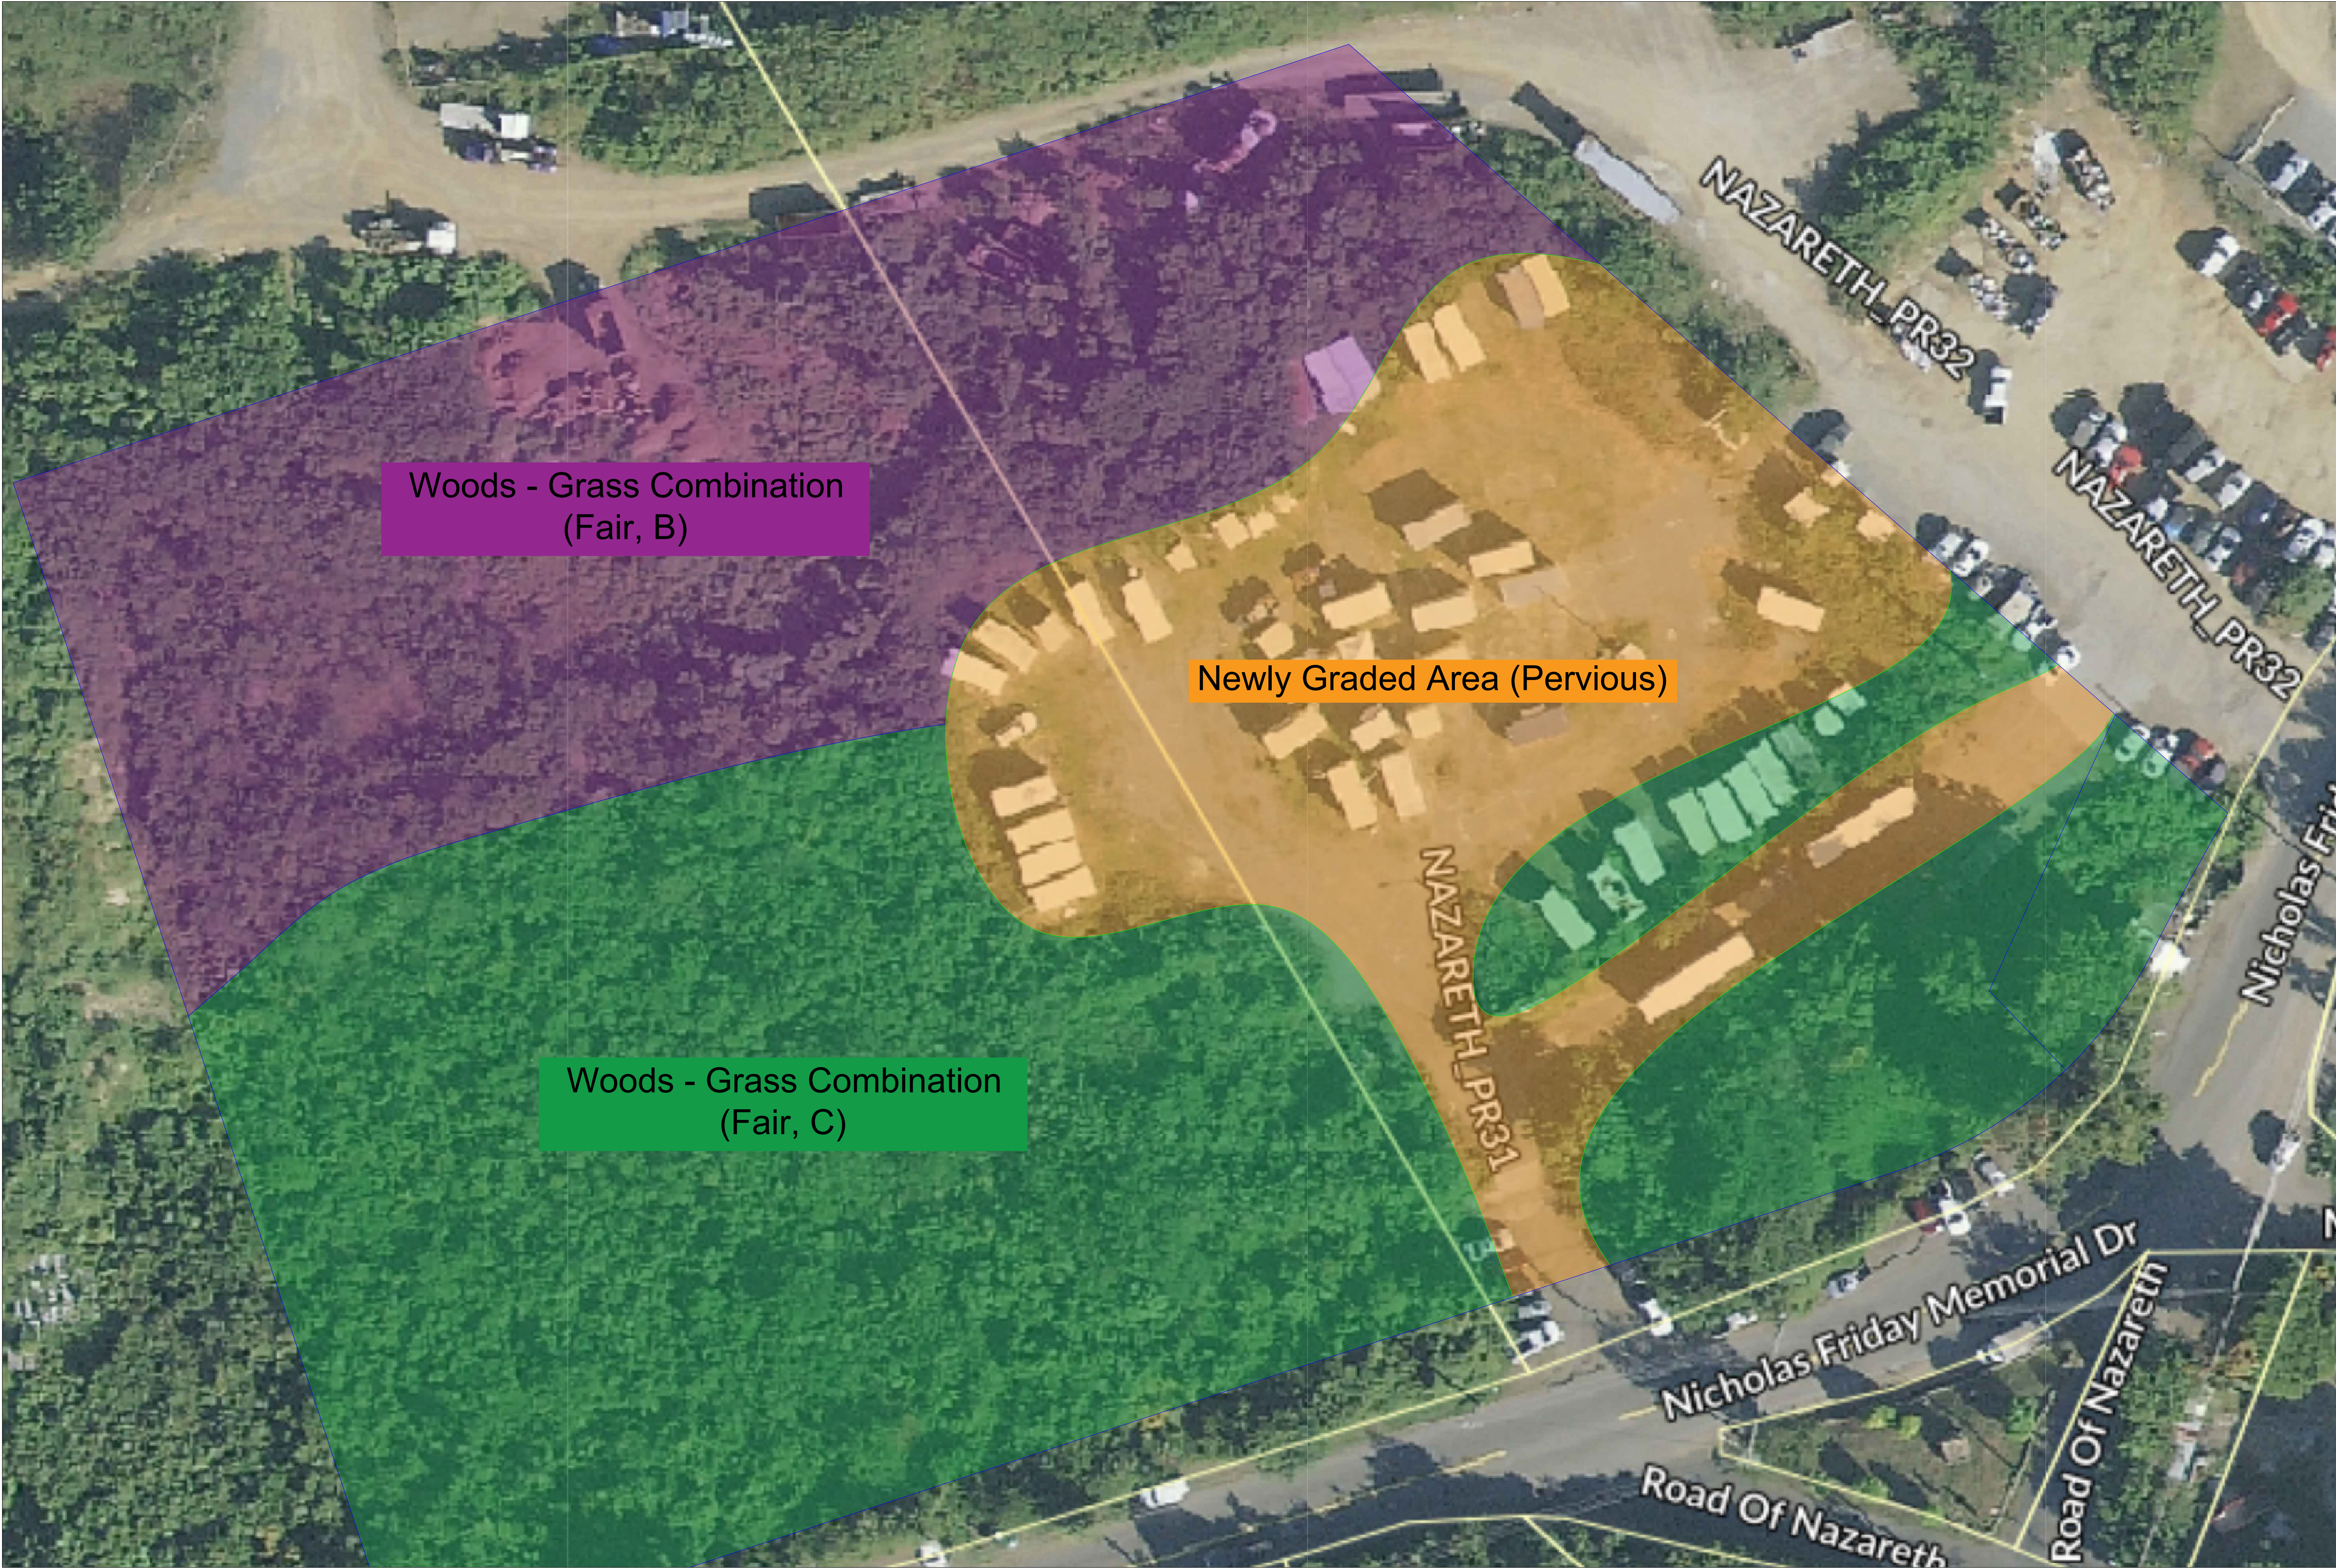
1.1

Pre-Development  
Conditions

The drainage for the property slopes from north to south and mainly discharges into an existing swale that traverses also west to east across the south border of the property. The ground cover for the existing conditions for the property is a mixture of woods/grass combination and newly graded area. The post development conditions considered that both the field and buildings were being constructed, including all the parking and driveway areas for all areas. The post development conditions considered the soccer field and parking lot as permeable surfaces, as discussed in previous meetings with the Soccer Federation, and driveway and building areas as impervious surfaces. The other disturbed surfaces will be covered with grass beyond the buildings, parking and driveways. The design point for the pre-and-post development conditions was taken at the southeast corner of the site where the exiting swale leaves the property.

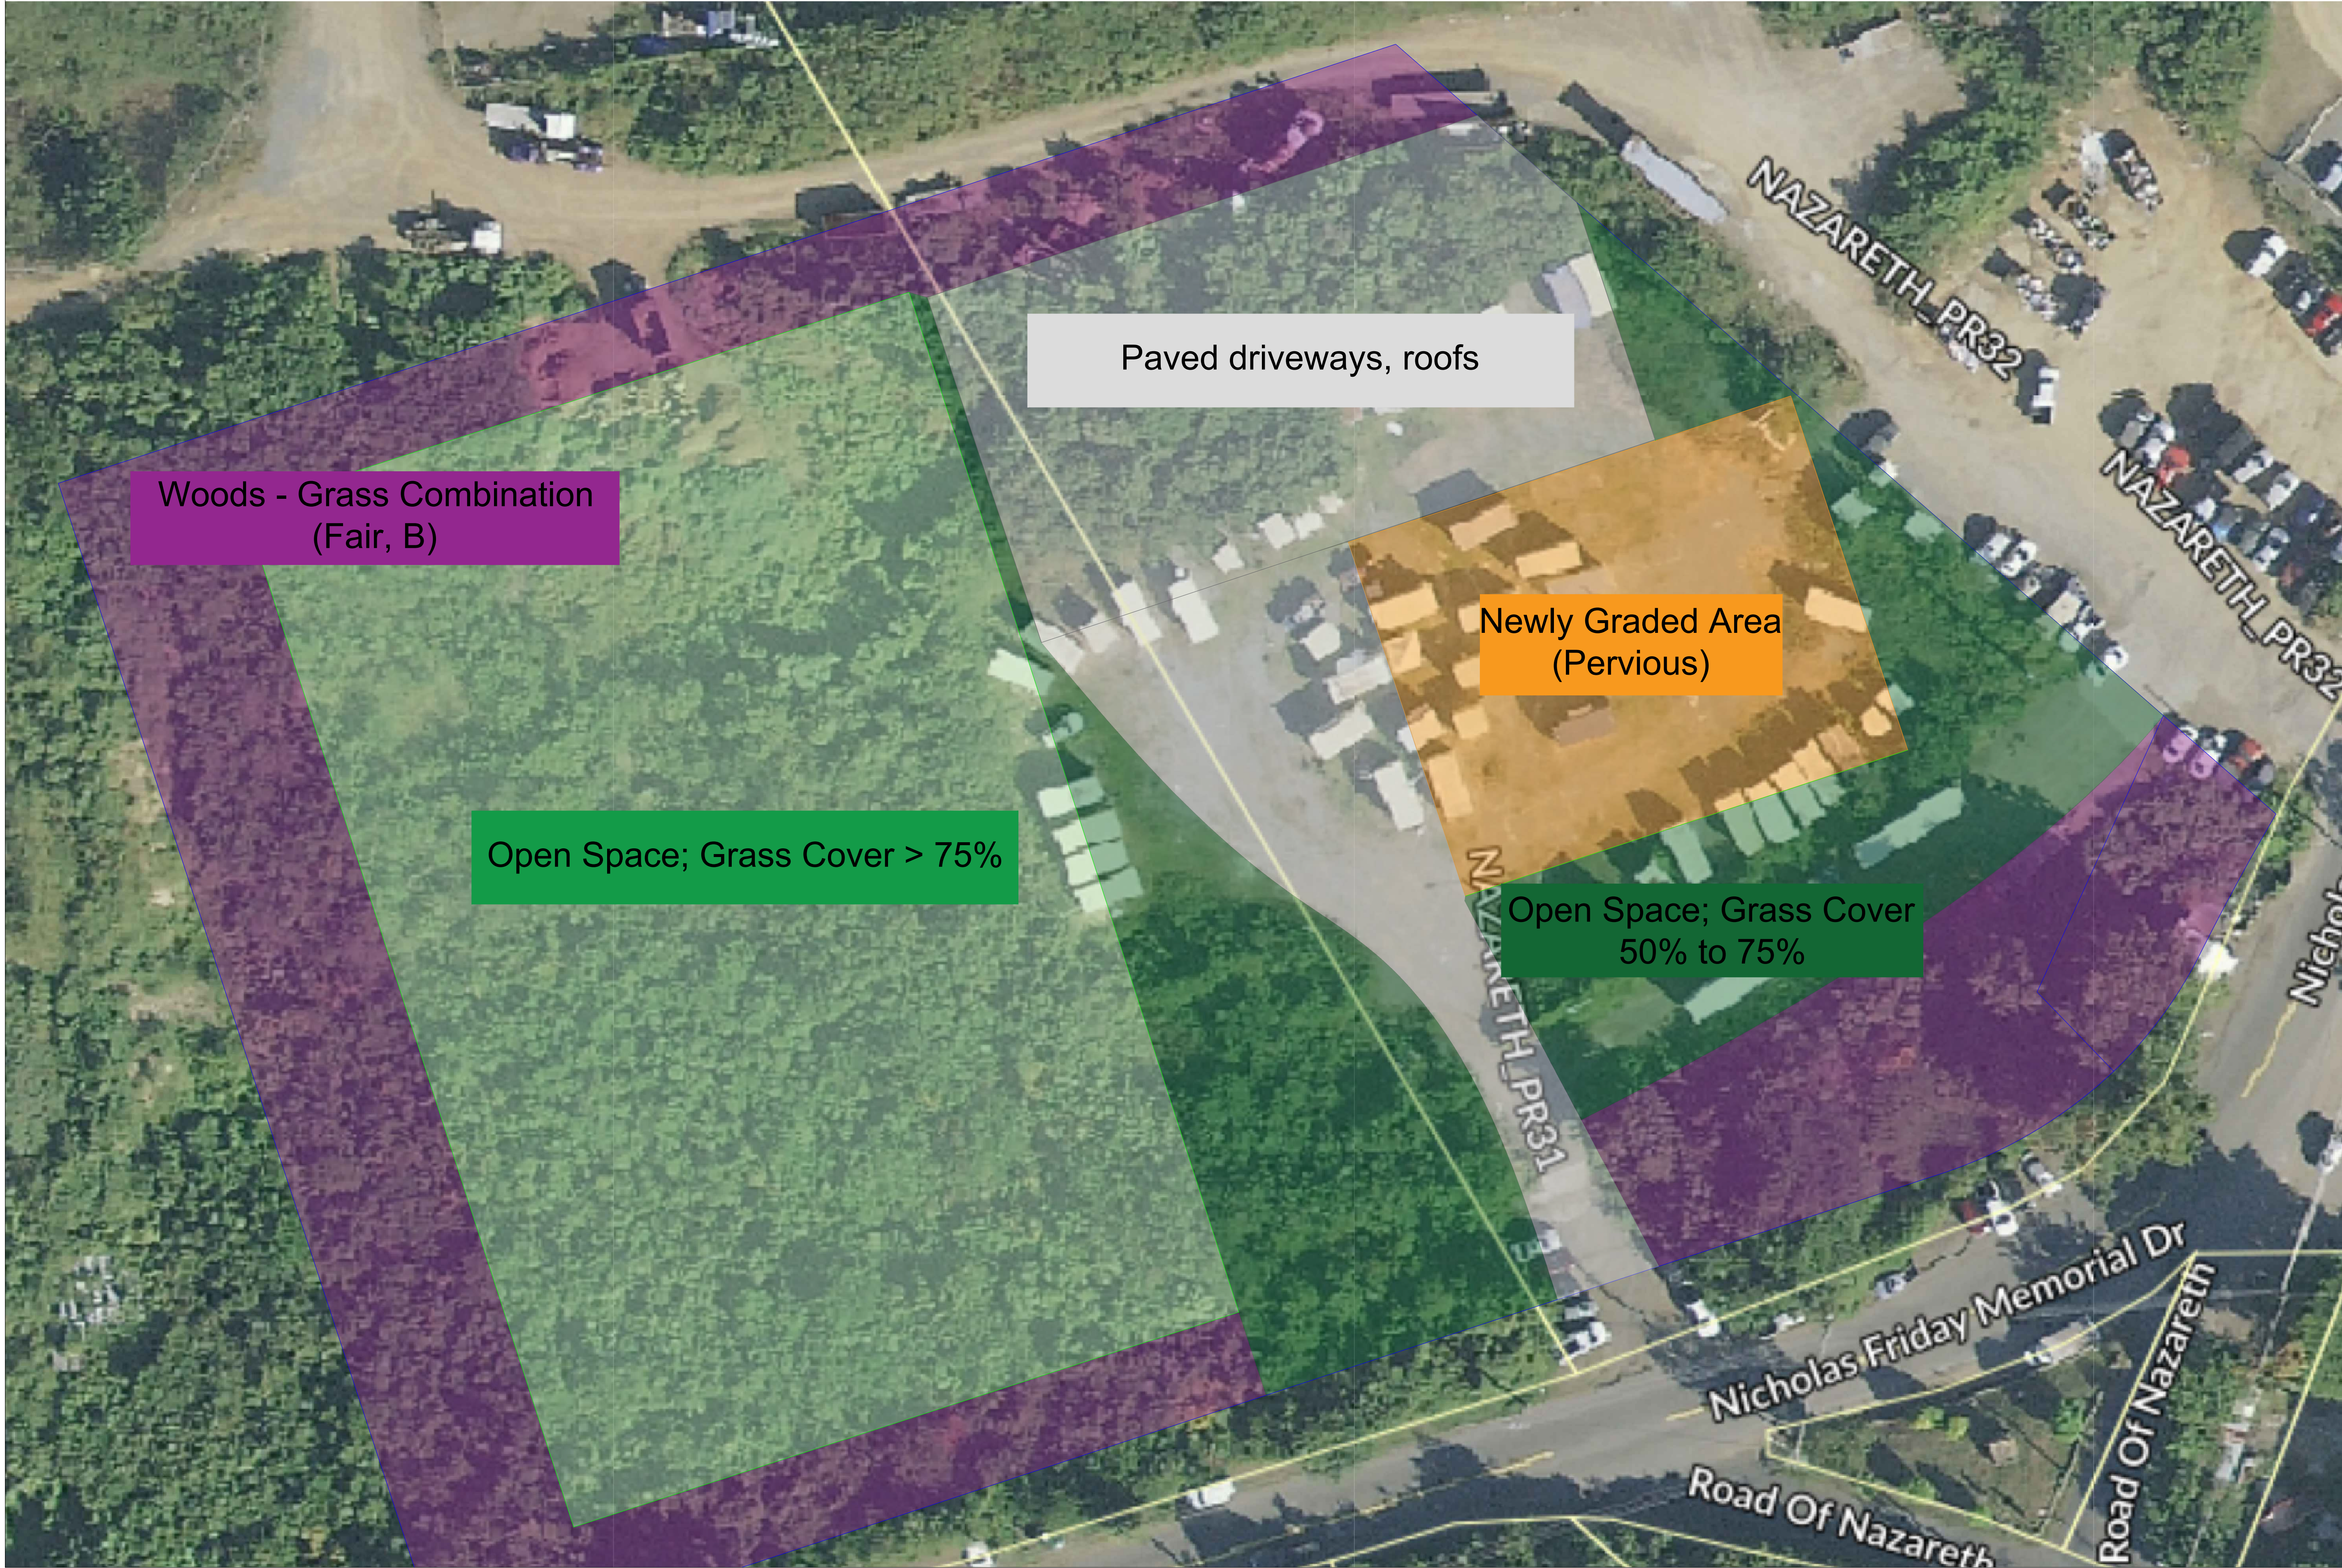
Post-Development  
Conditions

The proposed BMP, a permeable soccer field and parking area with overflows into the existing swale, was sized to maximize peak discharge reduction benefits during the 1-year storm event and to provide water quality treatment for the 1.1" rainfall event, the 90th percentile rainfall event. A peak flow comparison can be seen in Table 1 below. The modeling results support that the proposed BMP is adequately sized to reduce stormwater flows associated with 1-year 24hour storm event (2.82 inches). The stormwater flow is controlled by the permeable field and parking area with gravels bases and potential underground graywater storage capabilities, with overflows piped directly into the existing drainage swale along the road.
